A Drainage Solution

SOLVING A DIFFICULT DRAINAGE PROBLEM

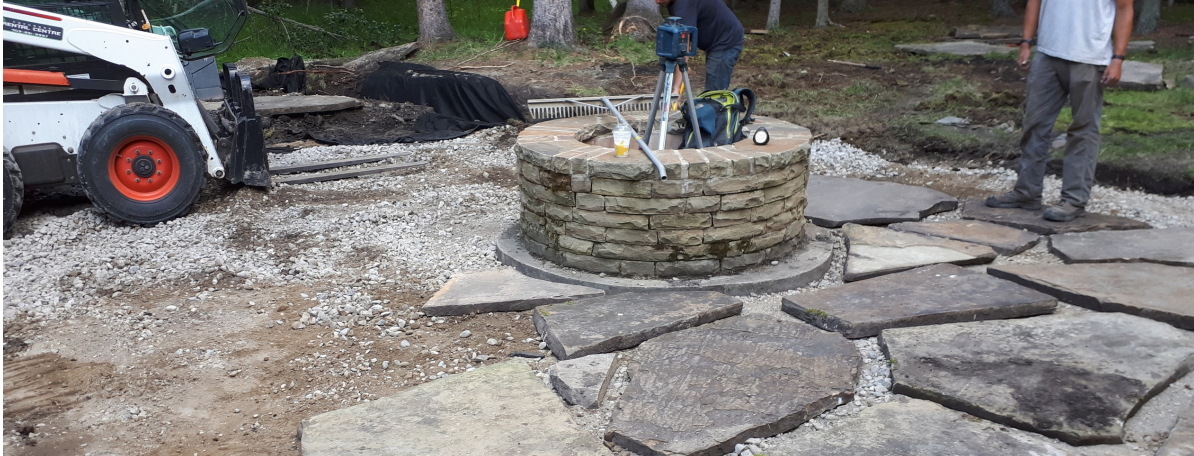
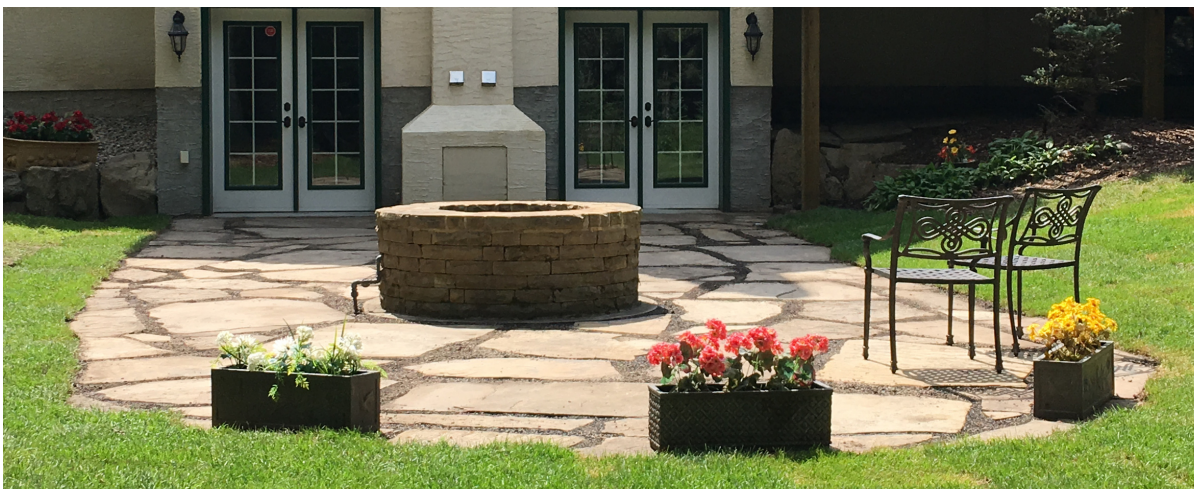
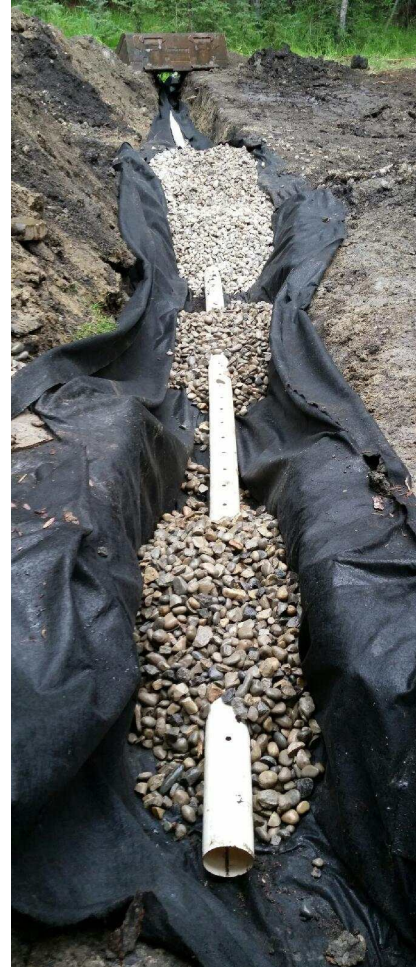
One particular backyard we had the privilege of renovating featured a flagstone patio and fire pit extending out from the basement door. The patio was set in a wooded backyard with a seasonal stream just beyond the patio. The problem with this backyard however, was that the patio was the lowest

point; it had no ability to drain and the result was perpetual soft ground and constant heaving of the flagstones. Having been asked to “fix it”, our solution involved the installation of two French drains on both sides of the patio that would then drain into the seasonal stream. Since the walk-out basement door was a fixed point of the patio, we couldn’t simply raise the elevation of the patio.

Hence, the French drains allowed us to keep the existing grade, but still drain the water out of the area. Having completed the French drains, we rebuilt the flagstone patio with a deeper rock base ensuring it was built on a layer of geotechnical fabric.

This allowed the load to be spread more evenly over the softer subsoils, preventing them from protruding into the clean rock base and compromising its’ load-bearing ability. Geotechnical fabric is a component that is often overlooked in base construction. It may not seem like a big differentiator, but the difference can often be noticed within 12 months of an installation. We are happy to say that the installation has maintained its’ integrity for over three years and should continue to offer a functional backyard space for years to come!
