# VIKING INSPECTIONS

# PROPERTY INSPECTION REPORT

205 Carriage Trail Lucas, TX 75098

Amy Motsenbocker  Name of Client  205 Carriage Trail, Lucas, TX 75098	12/02/2024 8:00 am  Date of Inspection		
Address of Inspected Property			
Michael Salazar	#20995		
Name of Inspector	TREC License #		
Name of Sponsor (if applicable)	TREC License #

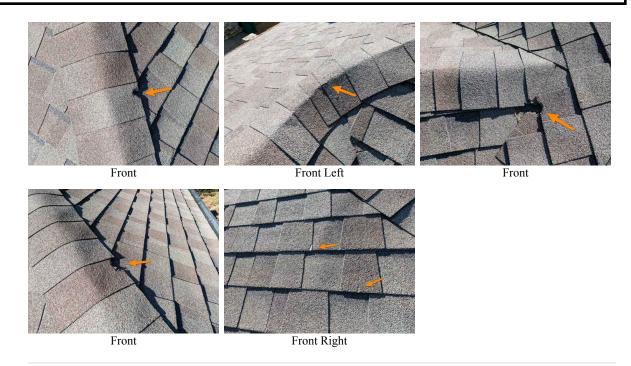
## 2: Flashing Loose/Missing/Damaged

Flashing was loose, missing, or damaged. A roofing contractor should evaluate the flashing details and make any needed repairs.

Recommendation: Contact a qualified roofing professional.
