HOME INSPECTIONS

Inspection Report

Property Address:
3926 Pacific Pl
Mukilteo WA 98275

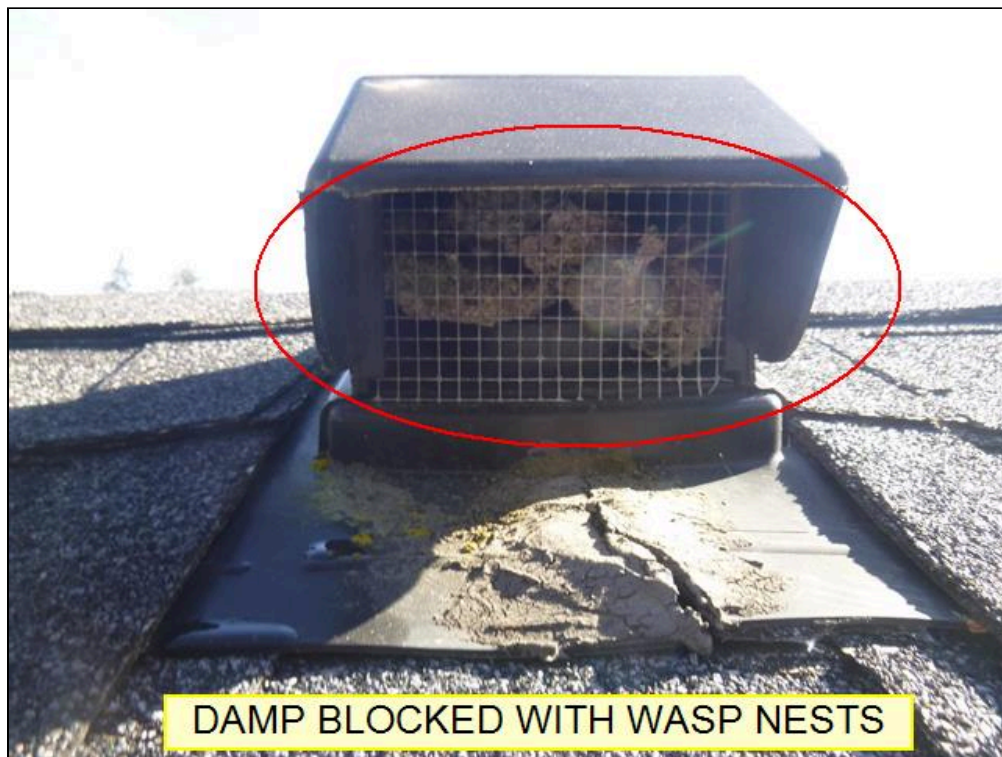
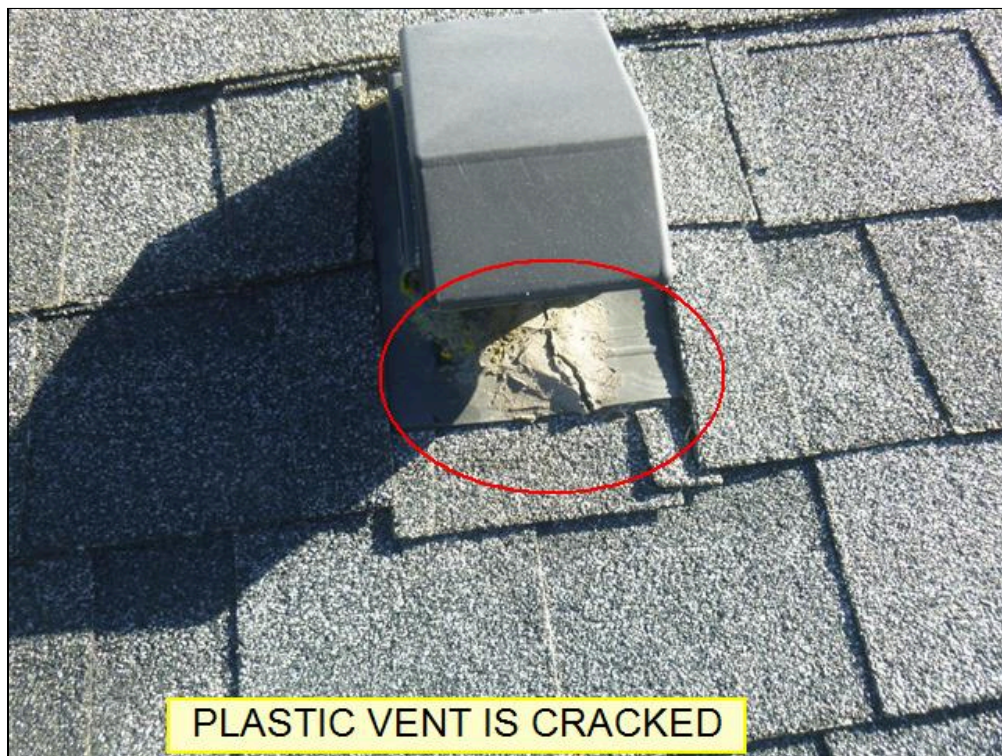
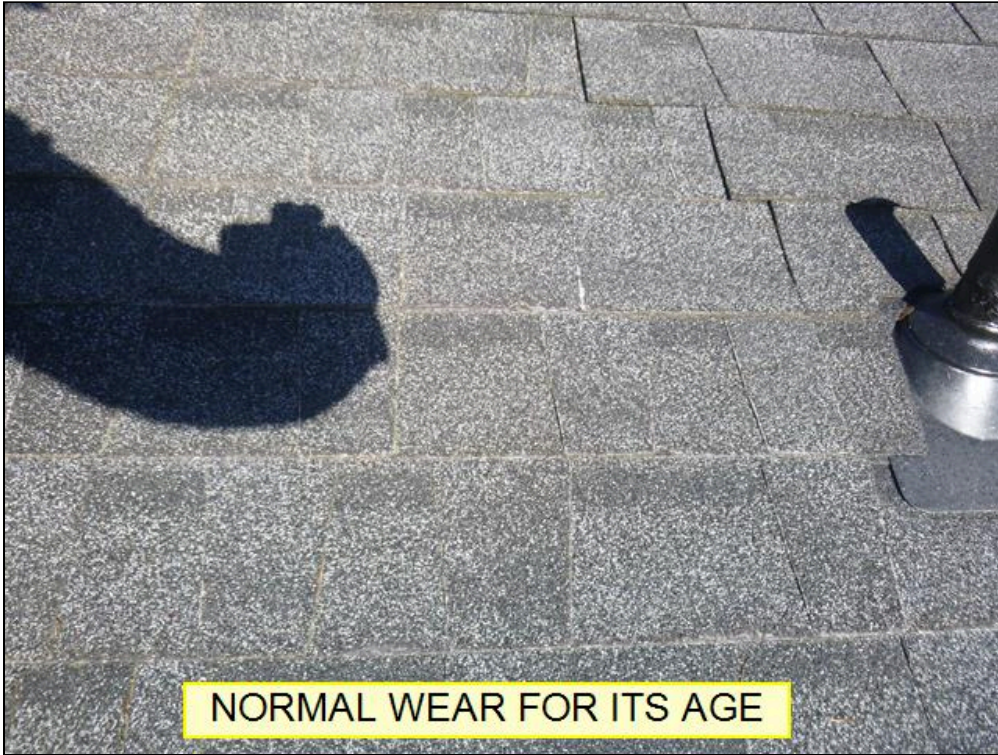
1.2 LARGE CRACKED AT THE BOTTOM OF ONE OF THE ROOF VENT CAPS FOR A BATHROOM FAN. FAN DAMPER IS ALSO BLOCKED WITH WASP NESTS. ROOFING MASTIC IS COVERING THE CRACKED, BUT HAS SINCE FAILED. RECOMMEND REPLACING ROOF CAP AND ENSURE CEILING FAN VENT PIPING IS FULLY CONNECTED TO VENT BATHROOM AIR TO THE EXTERIOR OF THE HOUSE.

LARGE CRACKED AT THE BOTTOM OF ONE OF THE ROOF VENT CAPS FOR A BATHROOM FAN. FAN DAMPER IS ALSO BLOCKED WITH WASP NESTS. ROOFING MASTIC IS COVERING THE CRACKED, BUT HAS SINCE FAILED. RECOMMEND REPLACING ROOF CAP AND ENSURE CEILING FAN VENT PIPING IS FULLY CONNECTED TO VENT BATHROOM AIR TO THE EXTERIOR OF THE HOUSE.

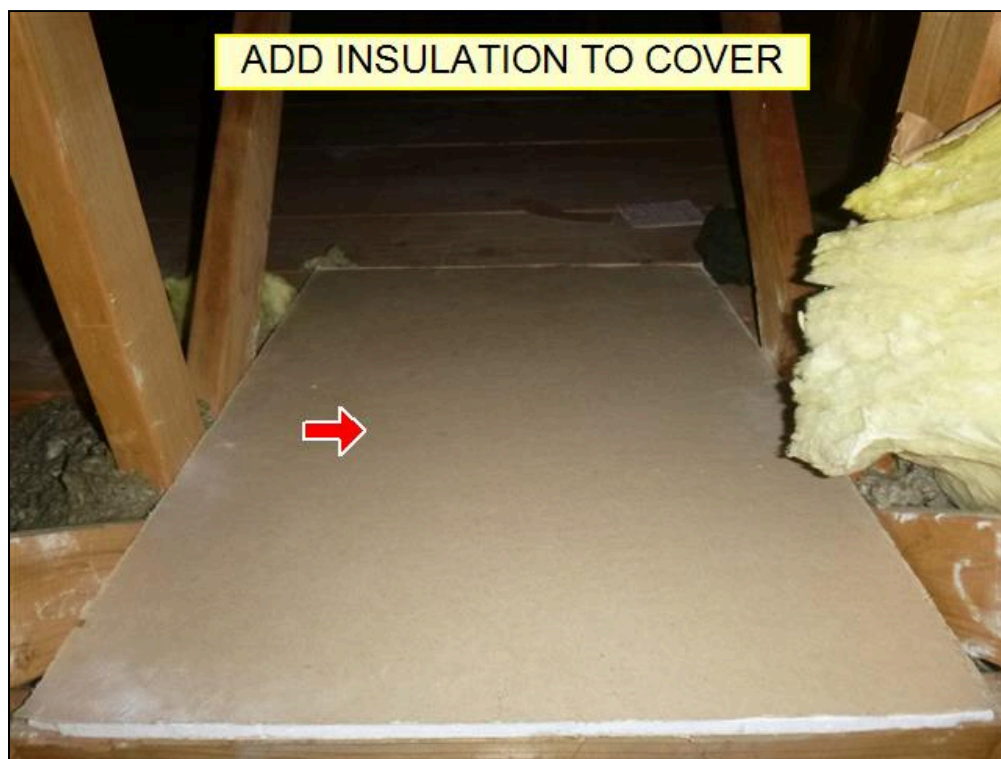
1.5 Picture 1

1.5 WOOD PLANKS HAVE PRESSED DOWN SOME OF THE INSULATION IN THE ATTIC SPACE. R VALUE IS NOT THE SAME AS THE REST OF THE ATTIC SPACE. ADD INSULATION OVER THE ATTIC ACCESS COVER PANEL.

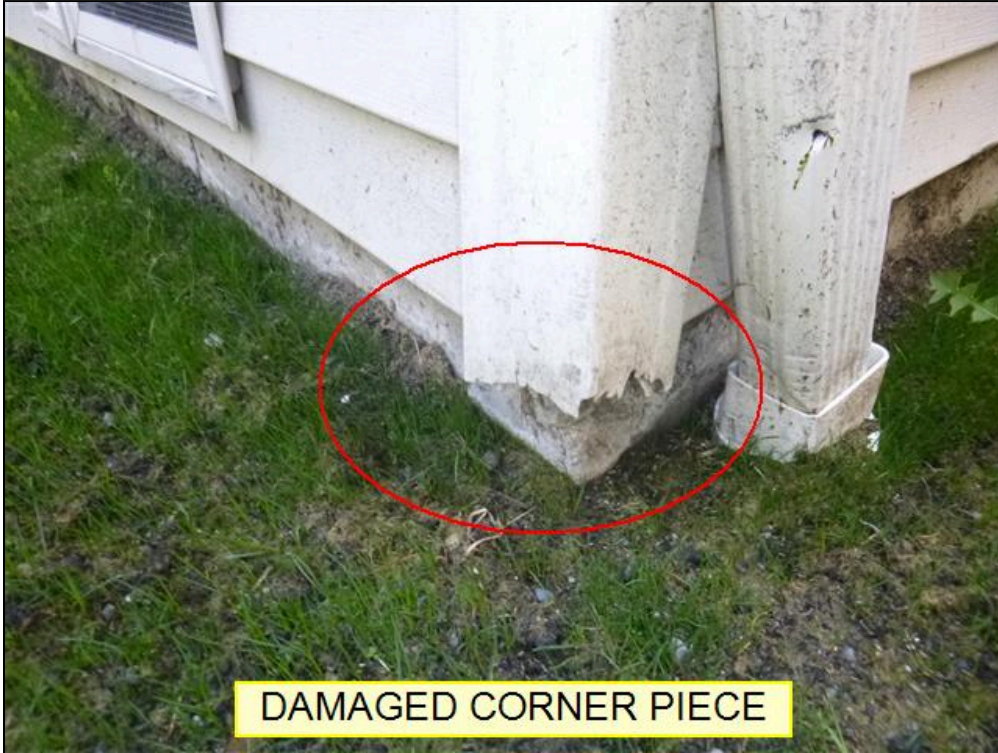
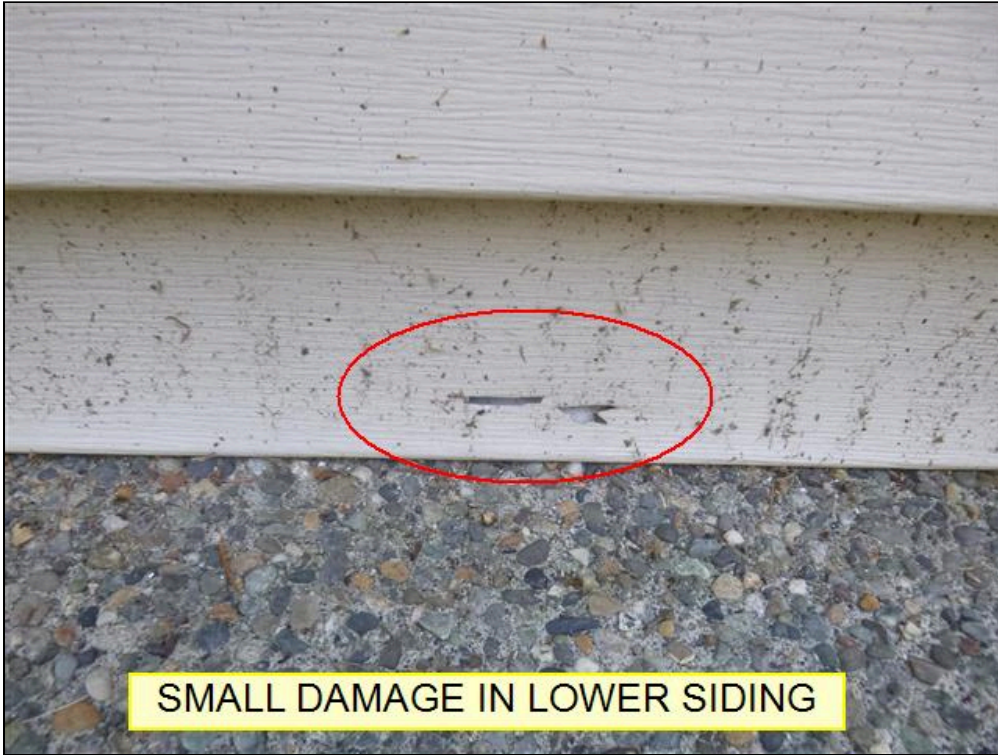
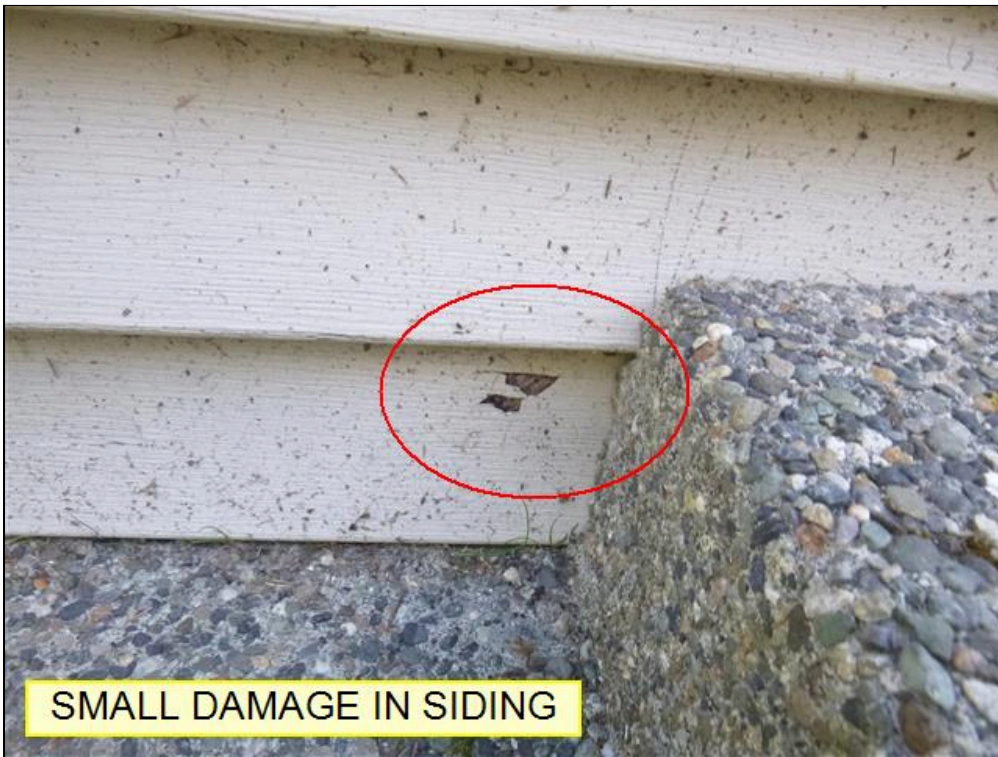
2.0 MINOR DAMAGE NOTED TO THE REAR VINYL SIDING AND CORNER TRIM. CORNER BOARD LIKELY DAMAGED BY A WEED TRIMMER.

SMALL HOLES NOTED IN THE LOWER SIDING PIECES. THESE SHOULD BE SEALED WITH AN EXTERIOR GRADE SILICONE OR OTHER HIGH QUALITY SEALANT.

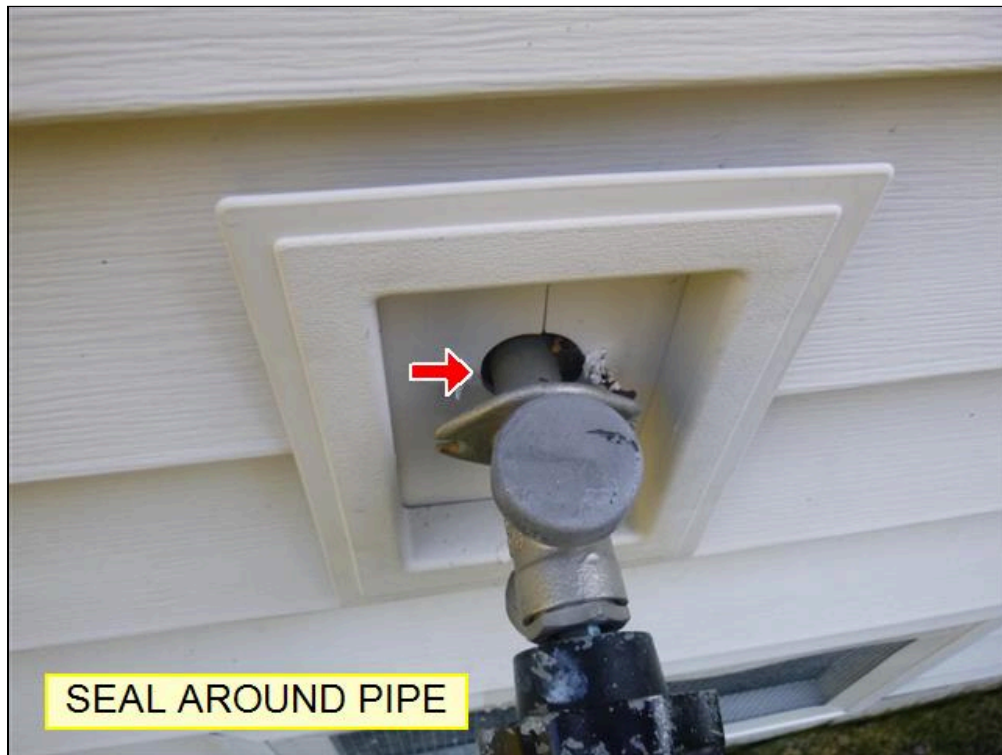
2.7 Picture 1

2.7 APPLY SEALANT TO THE REAR HOSE BIB PENETRATION INTO THE WALL. THIS SHOULD HELP KEEP WATER OUT ALONG WITH INSECTS.

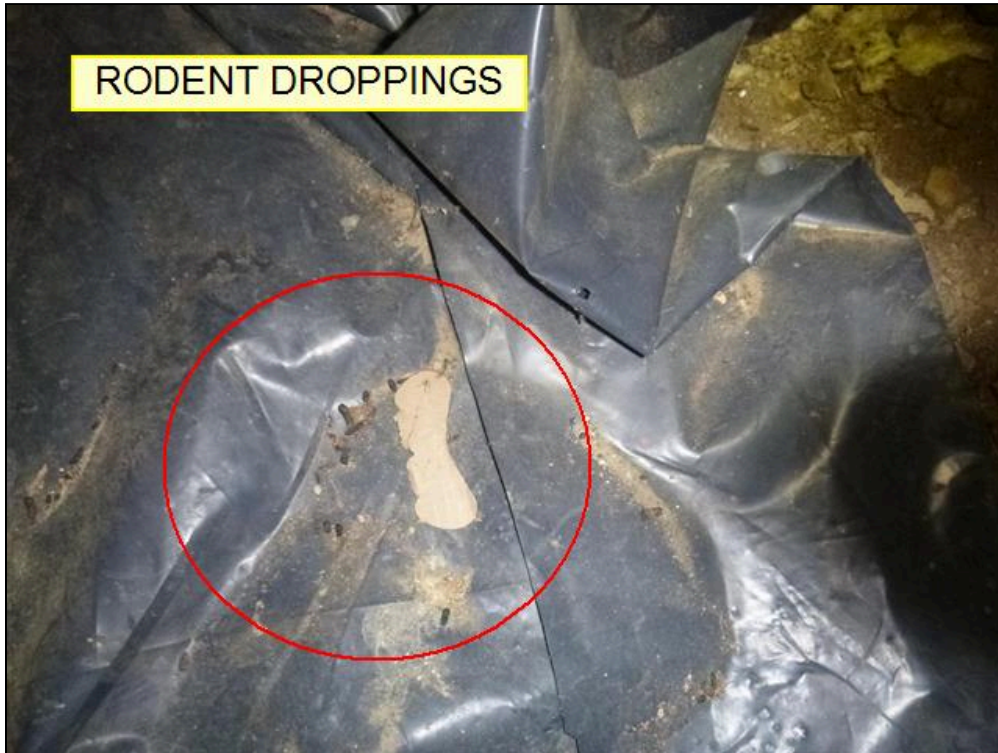
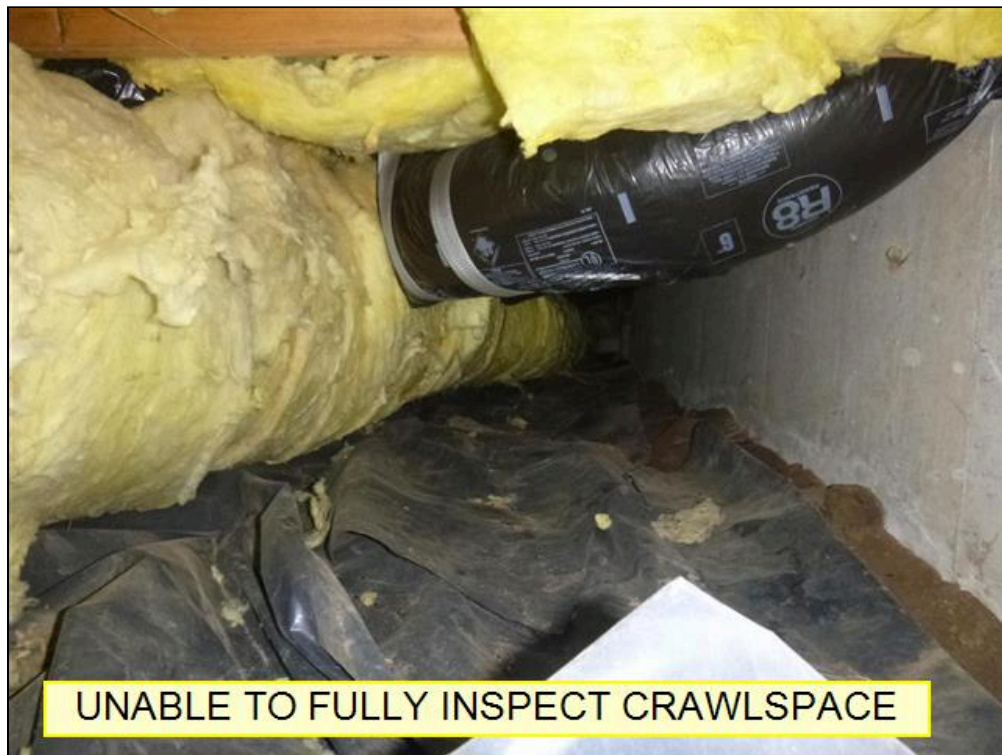
5.4 THE CRAWLSPACE WAS NOT FULLY INSPECTED. I WAS NOT ABLE TO GET AROUND THE AIR DUCTING. UNKNOWN REMAINING CONDITION OF THE CRAWLSPACE. INSULATION, WATER AND DRAIN LINES, AND VAPOR BARRIER NOT FULLY INSPECTED. RECOMMEND FULLY INSPECTING THE CRAWLSPACE ONCE ACCESS IS ATTAINED. A SMALLER PERSON MAY BE ABLE TO GET BY ONE END OF THE HEAT DUCTING.

RODENT DROPPINGS FOUND IN THE CRAWLSPACE. UNKNOWN IF RODENTS ARE ACTIVE OR NOT. RECOMMEND HIRING A LICENSED RODENT REMOVAL CONTRACTOR TO FULLY INSPECT THE CRAWLSPACE. TREAT FOR RODENTS AS NEEDED.

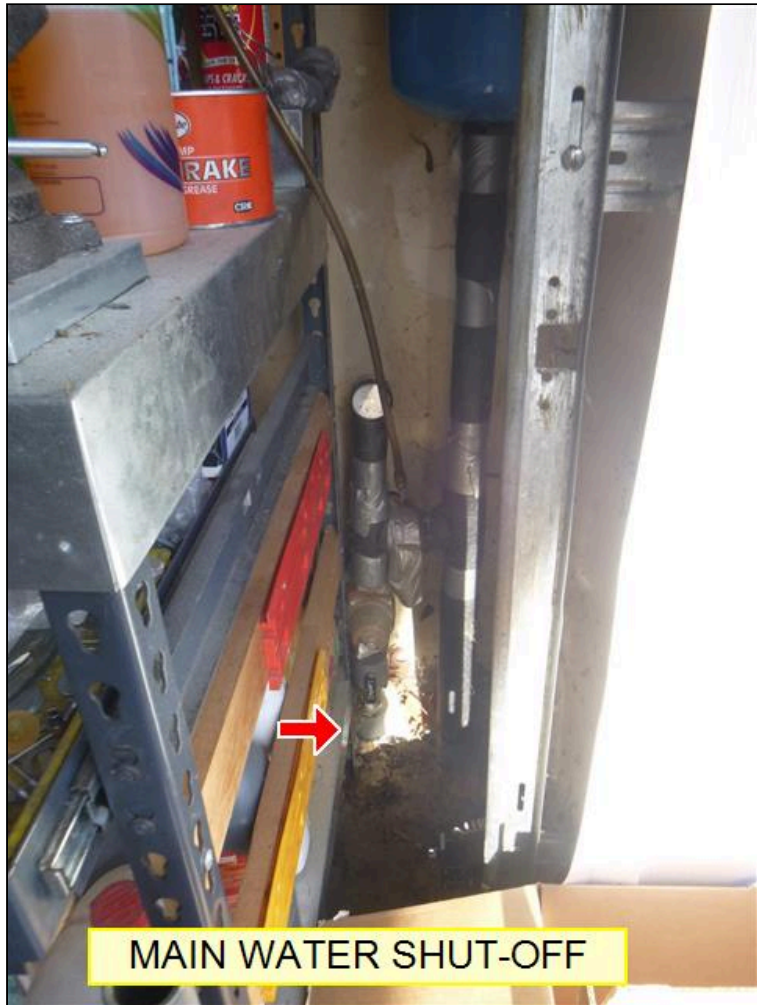
6.3 Picture 1

6.3 MAIN WATER SHUT-OFF IS LOCATED TOWARDS THE FRONT OF THE GARAGE DOOR.

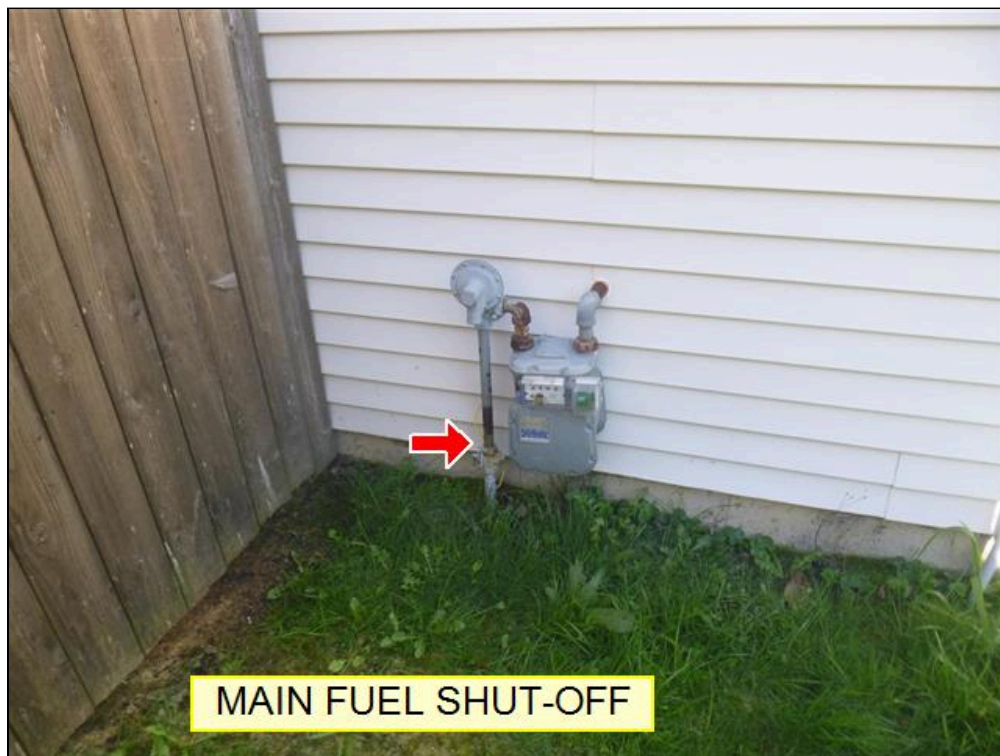
6.5 Picture 1

6.5 MAIN FUEL SHUT-OFF IS LOCATED ON THE EAST SIDE OF THE HOUSE.

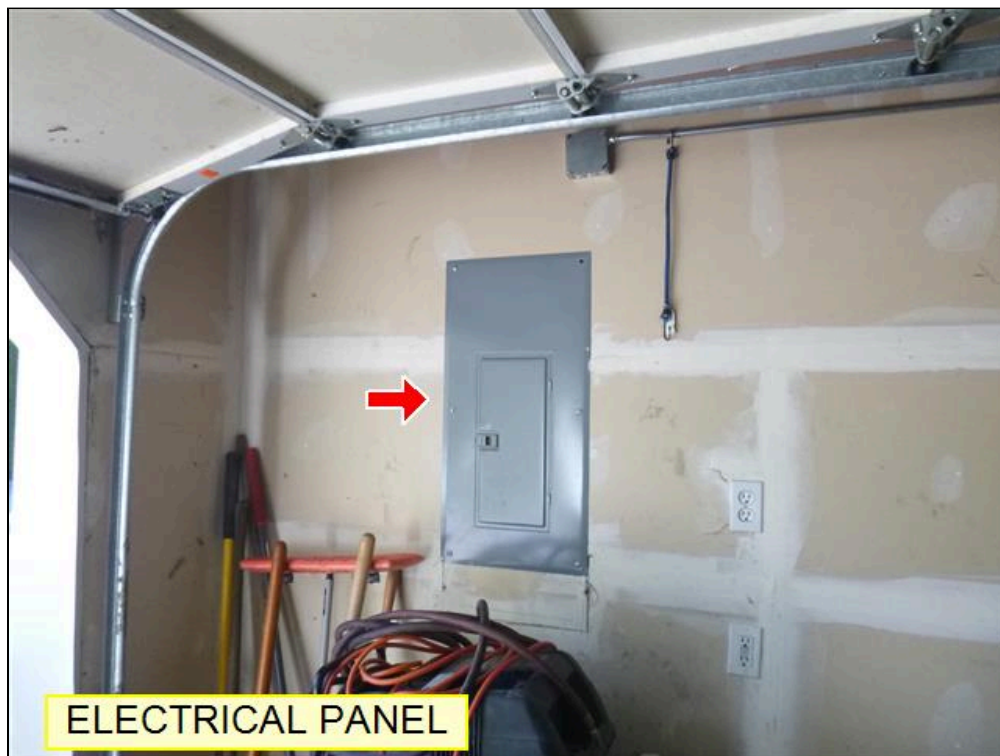
7.6 Picture 1

7.6 ELECTRICAL PANEL IS LOCATED IN THE GARAGE.

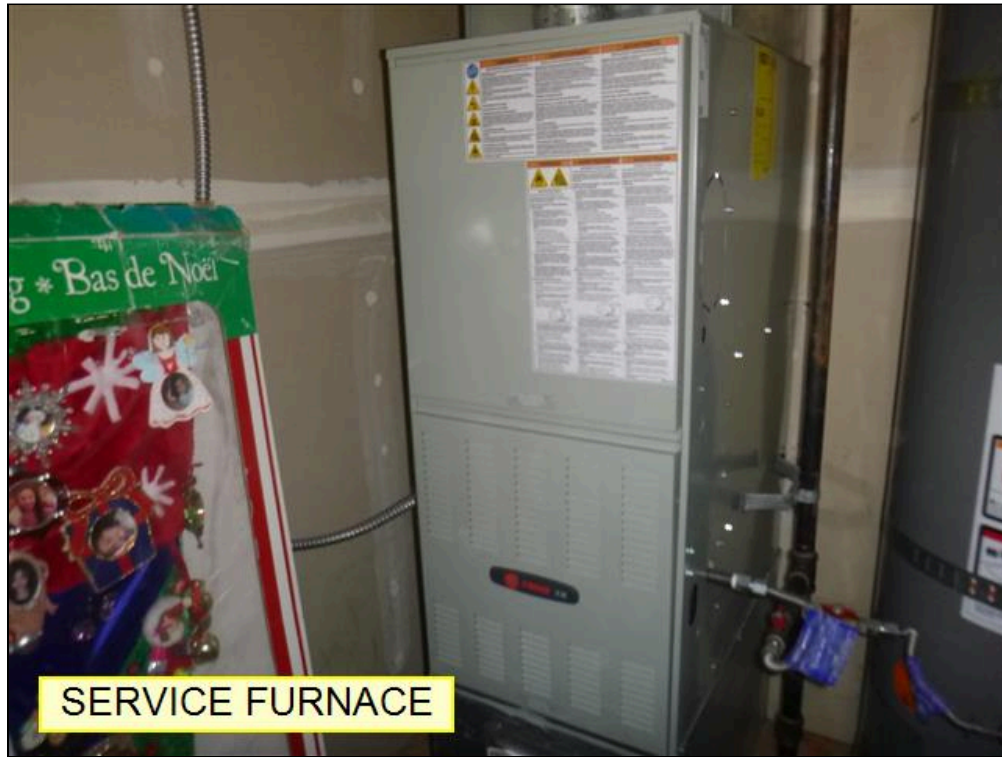
8.0 Picture 1

8.0 NO SERVICE TAGS FOR THE GAS FURNACE. ANNUAL SERVICING IS TYPICALLY RECOMMENDED FOR THIS TYPE OF GAS FURNACE. RECOMMEND HIRING A LICENSED HVAC CONTRACTOR TO SERVICE THE FURNACE.

NO SERVICE TAGS FOR THE GAS FURNACE. ANNUAL SERVICING IS TYPICALLY RECOMMENDED FOR THIS TYPE OF GAS FURNACE. RECOMMEND HIRING A LICENSED HVAC CONTRACTOR TO SERVICE THE FURNACE.

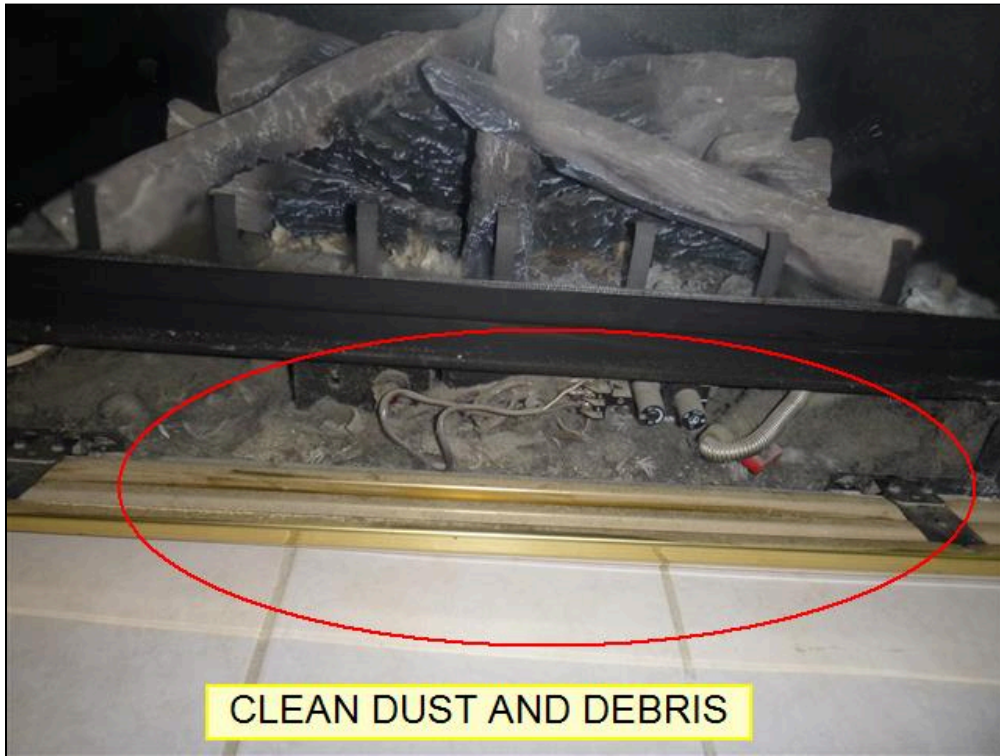
8.7 Picture 1

8.7 CLEAN DUST AND DEBRIS FROM UNDER THE GAS FIREPLACE.
