United States Department of the Interior
National Park ServiceNational Register of Historic Places
Inventory—Nomination Form

1. Name: Aztec Main Street Historic District
2. Location: Generally bounded by Main (E), Chuska (S), the alley between Park and Main (W), and Chaco (N).
4. Owners:

AZTEC MAIN STREET HISTORIC DISTRICT

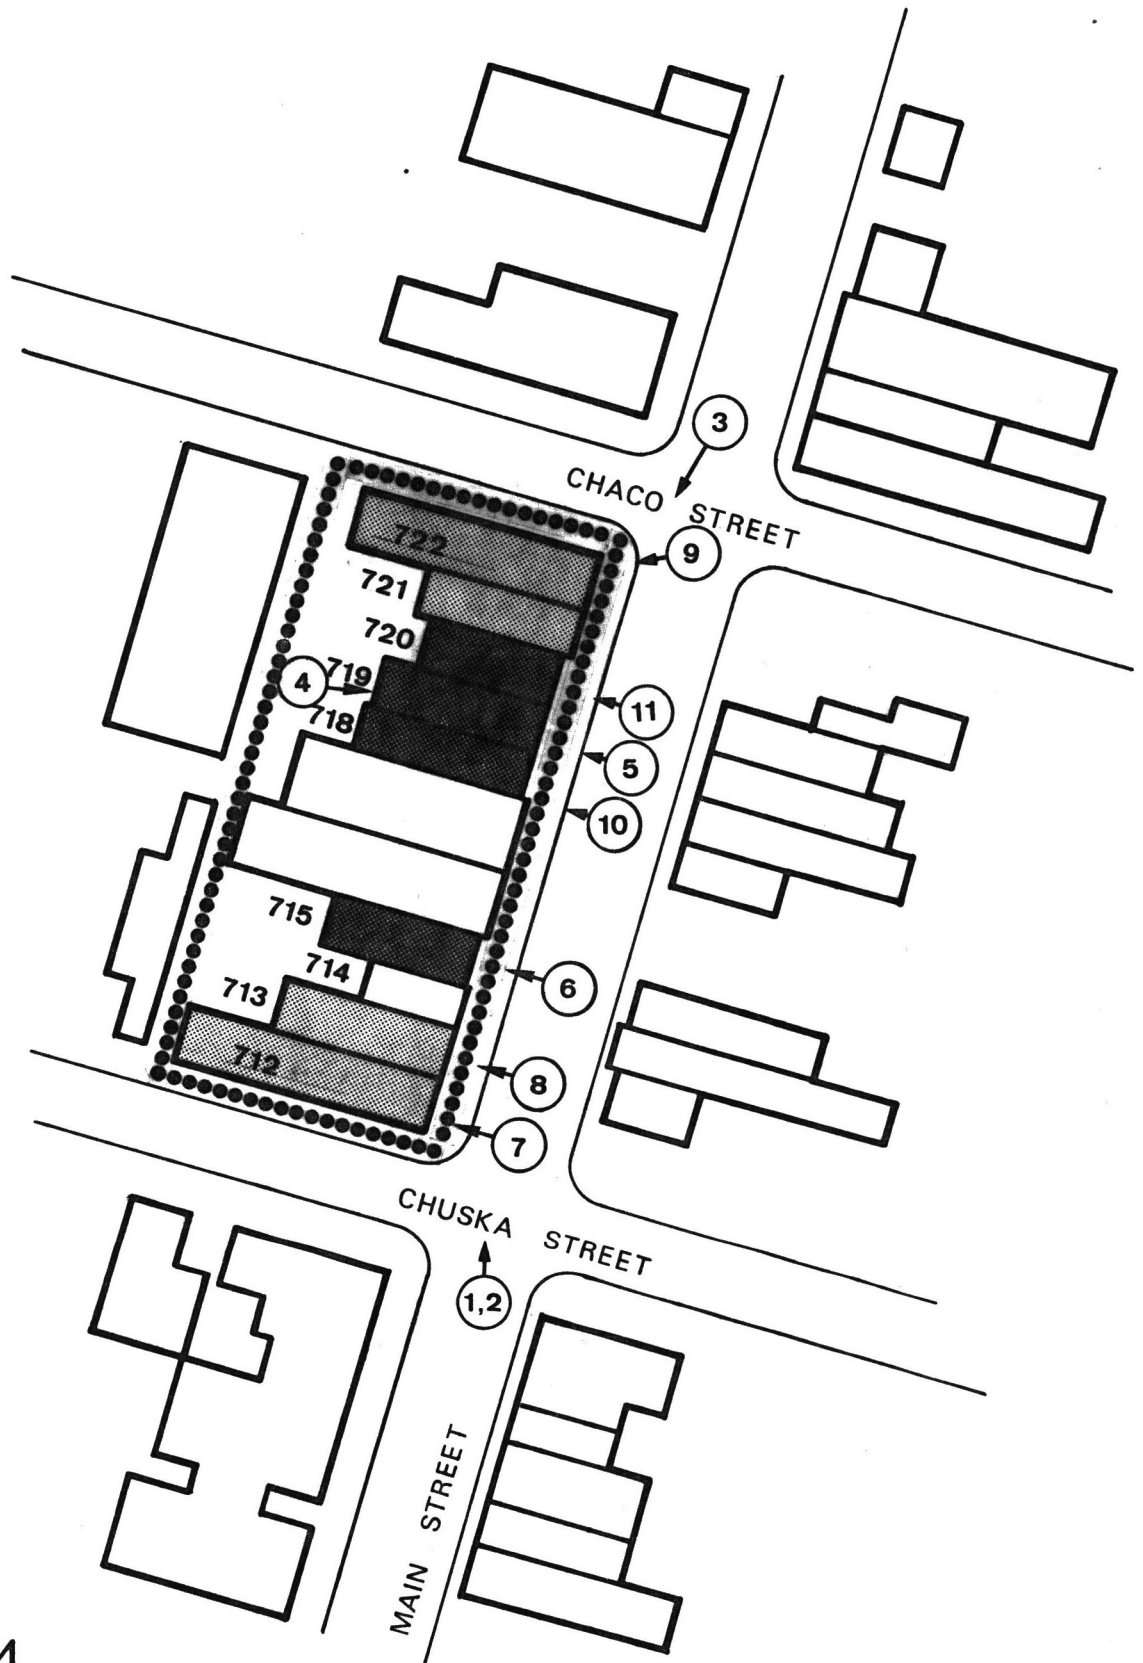
4.

..... BOUNDARY

■ SIGNIFICANT

▨ CONTRIBUTING

□ NON-CONTRIBUTING

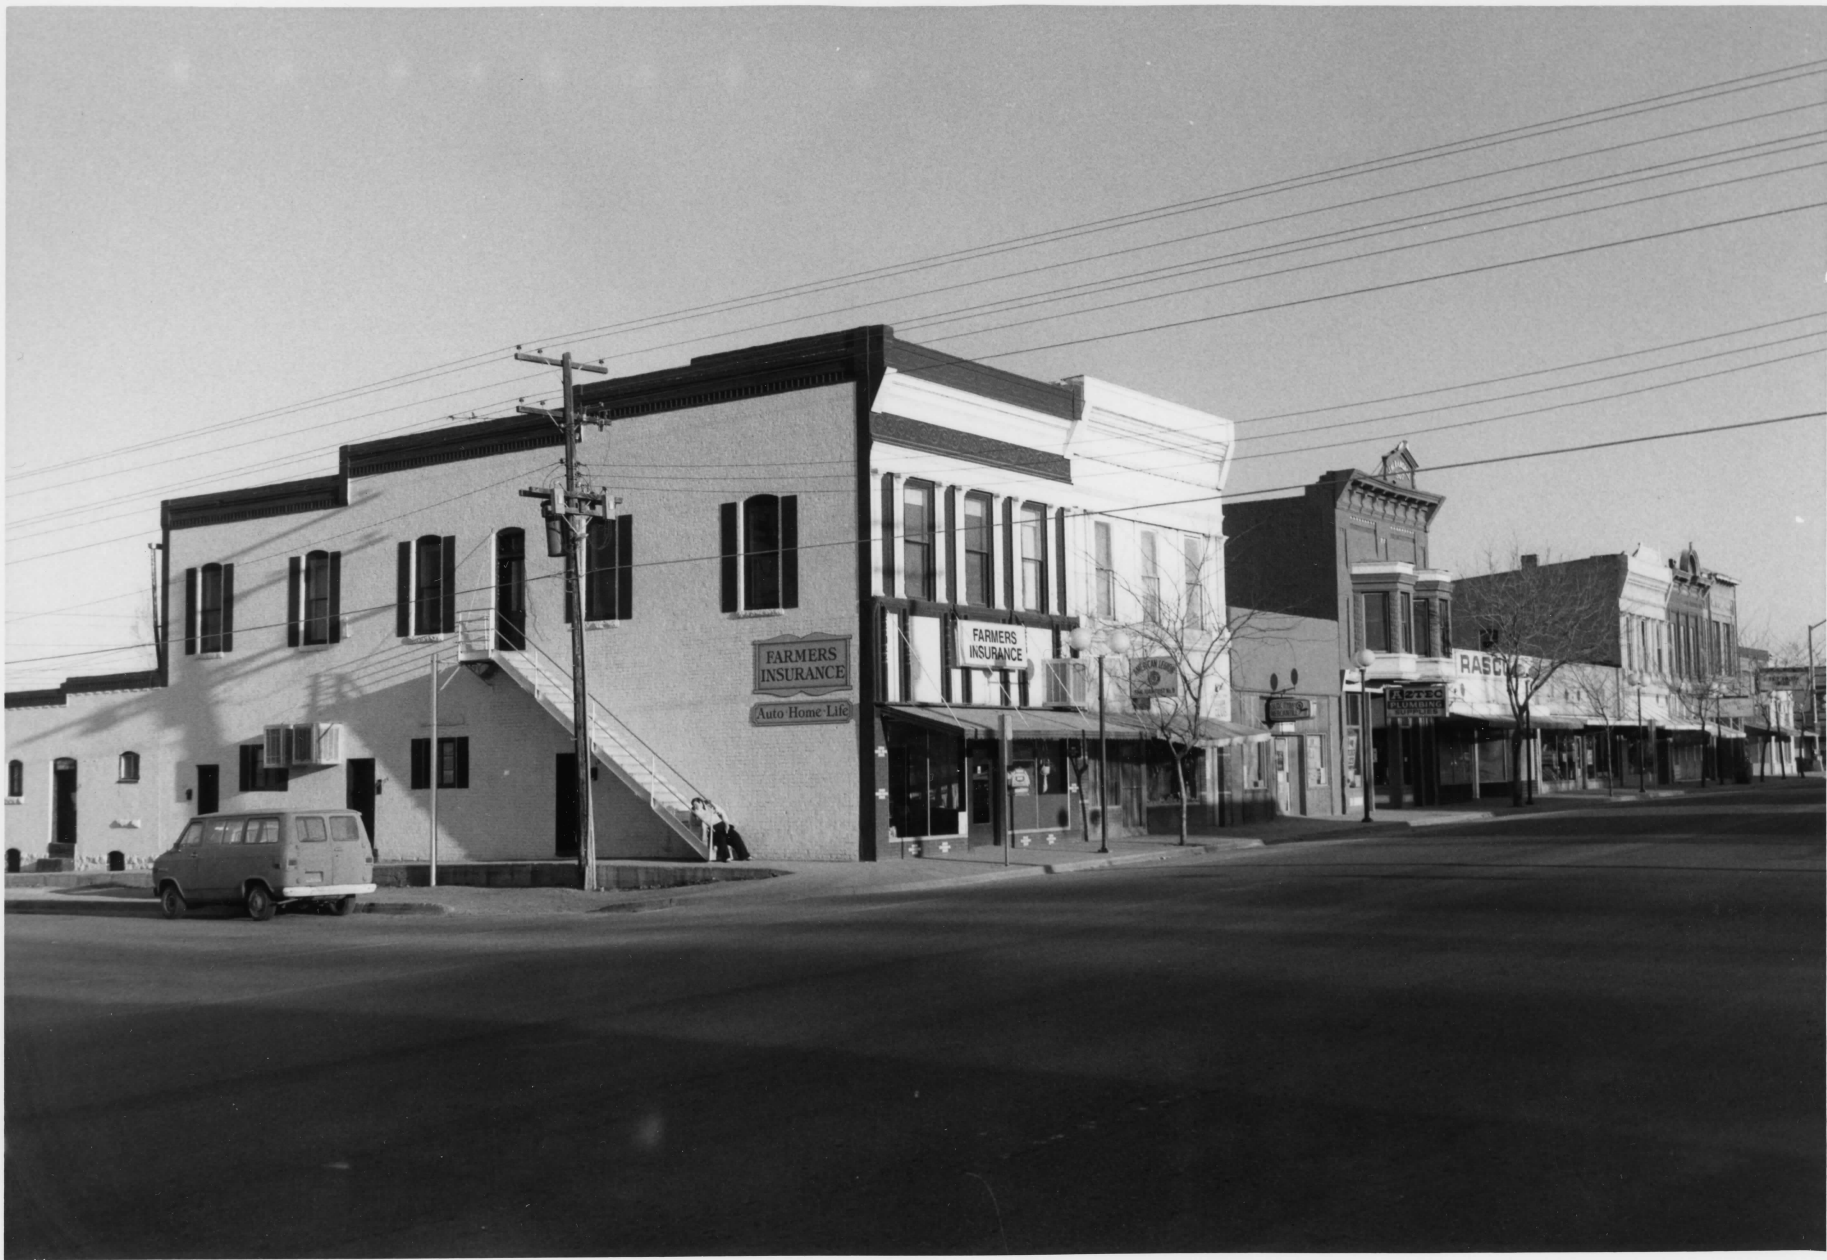
2. Main Street Historic District;
Aztec, NM; C. Wilson; 1984;
NMSHPD; looking NW along
district. (from left: sig, sig,
non-cont, sig, non-cont)

The Main Street Historic District of Aztec is a one-half block (one block front) area of commercial buildings. Nine of the eleven buildings were erected between 1900 and 1915; the remaining two were built after the Second World War. Of the historic buildings, only one (ill. 2, 3rd from left) has received a substantial detrimental remodeling; three have had minor first-floor facelifts. As a result, the district (ills. 2, 3) appears virtually as it did in 1915 and substantially as it appeared in 1908 (ill. 1). The majority of the historic structures are two story; all stand at the sidewalk's edge. The common bond brick walls of the rear of the buildings present a less uniform appearance (ill. 4). Stylish ornament is reserved for the street facades. Cast iron, pressed metal and decorative brick work details employ the Italianate, the Neo-Classical and a local Decorative Brick style. Fixed metal shades have replaced the earlier canvas awnings, as concrete sidewalks have replaced the earlier boardwalk.

#721 Bailey and Howe Dry Goods Building; 123 S. Main; ills. 2, 7; Neo-Classical/decorative brick 1905-08; Flemish/common bond brick walls, rusticated sandstone sills, segmental arches, stepping Decorative Brick cornice (side and rear), remodeled (1st, front); pressed metal, Neo-Classical sheathing and cornice (2nd).

#714 119 S. Main; ill. 1, 2, third from left; pre-1908; major facade remodeling; first funeral parlor operated by J. W. Dial.

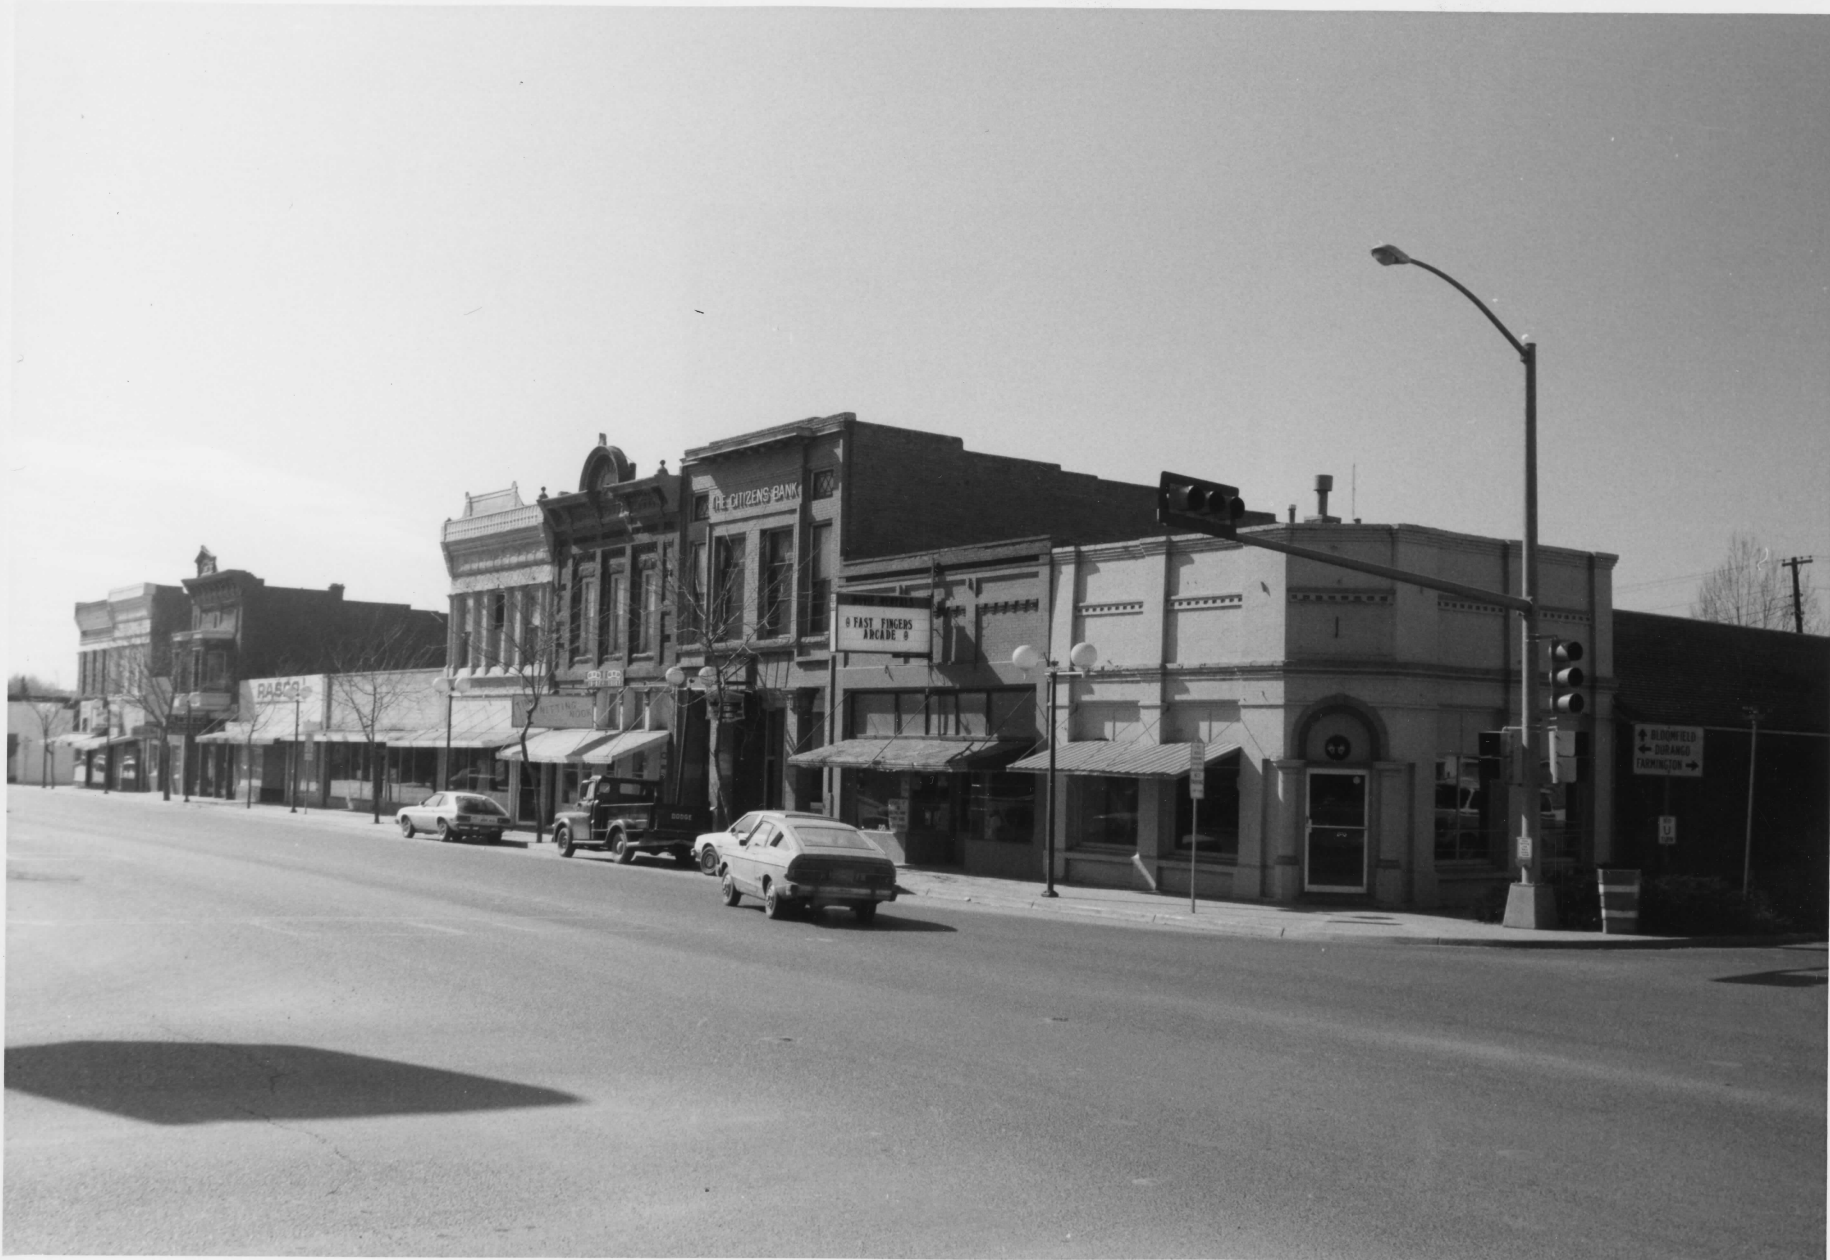
3. Main Street Historic District;
Aztec, NM; C. Wilson; 1984;
NMSHPD; looking SW along
district. (from right: cont.,
cont., sig, sig, sig.)

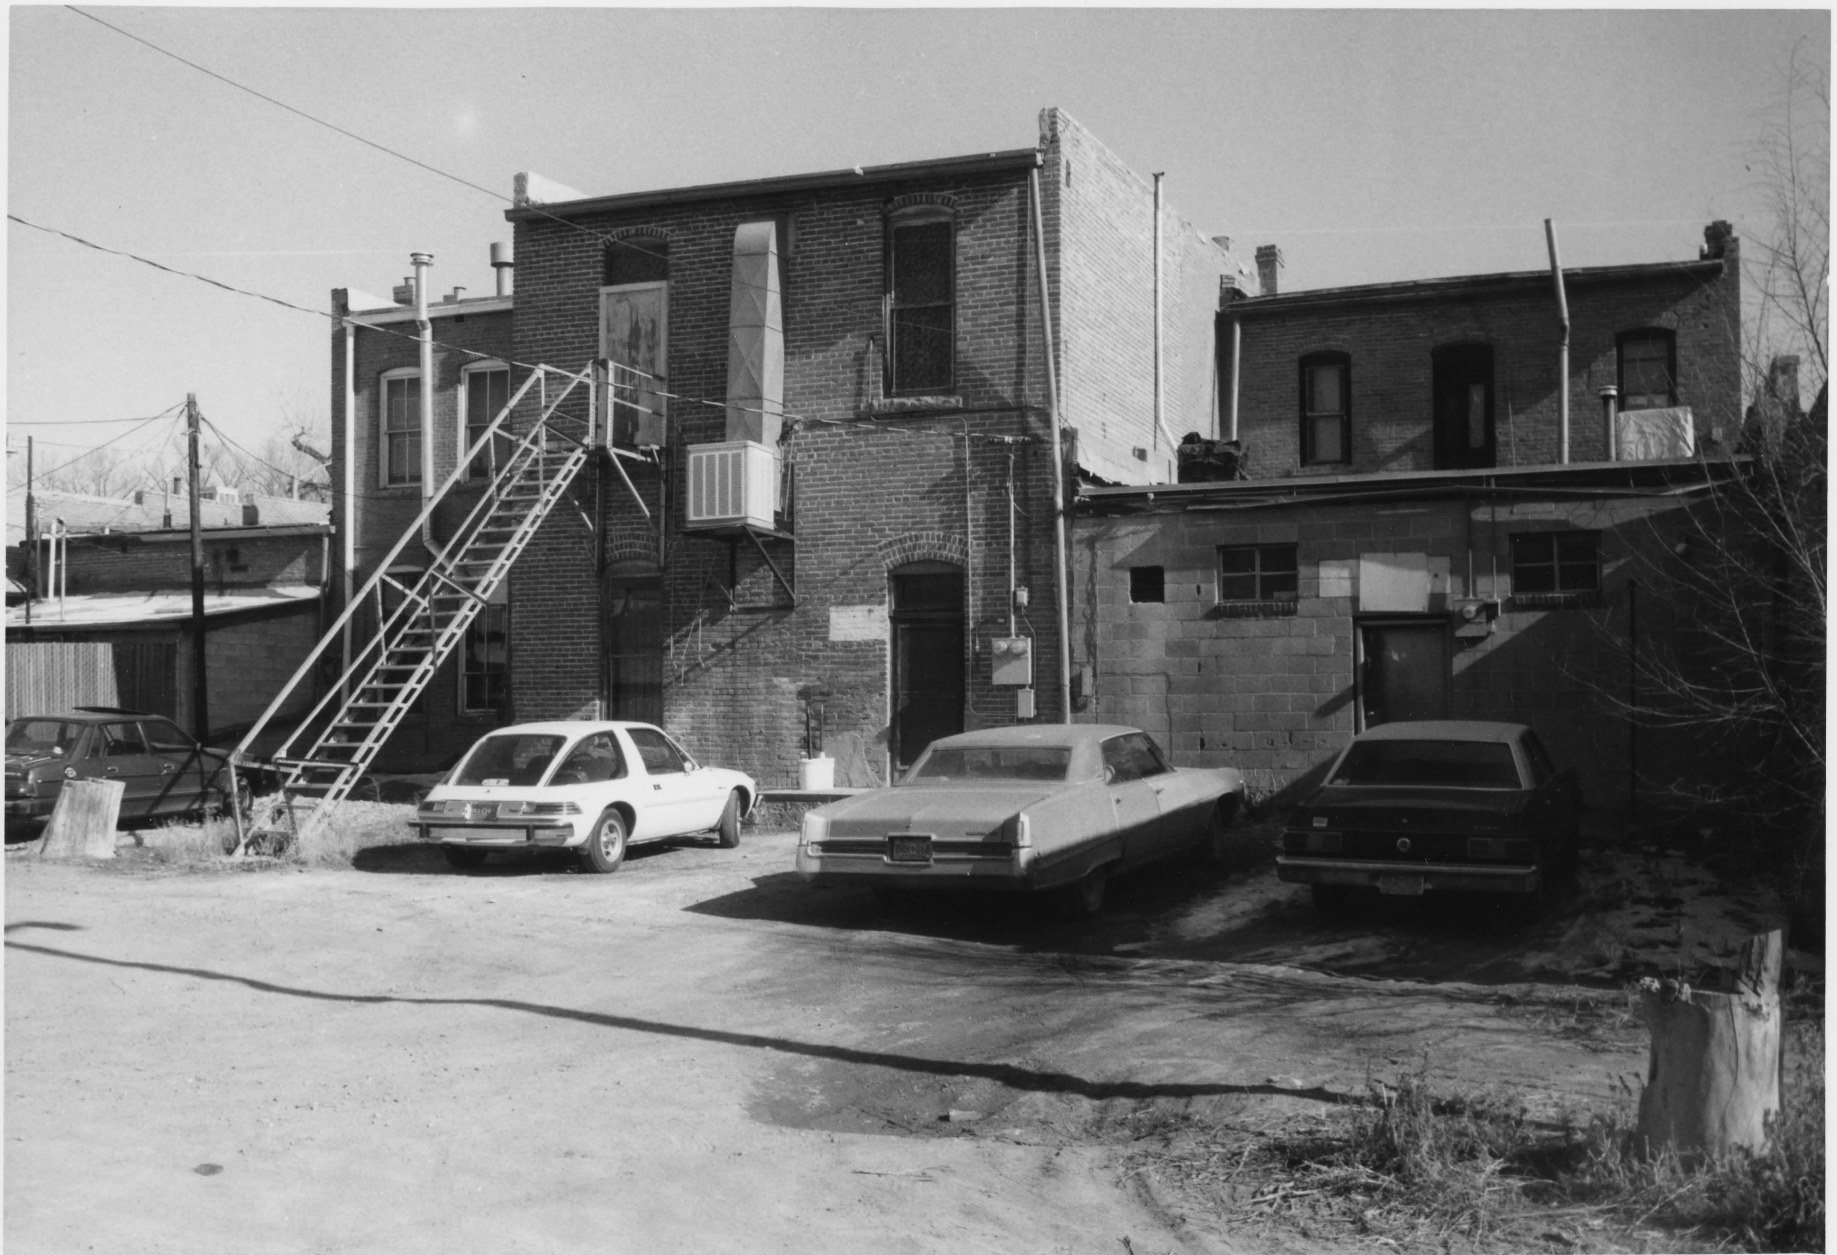
4. Main Street District; Aztec, NM;
C. Wilson; 1984; NMSHPD;
looking NE at rear of the
Townsend Building, Odd Fellows
and Citizen's Bank.

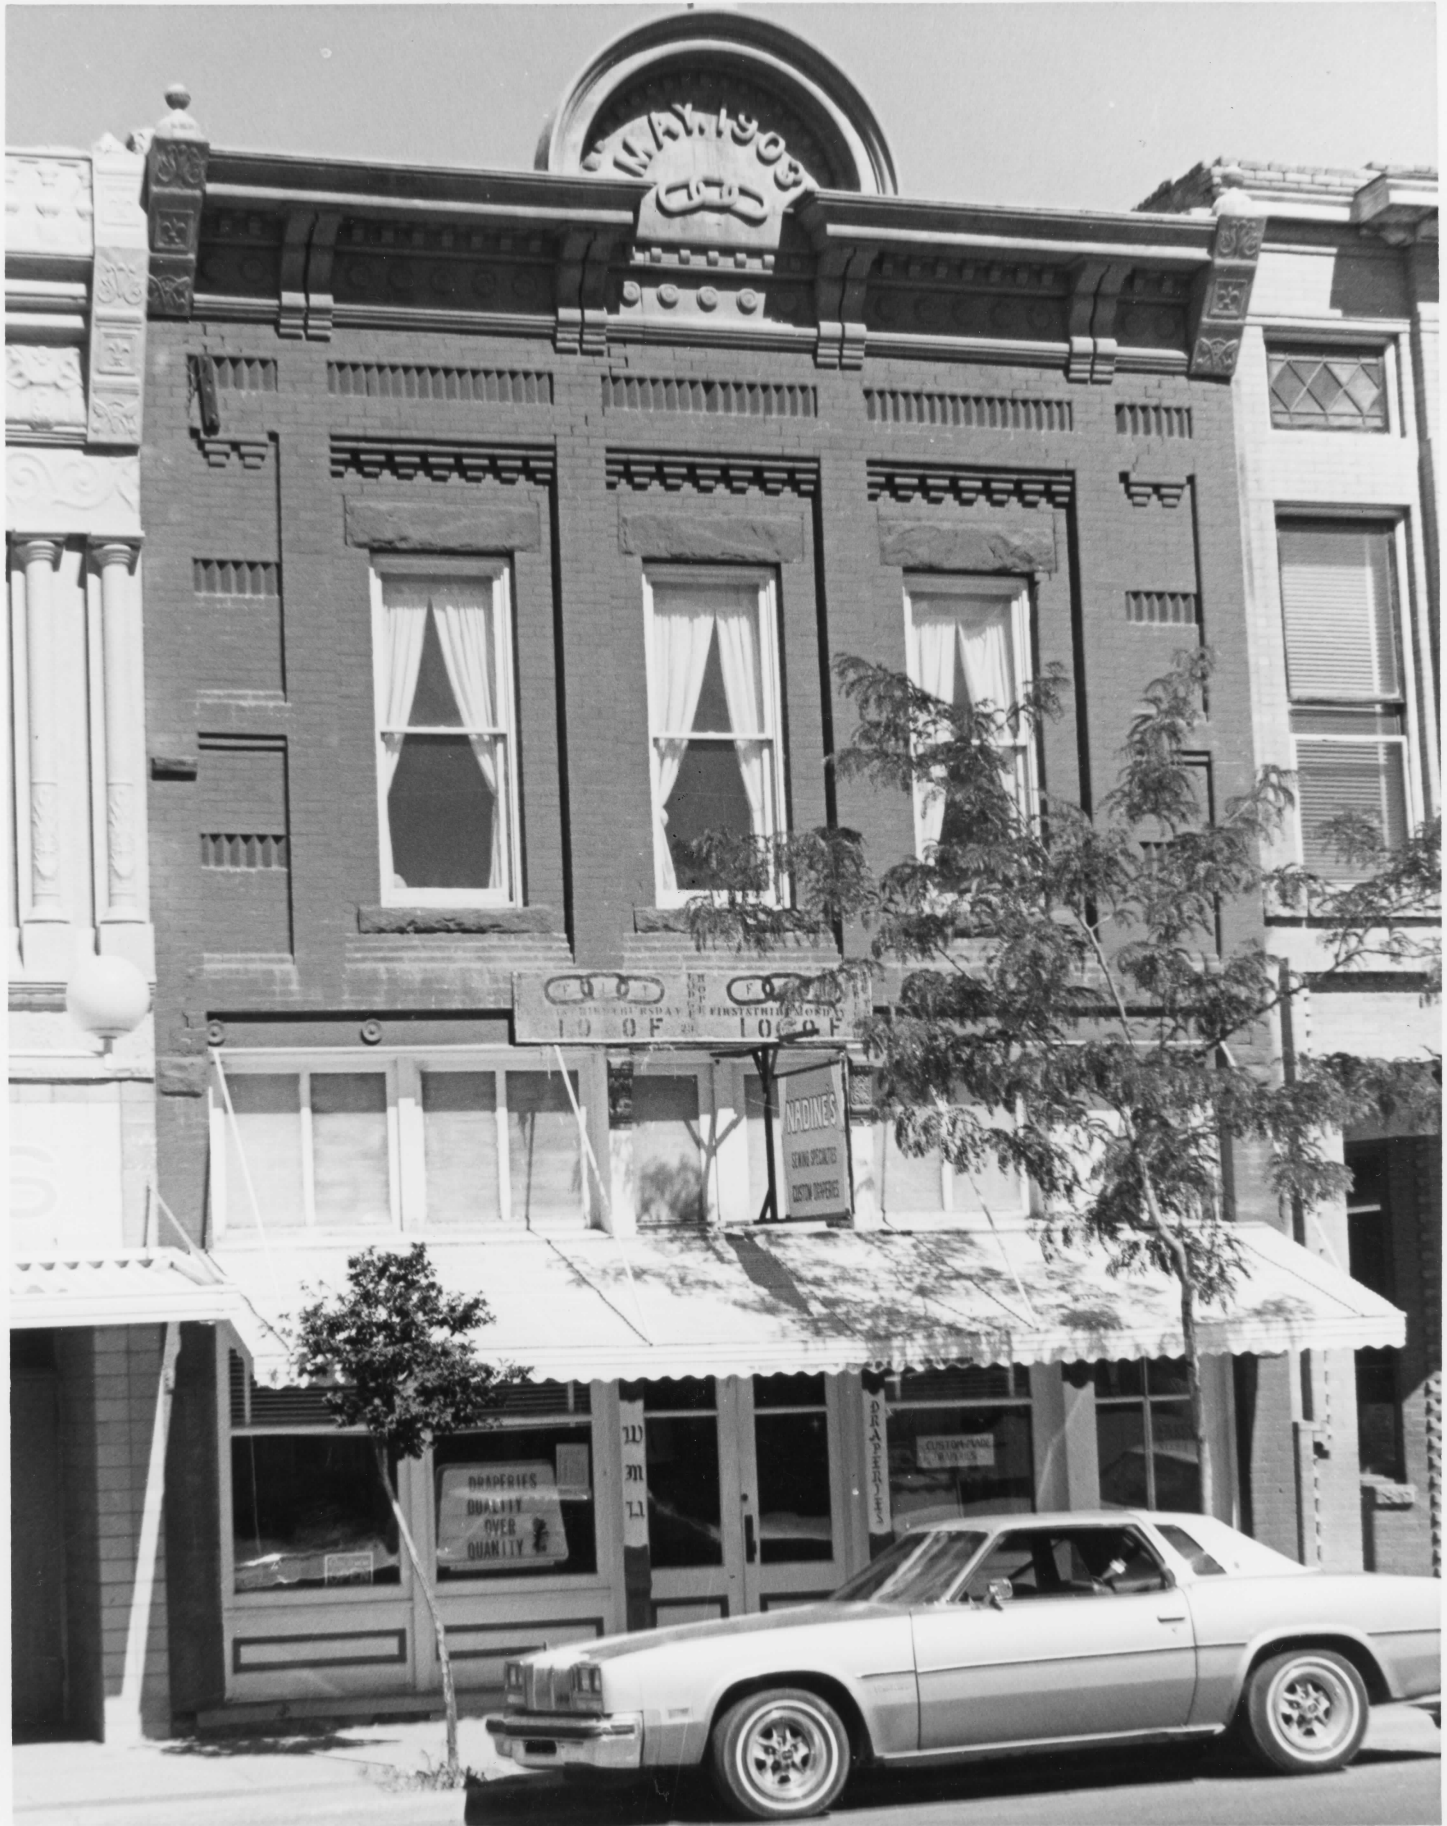
5. Odd Fellows Building; Main Street
District; Aztec, NM; B. Barsook;
1981; NMSHPD; street facade;
significant.

#719 Odd Fellows Lodge Building; 109 S. Main; ill. 5; Italianate/Decorative Brick style; 1903; common bond brick walls with stone sills and segmental arches (rear); cast-iron piers (1st, front); decorative zipper-brick, recessed panels, corbeling; stone sills and lintels (2nd); pressed metal cornice.

As the first major commercial building, with especially fine decorative brick details, the Odd Fellows building reflected the optimism which pervaded Aztec just before the arrival of the railroad.

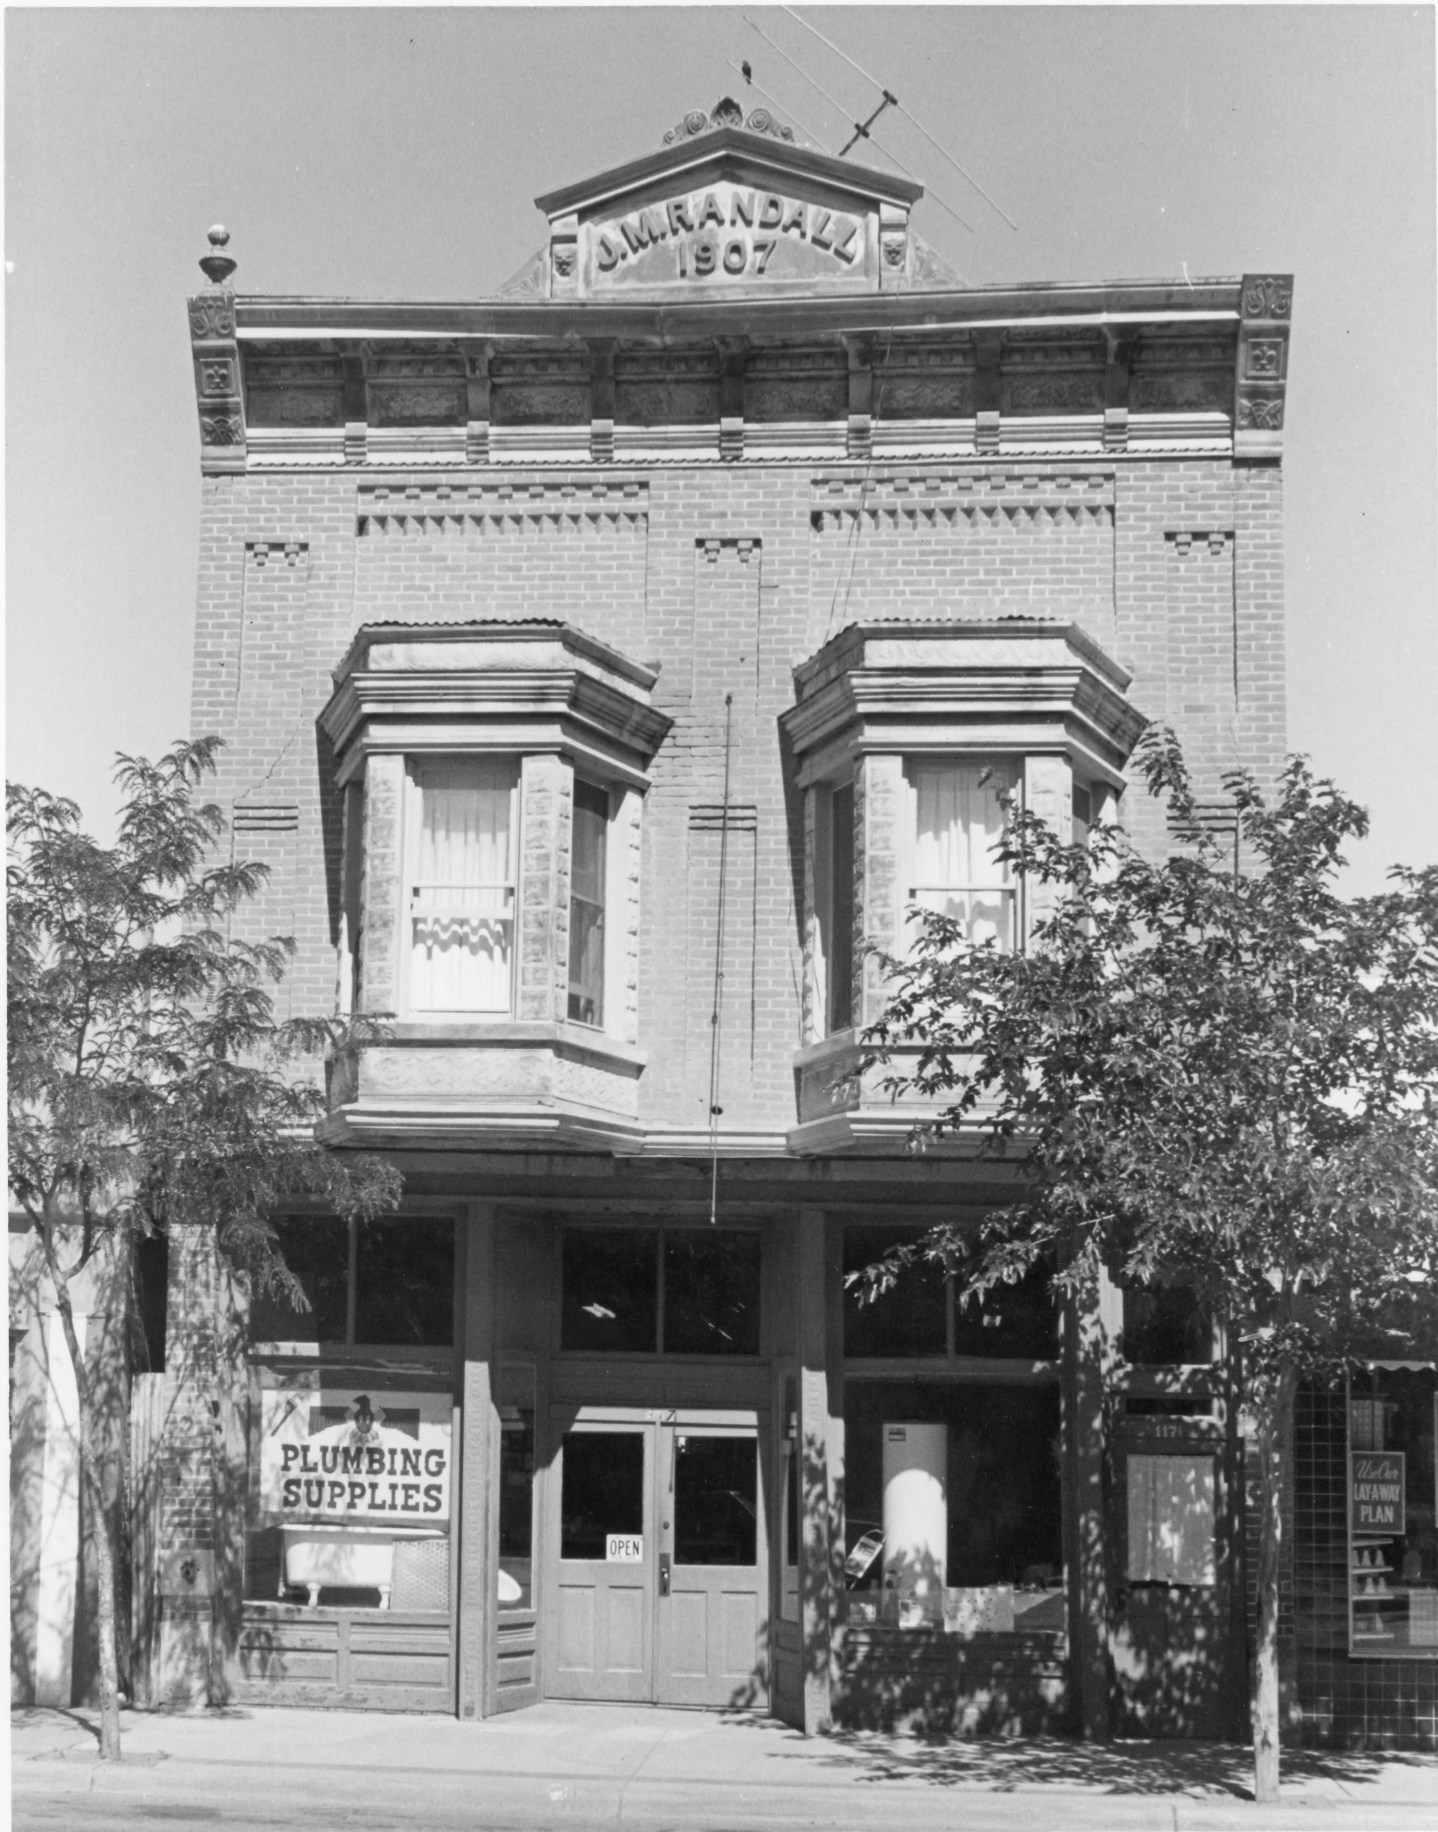
6. Randall Building; Main Street
District; Aztec, NM; B. Barsook;
1981; NMSHPD; street facade;
sig.

#715 J. M. Randall Building; 117 S. Main; ill. 6; Italianate/Decorative Brick style; 1907; common bond brick walls; projecting sills and segmental arches (sides and rear); (front) cast-iron posts, fixed windows with transoms; paired window bays with pressed metal cornices and rusticated piers; decorative brick dentils, zipper-brick and recessed panels; pressed metal cornice. Original interior with pressed metal ceiling.

Built and long operated as a dry goods store by one of the city's leading merchants, J. M. Randall. The Randall family occupied the second floor apartment.

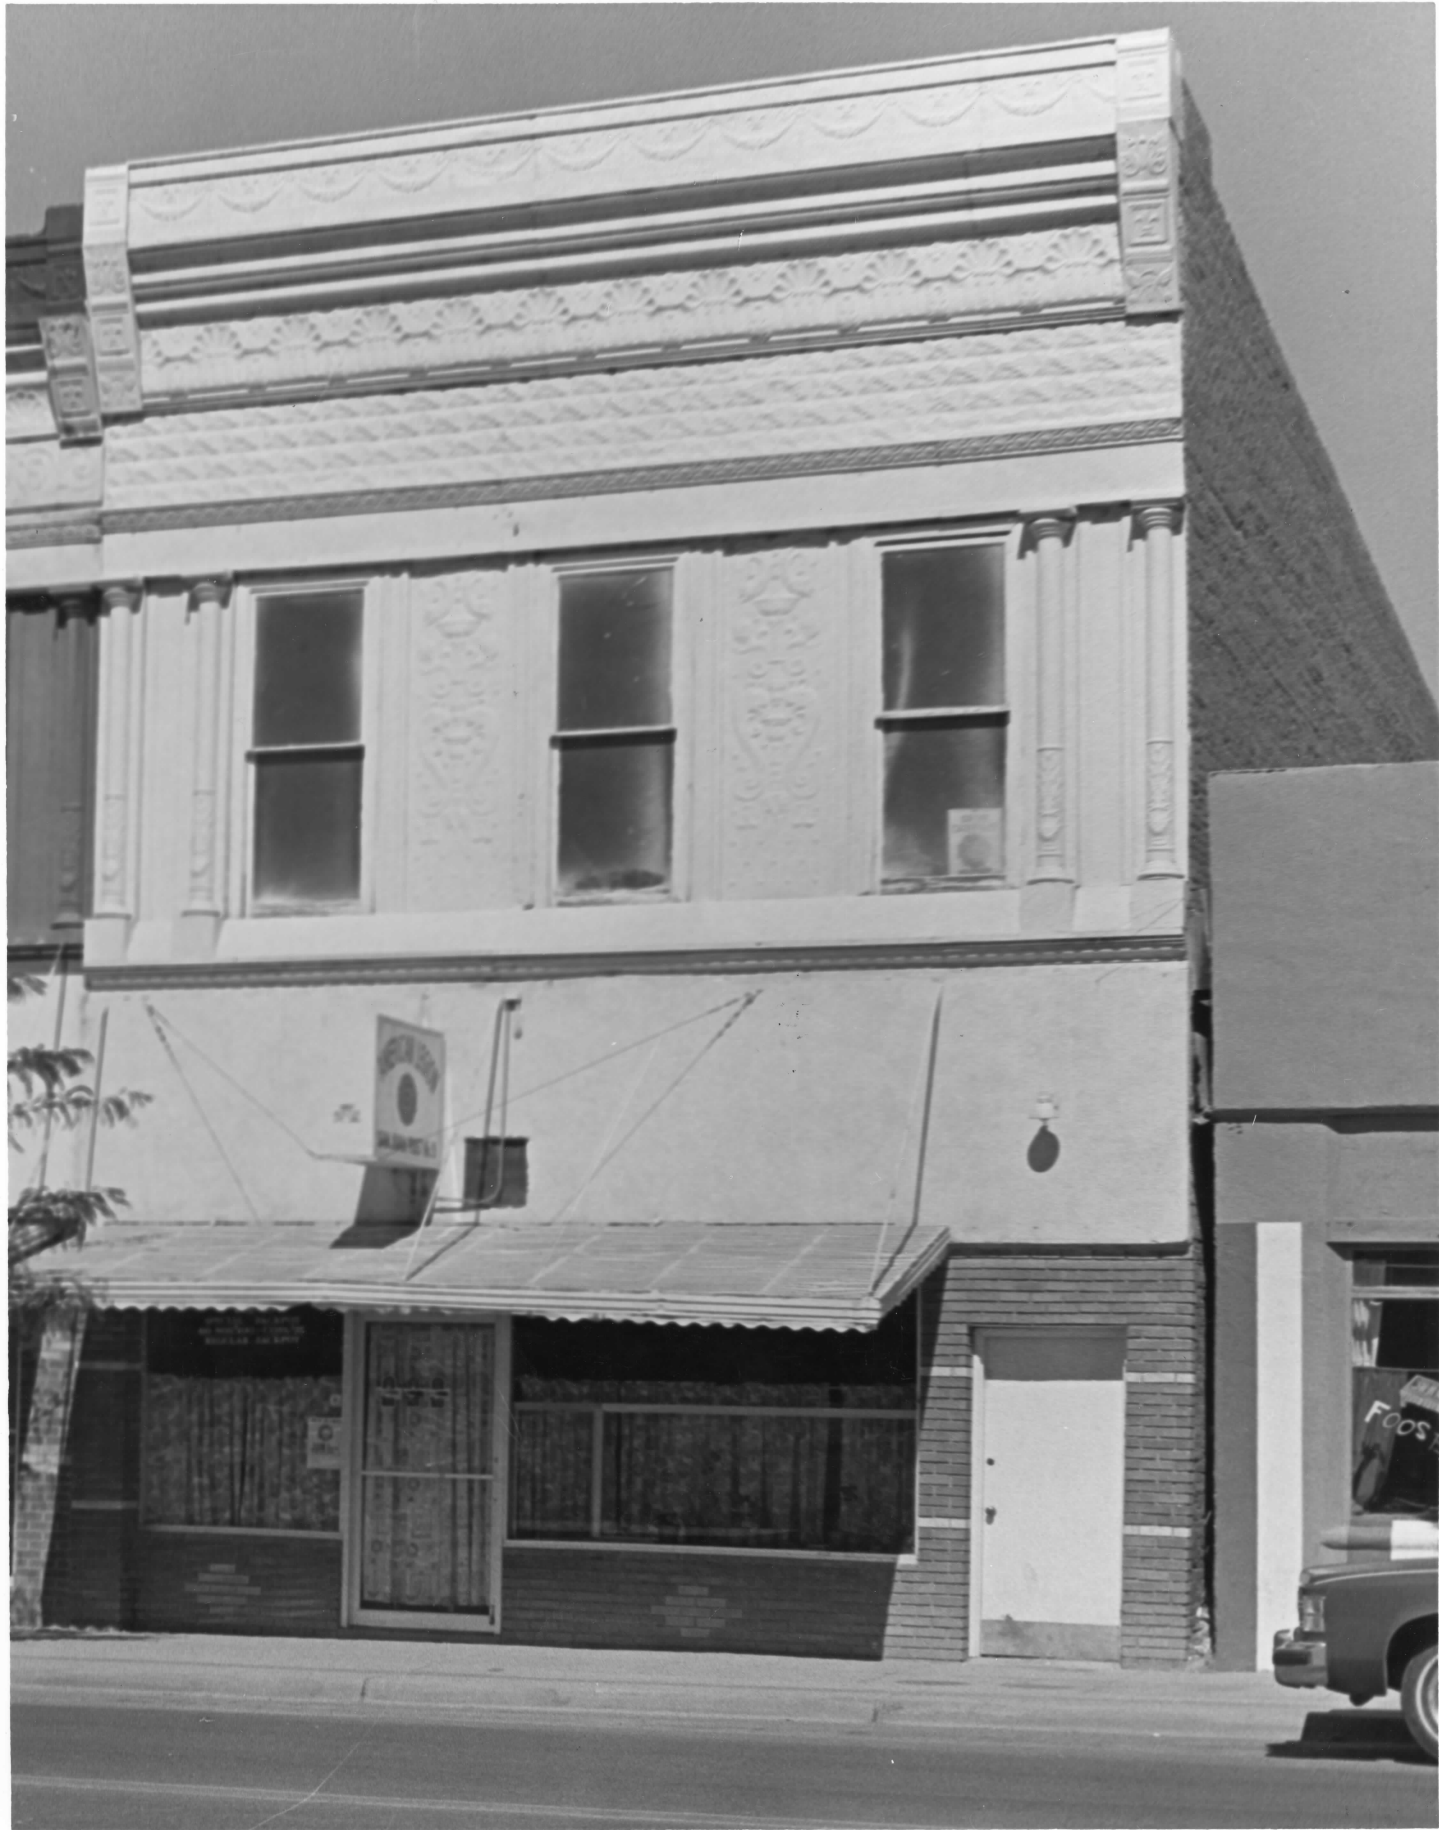
8. Taylor Building; Main Street
District; Aztec, NM; B. Barsook;
1981; NMSHPD; street facade;
sig.

#713 Taylor Building; 121 S. Main; ill. 8; Neo-Classical 1905-08; common bond brick walls (side and rear); remodeled (1st, front); pressed metal, Neo-Classical sheathing and cornice (2nd).

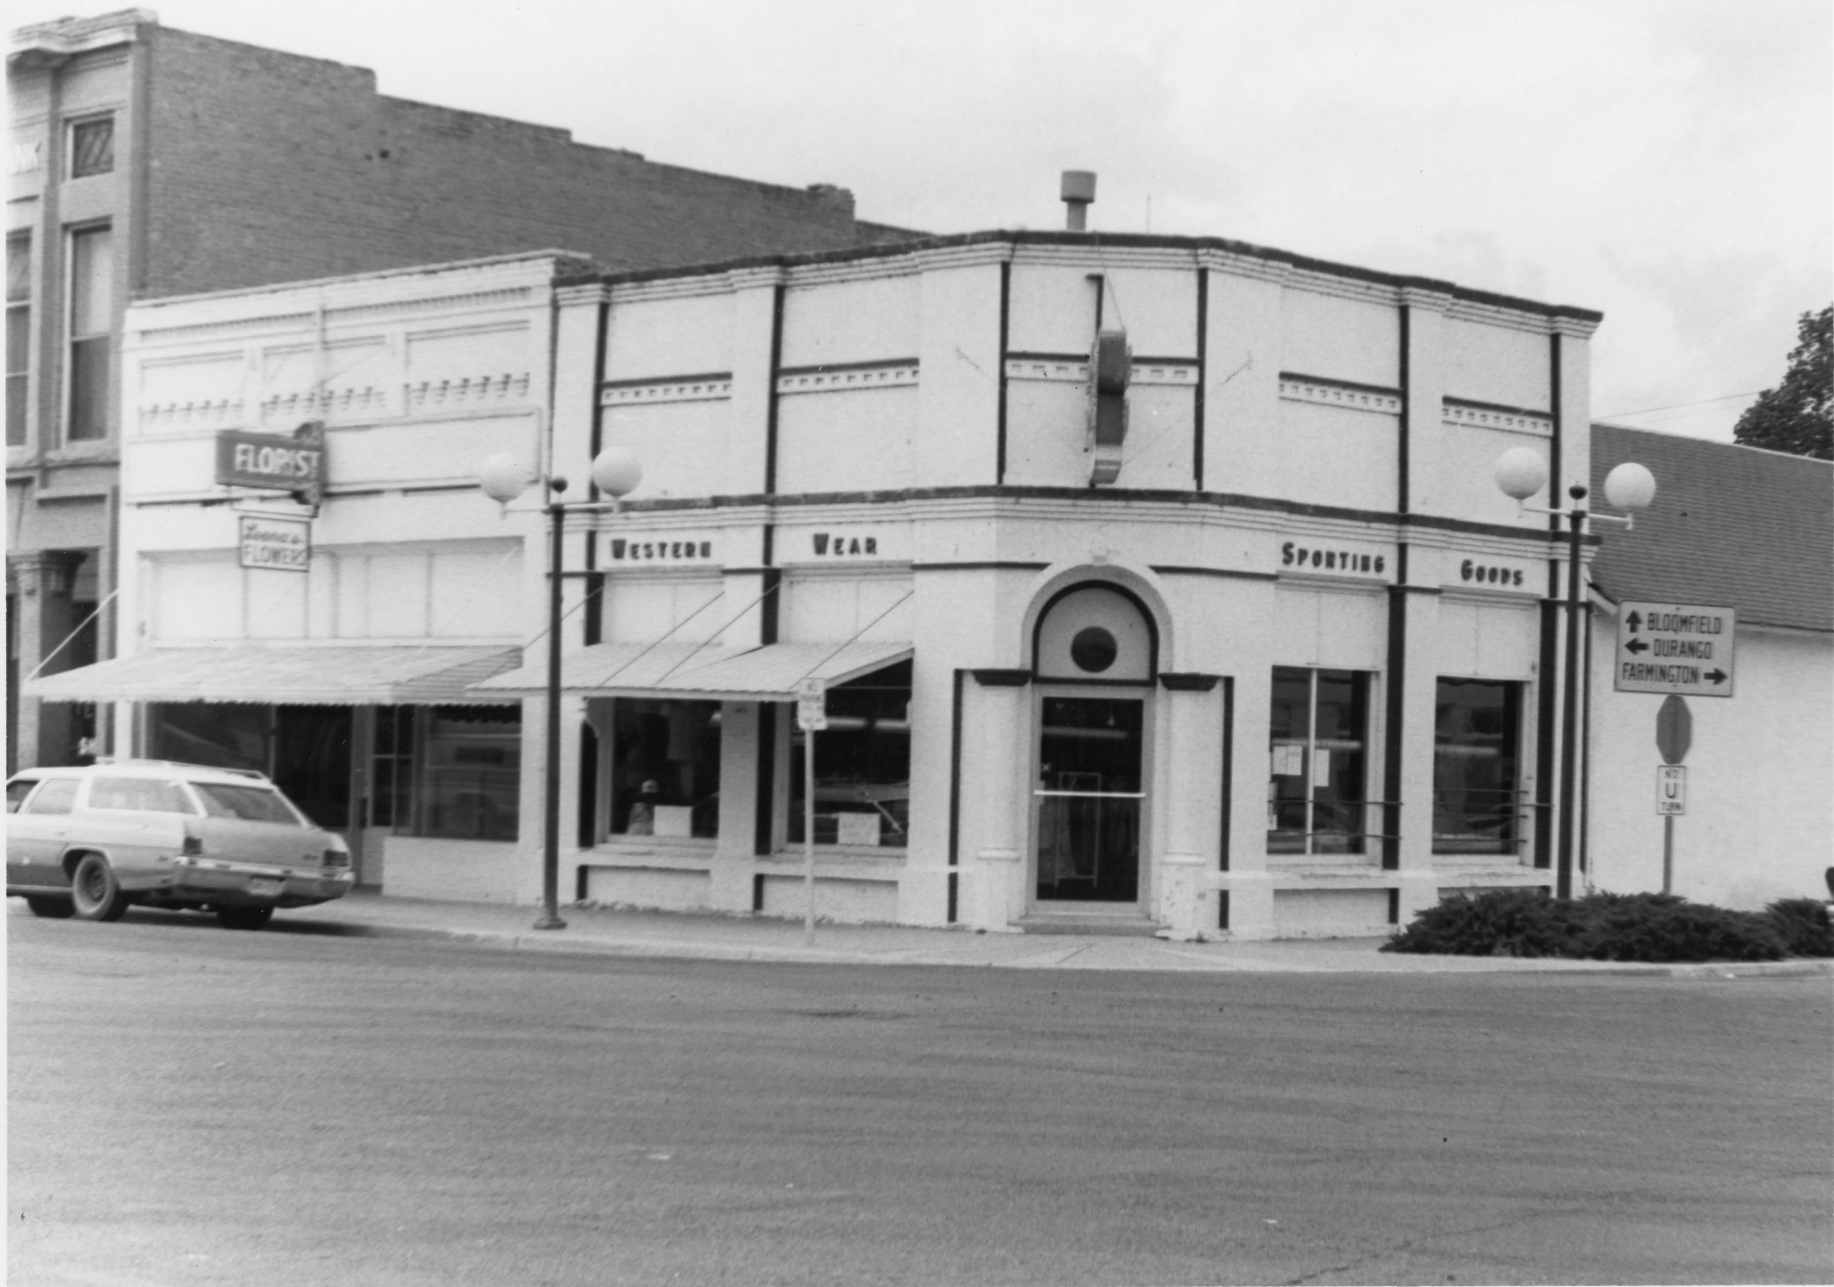
9. Hubbard Building/First State Bank;
Main Street District; Aztec, NM; B.
Barsook; 1981; NMSHPD; 3/4 view;
sig.

#721 Waring-Hubbard Building; 103 S. Main; ill. 9, left; Decorative Brick Style; 1908-1913; minor remodeling (1st, front); transom (above awning); decorative zipper-brick, panels and corbeled dentils.

#722 First State Bank; 100 S. Main; ill. 9, right; Decorative Brick style; pre-1908/facade post-1913; adobe with brick and board veneers; stone columns, keystone and two string courses; transoms (above awnings); decorative brick piers and cornice.

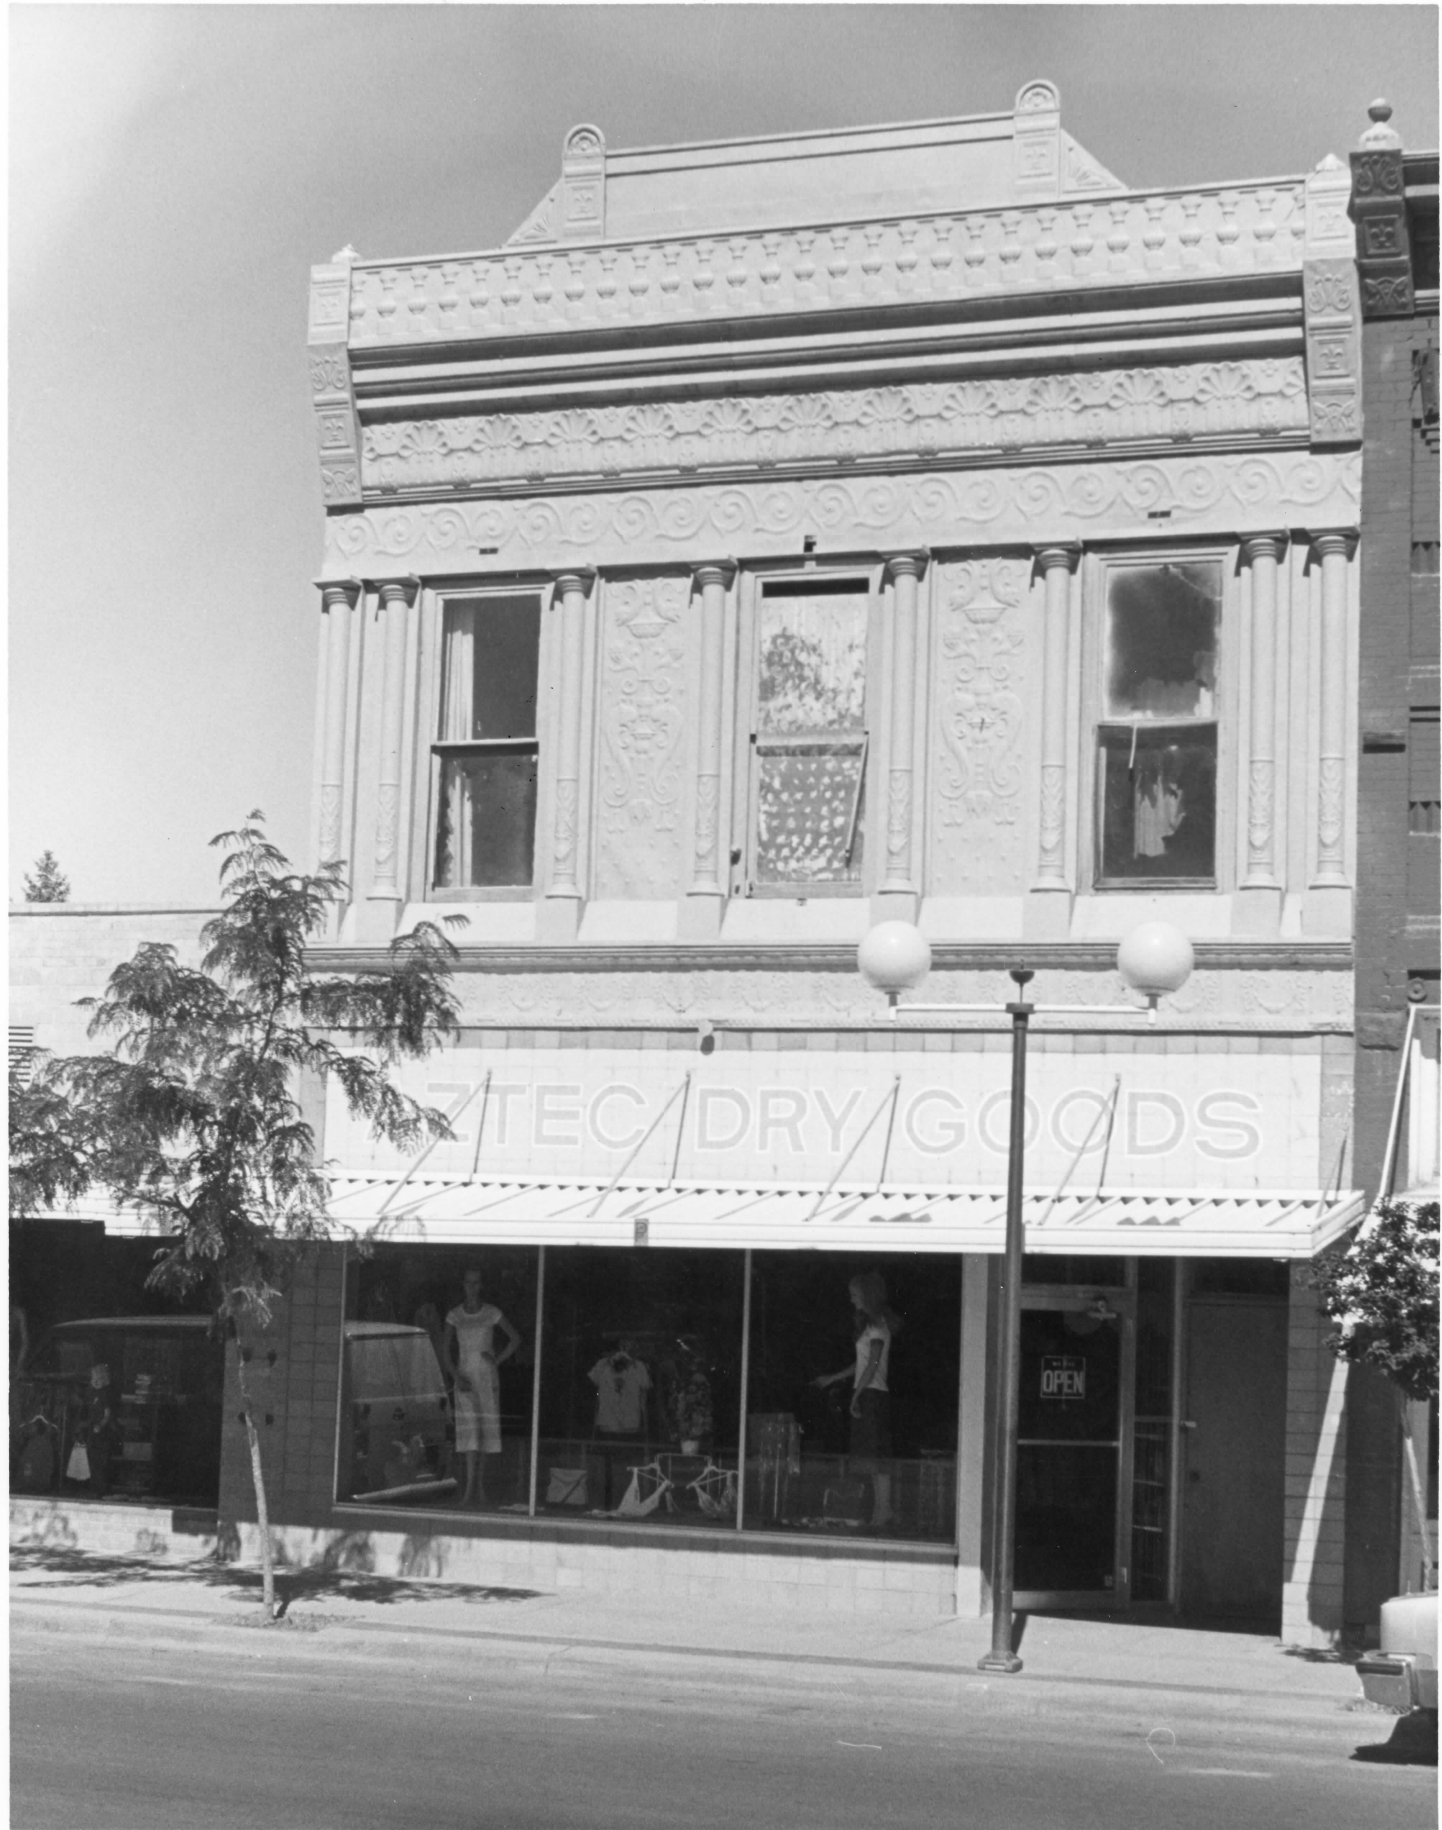
10. Townsend Building; Main Street
District; Aztec, NM; B. Barsook;
1981; NMSHPD; street facade;
sig.

#718 Townsend Building; 111 S. Main; ill. 10; Neo-Classical; 1908-1913; common bond brick walls; remodeled 1st-floor facade; decorative Neo-Classical pressed metal sheathing and cornice (2nd).

Built for Fred W. Townsend, who operated a meat market/grocery through the 1930s with a variety of partners.
