Effectiveness of Coanda Screens for Removal of Sediment, Nutrients, and Metals From Urban Runoff

Steve Esmond, PE, COANDA, Inc., Irvine, CA, sesmond@coanda.com

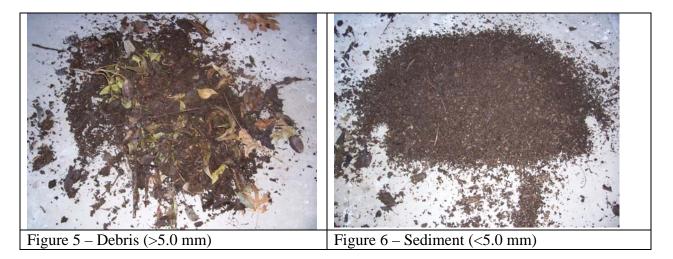
Figure 6D shows the quantity of debris plus sediment collected, which for this particular period averaged 194 lb per acre per year. As a function of weight, the fine debris or sediment (particle size fraction less than 5.0 mm) averaged 35.4 percent of the total gross weight collected. The percentage of fine material or sediment within any batch ranged between about 26 to 40 percent of the total weight.

Figure 6E shows where the nitrogen resided in the bulk sample. On average, 35.1 percent of the total nitrogen was retained on the sediment (<5.0 mm). This partitioning varied seasonally from a low of 17.8 percent in Sep 2010 to a high of 45.5% in May 2010. The higher nitrogen content of the sediment seems to coincide with spring and summer months, which corresponds with the growing season and period in which fertilizers are typically being applied.

Similarly, in Figure 6F it can be seen that 29.2 percent of the total phosphorus is partitioned off with sediment particulates (<5.0 mm). This percentage varied from a low of 12.2 percent in Sep 2011 to a high of 34.2 percent in Jul 2010. As with nitrogen, phosphorus seems to have increasing affinity for sediment as opposed to debris during the growing season.
