Dixon Quarry Group Haerses Road Quarry, Maroota

Annual Review 2024 – 2025

Client: Dixon Sand (No.1) Pty Ltd

Prepared by: Project Environmental Services Pt Ltd

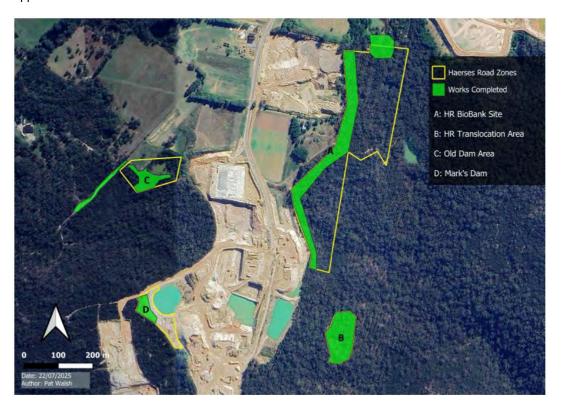
Figure 6: Location of bush regeneration works within the western boundary of the biobank area, offset area, old dam in Stage 3 and Stage 2 west (source: BushIT 2025).

Figures 6 to 9 (inclusive) illustrate the areas and methodologies where bush regeneration works have been completed during this reporting period.

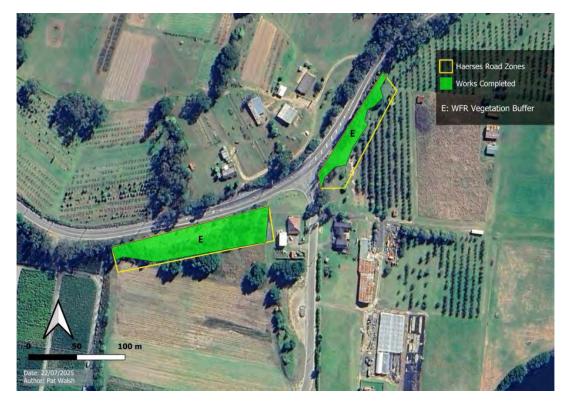
Figure 8: Location of bush regeneration works within the 30m buffer to Wisemans Ferry Road (source: BushIT 2025).

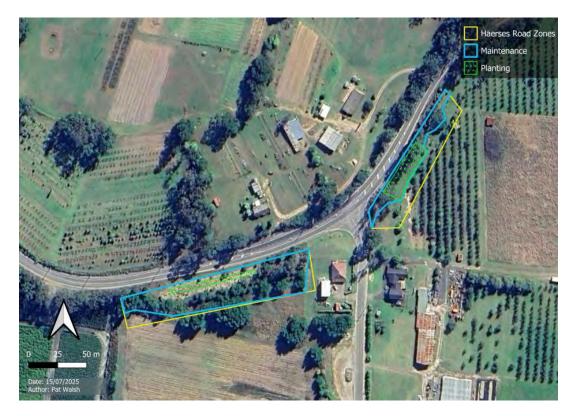
Figure 9: Bush regeneration methodologies undertaken within the 30m buffer to Wisemans Ferry Road (source: BushIT 2025).

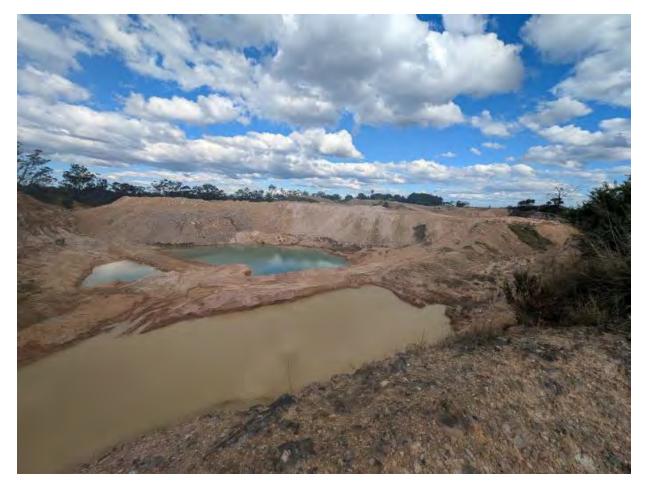
Plate 1 - Continued final landform shaping in Stage 1 Extraction area (South East Environmental 2025).

Approximately 5.68 hectares of Stage 1 has been disturbed for sand extraction. The remaining area to the east comprised of remnant native vegetation. Extraction has concluded for the eastern section (approximately 3 hectares) which is in the process of rehabilitation to agricultural land (refer to Plate 2). During this reporting period, rehabilitation work has continued in the eastern portion of Stage 1. A combination of imported VENM and ENM (after the reporting period) and overburden and interburden of clay and shale material from Extraction Cells A and B (Modification 1 area) have been utilised to fill in the void to achieve final landform height. Rehabilitation work is expected to continue during the next reporting period with the aim of rehabilitation the land to Agricultural Class 4 over the next two years.

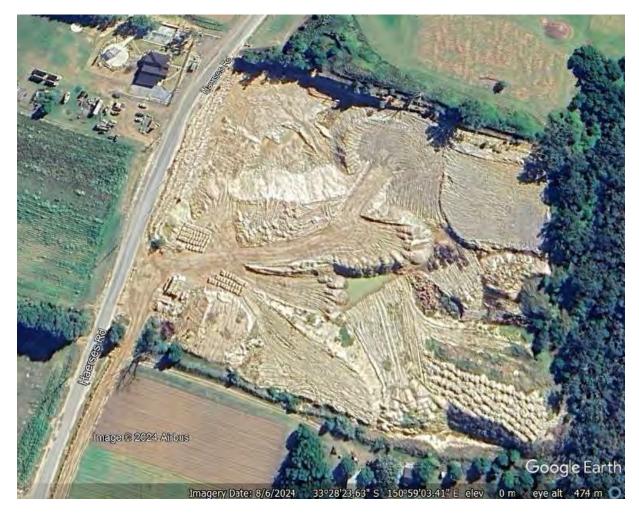
Plate 2 - Rehabilitation area in Stage 1, Google Imagery dated August 2024 (South East Environmental, 2025).

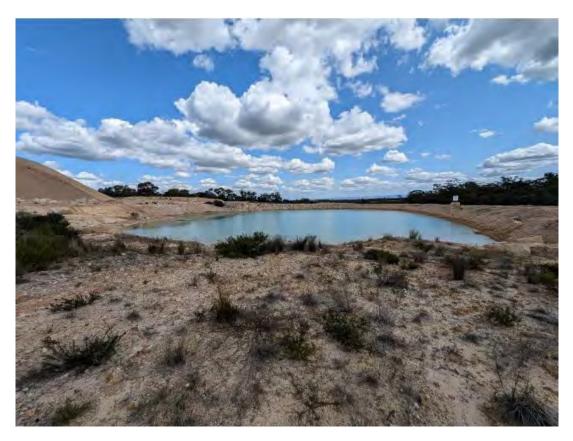
Stage 2 extraction cell is still an active quarry extraction area. Rehabilitation has commenced in Stage 2 west where sandstone extraction took place and concluded. The farm dam constructed in this area which will form a permanent water infrastructure for the property, in accordance with the Soil and Water Management Plan (refer to Plate 3).

Plate 3 – Farm dam located in Stage 2 west (South East Environmental, 2025).

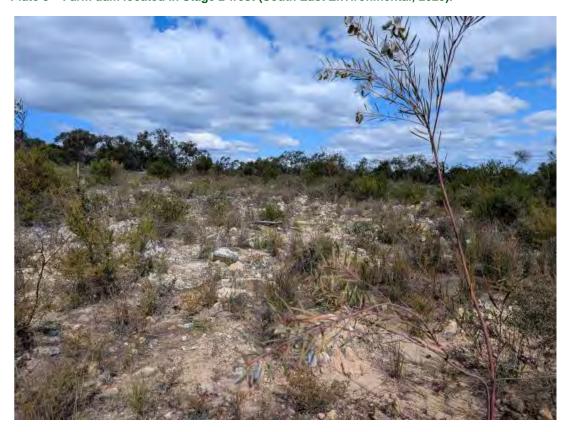
Plate 4 – Stage 2 west rehabilitation area west of the farm dam (South East Environmental, 2025).

Soil containing native vegetation seed bank from the extraction cells A and B was spread over the area between the dam and native vegetation on the western boundary. The natural regeneration process has commenced with a good diversity ground cover species emerging. In addition, the threatened *Darwinia biflora* and *Tetratheca glandulosa* have emerged with *Darwinia biflora* being prolific across the area (refer to Plate 4). Emergence of *Acacia bynoeana* has also been observed in the area immediately surrounding the dam, as previously observed in the previous two reporting periods.

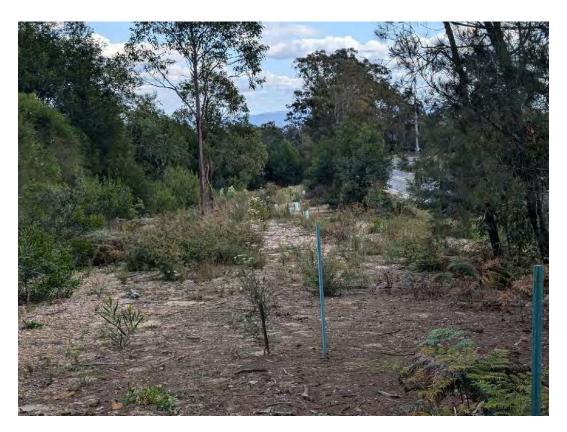
Plate 5 – Western side of 30m buffer to Wisemans Ferry Road in 2024 (South East Environmental, 2024).

Assisted planting was undertaken during the previous 2022 – 2023 reporting period on the western section of the buffer area, utilising soil and mulch containing native seed bank. Currently a diverse Eucalyptus, Acacia, Leptospermum and native grass and forb species have emerged (refer to Plates 5 and 6). The success of revegetation in this western buffer area has so far outperformed the eastern area where the ground has been highly compacted. The eastern section of the buffer area has not shown any signs of natural regeneration due to the density of exotic pasture species dominating the area. Assisted rehabilitation planting has been carried previously and additional planting undertaken during this reporting period with the aim of breaking up compacted soil to allow vegetation establishment in the future (refer to Plates 6 and 7).

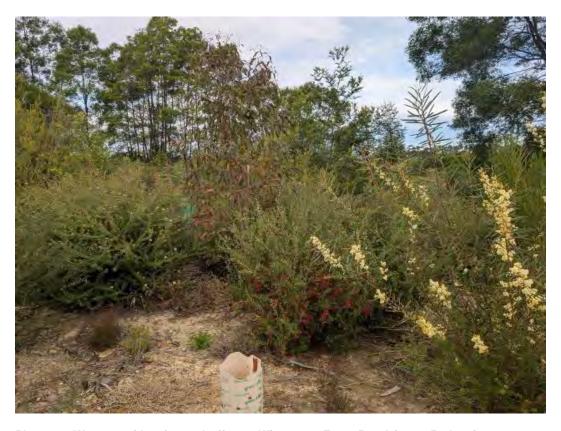
Plate 6 – Western side of 30m buffer to Wisemans Ferry Road in 2025 showing progress of vegetation establishment and weed management (South East Environmental, 2025).

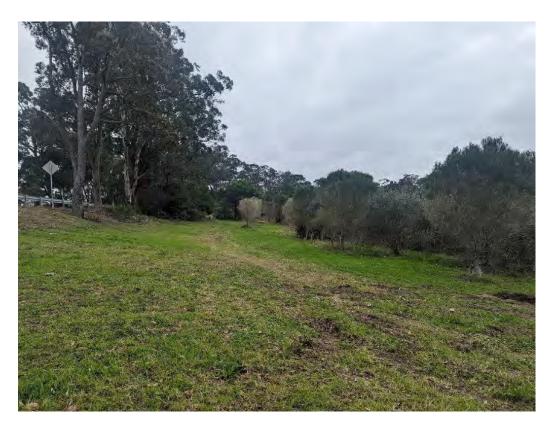
Plate 7 – Eastern side of 30m buffer to Wisemans Ferry Road in 2024 (South East Environmental, 2024).

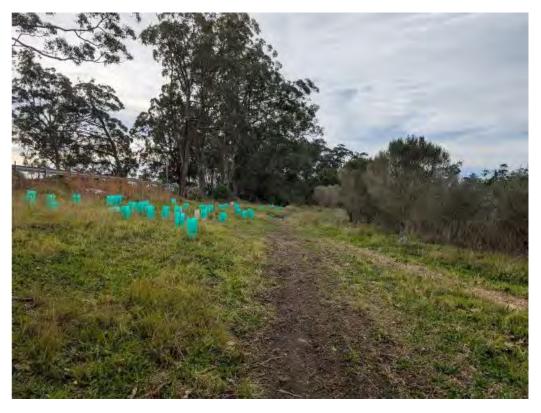
Plate 8 – Eastern side of 30m buffer to Wisemans Ferry Road in 2025 showing supplementary planting to assist in breaking up compacted soil (South East Environmental, 2025).

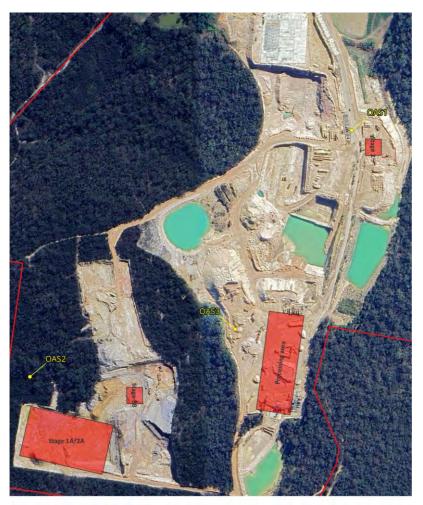
Haerses Road modelled work areas

Measurements close to these plant items established a representative noise model of the operations. A summary of noise emission data for these items is presented in Appendix A. See Figure 2 for work locations.

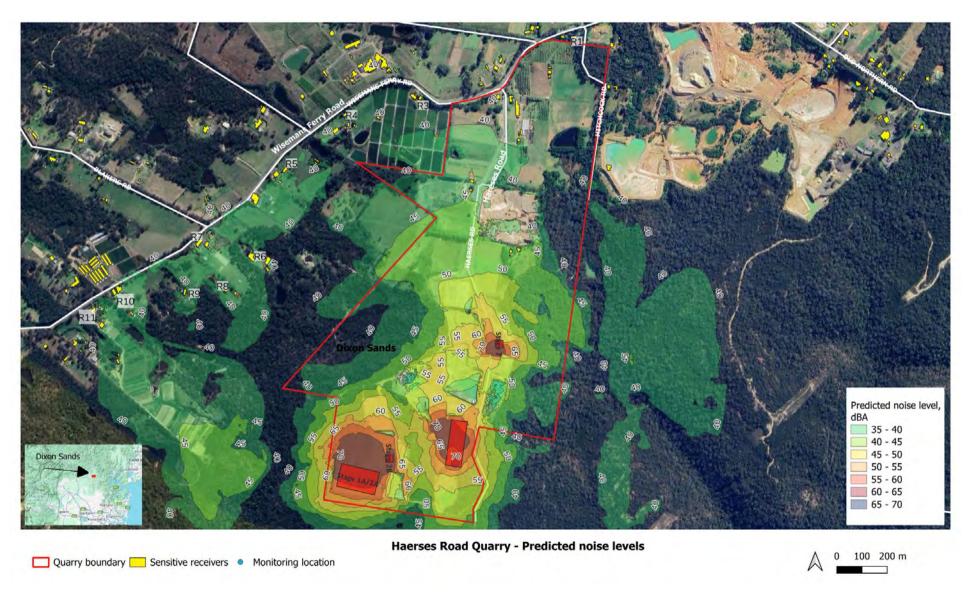
Figure 3 Extrapolated noise levels from Haerses Road quarry based on on-site measurements.

Results of attended noise monitoring and extrapolated noise levels indicate that Haerses Road quarry operations are compliant with shoulder and daytime noise criteria under the meteorological conditions at the time of monitoring in December 2024 and June 2025. The daytime noise results are less than or equal to 2dB above the noise criteria. In accordance with Table 4.1 of the Noise Policy for Industry (EPA, 2017), if the predicted noise level minus the project noise trigger level is less than or equal to 2 dB, the significance of residual noise level is considered negligible and the total cumulative industrial noise level is not applicable.

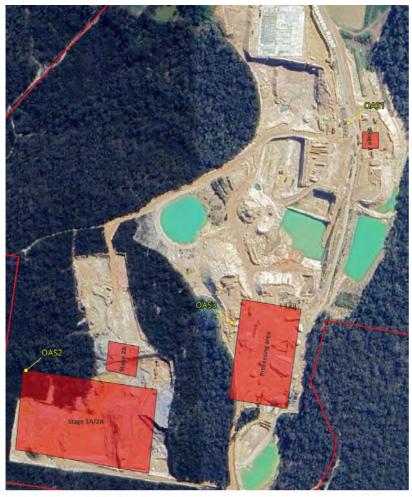
Haerses Road modelled work areas

Measurements close to these plant items established a representative noise model of the operations. A summary of noise emission data for these items is presented in Appendix A. See Figure 2 for work locations.

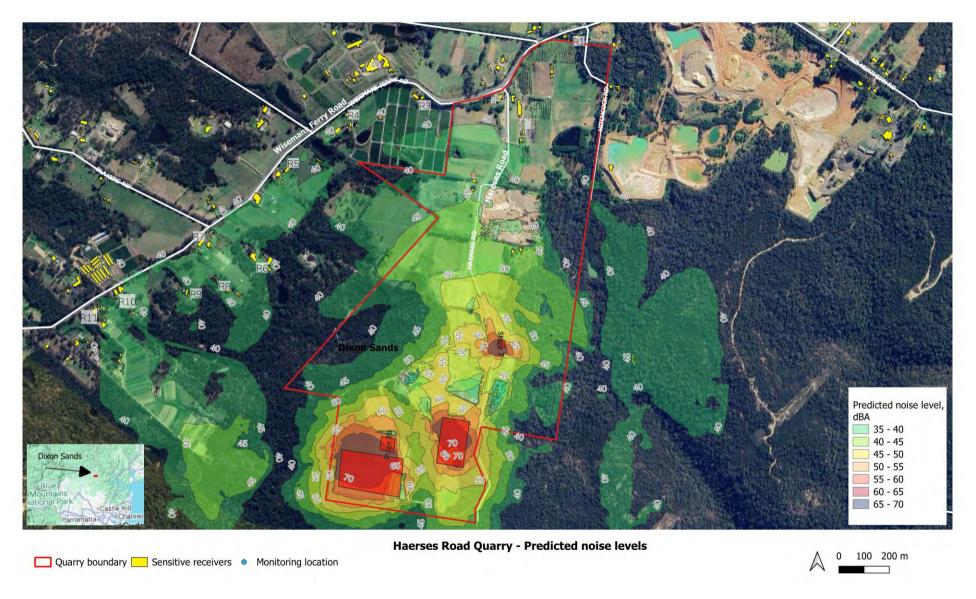
Figure 3 Extrapolated noise levels from Haerses Road quarry based on on-site measurements.

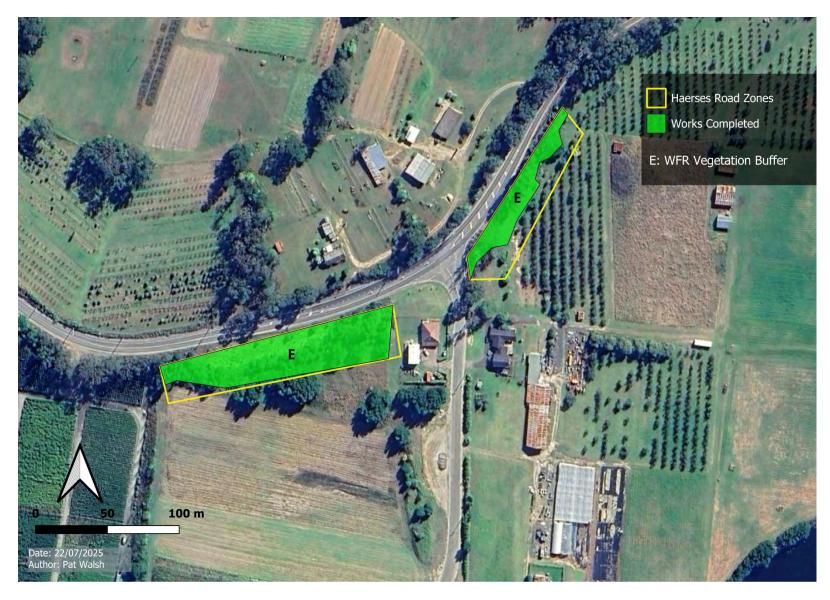
Figure 3 – Map depicting the areas worked in the Wisemans Ferry Rd vegetation buffer.

Management and access of the buffer at the corner of Haerses Road and Wisemans Ferry Road (Area E in **Figure 3**) has improved since the roadwork undertaken by Roads and Maritime Services (RMS) in 2020. This is due to the western buffer strip being stripped back and capped with a sandstone crush in the previous financial year. The plantings conducted by Bush-it in that same year have also started to establish. The area is still prone to weed infestations due to exposure and soil compaction, however the weed density has been significantly reduced, and native competition has increased significantly since the sandstone capping conducted by Dixon Sand.

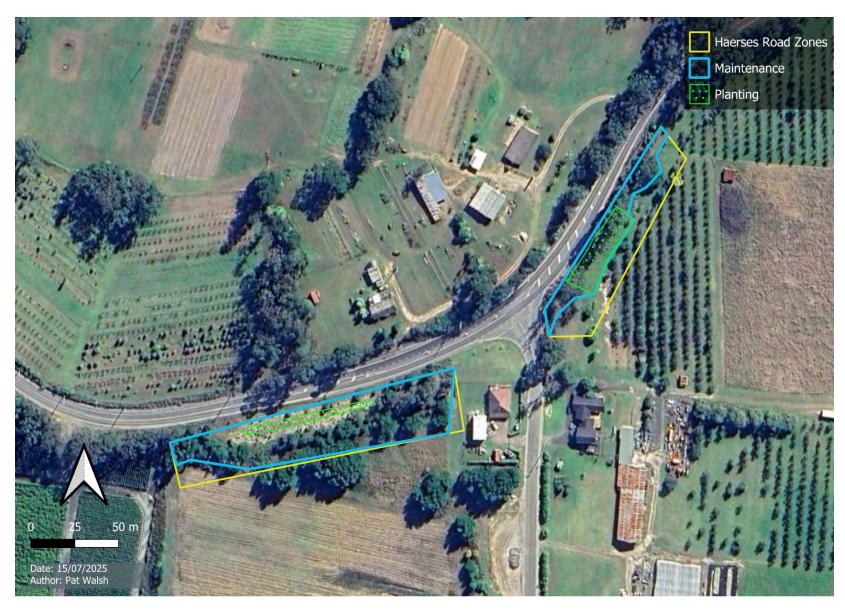
Figure 4 – Activities undertaken at Wisemans Ferry Road for 2024-2025.

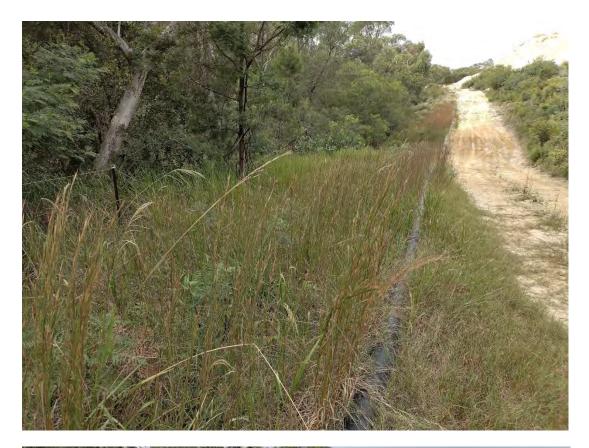
Figure 5 – Before and after photos of *Andopogon virginicus* control prior to seeding bordering HR Biobank Site

Monitor and manage competitive native shrubs and trees in the (2009) translocation area, especially *K. ambigua* where it overshadows or encroaches on ground dwelling plants. Bush-it will selectively cull or cut back growth to encourage the most diverse assemblage of plants possible.

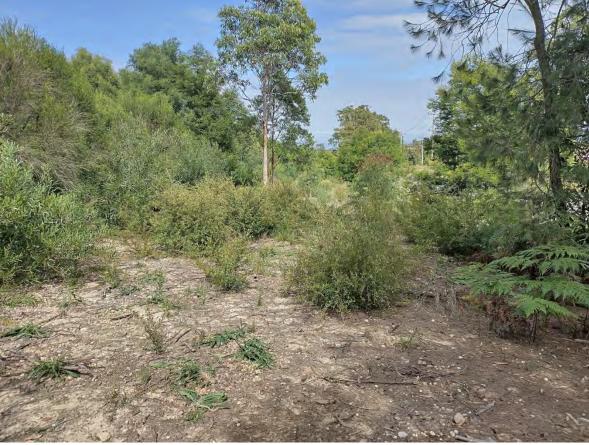
Figure 6 – Before and after of annual control within the capped area of the visual buffer.

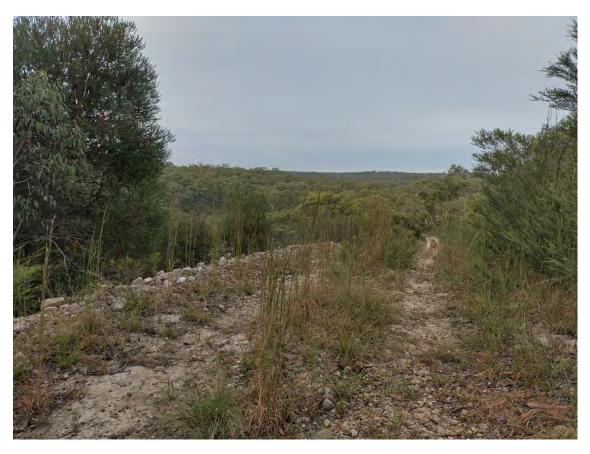
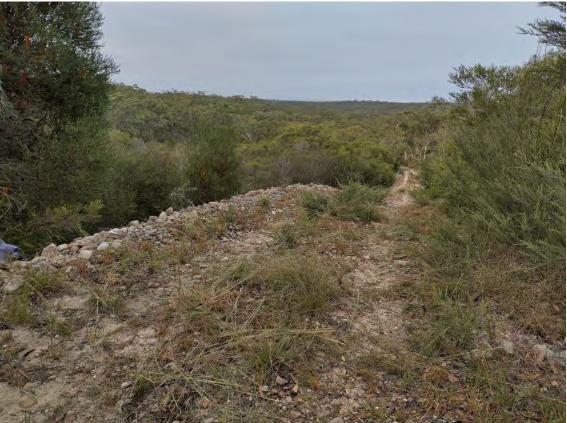
Figure 7 – Before and after of *Andropogon virginicus* along fire trail abutting old dam area.

Management of *Ageratina adenophora*, especially prior to flowering in August/September is recommended, through slashing and/or spraying.

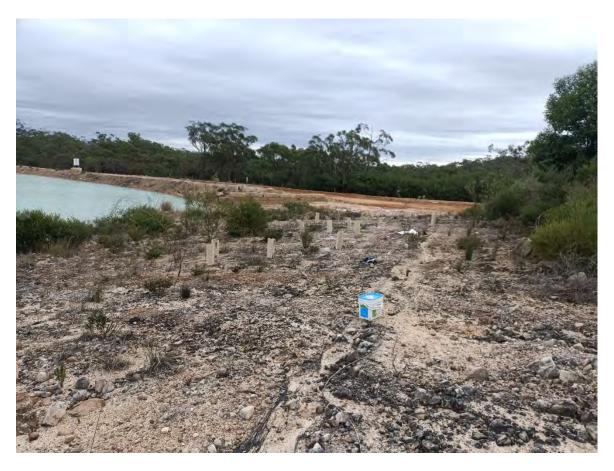
Mark's Dam (Area D in **Figure 1**) is an area that is largely cleared with native regrowth emerging. The cleared area abuts a parcel a good quality Scribbly Gum – Dwarf Apple woodland to the west and a parcel of lower condition woodland to the east.

Figure 8 - Planting at Mark's Dam.

Continued maintenance and monitoring of plantings, including further watering if dry conditions persist.

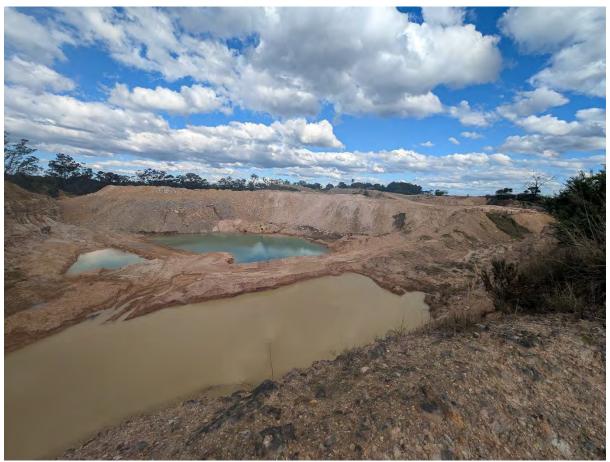
Rehabilitation work within stage 1 has continued with clay and shale material from Extraction Areas A and B along with imported VENM and ENM being used to raise the surface level. These works are expected to continue during the 2025-2026 reporting period with an aim at rehabilitating stage 1 to agricultural usage sometime in the next two years.

Image 2. Extraction area stage 1 with rehabilitation material raising the ground level to final contour height

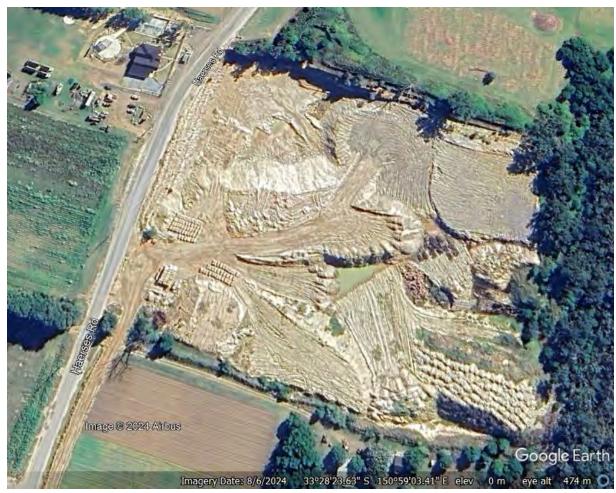
Image 3. Extraction area stage 1 active rehabilitation area (Image sourced from Google Earth Pro August 2024)

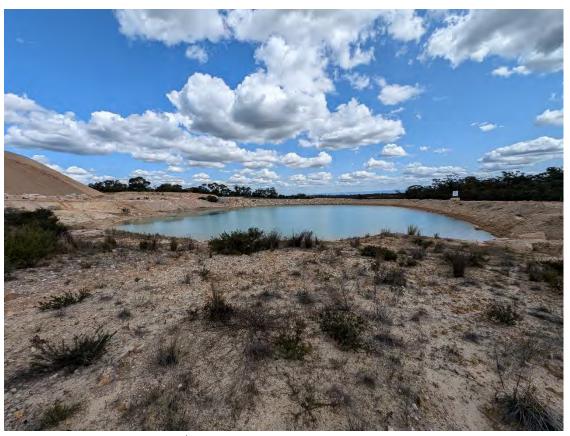
Image 4. Extraction area stage 2 dam

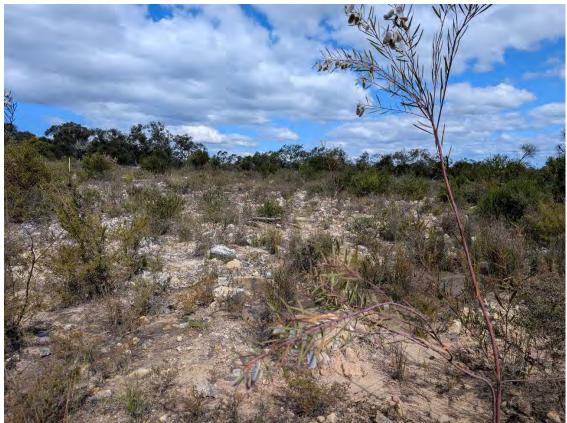
Image 5. Stage 2 rehabilitation area west of the dam

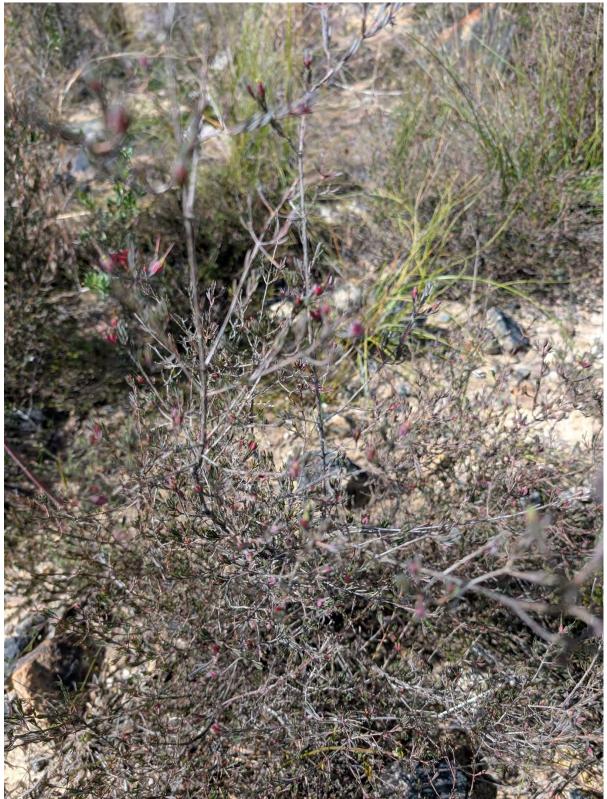
Image 6. Darwinia biflora flowering in Stage 2 rehabilitation area west of the dam

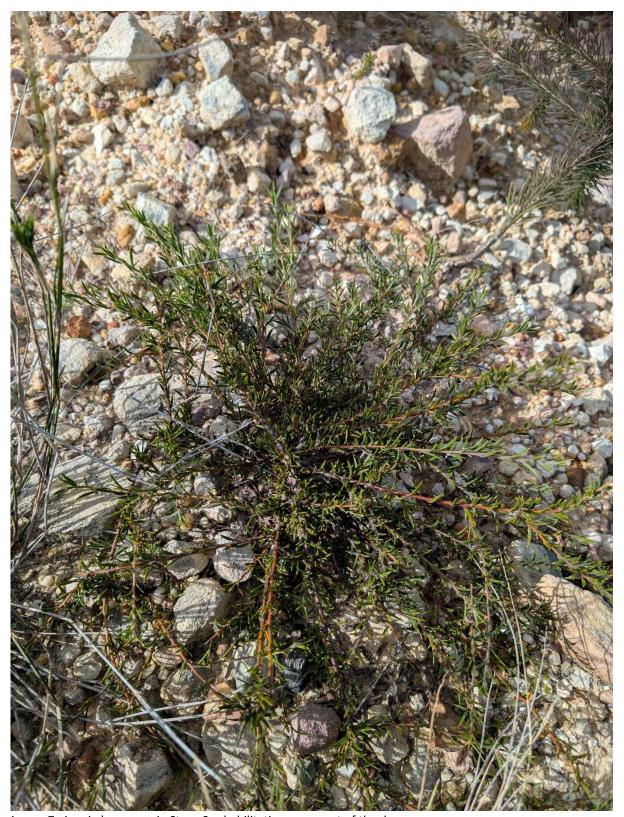
Image 7. Acacia bynoeana in Stage 2 rehabilitation area west of the dam

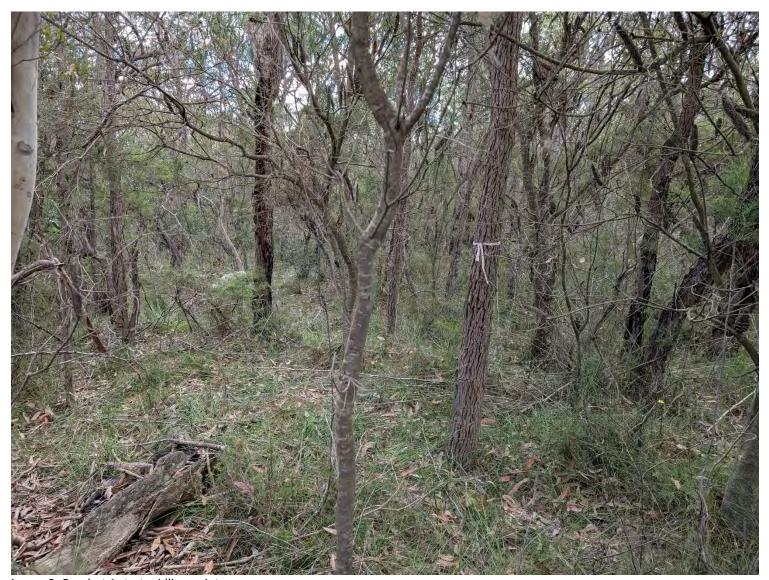
Image 9. Quadrat 1 start midline point

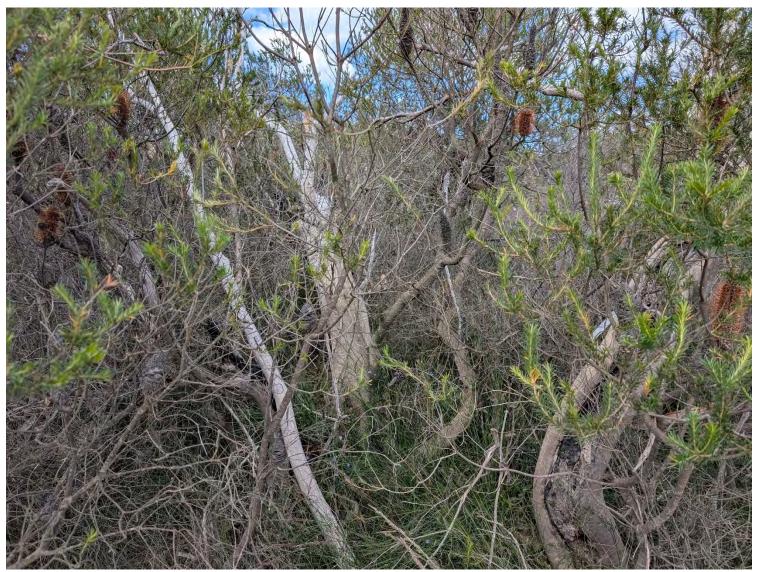
Image 10. Quadrat 2 centre midline point

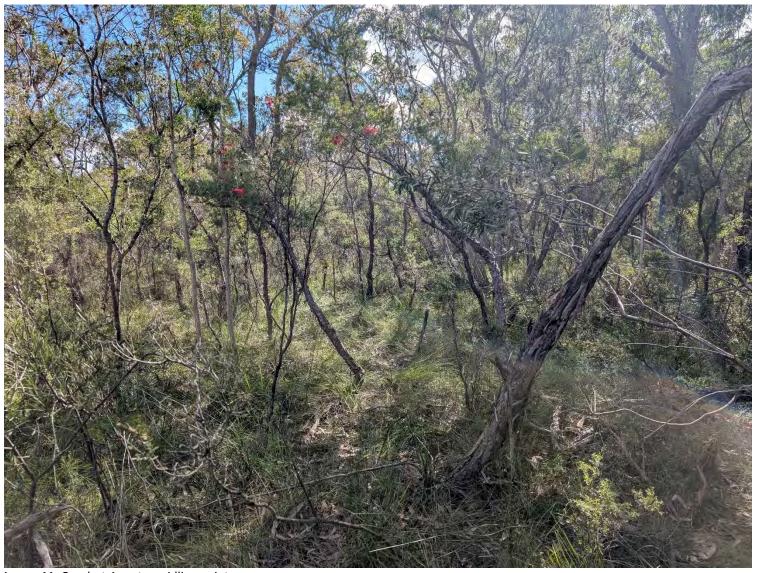
Image 11. Quadrat 4 centre midline point

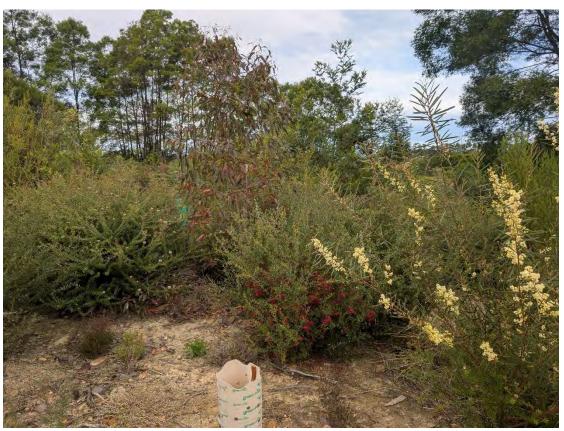
Exotic species occur in both areas with Weeds of National Significance (WoNS) and High Threat Weeds (HTW) present. Weed density has been damatically decreased over the reporting period from a dedicated weed management program. Weed management and control will continue during the next reporting period with the WoNS and HTW being the species of targeted priority.

Image 14. Western side of Haerses Road within the Wisemans Ferry Road buffer area

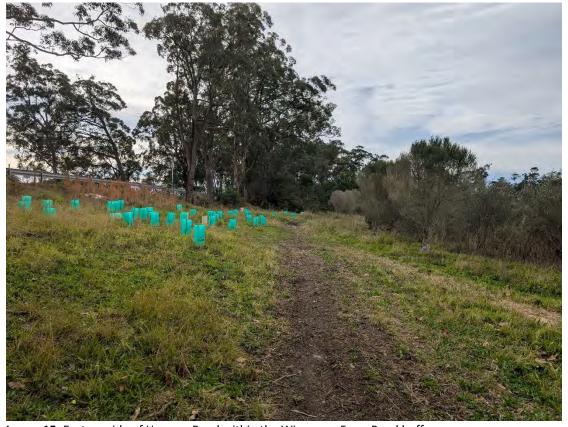
Image 15. Eastern side of Haerses Road within the Wisemans Ferry Road buffer area
