**Dixon Sand Pty Ltd**  
**Old Northern Road and Haerses Road**  
**Quarries, Maroota**  
**Annual Review**  
**2018 – 2019**

Prepared by: Project Environmental Services Pty Ltd

File name	J16-001_AR_2018-19	Version	1.0
Report name	Dixon Sand Pty Ltd - Old Northern Road and Haerses Road Quarries, Maroota Annual Review 2018 - 2019		
Cover Page Image	Native Vegetation Corridor, Old Northern Road Quarry (courtesy: PES, June 2019)		
Prepared by:	Hunsamon Churcher	Date:	29/09/2019

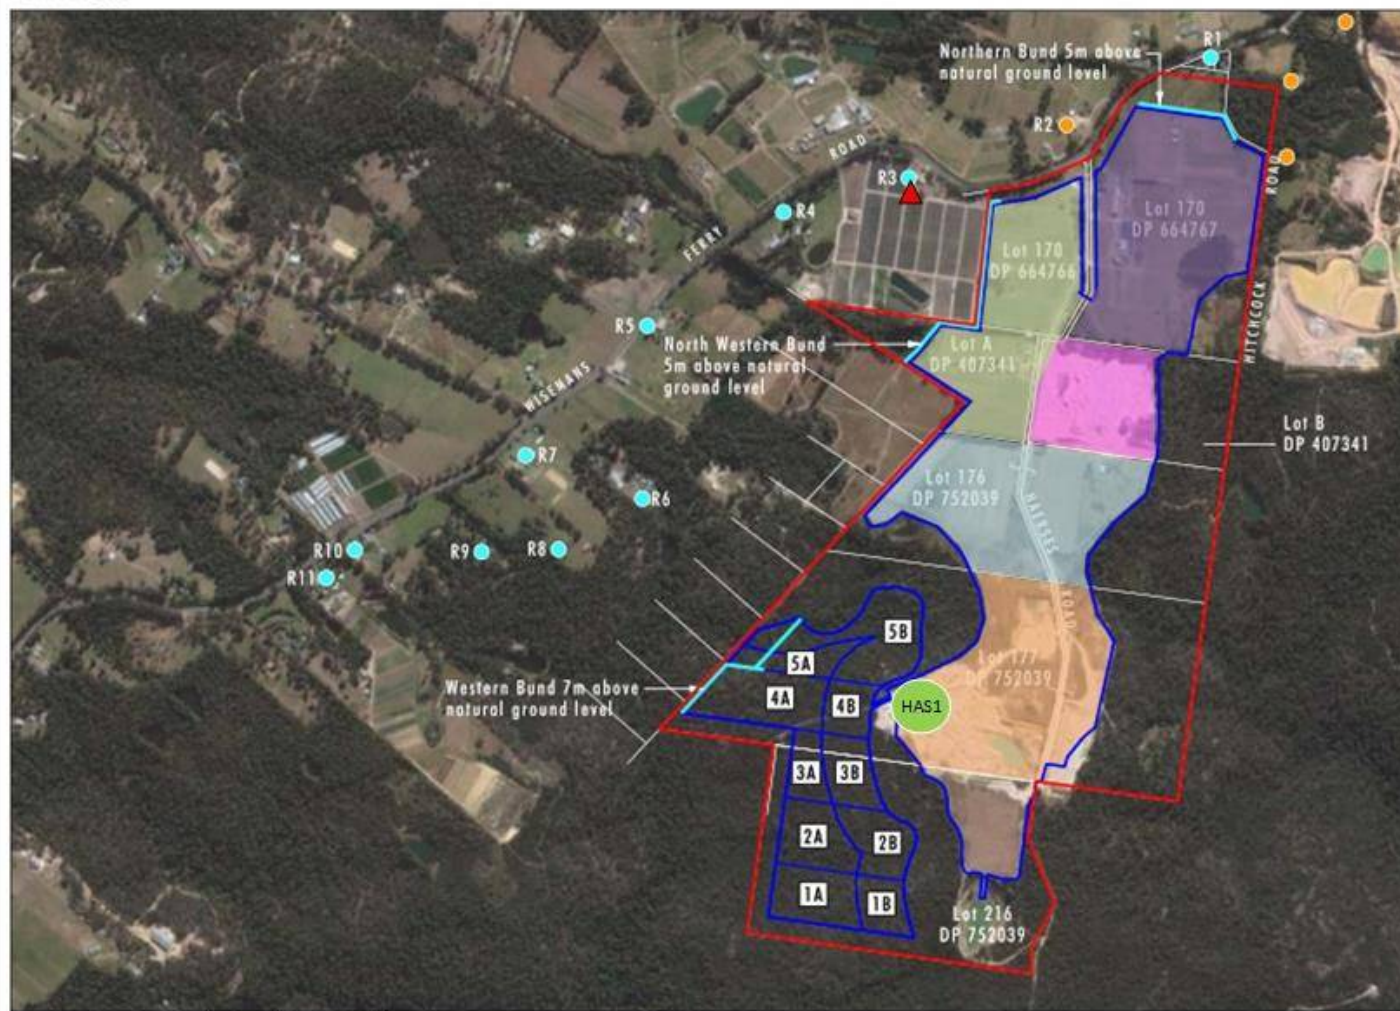
Figures 2 shows the locations of the noise receivers and at-source monitoring in reference to the quarry.

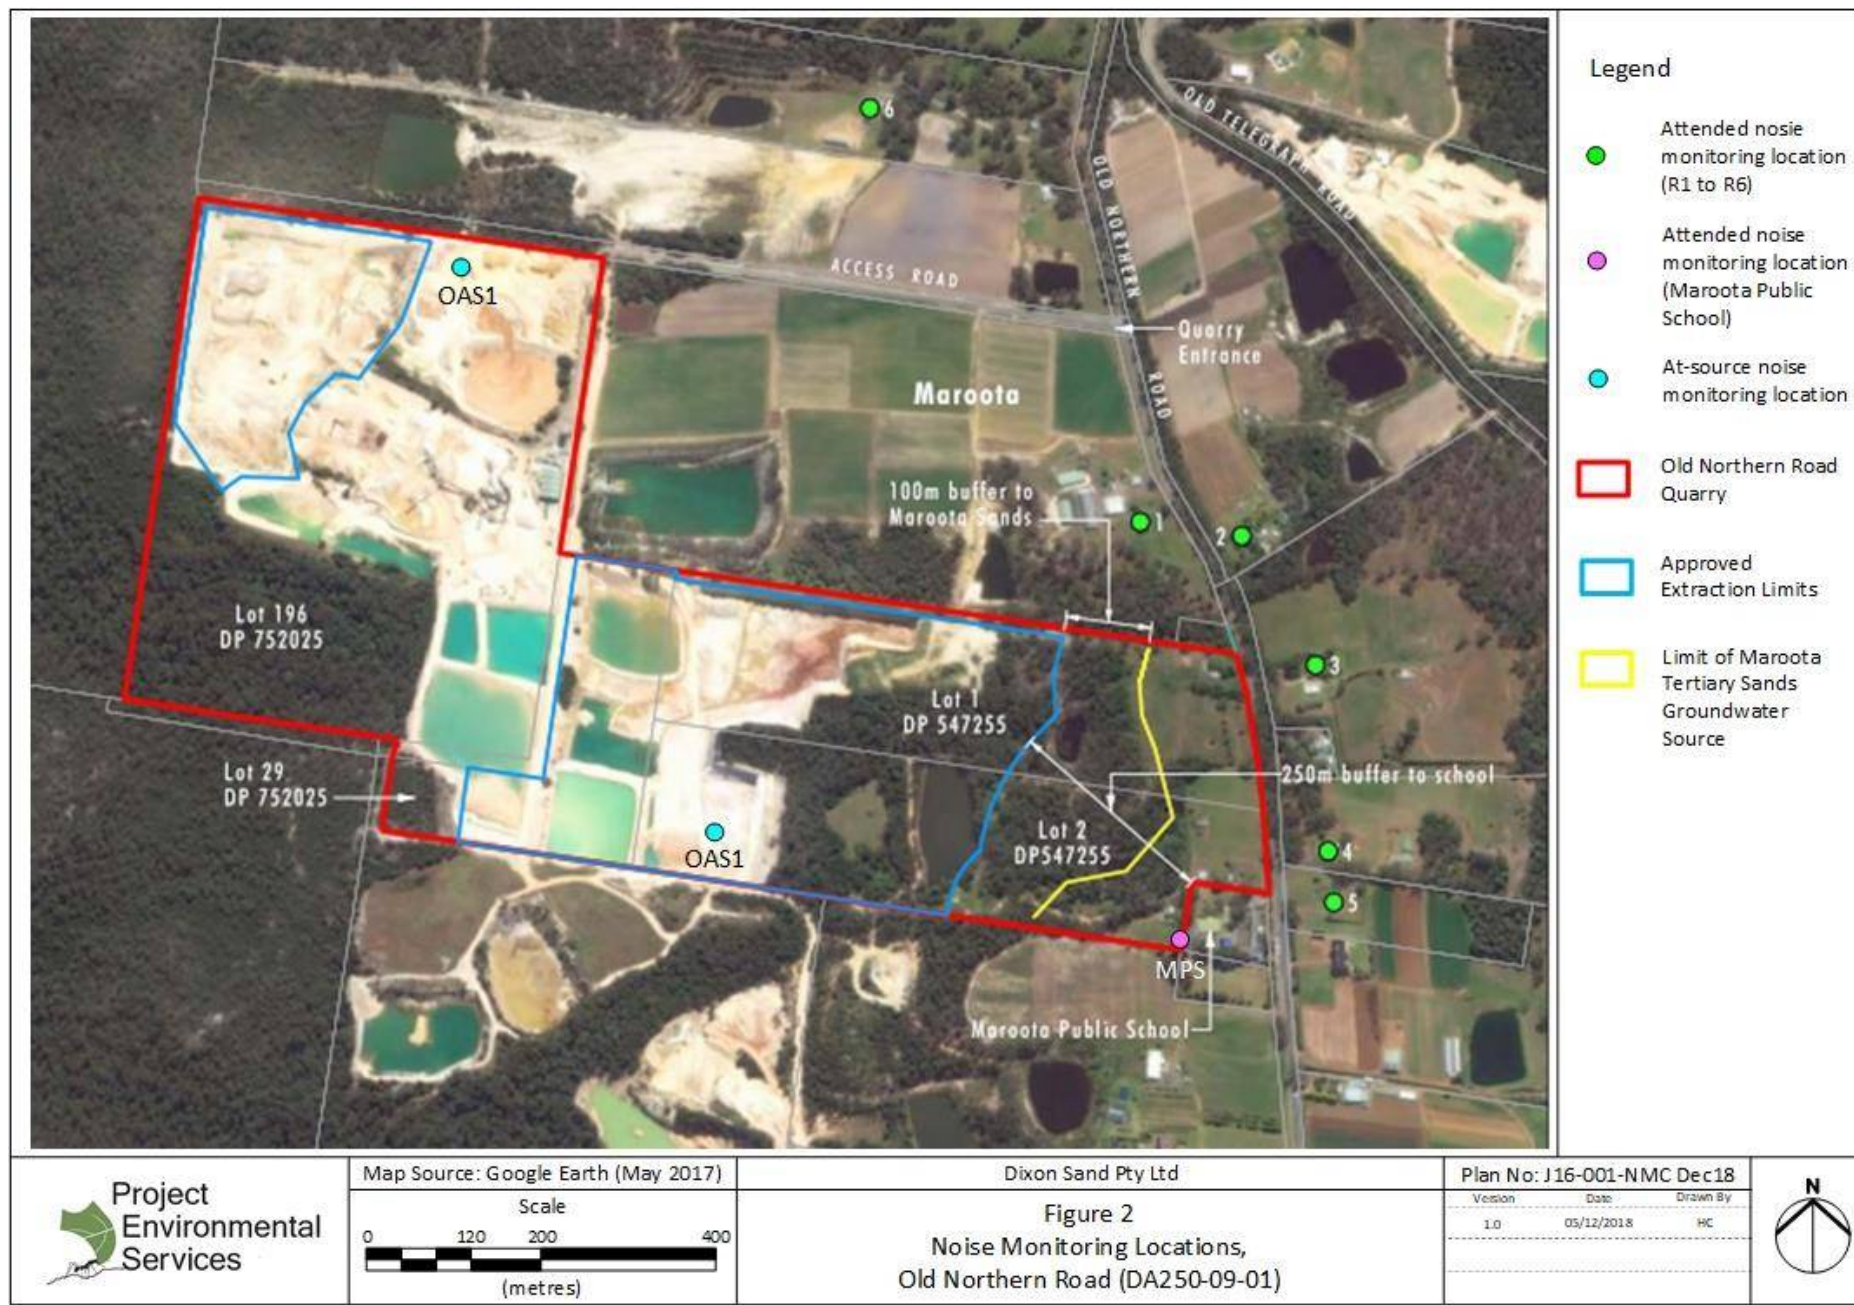
Figures 2 shows the locations of the identified noise receivers, attended noise monitoring and at-source monitoring in reference to the quarry.

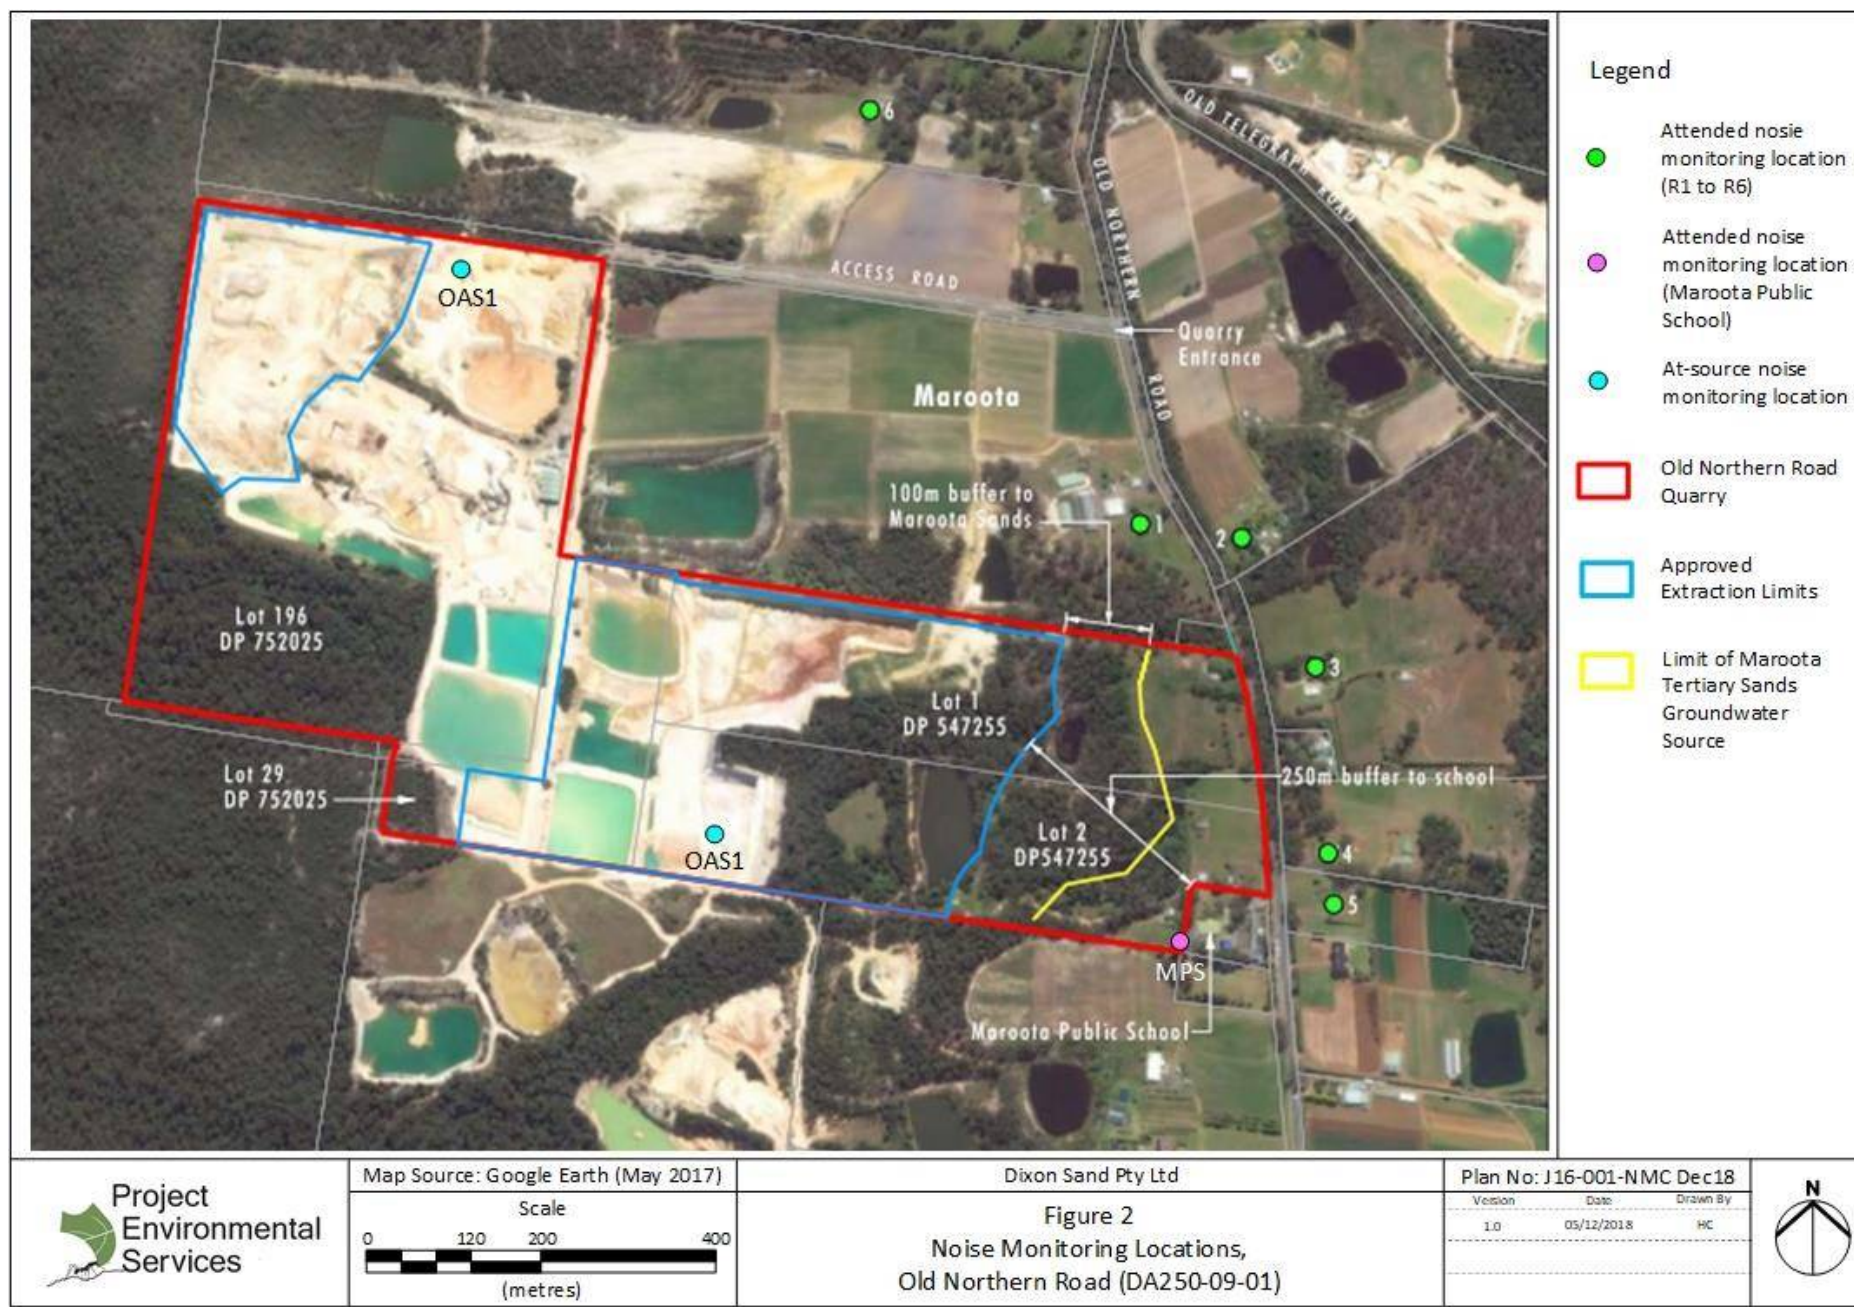
Figures 2 shows the locations of the identified noise receivers, attended noise monitoring and at-source monitoring in reference to the quarry.
