Dixon Sand Pty Ltd
Haerses Road Quarry, Maroota
Annual Review
2019 – 2020

File Name: J16-001_AR_HR_2019-20

Client: Dixon Sand (No. 1) Pty Ltd

Prepared by: Project Environmental Services Pty Ltd

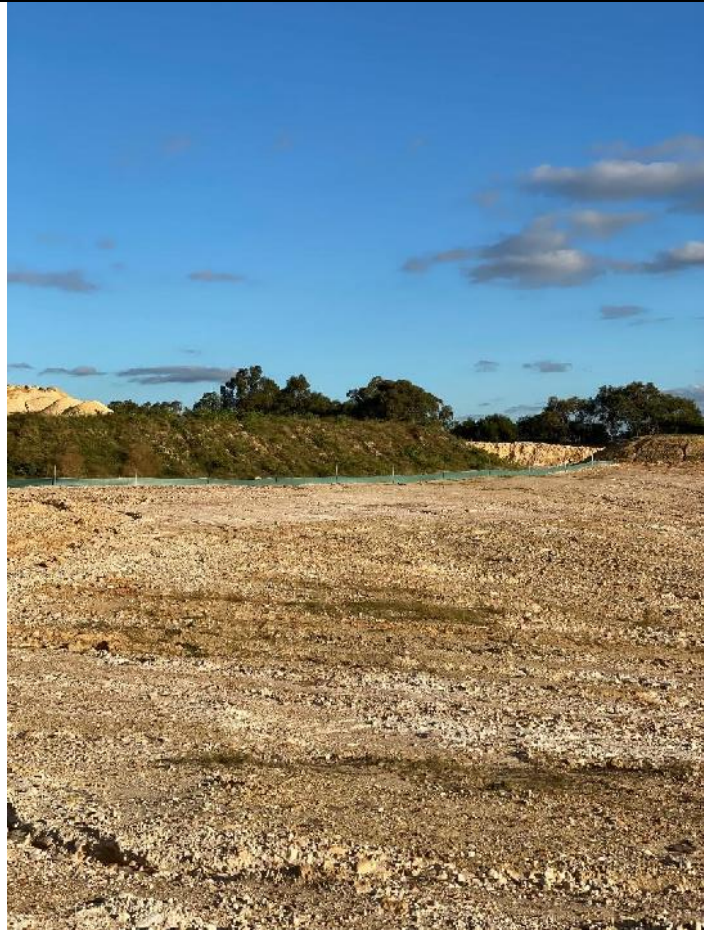
<p data-bbox="1182 1273 2063 1331">Plate 2: Stockpiles have been reshaped to < 3 metres in height and silt fence installed at the base on the downslope side.</p>

ID	IEA Comments and Recommended Action	Proposed Action and Implementation Timeframe by Dixon Sand
HR R16/19	<p>Ensure that topsoil stockpiles are constructed in accordance with the topsoil management measures outlined in the Biodiversity and Rehabilitation Management Plan.</p> <p><i>Topsoil stockpile management measures include the location of stockpiles away from quarrying, traffic affected areas and watercourses, positioning within closed water management areas and within the Quarry disturbance footprint, positioning on level or gently sloping ground, establishment in windrows to a height no greater than 3m, and the establishment of silt fences at the base of stockpiles. Topsoil stockpiles to be kept longer than 3 months must be sown with a vegetation cover, with weed growth monitored on a monthly basis and controlled appropriately.</i></p>	<p>Proposed Action: A review of the current topsoil stockpile locations will be undertaken and where required, the stockpiles will be rectified and/or establish a windrow to a height no greater than 3 metres and silt fences installed at the base on the downslope side. Advice from a qualified ecologist will be sought regarding the best approach to preserve the native seedbank within topsoil stockpiles whilst limiting dust generation.</p> <p>Implementation Timeframe: 31 March 2020</p> <p>Status: Closed out - actioned in February 2020.</p>

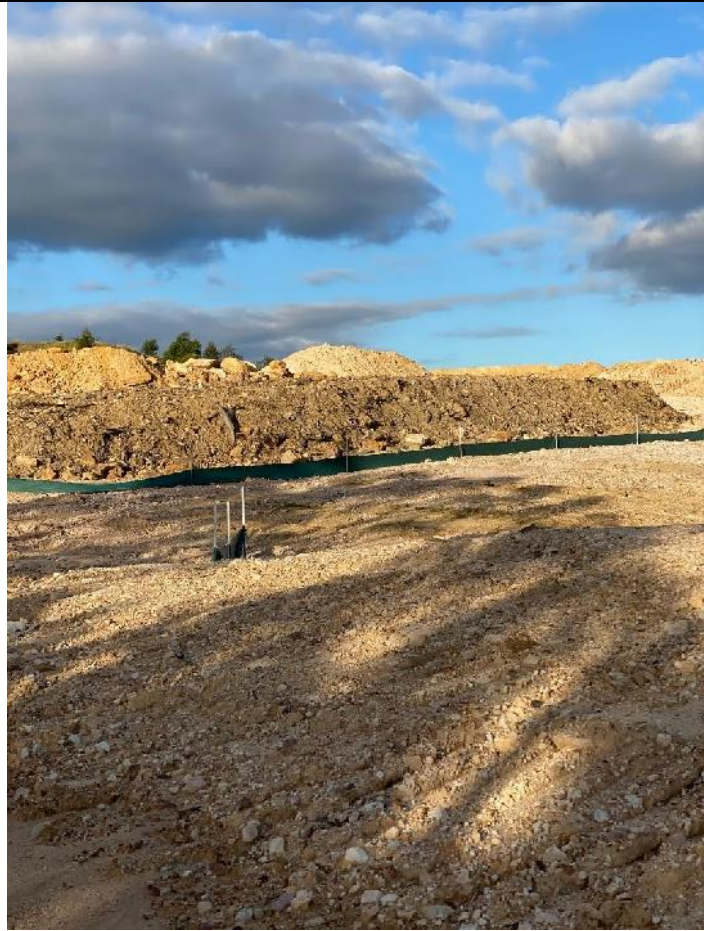
<p data-bbox="1182 1273 2063 1331">Plate 3: Stockpiles have been reshaped to < 3 metres in height and silt fence installed at the base on the downslope side.</p>
