# Dixon Sand

Resource Management Plan

Name of Operation	Haerses Road Quarry, Maroota
Name of Operator	Dixon Sand (No. 1) Pty Ltd
Development Consent / Project Approval #	DA165-7-2005 (Mod 4) – Haerses Road Quarry
Annual Review Start Date	1 July 2021
Annual Review End Date	30 June 2022
Name of Authorised reporting officer	Hunsamon Churcher
Title of Authorised reporting officer	Environmental Advisor
Signature of Authorised reporting officer	<i>J. Hunsamon</i>
Date	30/09/2021

File name	J16-001_AR_HR_2021-22	Version	1.0
Report name	Dixon Sand - Haerses Road Quarry Annual Review 2021 - 2022		
Cover Page Image	Haerses Road Quarry – Monitoring Site Quadrat 4 (Photograph courtesy: South East Environmental, 2022)		
Prepared by:	Hunsamon Churcher	Date:	30/09/2021

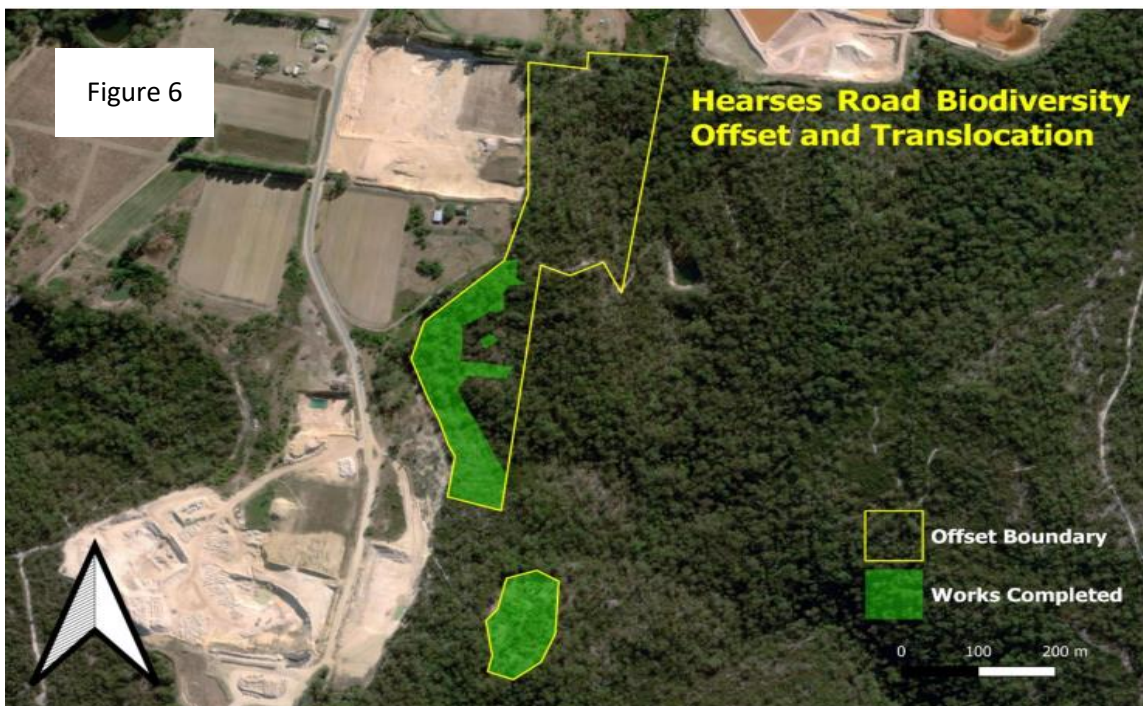
Figure 6: Bush regeneration and weed management works area at Haerses Road Quarry (source: BushIT 2022).

Recent above average rainfall has provided ideal condition for exotic grasses through the open areas of the Translocation site to flourish. Maintenance works at the areas shown in Figure 6 focused on controlling infestations of whiskey grass, African love grass and couch. The growth of *Kunzea ambigua* and other canopy trees were managed in order to assist regeneration at groundcover stratum.

Haerses Road and Porters Road Biobank Sites are currently undergoing 'passive' management. However, as the western perimeter of Haerses Road biobank site borders exotic grassland containing several different invasive perennial grass and exotic annual species, weed management have occurred in the area highlighted in Figure 6.

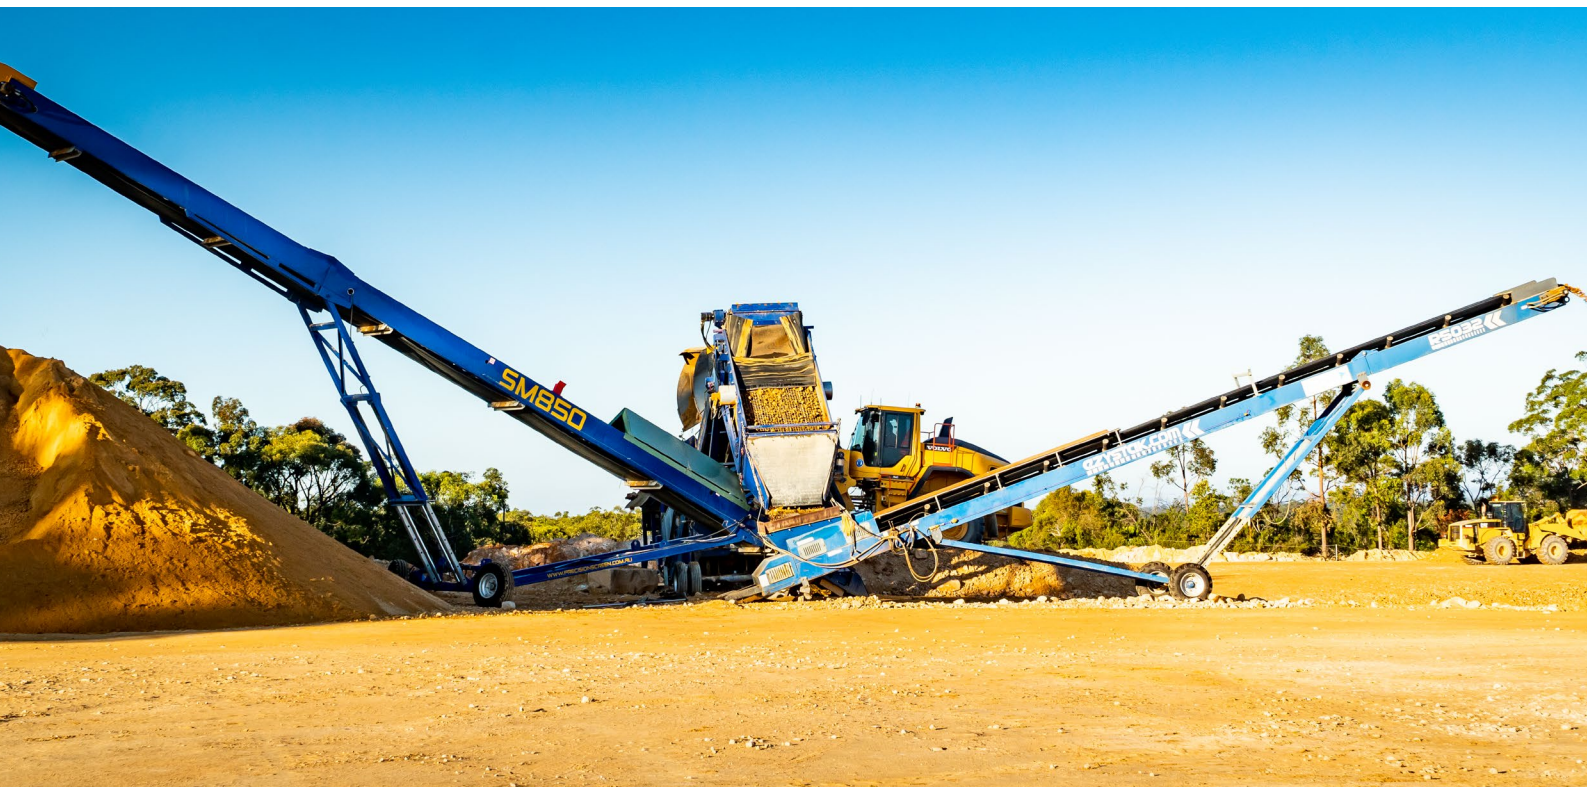
Figure 2 Extrapolated noise levels from Haerses Road quarry based on on-site measurements.

Based on measurements described in Table 4, extrapolated noise results for each receiver are presented in Table 5 and illustrated in Figure 2. Results are shown for all equipment operating (screen / loader and rock saw).

Receiver	Noise criteria	Extrapolated noise level, LAeq, 15 minute	Comment
R12	40	27	Predicted levels correlate well with measured levels and all locations shown to comply with noise limits.
R3	40	29	
R4	40	32	
R6	41	32	
R7	40	33	
R8	40	36	
All other receivers	40	See Figure 2

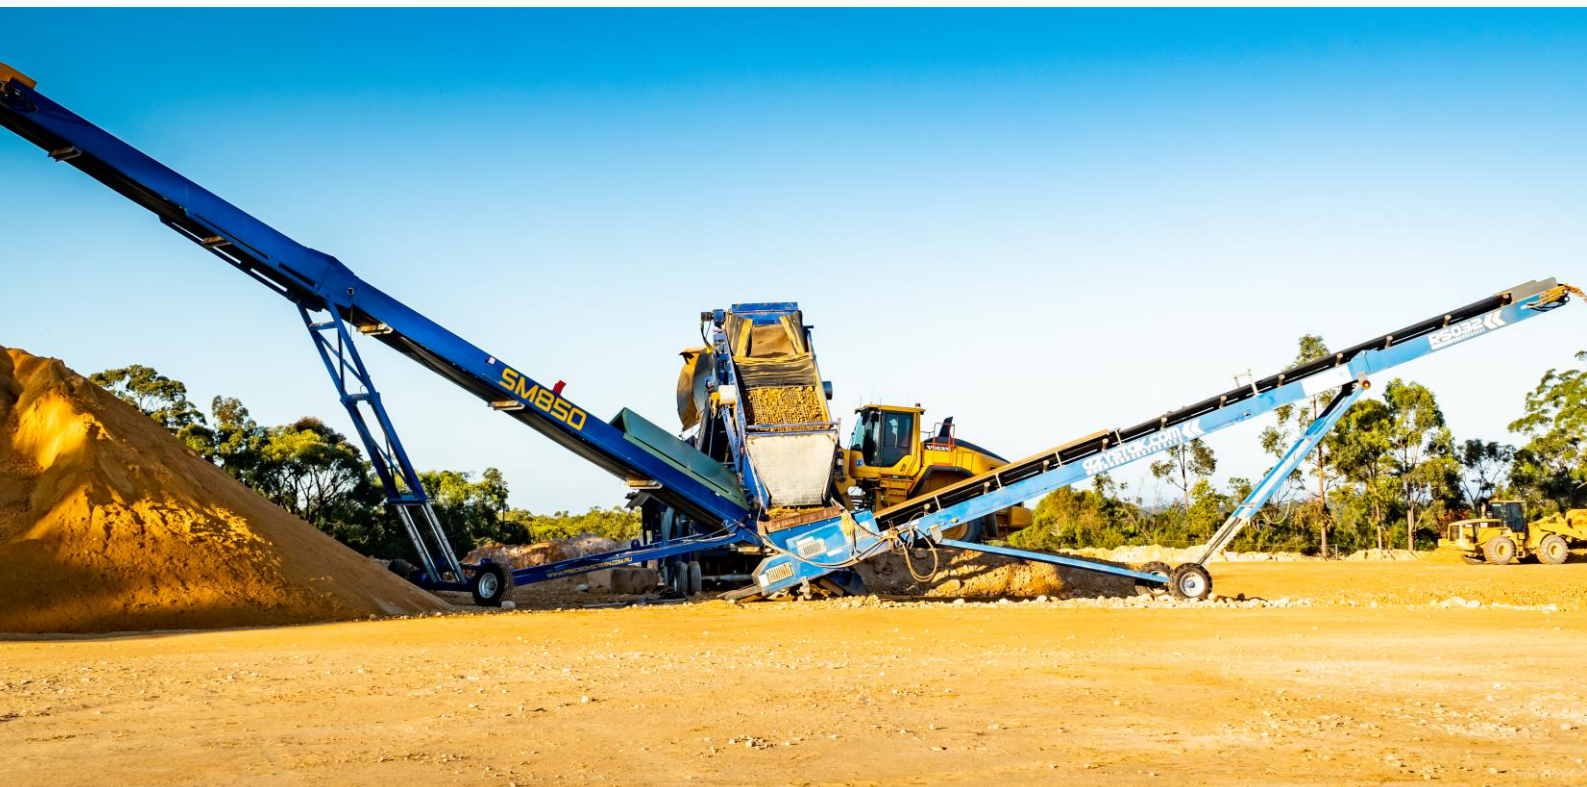
Figure 2 Extrapolated noise levels from Haerses Road quarry based on on-site measurements.

Based on measurements described in Table 4, extrapolated noise results for each receiver are presented in Table 5 and illustrated in Figure 2. Results are shown for all equipment operating (screen / loader and rock saw).

Receiver	Noise criteria	Extrapolated noise level, LAeq, 15 minute	Comment
R12	40	29	Predicted levels correlate well with measured levels and all locations shown to comply with noise limits.
R3	40	31	
R4	40	31	
R6	41	36	
R7	40	32	
R8	40	33	
All other receivers	40	See Figure 2

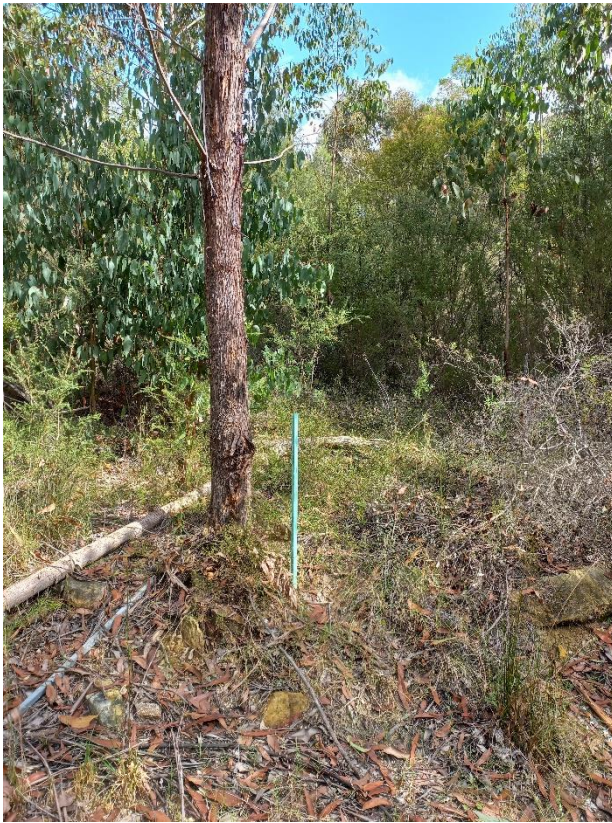
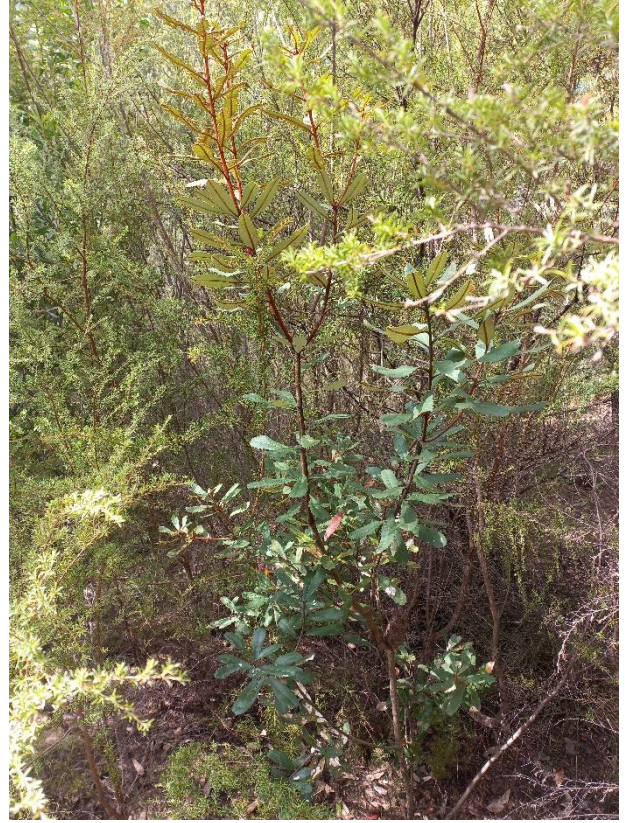
□□□□r□□□□□Culling assertive natives has encouraged understorey shrubs and groundcovers.□

The remaining hours at (2009) translocation site were spent cutting back thickets of *Kunzea* and culling canopy trees where smaller shrubs and groundcovers are struggling to get sunlight. ( Figures 3 and 4) In the thickly forested areas of the translocation area, an infestation of common couch has also been targeted with a monocot specific herbicide.

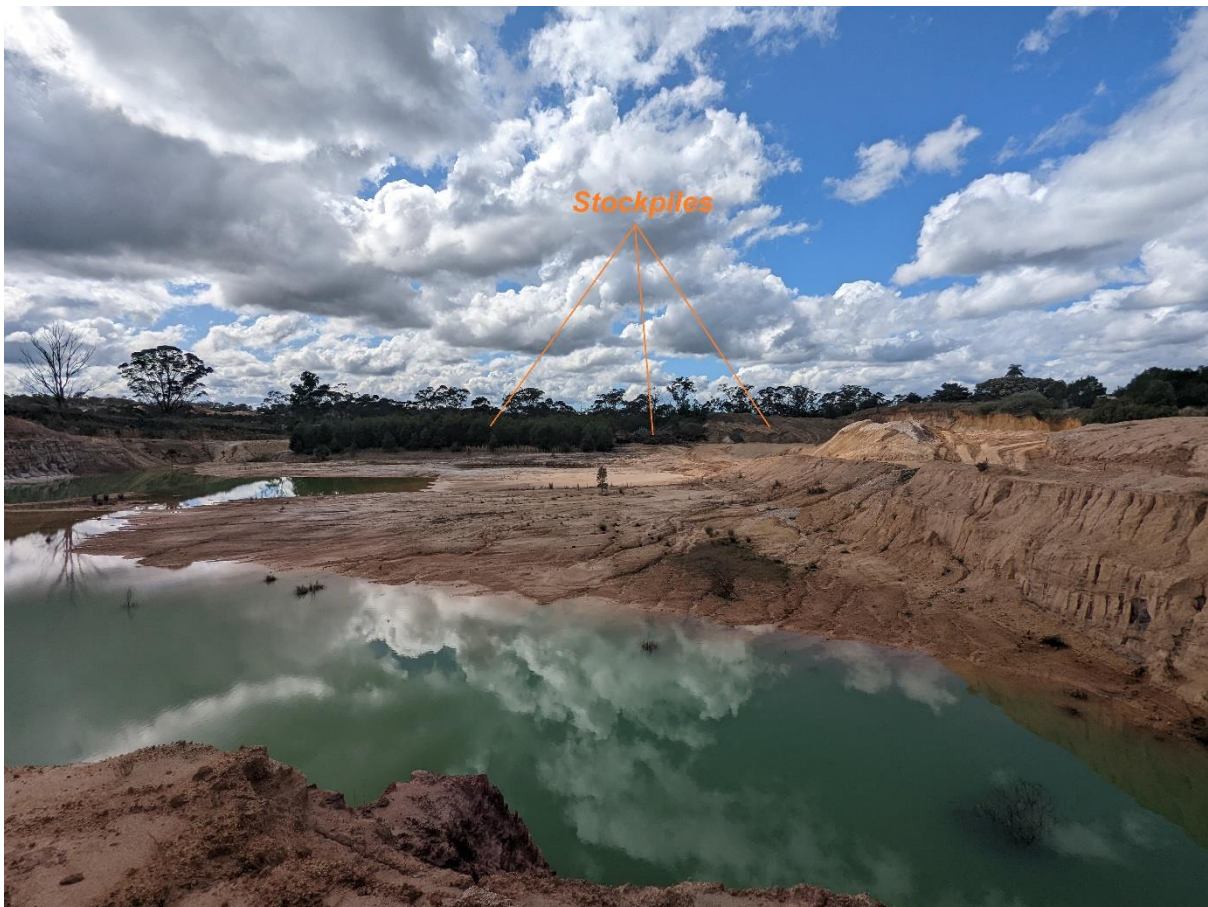
The eastern area of the site is currently being used to stockpile material for rehabilitation. It is expected that within the next reporting period these stockpiles will be screened to remove rock fragments larger than 150mm in diameter. The material will then be spread across the site in preparation for agricultural use.

**Image 2.** Extraction area stage 1 stockpile locations

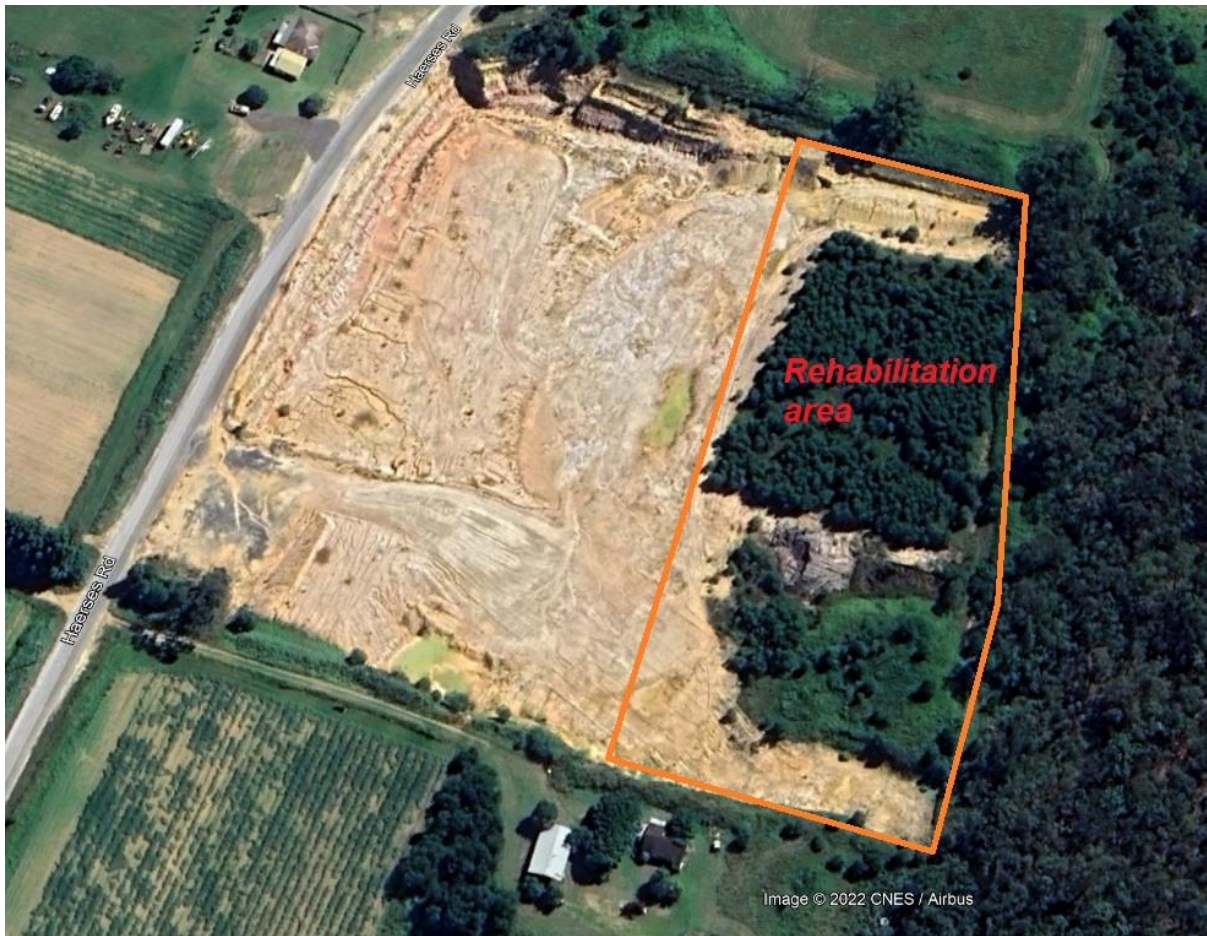
Extraction of sand products is still taking place within the western portion of extraction area stage 1. The eastern portion of the extraction area remains exhausted and is currently awaiting the start of rehabilitation works. These works are expected to begin during the 2022-2023 reporting period if weather becomes favorable.

**Image 3.** Extraction area stage 1 active rehabilitation area (Image sourced from Google Earth Pro 2022)

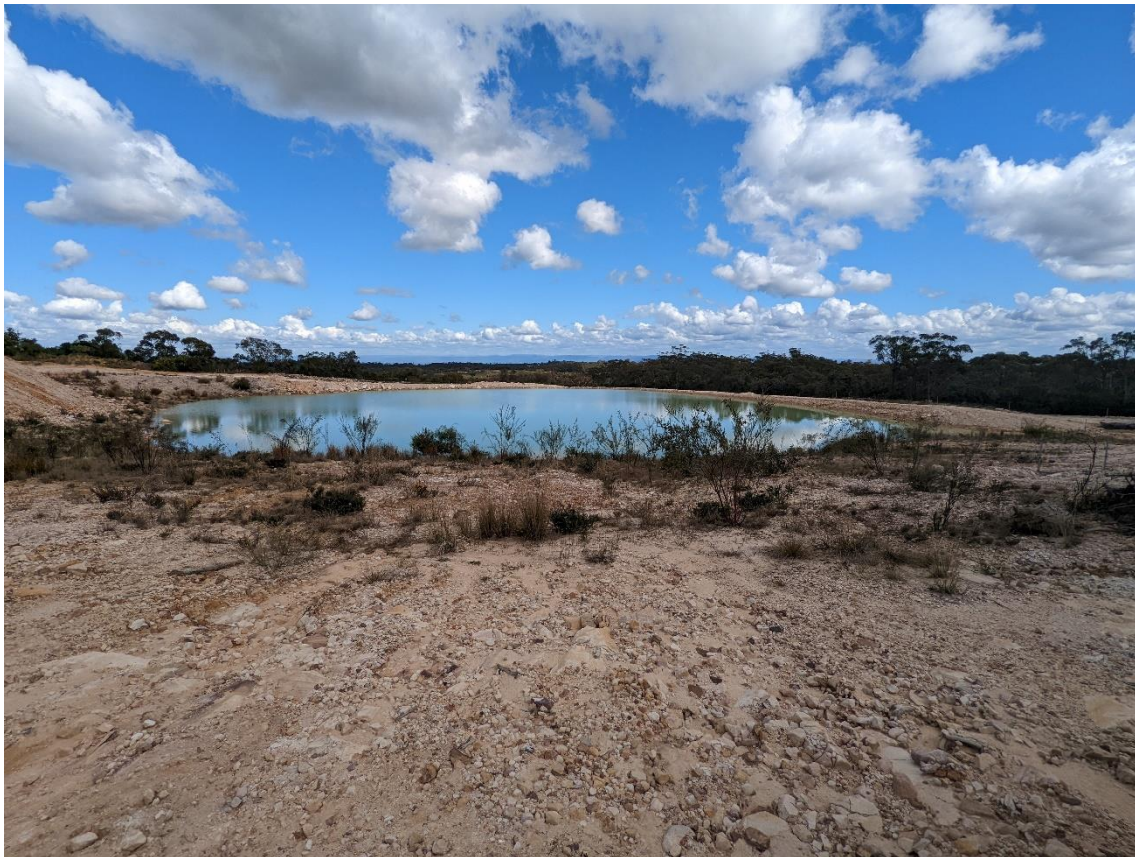
The dam wall has sunk slightly on the western edge which will require remediation work to take place for structural integrity. All efforts will be undertaken to avoid the emerging threatened flora species.

**Image 4.** Extraction area stage 2 dam

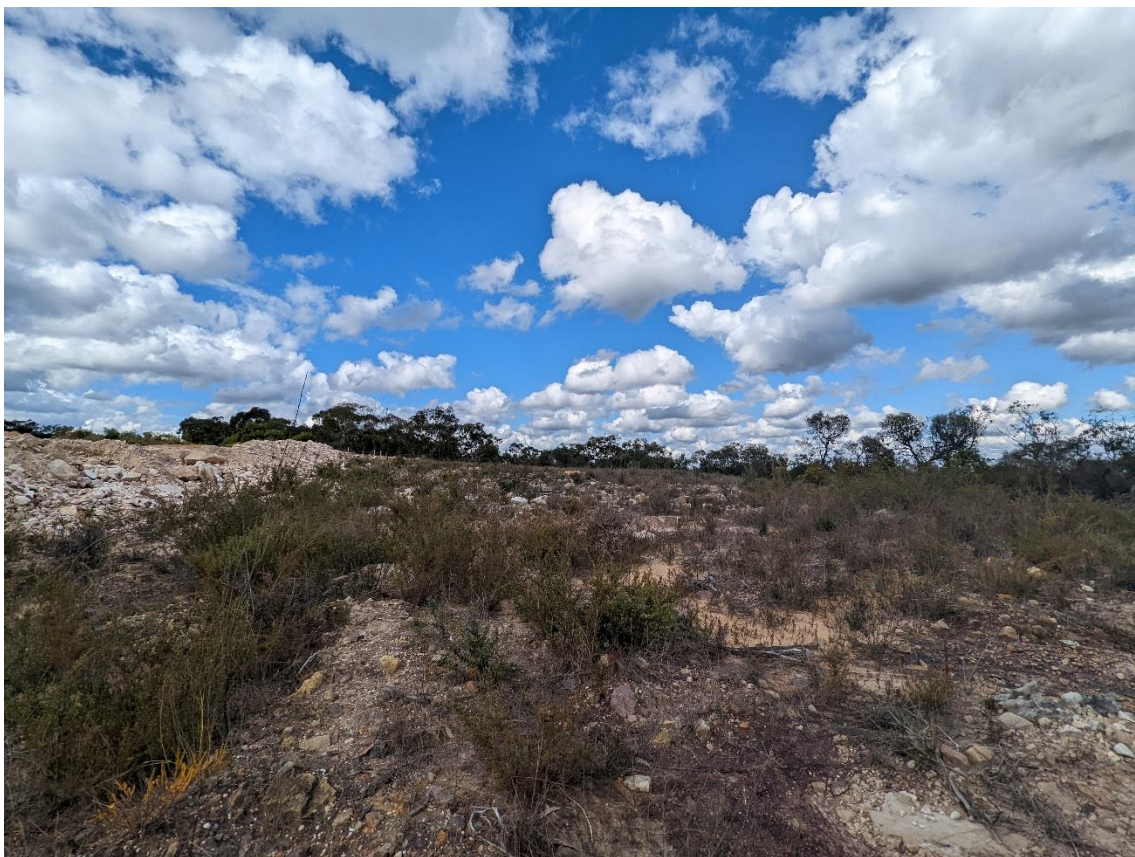
The construction of a farm dam has taken place to fill the void and make the area beneficial for agricultural use. The expanse between the dam and native vegetation to the west has been spread with soil from extraction area A and B which contains native seed bank. The natural regeneration process has begun in earnest with a good diversity of ground cover species emerging. Threatened flora species *Darwinia biflora* and *Tetratheca glandulosa* have emerged with *Darwinia biflora* being prolific across the site. *Acacia bynoeana* has also emerged in the compact soils immediately surrounding the dam.

**Image 5.** Stage 2 rehabilitation area west of the dam

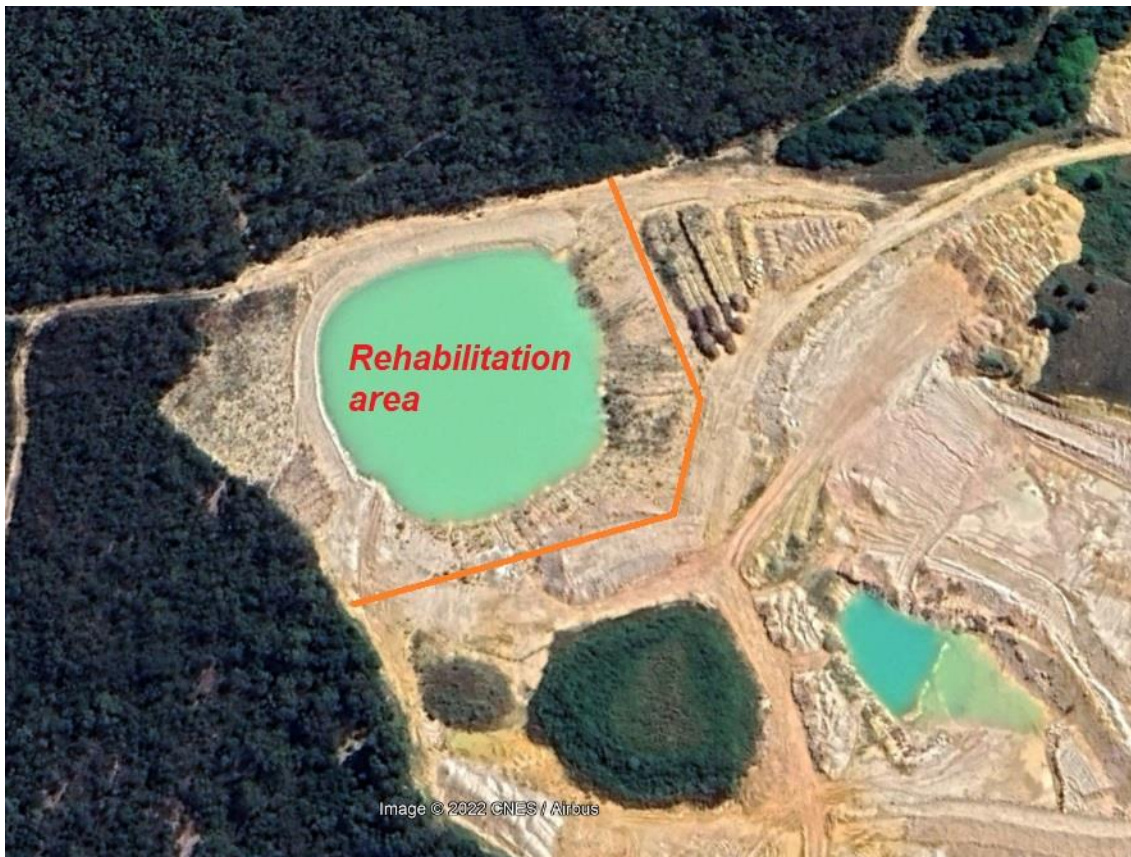
**Image 6.** Extraction area stage 2 active rehabilitation area

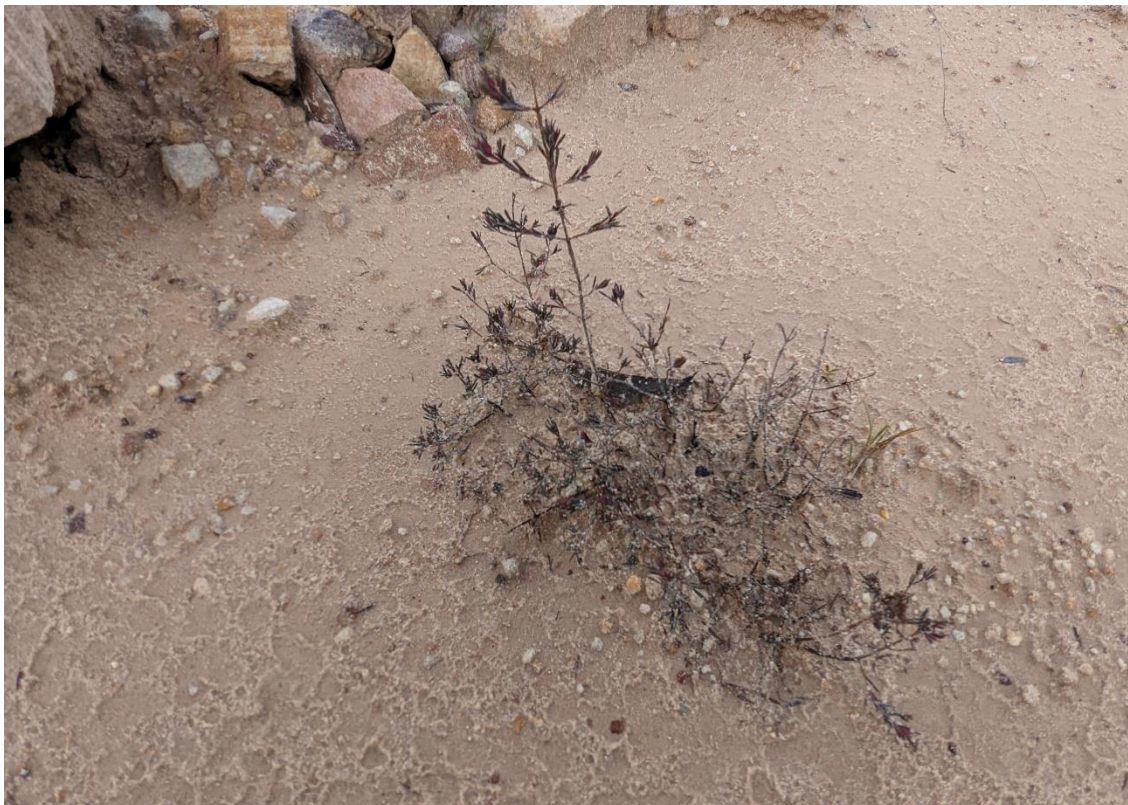
**Image 7.** Emerging *Darwinia biflora* in stage 2 rehabilitation area

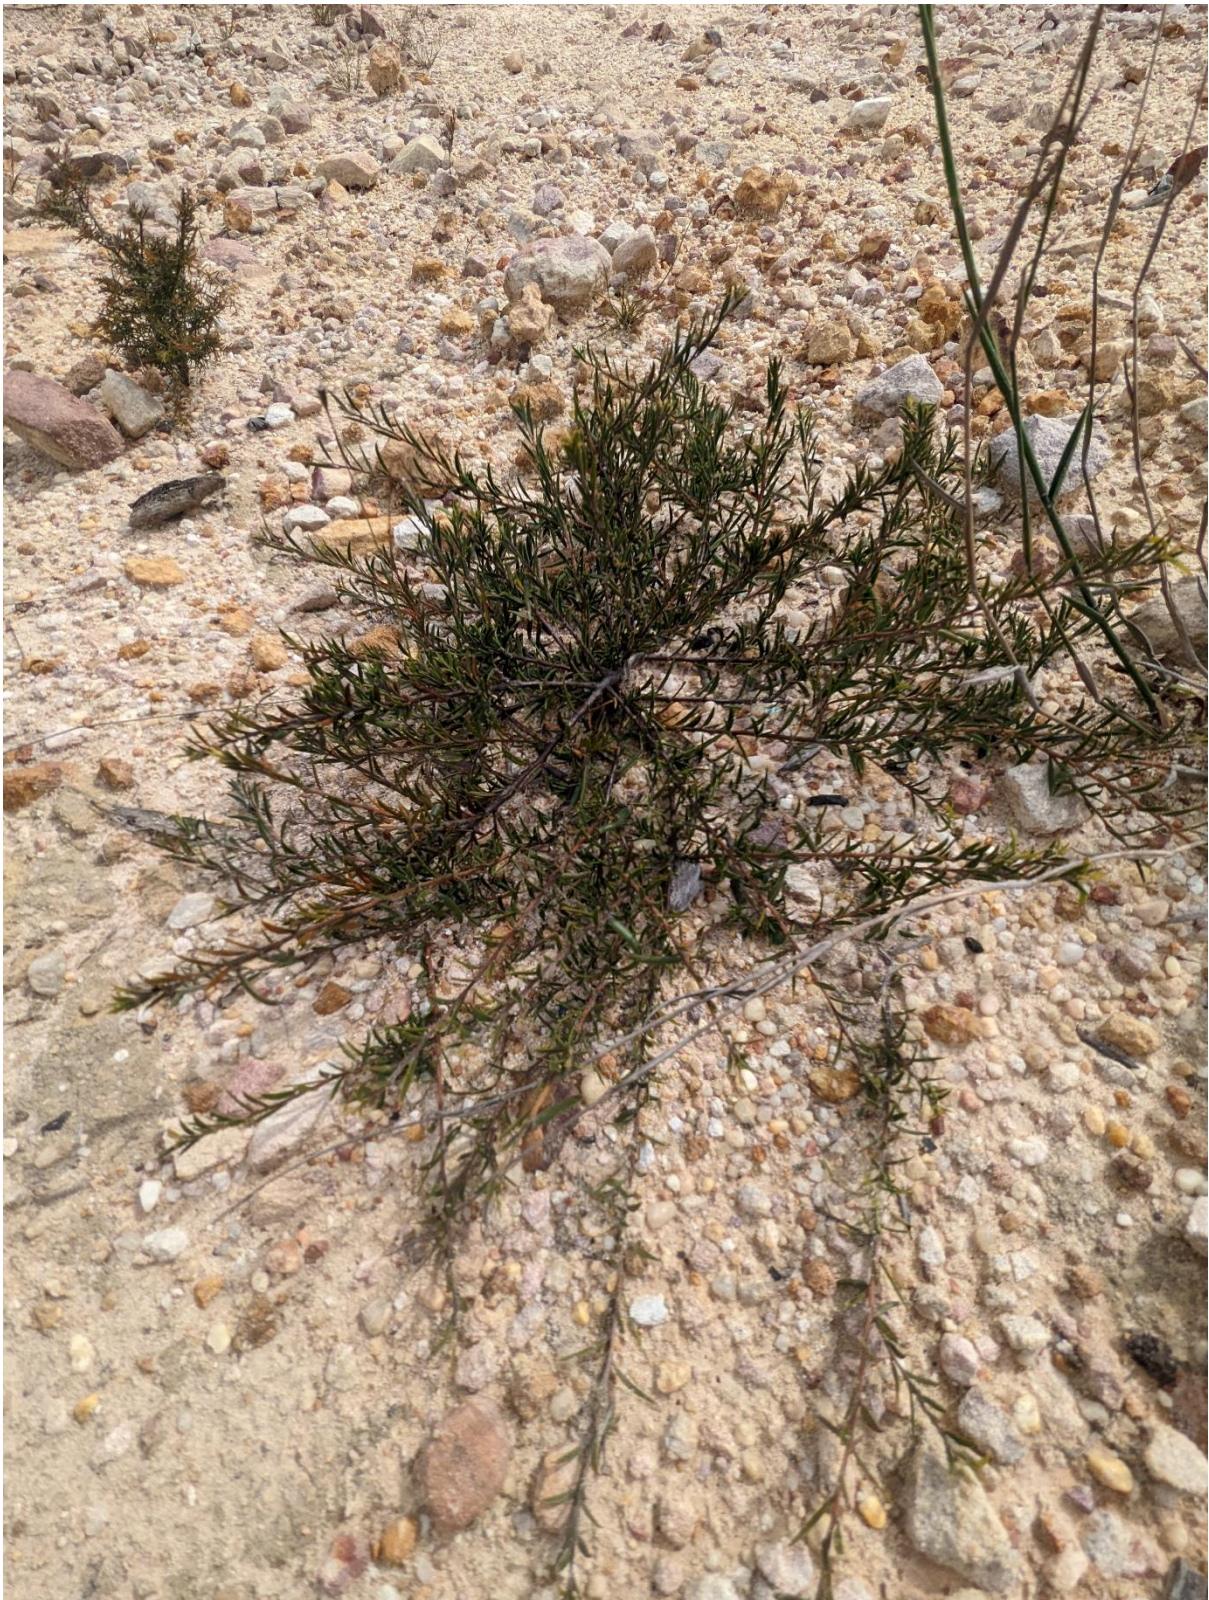
**Image 8.** *Acacia bynoeana* emerging on the dam wall in stage 2 rehabilitation area

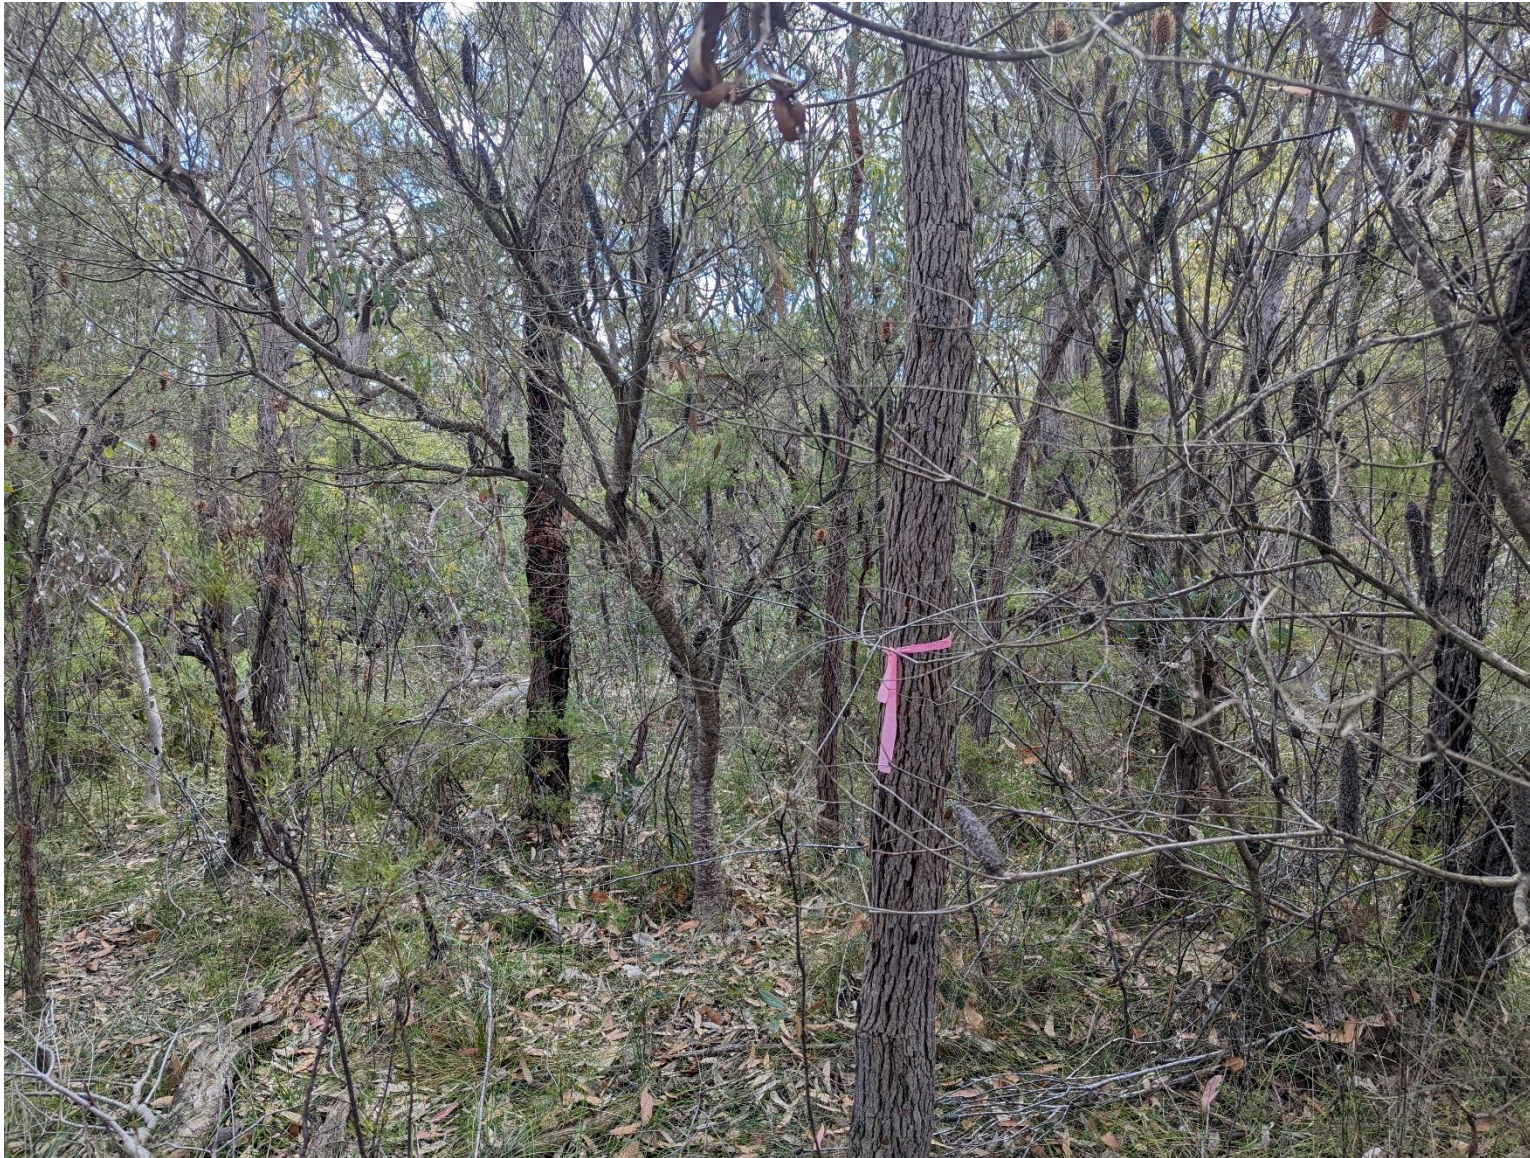
**Image 9.** Quadrat 1 start midline point

1083 - Red Bloodwood – Scribbly Gum heathy woodland on sandstone plateaux of the Sydney Basin, Sydney Basin Bioregion				
AGD Zone 56 Easting – 0312510 Northing – 06296390 Midline - 0°				
Vegetation Layer	Height Range	Vegetation Layer		
Trees	15 – 20m	<i>Corymbia gummifera, Eucalyptus haemastoma, Eucalyptus punctata, Angophora hispida, Eucalyptus oblonga</i>		
Shrubs	0.5 – 2m	<i>Grevillea buxifolia, Persoonia levis, Phyllanthus hirtellus, Lambertia Formosa, Calytrix tetragona</i>		
Groundcover	0.1 – 0.5m	<i>Lomandra multiflora, Entolasia stricta, Actinotus minor, Billardiera scandens, Cyathochaeta diandra</i>		
Stem Class	Hollows			
Dbh	Eucalyptus	Non-Eucalypt	<20cm	>20cm
80cm+				
50-79cm	✓		4	2
30-49cm	✓		2	
20-29cm	✓			
10-19cm	✓			
5-9cm	✓			
<5cm	✓			
Composition & Structure	Composition Count		Structure cover %	
Trees	5		40	
Shrubs	26		70	
Grasses etc	13		30	
Forbs	8		10	
Ferns	0		0	
Other	3		1	
High Threat Weeds	0		0

Ecosystem Functions				
Length of habitat logs	25m			
Litter cover	35%			
Bare ground cover	0%			
Cryptogam cover	15%			
Rock cover	5%			
Overstorey foliage cover	30%			
Mid-storey foliage cover	60%			
Groundcover foliage cover	25%

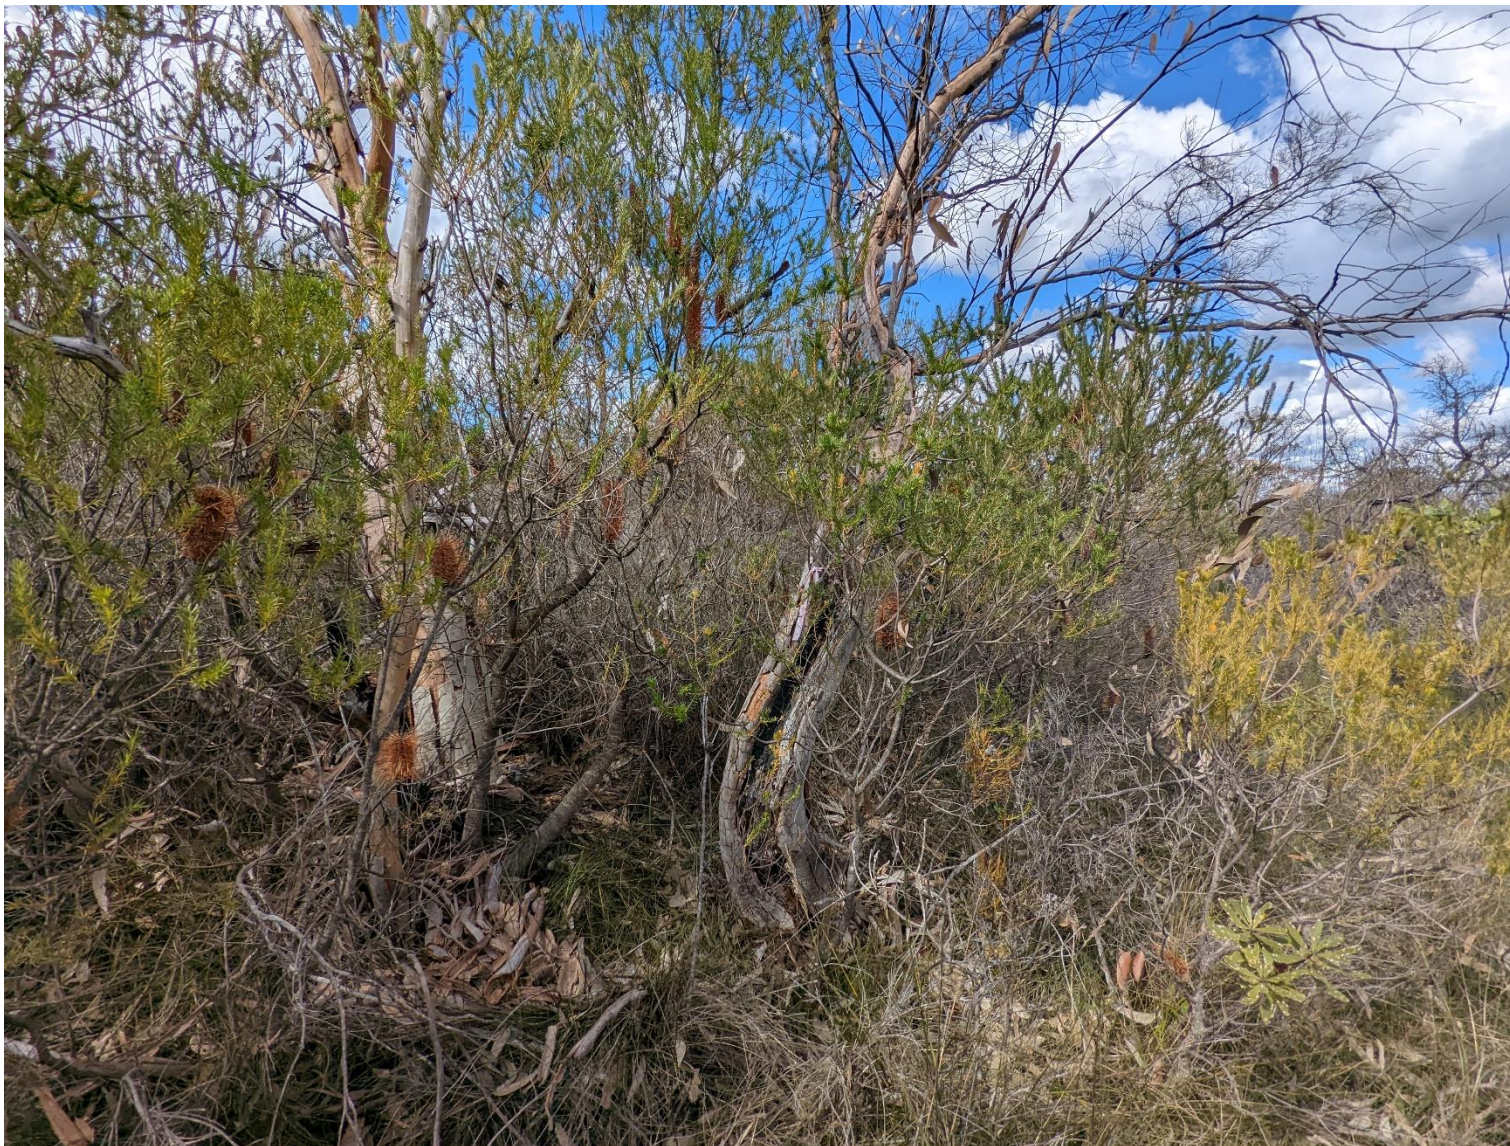
**Image 10.** Quadrat 2 centre midline point

1134 – Scribbly Gum – Hairpin Banksia – Dwarf Apple heathy woodland on sandstone plateaux of the Central Coast, Sydney Basin Bioregion				
AGD Zone 56 Easting – 0312226 Northing – 06293607 Midline - 190°				
Vegetation Layer	Height Range	Vegetation Layer		
Trees	15 – 20m	<i>Eucalyptus haemastoma</i> , <i>Angophora hispida</i> , <i>Eucalyptus squamosal</i> , <i>Banksia serrata</i>		
Shrubs	0.5 – 2m	<i>Banksia ericifolia</i> , <i>Grevillea buxifolia</i> , <i>Persoonia lanceolata</i> , <i>Lambertia Formosa</i> , <i>Petrophile pulchella</i> , <i>Banksia spinulosa</i>		
Groundcover	0.1 – 0.5m	<i>Lomandra multiflora</i> , <i>Cyathochaeta diandra</i> , <i>Lepidosperma neesii</i> , <i>Actinotus minor</i>		
Stem Class			Hollows	
Dbh	Eucalyptus	Non-Eucalypt	<20cm	>20cm
80cm+				
50-79cm				
30-49cm	✓		2	
20-29cm	✓			
10-19cm	✓			
5-9cm	✓			
<5cm	✓			
Composition & Structure		Composition Count		Structure cover %
Trees		4		20

Shrubs		22		70
Grasses etc		9		50
Forbs		3		5
Ferns		1		0.1
Other		2		0.1
High Threat Weeds		0		0
Ecosystem Functions				
Length of habitat logs		12.5m		
Litter cover		10%		
Bare ground cover		0%		
Cryptogam cover		10%		
Rock cover		0%		
Overstorey foliage cover		10%		
Mid-storey foliage cover		40%		
Groundcover foliage cover		50%

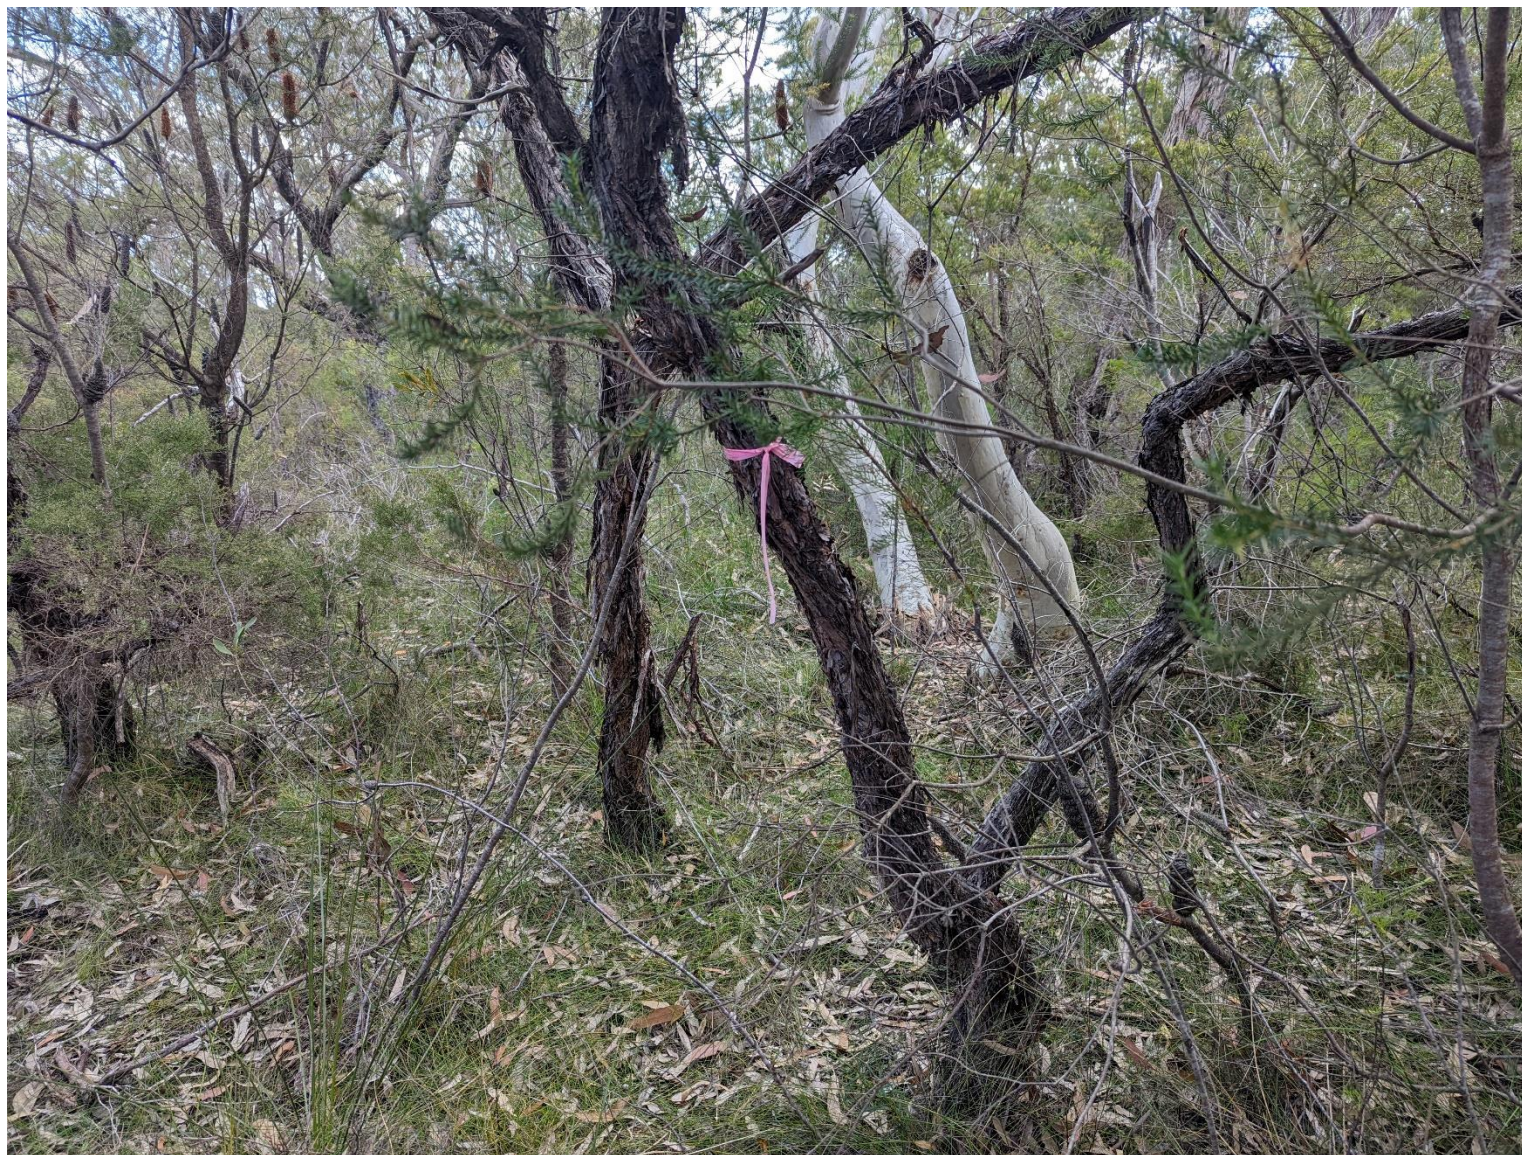
**Image 11.** Quadrat 4 centre midline point

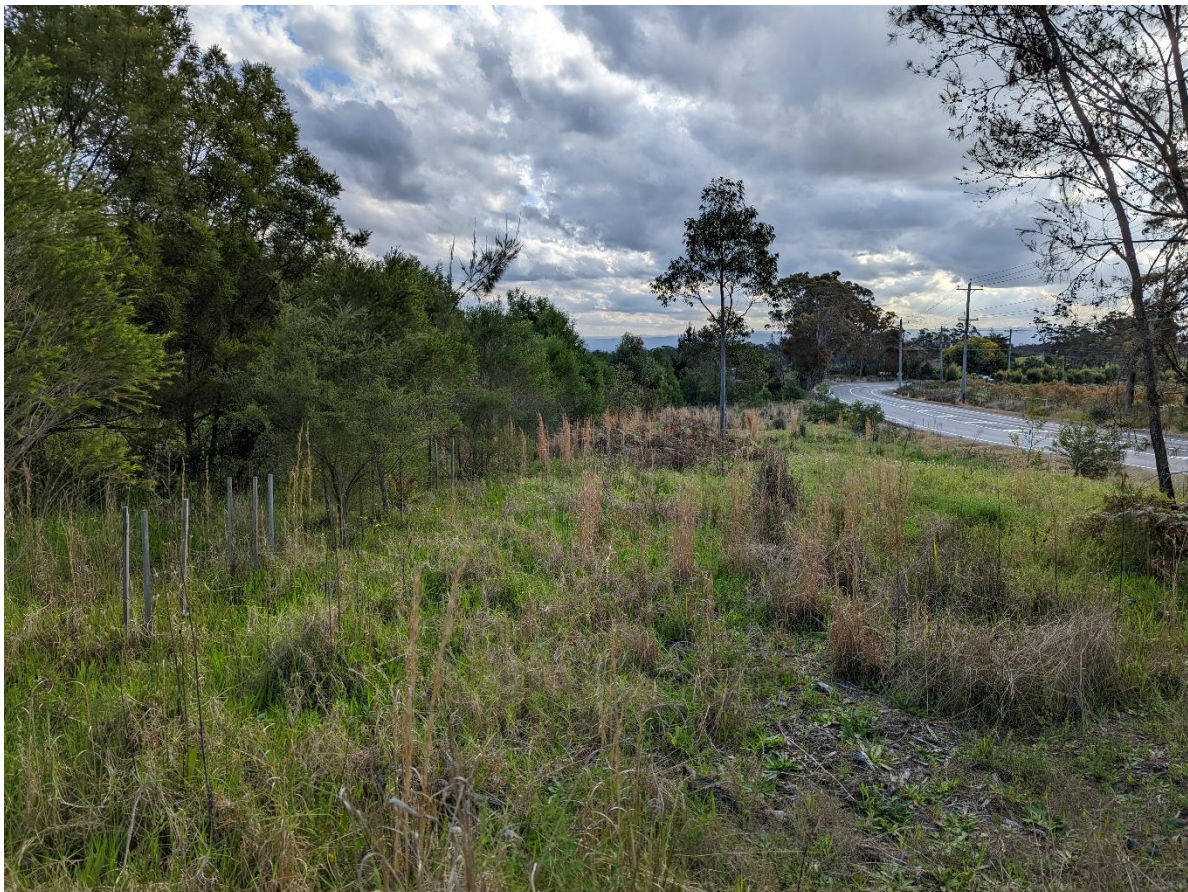
Exotic species occur in both areas with Weeds of National Significance (WoNS) and High Threat Weeds (HTW) present. Weed management and control will commence during the next reporting period with the WoNS and HTW being the species of targeted priority.

**Image 12.** Western side of Haerses Road within the Wisemans Ferry Road buffer area

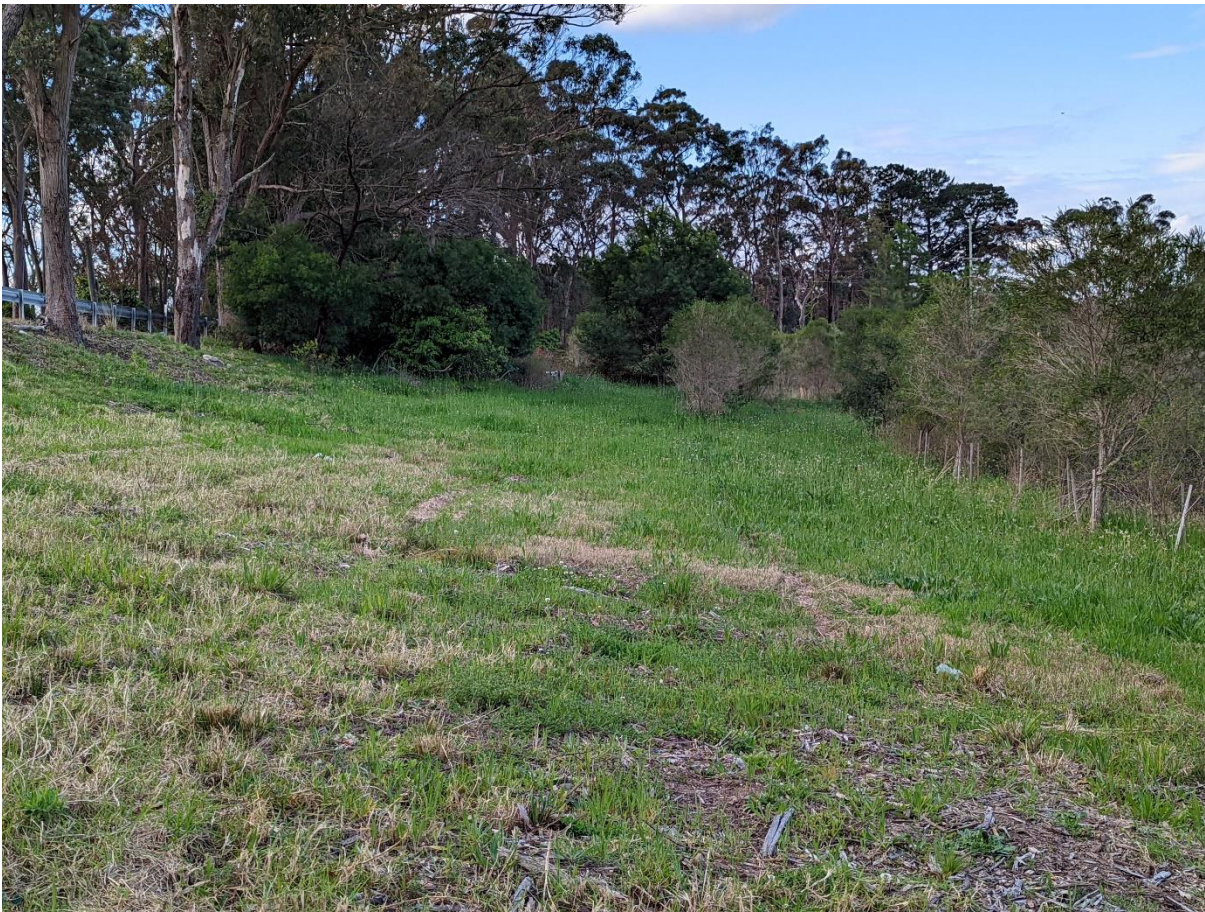
The Eastern side of the Haerses Road intersection has not shown any signs of natural regeneration therefore further buffer screening will be required to take place during the next reporting period.

**Image 13.** Eastern side of Haerses Road within the Wisemans Ferry Road buffer area

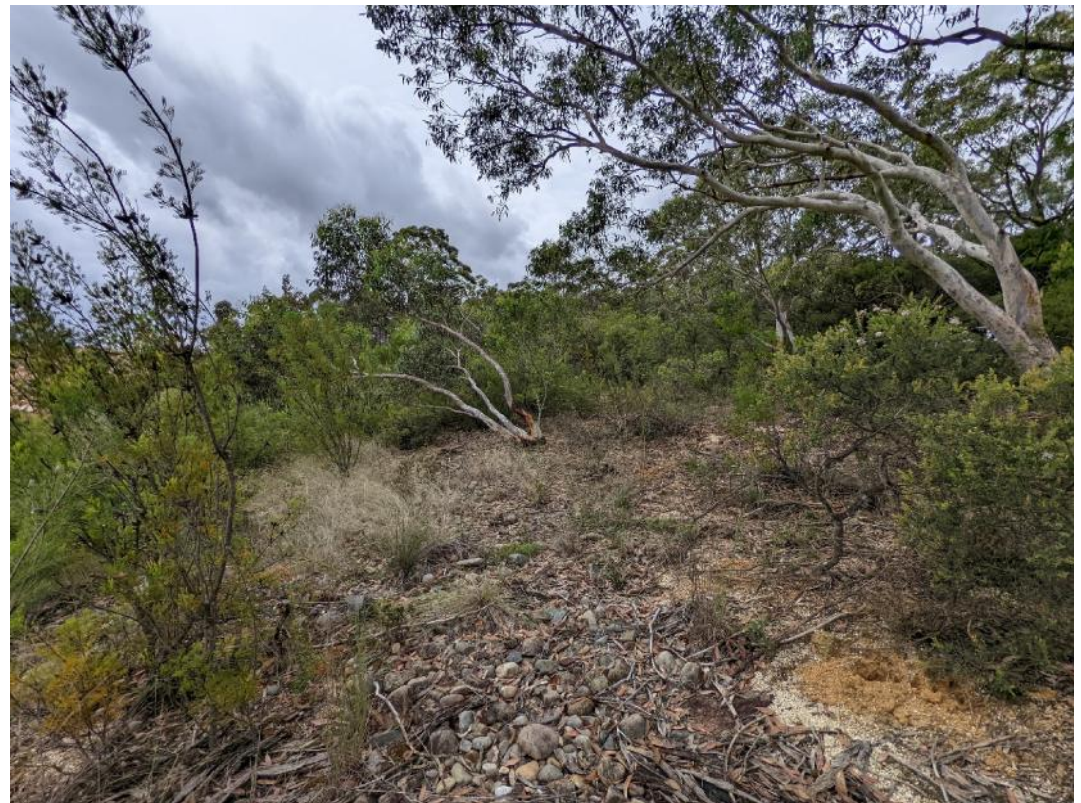
**Photo monitoring site 1.**

A good increase in ground cover diversity within the site given the ideal climatic conditions for plant growth during the previous 12 month period.
