# Dixon Sand

Resource Management Plan

Name of Operation	Haerses Road Quarry, Maroota
Name of Operator	Dixon Sand (No. 1) Pty Ltd
Development Consent / Project Approval #	DA165-7-2005 (Mod 4) – Haerses Road Quarry
Annual Review Start Date	1 July 2021
Annual Review End Date	30 June 2022
Name of Authorised reporting officer	Hunsamon Churcher
Title of Authorised reporting officer	Environmental Advisor
Signature of Authorised reporting officer	<i>J. Hunsamon</i>
Date	30/09/2021

File name	J16-001_AR_HR_2021-22	Version	1.0
Report name	Dixon Sand - Haerses Road Quarry Annual Review 2021 - 2022		
Cover Page Image	Haerses Road Quarry – Monitoring Site Quadrat 4 (Photograph courtesy: South East Environmental, 2022)		
Prepared by:	Hunsamon Churcher	Date:	30/09/2021

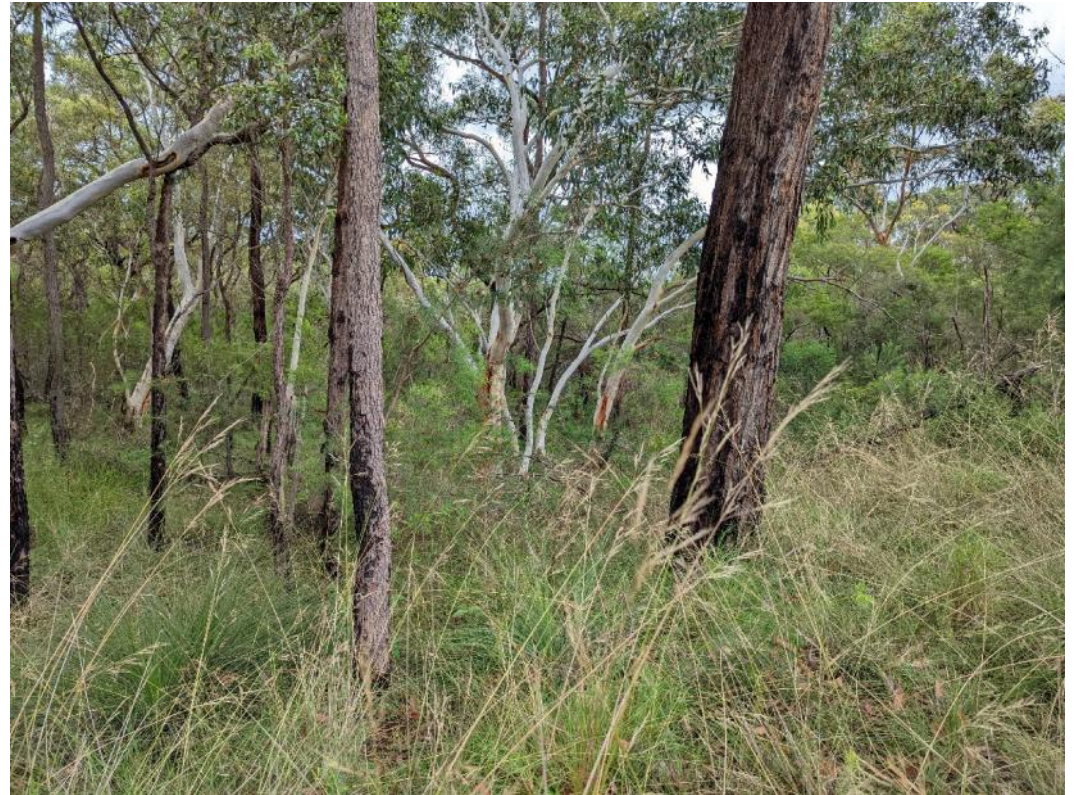
**Photo monitoring site 2.**

Ground cover density has increased dramatically at this site during this monitoring period. Shrub growth is increasing in density and diversity. Annual herbaceous weeds such as *Bidens pilosa* and *Conyza bonariensis* are present in low density. The woody weed *Lantana camara* has emerged within this monitoring location and is growing prolifically nearby on the margin of the BSA site.

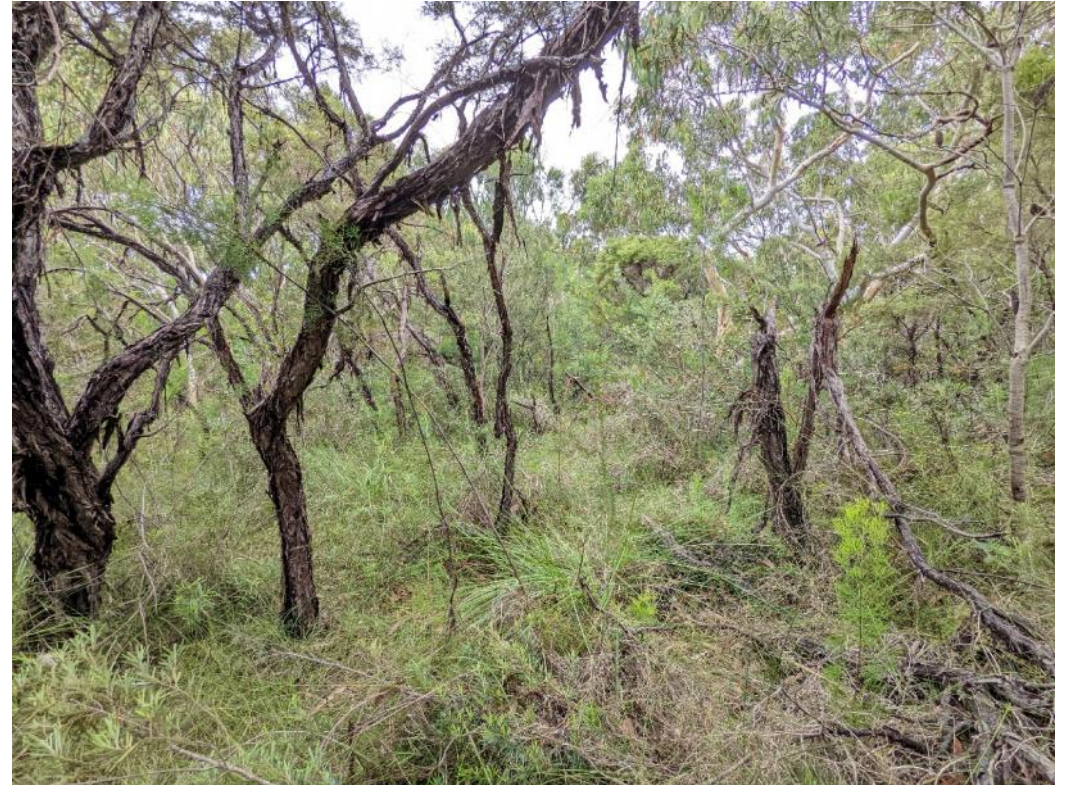
**Photo monitoring site 3.**

A good increase in ground cover diversity within the site given the ideal climatic conditions for plant growth during the previous 12 month period. Small fallen shrubs noted to have perished during the 2018-2019 drought in the previous monitoring periods are now almost completely covered in ground cover growth and appear to be breaking down into organic material well.

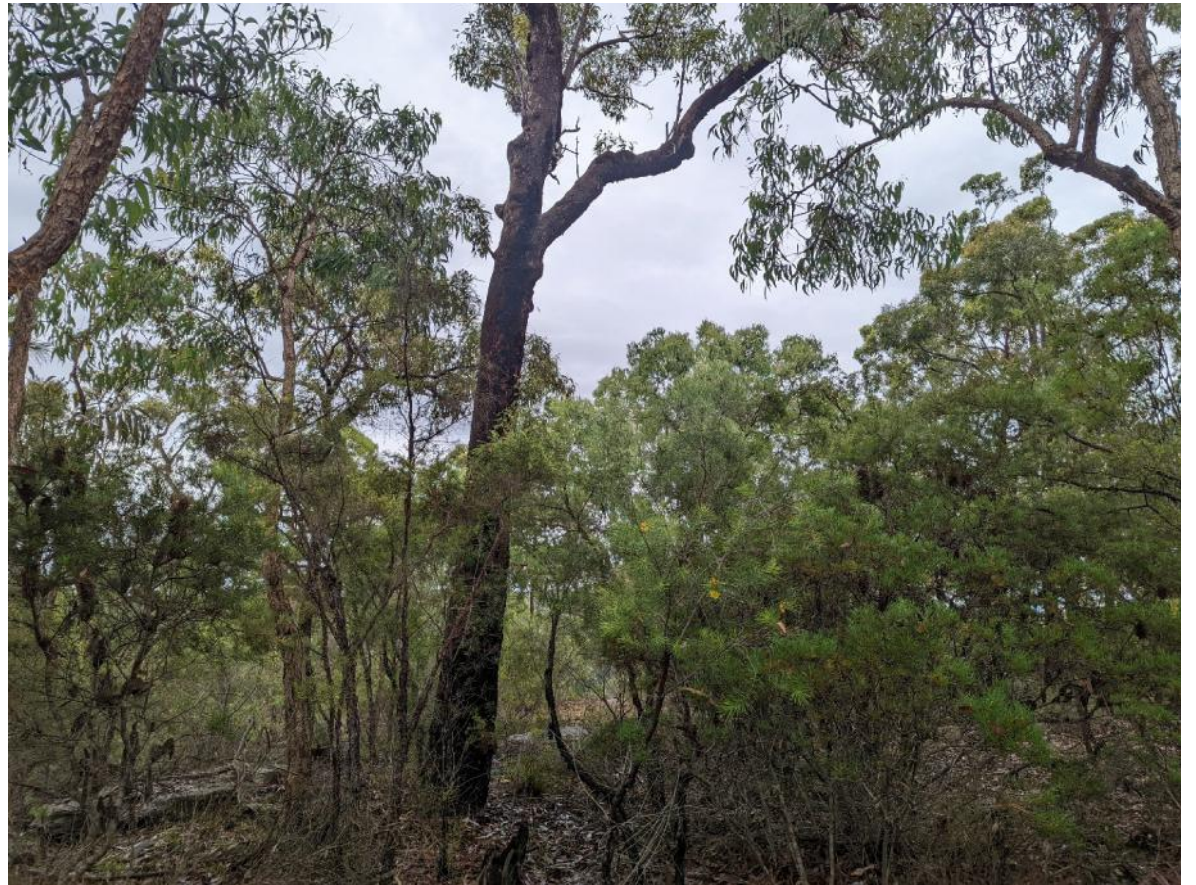
**Photo monitoring site 2.**

Shrub density has increased at this location during the past 12 month period.

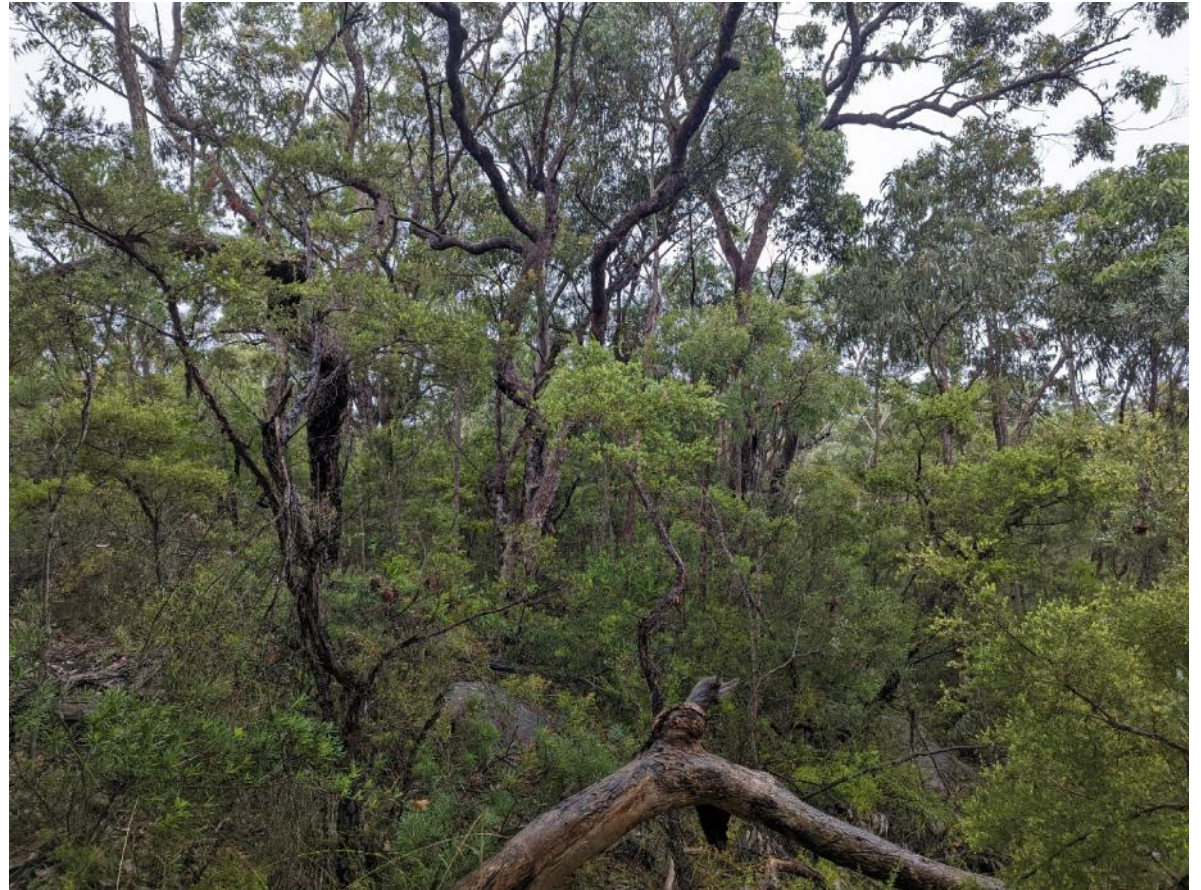
**Photo monitoring site 3.**

Shrub density has increased at this location during the past 12 month period.
