**Dixon Sand
Haerses Road Quarry, Maroota
Annual Review
2022 - 2023**

File Name: J16-001_AR_HR_2022-23

Client: Dixon Sand (No. 1) Pty Ltd

Prepared by: Project Environmental Services Pty Ltd

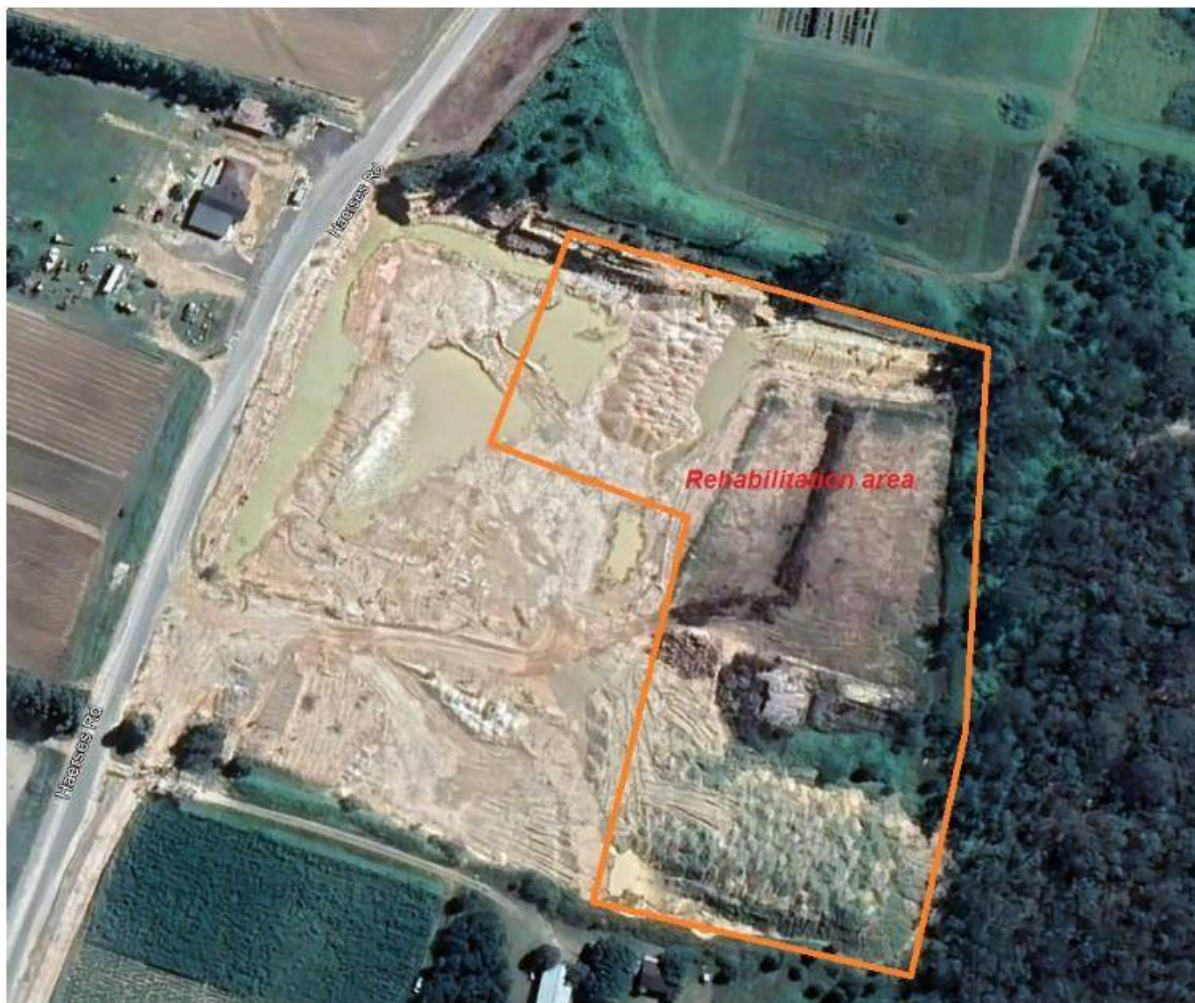
Plate 2 - Rehabilitation area in Stage 1 (South East Environmental, 2023).

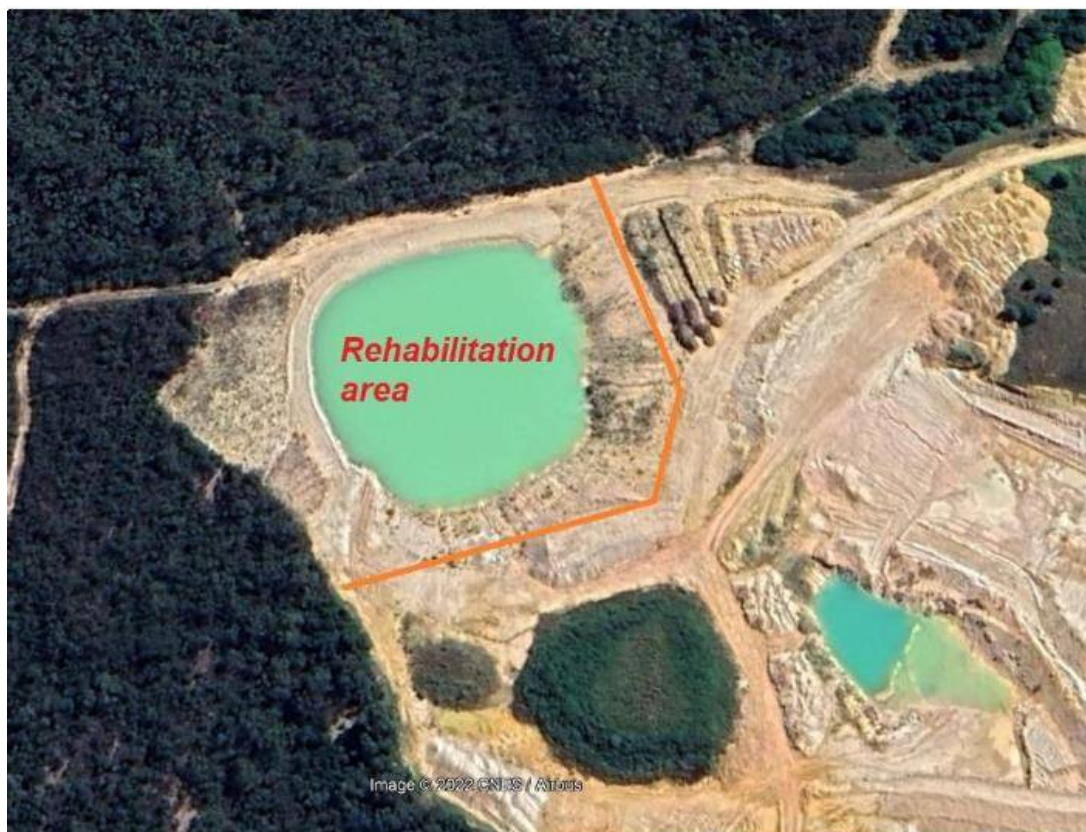
Soil containing native vegetation seed bank from the extraction cells A and B was spread over the area between the dam and native vegetation on the western boundary. The natural regeneration process has commenced with a good diversity ground cover species emerging. In addition, the threatened *Darwinia biflora* and *Tetratheca glandulosa* have emerged with *Darwinia biflora* being prolific across the area (refer to Plate 4). Emergence of *Acacia bynoeana* has also been observed in the area immediately surrounding the dam, as previously observed in the last reporting period.

Plate 3 – Farm dam located in Stage 2 west (South East Environmental, 2023).

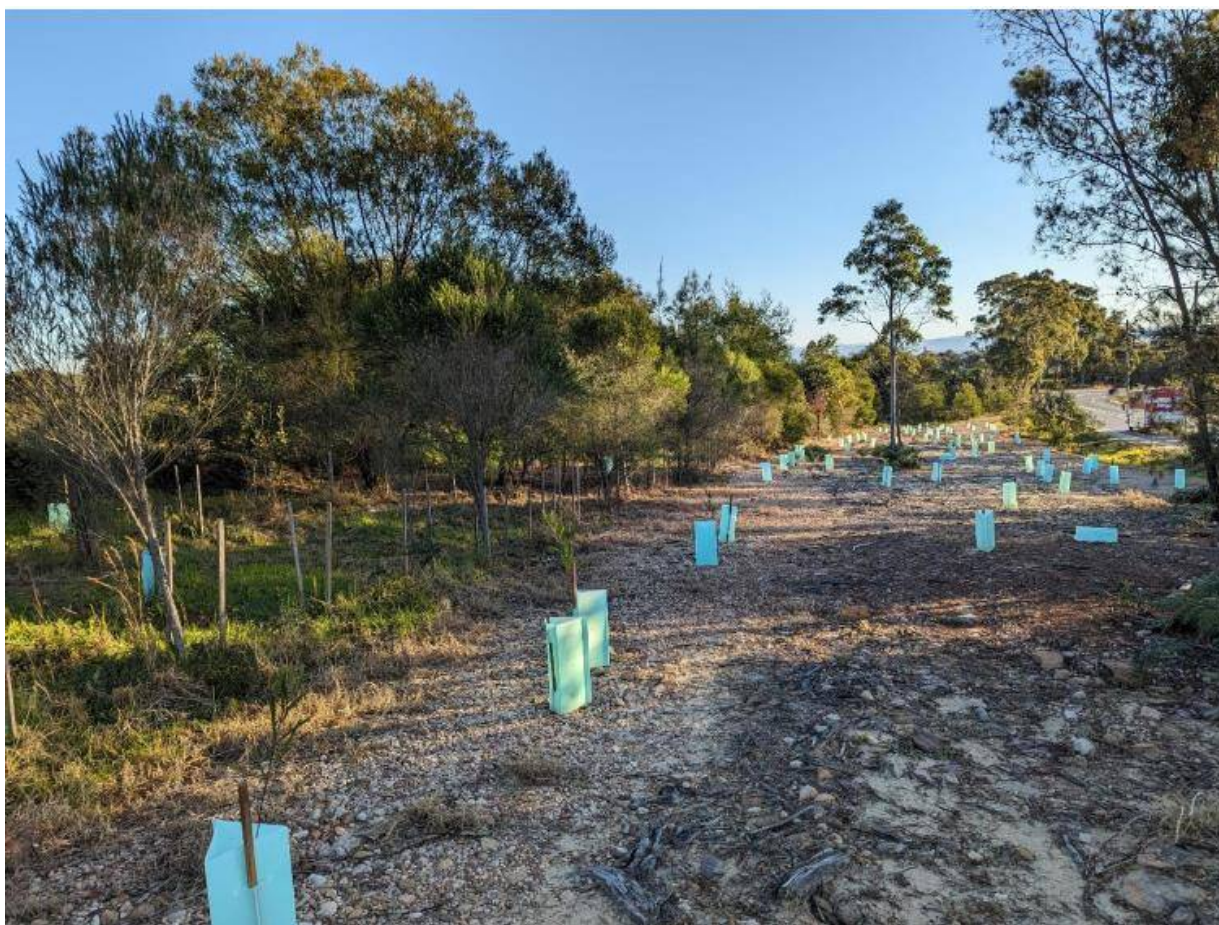
Exotic species occur in the 30-metre buffer with Weeds of National Significance (WoNS) and High Threat Weeds (HTW) present. Weed management and control has commenced during this reporting period and will continue into the future, with priority given to management of WoNS and HTW.

Plate 5 – Western side of 30m buffer to Wisemans Ferry Road (South East Environmental, 2023).

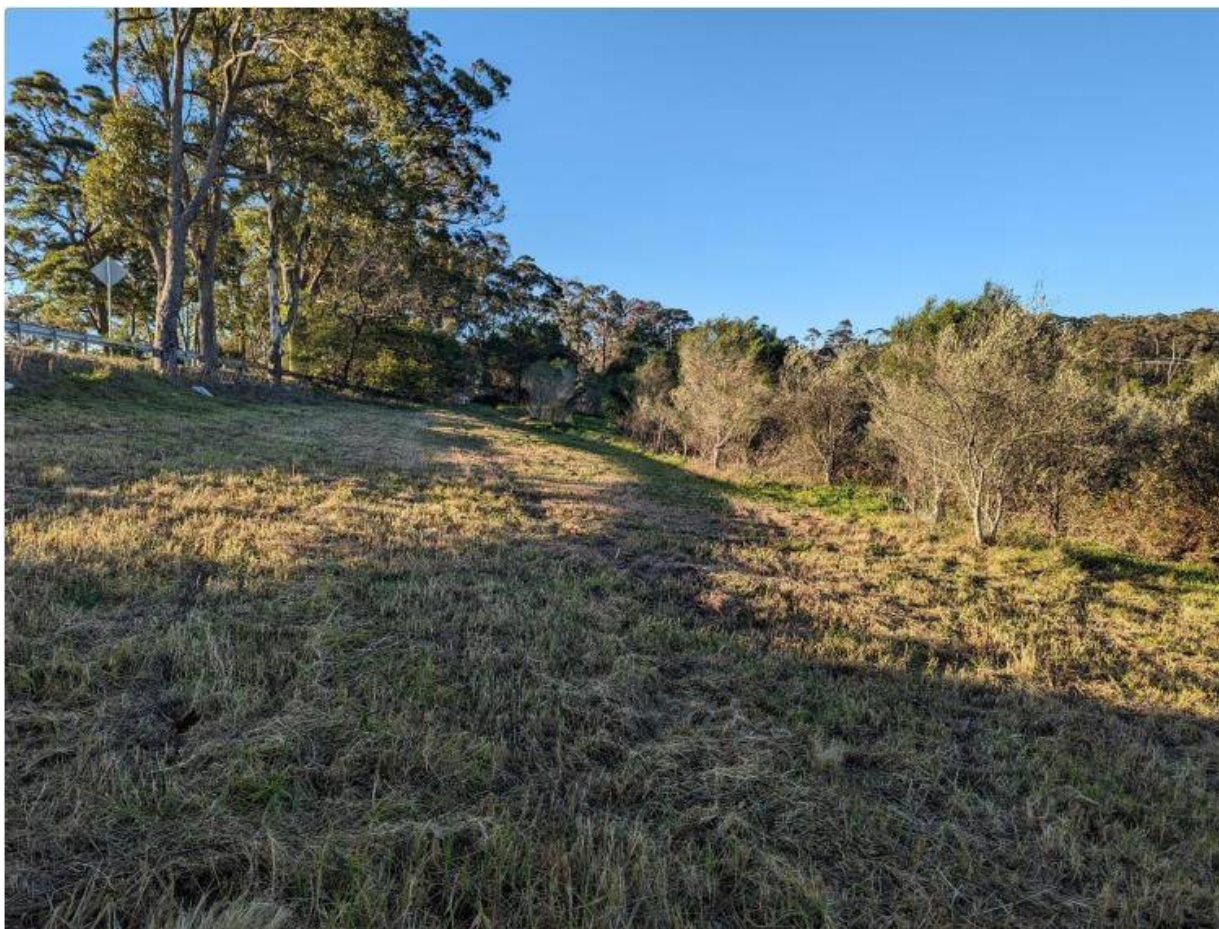
Plate 6 – Eastern side of 30m buffer to Wisemans Ferry Road (South East Environmental, 2023).

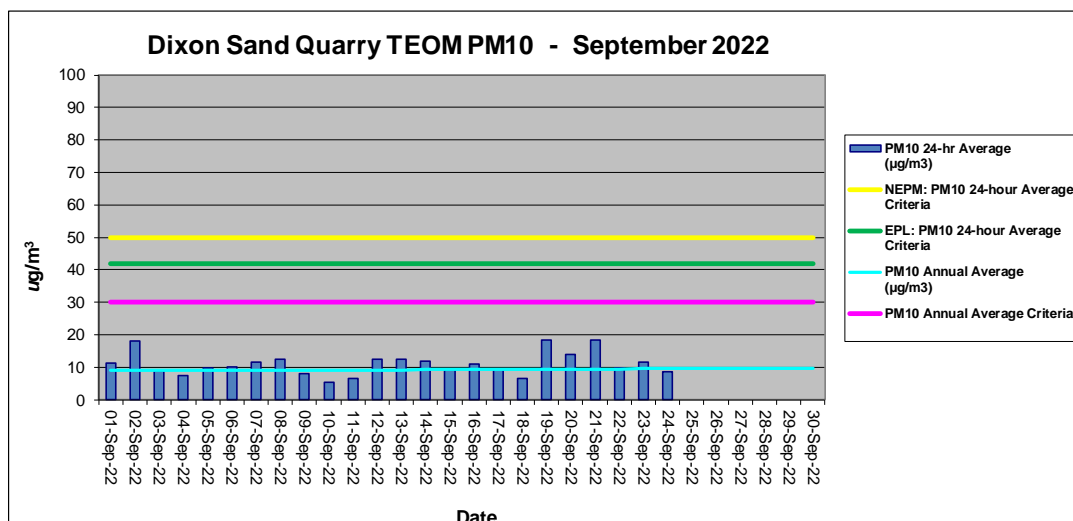
Figure 1: *TEOM PM₁₀ 24 hr, Annual Average and Criteria*

Note: results above the Dixon Sand EPL criteria limit of 42 ug/m3 highlighted in yellow, when applicable

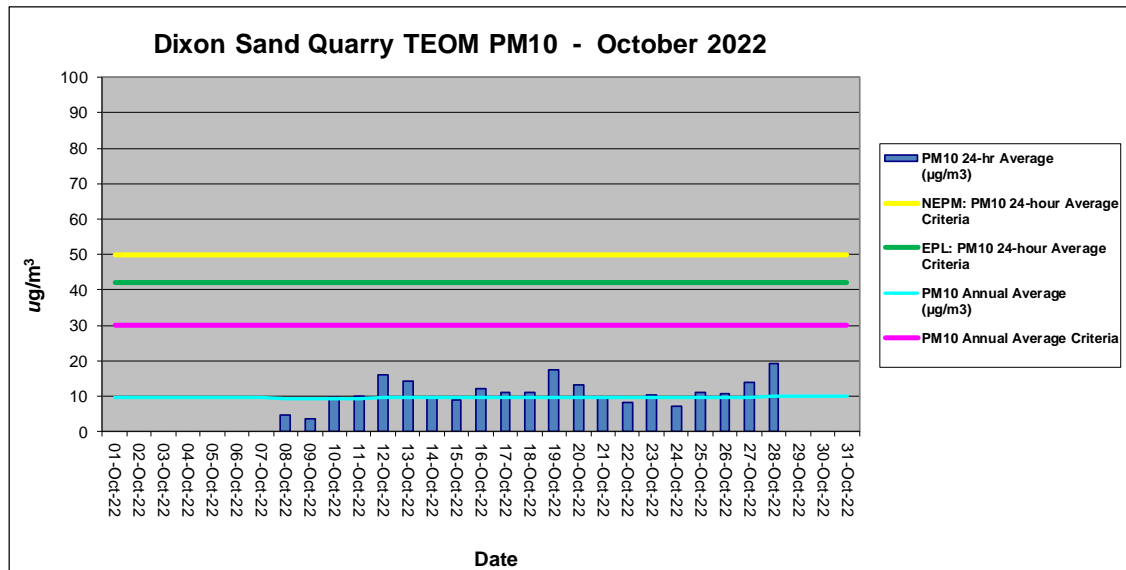
Figure 1: *TEOM PM₁₀ 24 hr, Annual Average and Criteria*

Note: results above the Dixon Sand EPL criteria limit of 42 ug/m3 highlighted in yellow, when applicable

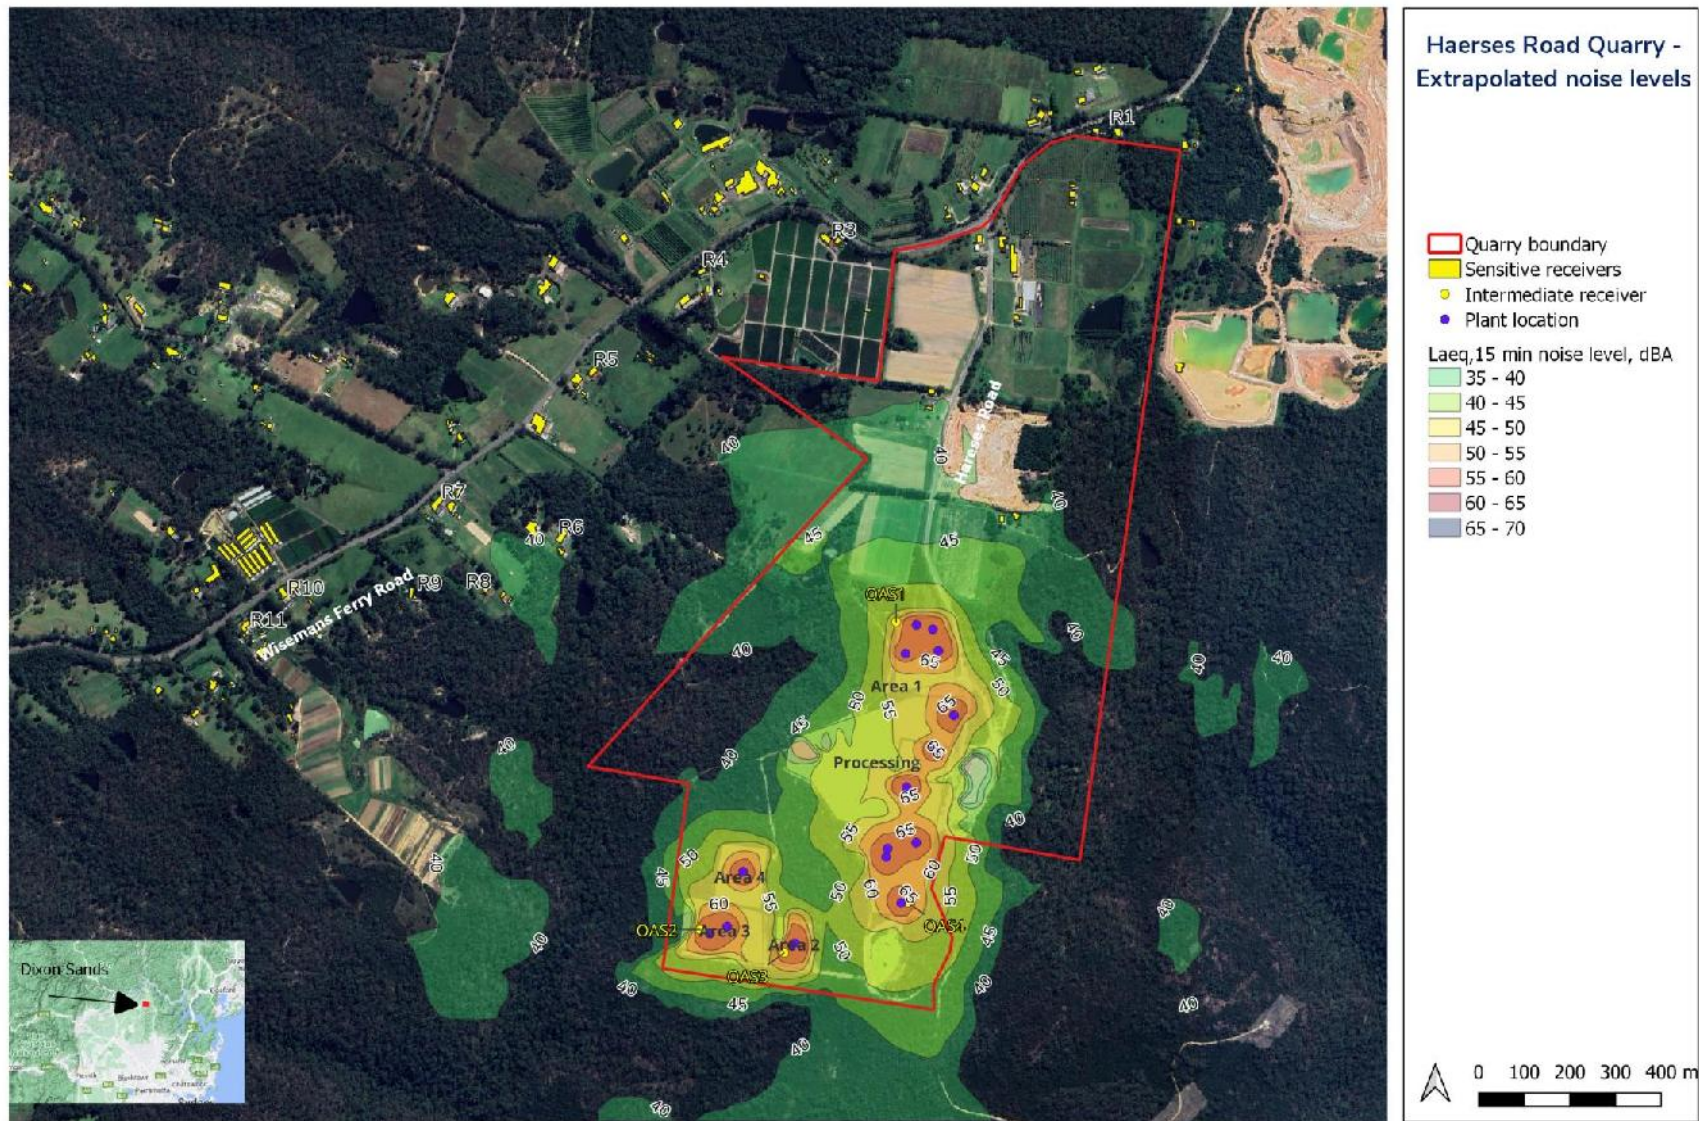
Figure 3 Extrapolated noise levels from Haerses Road quarry based on on-site measurements.

Results of attended monitoring and extrapolated noise levels demonstrate observed operations during shoulder and day periods were compliant with the noise criteria at each receiver under the meteorological conditions at the time.

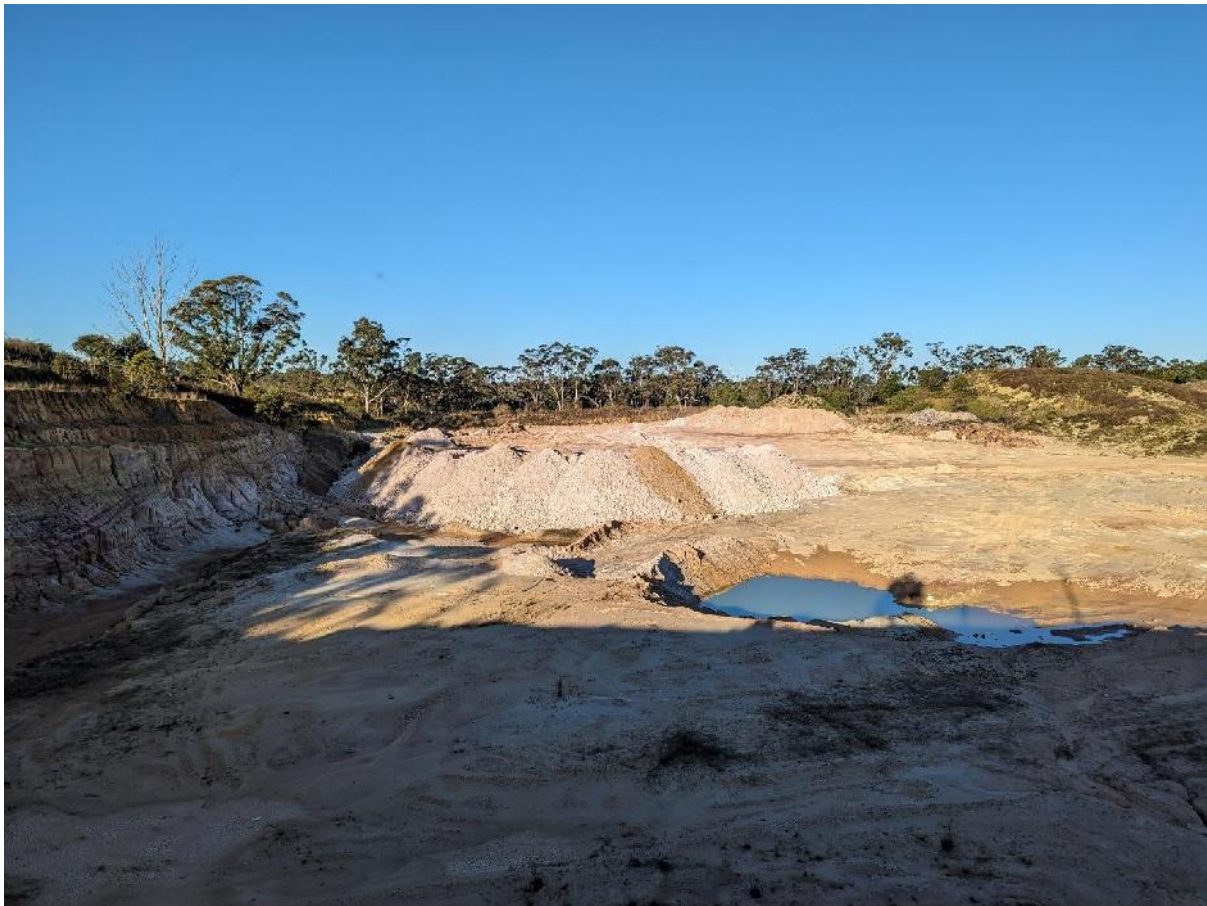
Extraction of sand products is still taking place within the western portion of extraction area stage 1. Rehabilitation work in the eastern portion stage 1 has begun with overburden clay material from stage 2 and 3 being used to raise ground levels. The wattle regrowth on the eastern stockpile was removed during the reporting period and the material within the stockpile was rescreened for use in rehabilitating the site. The stockpiles were found to contain rock which was deemed unsuitable for an agricultural soil profile. These works are expected to continue during the 2023-2024 reporting period with an aim at rehabilitating stage 1 to agricultural usage sometime in the next few years.

Image 2. Extraction area stage 1 with rehabilitation material located within the area

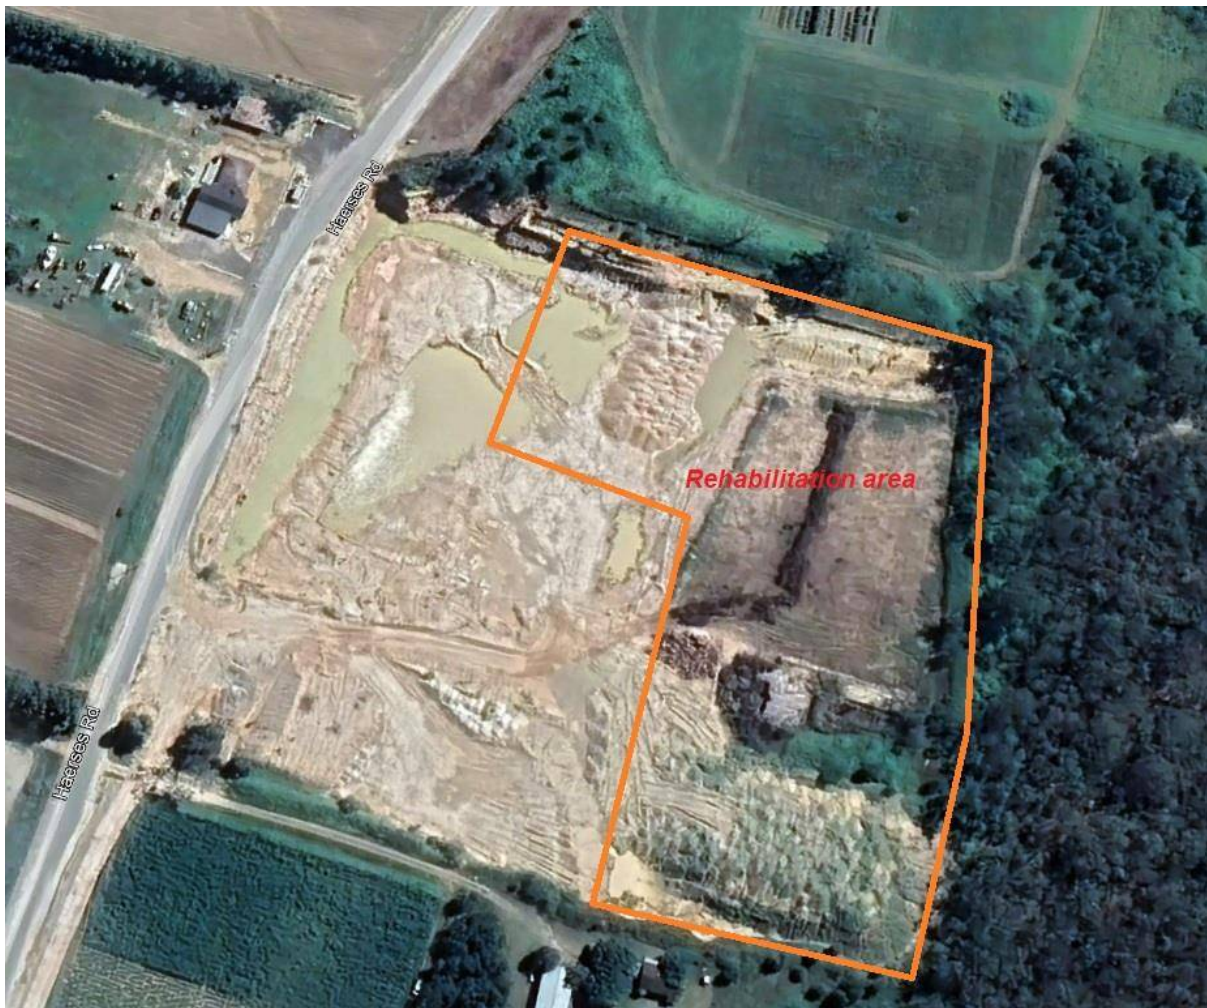
Image 3. Extraction area stage 1 active rehabilitation area (Image sourced from Google Earth Pro Feb 2023)

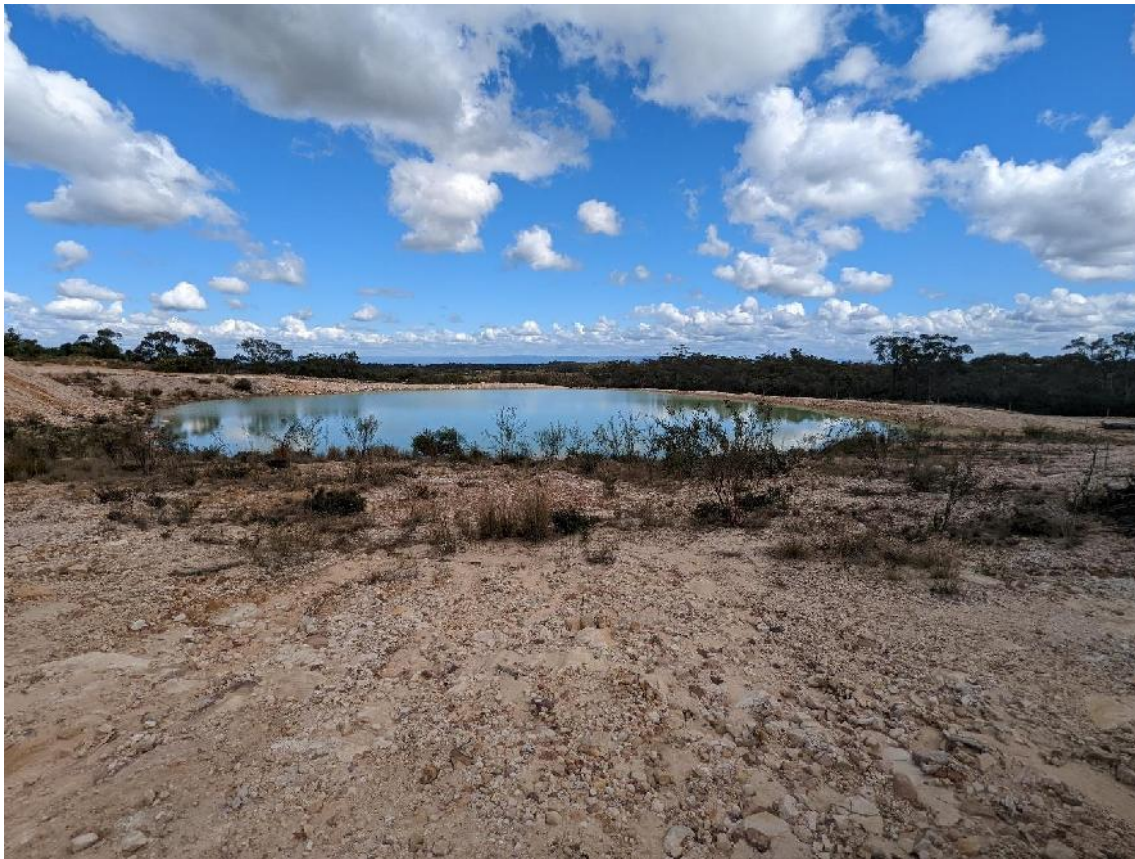
The dam wall which had previously sunk slightly on the western edge has undergone some remediation work to improve structural integrity. The dam has been leaking and therefore soils to the west became saturated and much of the rehabilitating vegetation was effected. Monitoring of this area will continue to ensure the vegetation is able to recover without assistance. Soil with native seed bank will be spread over the area should it be required to assist with recovery.

Image 4. Extraction area stage 2 dam
