Dixon Sand Old Northern Road Quarry, Maroota

Annual Review 2019 – 2020

□lient: Dixon □and Pt□Ltd

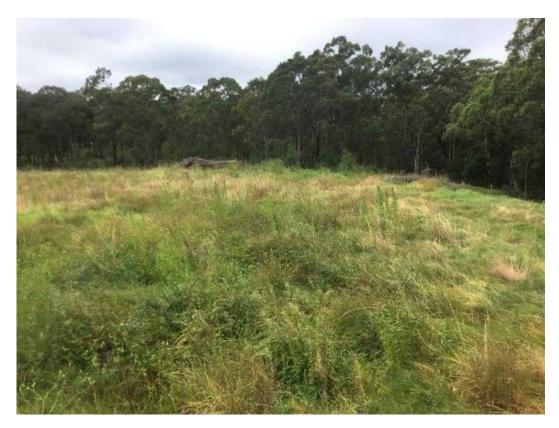
Figure 1: Field above Lot 1 before quarry works in May 2020

- Monitor recently disturbed boundary zones from quarry works of May 2020, as it is likely fast colonisers will exploit the disturbed areas.
- Continue pushing A. virginicus and E. curvula from north west area near dam
- *L. camara* works could be undertaken east of the dam where the vegetation community is in good condition apart from the presence of *L. camara*, subject to the boundary of Lot 1.

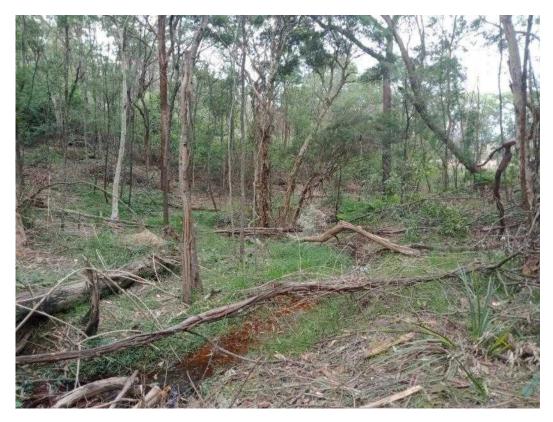
Figure 9: Creek line of Lot 2 clear of L. camara

- Continue treatment and follow up treatment of *L. camara*
- Clearing wood from *L. camara* works to let more light in and spread seed from native grasses for ground cover

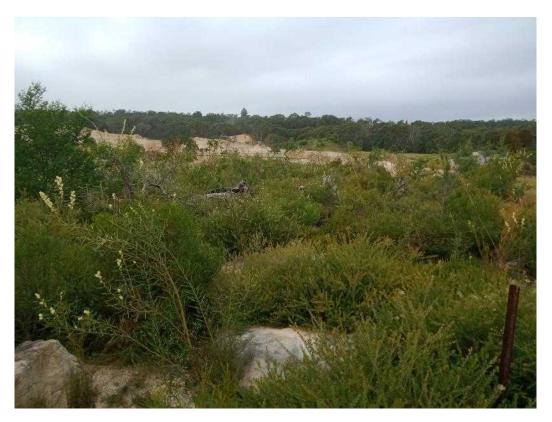
Figure 15: Native species thriving in the rehabilitation area

- Continue regular maintenance of the area to ensure it remains in excellent condition
- Monitor regeneration of native species to ensure biodiversity of the area is upheld.

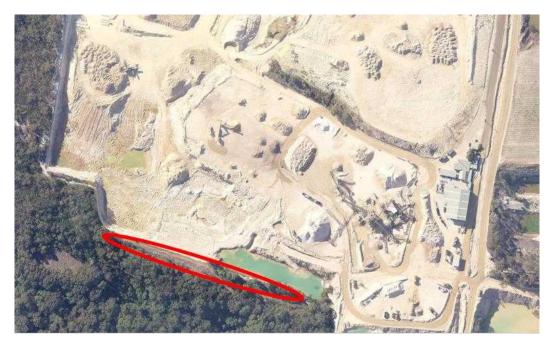
Outline of Works	Methodology	Objective Achieved
Suppression of invasive	 Spot spraying of A. 	Prevented seed dispersal of
grasses	virginicus and E.	A. virginicus and E. curvula
	curvula	into the surrounding areas
		in good condition and
		prevented the plantings
		from been outcompeted by
		the invasive grasses.
Removal of plant guards	 Removed plastic 	Removal of plant guards
	plant guards from	allowed plantings to grow
	established plantings	without restrictions and
		prevents invasive species
		from establishing in plant
		guards.

Figure 23: Area of treatment

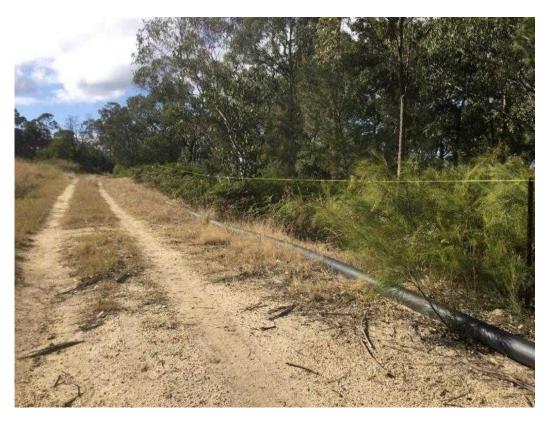
Figure 26: Suppression of E. curvula on western boundary of buffer zone

- Repairs to sediment fence along western boundary to prevent spread of invasive species from mine site into biodiversity offset area.
- Continued maintenance of western boundary and buffer zone to ensure the excellent condition of the biodiversity offset area is preserved.

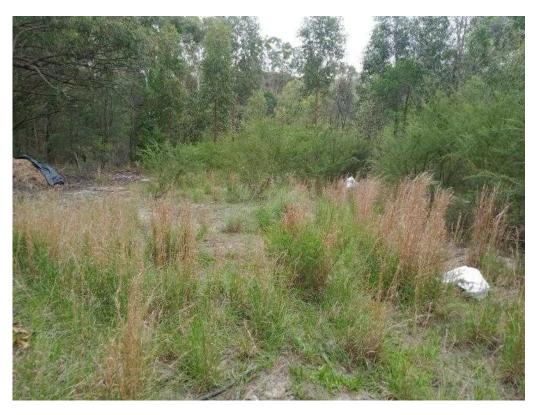
Figure 30: De-seeding of A. virginicus on edge of Haerses Road translocation

• Continued suppression of *A. virginicus* and *E. curvula and* conduct regular sweeps to ensure translocation area and the biodiversity offset remain in good condition.
