Dixon Quarry Group Old Northern Road Quarry, Maroota

Annual Review 2024 - 2025

Client: Dixon Sand Pty Ltd

Prepared by: Project Environmental Services Pt Ltd

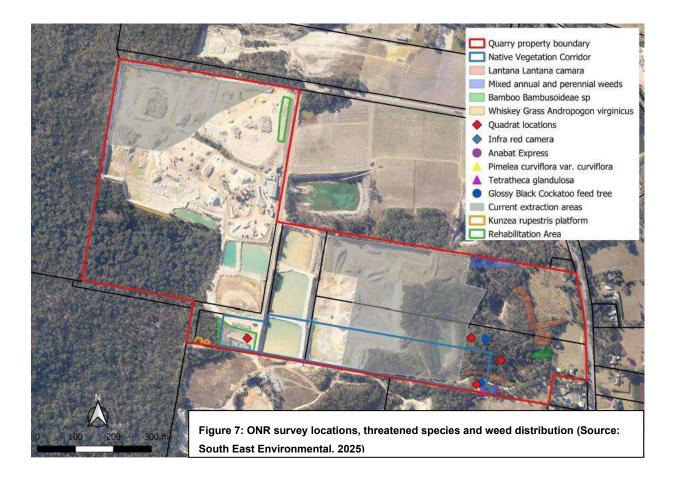
The locations survey quadrats, fauna survey, weed species and threatened species monitoring are depicted in Figure 7.

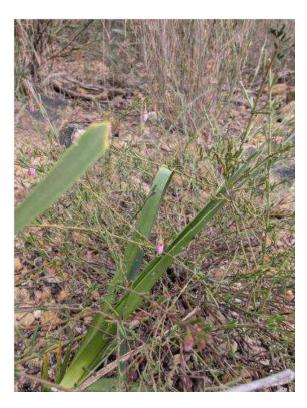
Plate 8: Translocated *Tetratheca glandulosa* flowering within the translocation area 2025 (source: South East Environmental, 2025)

Plate 8 shows the translocated *Tetratheca glandulosa* flowering within the translocation area in 2025. Plate 9 contains a specimen of *M. deanei* which was planted in the translocation area in 2017. Plate 10 shows another *Darwinia fascicularis ssp oligantha* specimen within this area. Plate 11 shows a specimen of *M. deanei* which was planted in the translocation area in 2021.

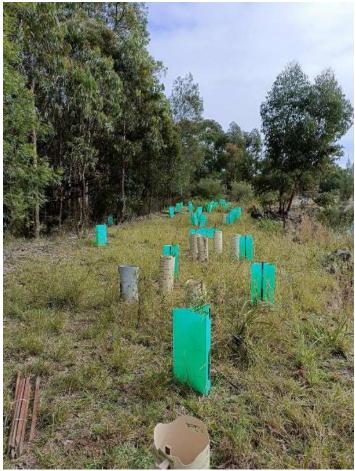
Figure 5 – Example of supplementary shrub plantings conducted in May 2025.

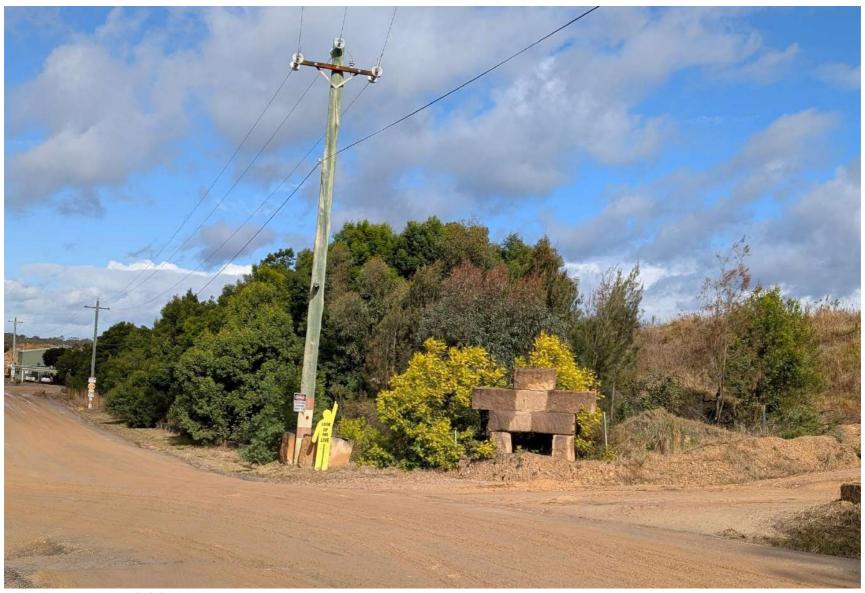
Image 18. Front gate rehabilitation area 2025

The area around the front gate of the quarry underwent initial rehabilitation in 2017 with supplementary planting of native species. However, hot dry conditions in 2017 and 2020 have resulted in a number of losses and slow growth of the surviving plants, despite regular watering and maintenance. Since the return of more regular rainfall, vegetation in the area has thrived with many shrubs flowering well and new recruitments observed, although weed density has increased. Previous gaps in vegetation are being filled with natural recruitment and regeneration. Two *M. deanei* propagated from cuttings were planted in this area in 2023 however both did not survive due to compact ground and lack of water.

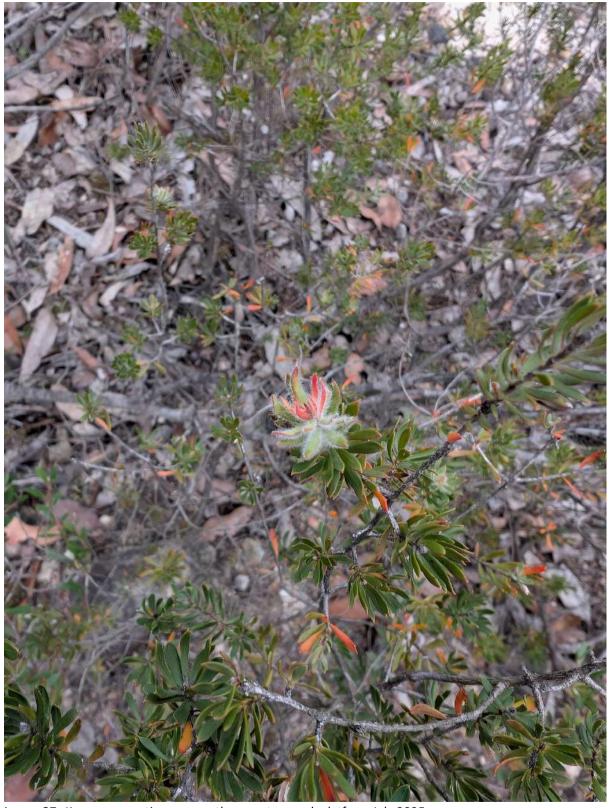
Image 37. Kunzea ruprestis new growth on eastern rock platform July 2025

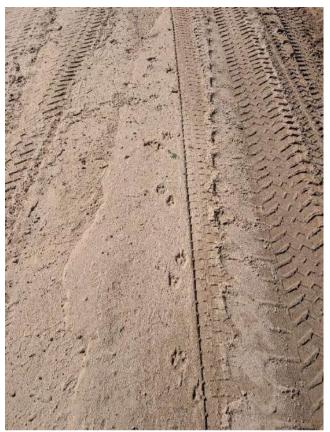
Figure 40. Sand plot monitoring results showing European Fox and Swamp Wallaby prints

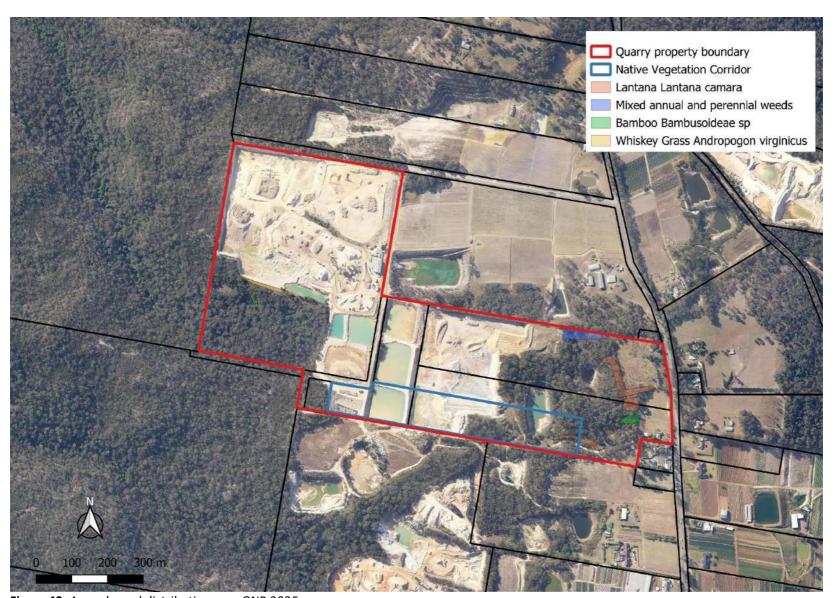
Figure 42. Annual weed distribution map ONR 2025

Regular slashing of *Andropogon virginicus* prior to seeding is recommended in addition to hand removal of any emerging *Ageratina adenophora*.
