Staff from the Missouri Department of Natural Resources conducted an inspection on August 18, 2021 of City of Carterville public water system. The system operates under the public water system identification number MO5010141.

**Missouri Department of Natural Resources
Southwest Regional Office/Public Drinking Water Branch
Report of Inspection
City of Carterville
Jasper County, Missouri
Public Water System ID Number MO5010141
September 17, 2021**

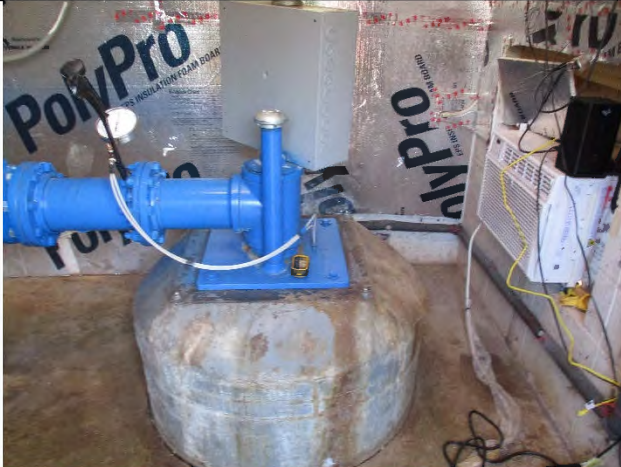
PHOTOGRAPH #1
TAKEN BY: Yvonne M. Franklin, EIT
ENTITY: City of Carterville
PERMIT: MO5010141
LOCATION: Carterville well house.
DESCRIPTION: Well #1 well head equipped with casing vent plus drawdown gauge and tube.
DATE TAKEN: August 18, 2021
PROGRAM: Public Drinking Water Branch

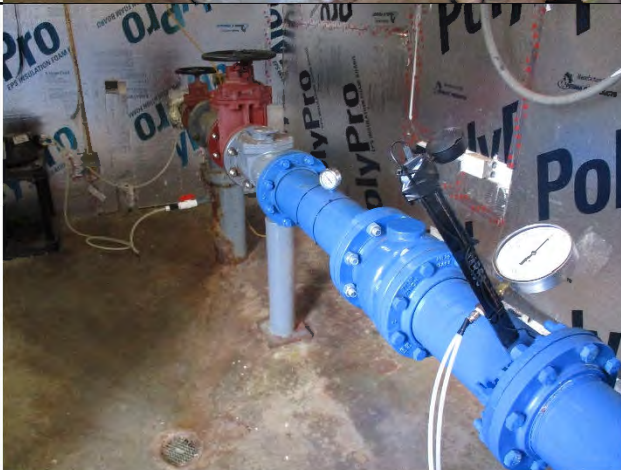
1. The well discharge piping was not protected against physical damage. The discharge piping near the chlorine injection point and all exposed piping should be protected against deterioration, physical damage, and freezing.

PHOTOGRAPH #2
TAKEN BY: Yvonne M. Franklin, EIT
ENTITY: City of Carterville
PERMIT: MO5010141
LOCATION: Carterville well house.
DESCRIPTION: Discharge piping at the well. Operators can view the drawdown gauge through the black camera via smartphone. Rust is occurring around the chlorine injection.
DATE TAKEN: August 18, 2021
PROGRAM: Public Drinking Water Branch

Paint the discharge piping to protect it from corrosion.

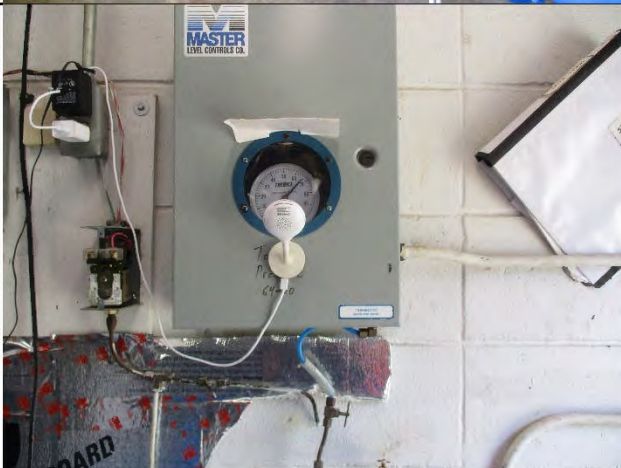
PHOTOGRAPH #3
TAKEN BY: Yvonne M. Franklin, EIT
ENTITY: City of Carterville
PERMIT: MO5010141
LOCATION: Carterville well house.
DESCRIPTION: Pressure gage reading the tower pressure. Operators can view the pressure through the white camera via smartphone.
DATE TAKEN: August 18, 2021
PROGRAM: Public Drinking Water Branch

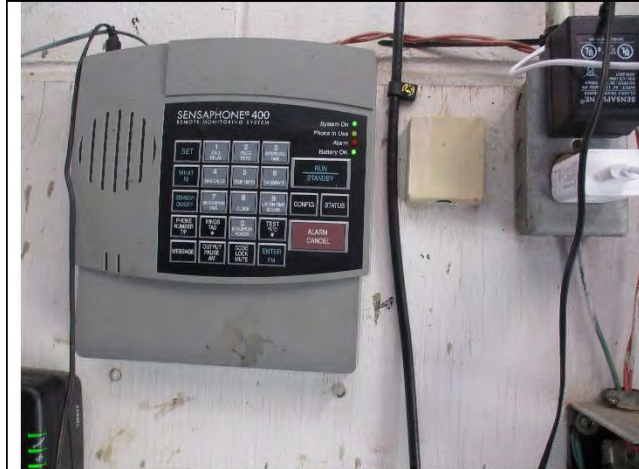
PHOTOGRAPH #4

TAKEN BY: Yvonne M. Franklin, EIT
ENTITY: City of Carterville
PERMIT: MO5010141
LOCATION: Carterville well house
DESCRIPTION: Sensaphone 400 alarm remote monitoring system accessed via smartphone.
DATE TAKEN: August 18, 2021
PROGRAM: Public Drinking Water Branch

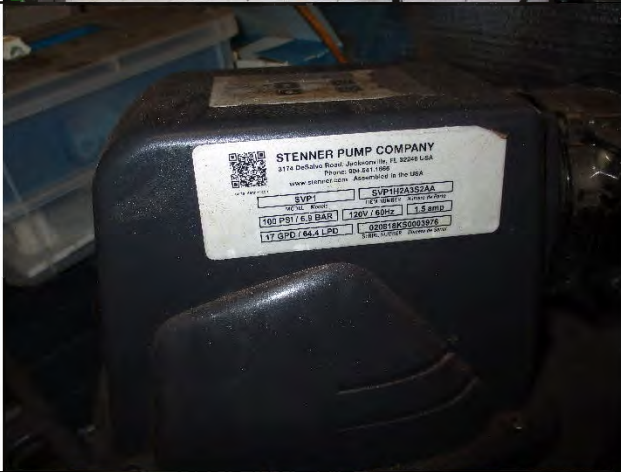
PHOTOGRAPH #5

TAKEN BY: Yvonne M. Franklin, EIT
ENTITY: City of Carterville
PERMIT: MO5010141
LOCATION: Carterville well house.
DESCRIPTION: Stenner peristaltic pump used for disinfection.
DATE TAKEN: August 18, 2021
PROGRAM: Public Drinking Water Branch

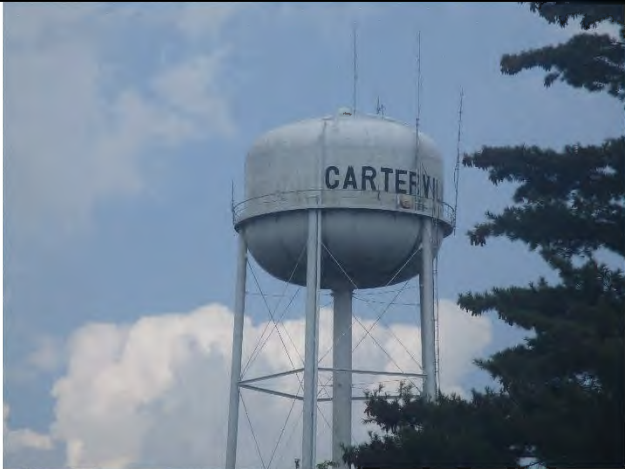
2. The storage tank needs exterior painting.

Steel tanks without adequate paint coating will quickly deteriorate from corrosion. The tanks must have the exteriors cleaned and painted. If the tank interiors have not been inspected in the past three years, the interiors should be inspected, cleaned, and repainted as necessary. Note that interior paint must be approved by Missouri Department of Natural Resources Public Drinking Water Branch.

PHOTOGRAPH #7
TAKEN BY: Yvonne M. Franklin, EIT
ENTITY: City of Carterville
PERMIT: MO5010141
LOCATION: North Pine Street next to well house.
DESCRIPTION: 300,000-gallon elevated tower.
DATE TAKEN: August 18, 2021
PROGRAM: Public Drinking Water Branch

The Department recommends cleaning and painting the exterior of the 300,000 gallon elevated storage tank. If the interior has not been inspected in the past three years, the interior should be inspected, cleaned, and repainted with Missouri Department of Natural Resources Public Drinking Water Branch approved paint as necessary.

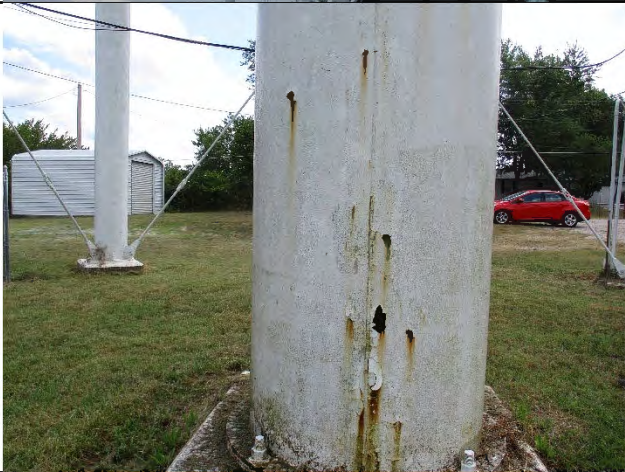
PHOTOGRAPH #8
TAKEN BY: Yvonne M. Franklin, EIT
ENTITY: City of Carterville
PERMIT: MO5010141
LOCATION: North Pine Street
DESCRIPTION: Delaminated spots with rust located on the tower riser.
DATE TAKEN: August 18, 2021
PROGRAM: Public Drinking Water Branch

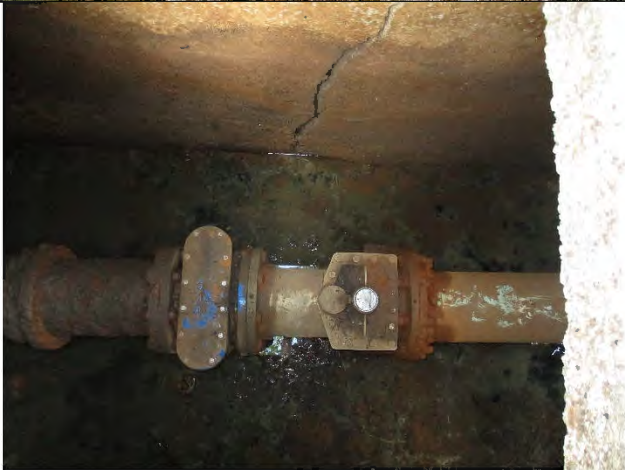
The emergency vault is located at the far west end of West Main Street. Pictures were taken of the vault. The main located inside of the vault should be painted to minimize the rusting of the steel pipe. In addition, tree roots and debris were noticed inside of the vault. Both Will and Carze stated that due to recent wells being not in service in Webb City, the emergency connection is just enough to keep the Carterville system pressurized; however, customers call to complain about the lack of water when they try to use it at their homes. After inspecting the Webb City emergency connection, we (Will, Carze, and I) returned to North Pine Street.

PHOTOGRAPH #9
TAKEN BY: Yvonne M. Franklin, EIT
ENTITY: City of Carterville
PERMIT: MO5010141
LOCATION: West Main Street (dead-end)
DESCRIPTION: Emergency water connection with Webb City.
DATE TAKEN: August 18, 2021
PROGRAM: Public Drinking Water Branch
