T2+ Case Study - 36" Natural Gas Line

Figures 1-4 were taken following a failed ILI run after a competitor "cleaned" the line.

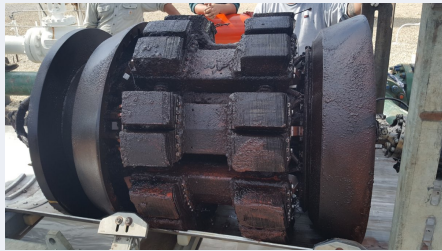
As seen in Figures 5-7, T2+ broke down the debris into soft, flowable remnants that were pigged out of the line.

Figure 5 - Heavy Duty Cleaning Pig - T2+ Cleaning Run

All the debris that came in during the cleaning runs was soft and flowable. T2+ broke the matrix and dissolved the iron sulfide and iron oxide debris that was restricting the pipeline flow. The operator was able to increase their profit per MCF from \$0.50 to \$2.50 because of little to no restriction in the line after we cleaned it. The lines throughput increased to 1BCF per day increasing the operators profit by \$2,000,000/day. The operator is extremely happy and is considering adding T2+ injection points along their pipelines to prevent this debris build up and keep their profits at a maximum.

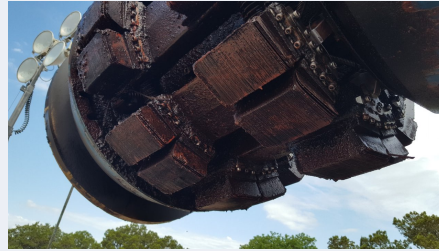
Figure 6 - Heavy Duty Cleaning Pig - T2+ Cleaning Run

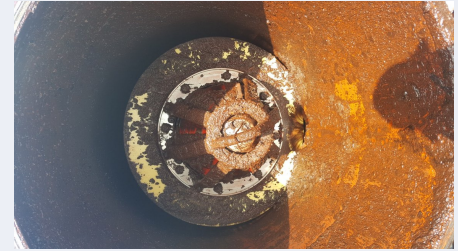
Figure 7 - Heavy Duty Cleaning Pig - T2+ Cleaning Run

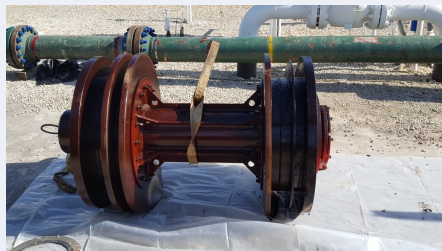
Figure 8 - Gauge pig following 2nd cleaning run (unscathed)

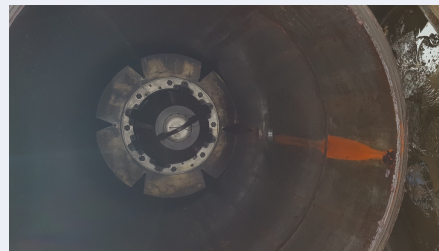
Figure 9 - ILI Run with no debris in receiver
