2018 AIS

Control

Progress of Eurasian Water Milfoil (EWM) & Curley Leaf Pondweed (CLP) control efforts in 2018. The more residents are educated the better we can manage these problems. EWM - Shift in location and slight reduction in area affected. Curley Leaf - Increased areas treated in Briggs and Julia

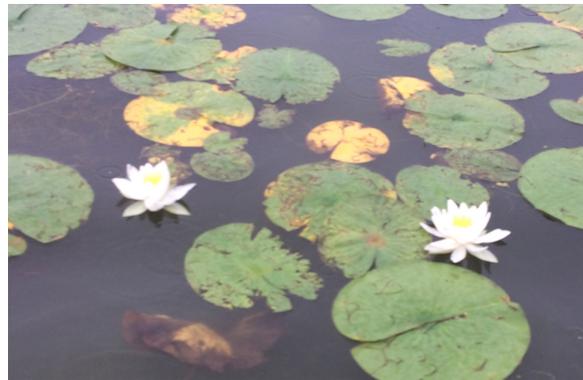
No Milfoil found in lily pad areas

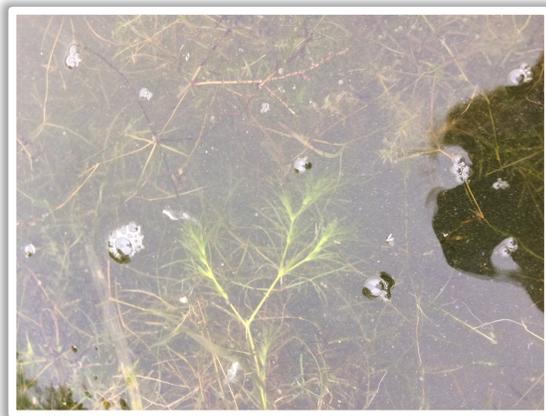
Clear water with good mix of native weeds helps reduce surface algae

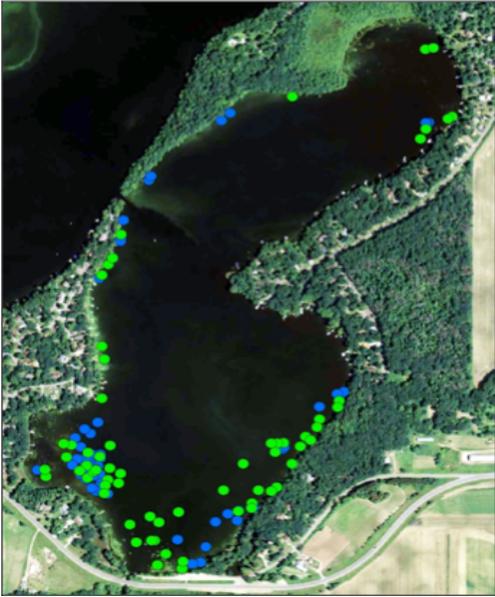
2016-17 EWM

In 2017 we found much EWM in Lily Pad areas. Due to timing of herbicide hand pulling took place last resulting in fewer surveyed plants found. Two hand pulls took place and work was heaviest in the Lily Pad areas in the southwest bay. 2016 = Blue dots
2017 = Green Dots.

2017 Acre affected = 16

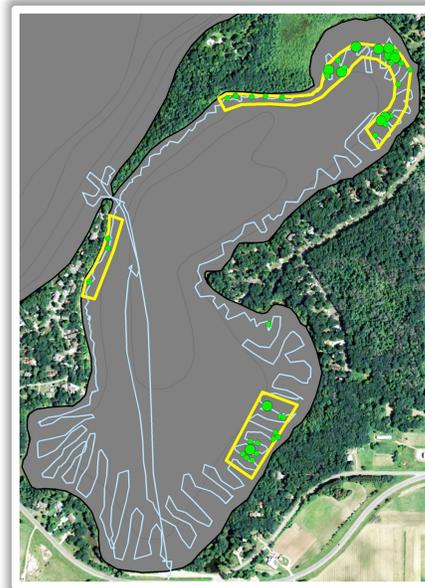
2018 EWM

In 2018 the Lily Pad areas were clear of EWM but the North are of the lake increased.

The area near the entrance to Briggs lake was hand pulled yielding many more plants than the survey indicated. This implies plants are harder to spot through the algae and affected areas may have changed very little.

Learning what works year to year is key to keeping the EWM population confined to the least area possible. 8/5/18 (12 days after treatment still found live plants) Wind appears to have moved plants near north end shore.

2018 Acre affected = 12.4

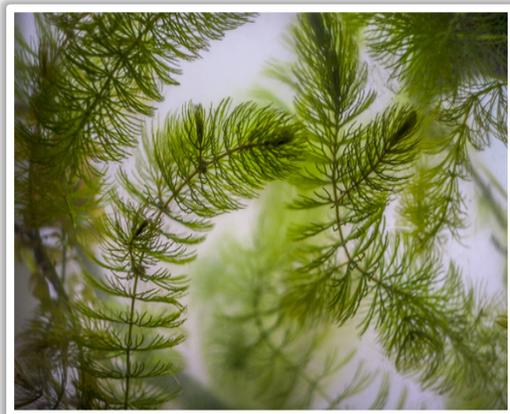
Complaints of increased weeds were reported in North end of Rush (above EWM noted area) and Northwest area on Julia both turned out to be mostly Coontail (see left example). It is a free-floating, rootless, native aquatic plant that is capable of covering large areas. Water clarity typically improves with abundant underwater aquatic vegetation. In Julia's north end Northern Milfoil has retreated to just the area where the creek enters the lake. Need more education about what to look for.

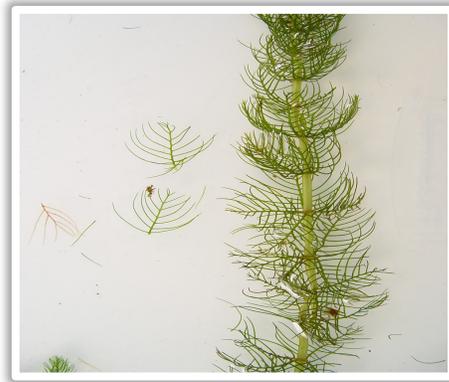
Northern Milfoil example

Poor water clarity limits the EWM growth creating more issues when water quality improves (Plants can grow in deeper water for example). Northern Milfoil which is native to the area is one of many plants that compete with the EWM but is also makes the EM harder to spot. The weevils found naturally in Northern Milfoil are known to inhibit EWM growth as well.

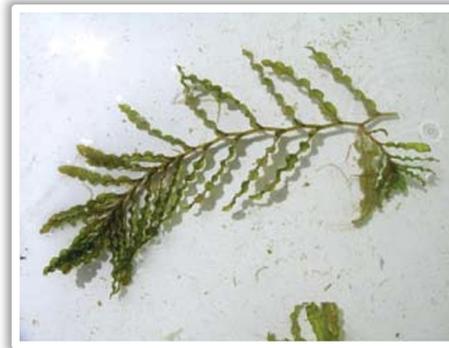
Curley Leaf example

Efforts from 2017 combined with late ice out conditions, fewer flooding events and other factors helped to produce clearer water in the chain. CLP is treated before turions (buds that can remain viable for years.) are allowed to form. The CLP dies off around the fourth of July creating more surface algae as it attempts to spread its turions. Increased Algae makes more difficult EWM survey and hand pull effectiveness.
