Process Design

Heat Treatment

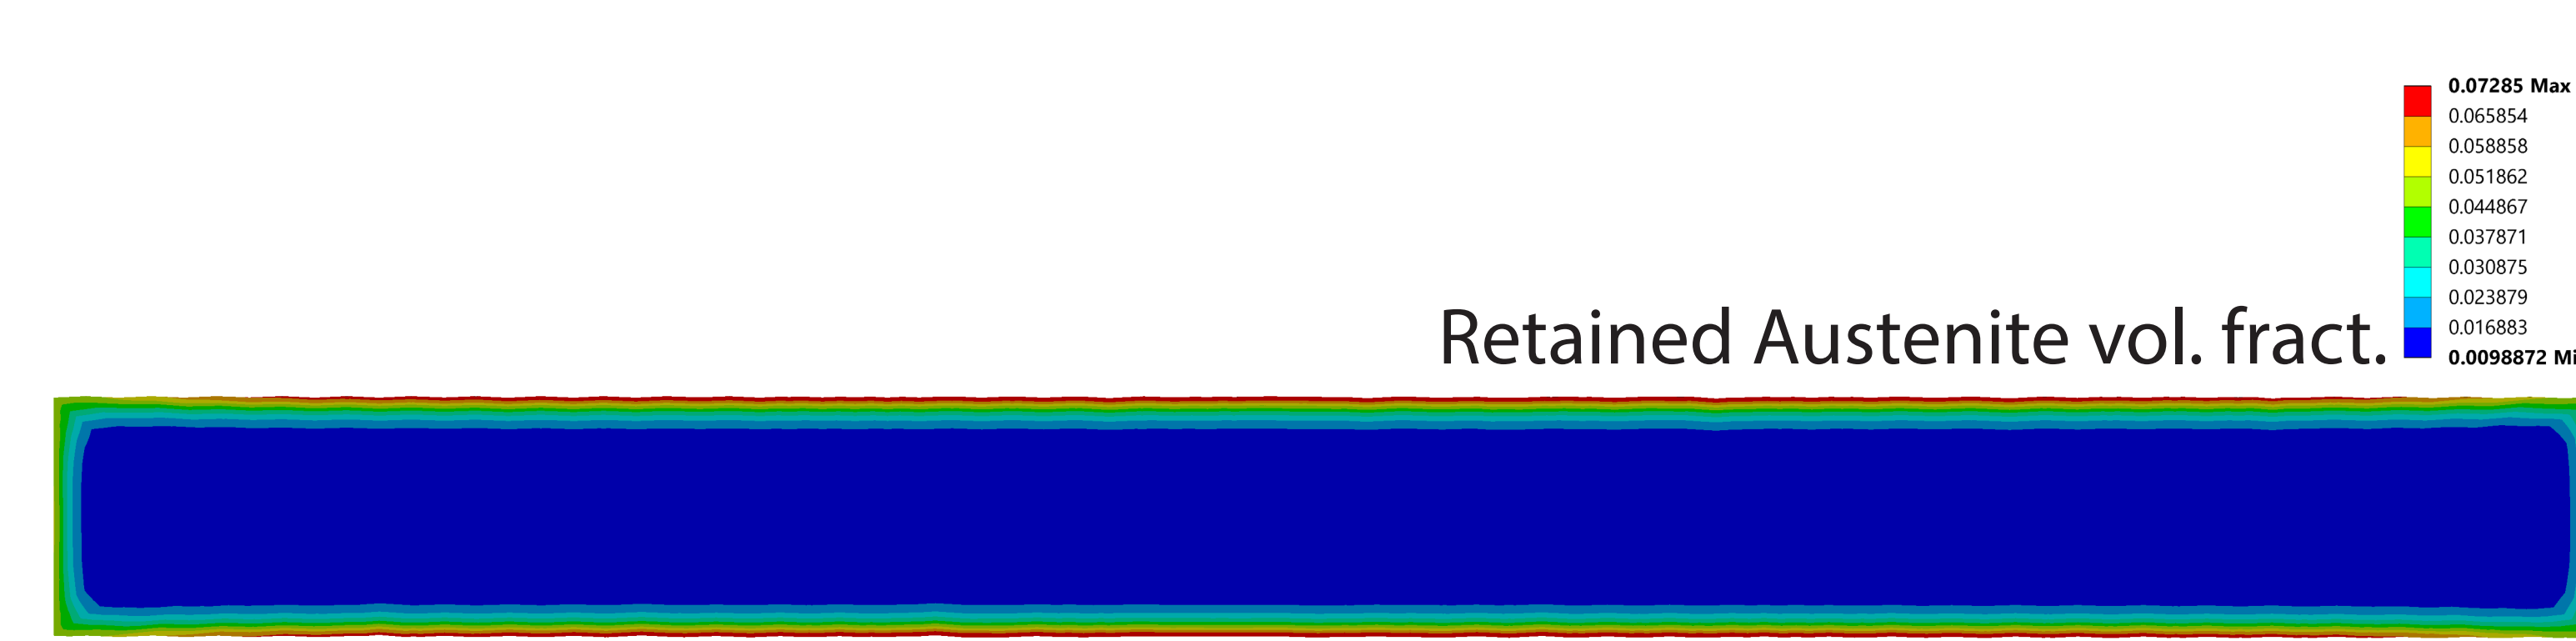
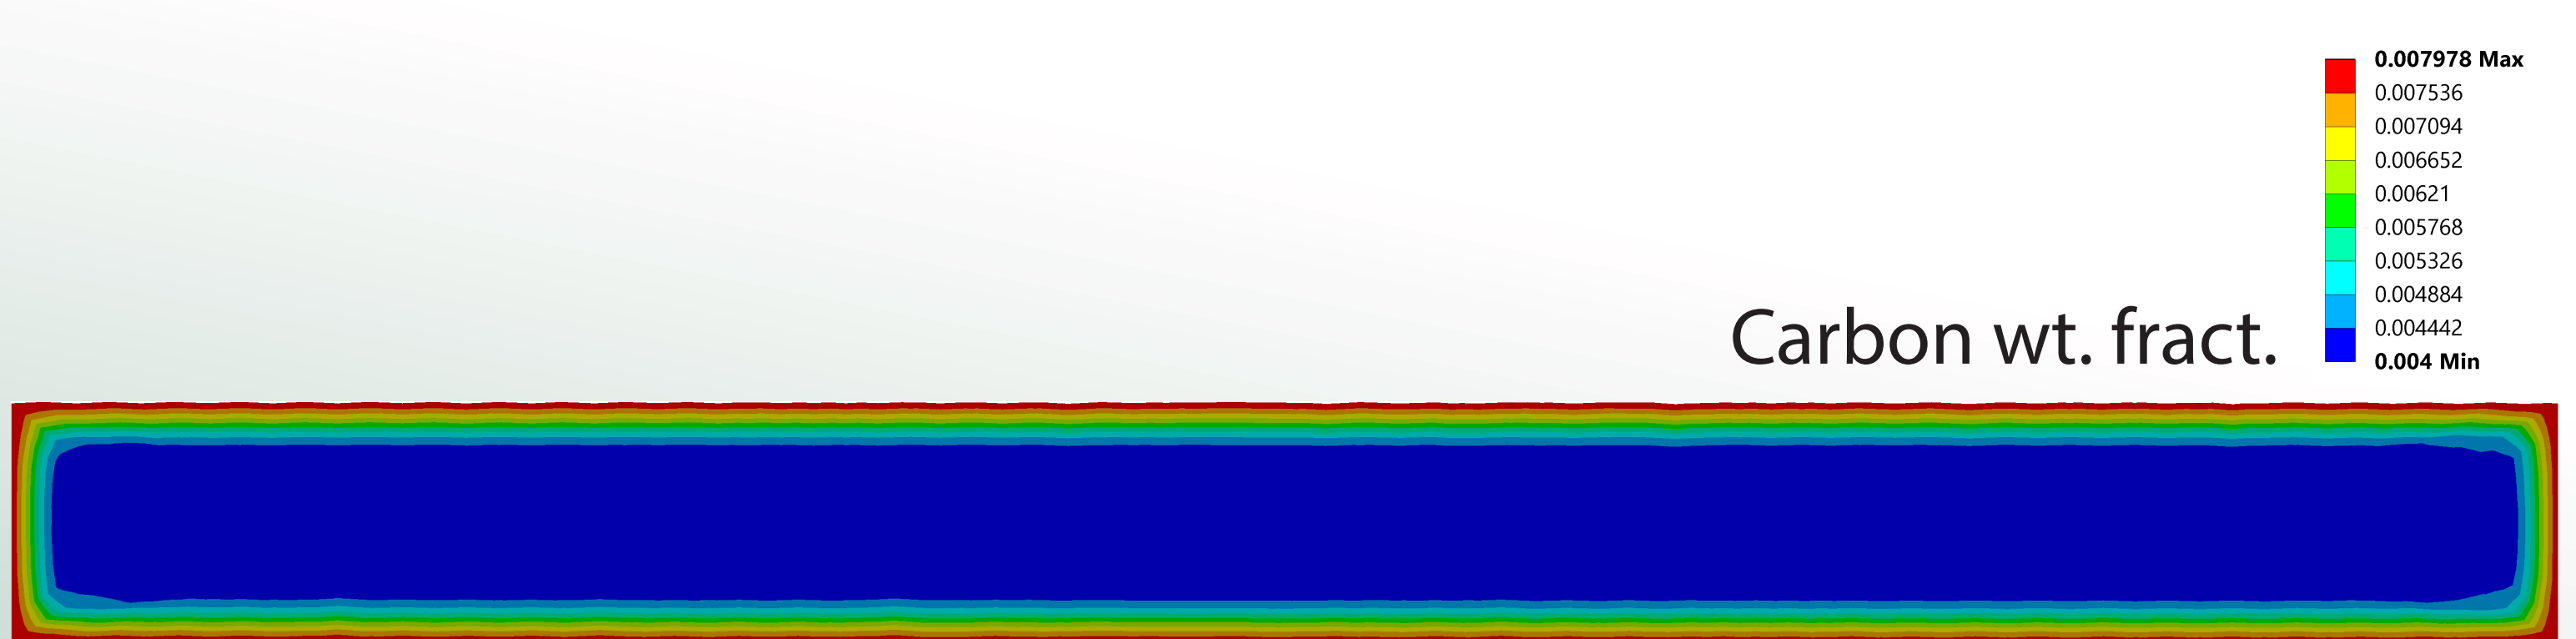
These process steps were applied to the Ansys Transient Thermal and Static Structural (Stress) models. The models were executed with the DANTE subroutine and with the carbon profile generated previously. The resulting contours for carbon weight fraction, Martensite, retained Austenite, tempered Martensite and Hardness (HRC) can be viewed to the left, right, and below, respectively.

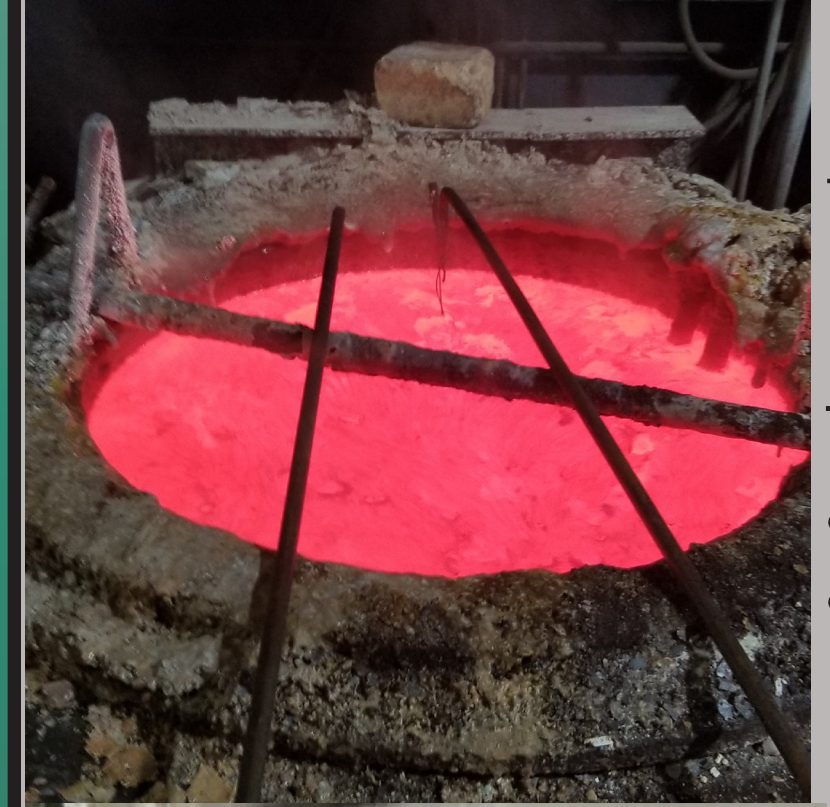
Reaustenitization was performed in the salt bath pictured to the left, and quenching was done in a polymer and water bucket with ice, as shown below.

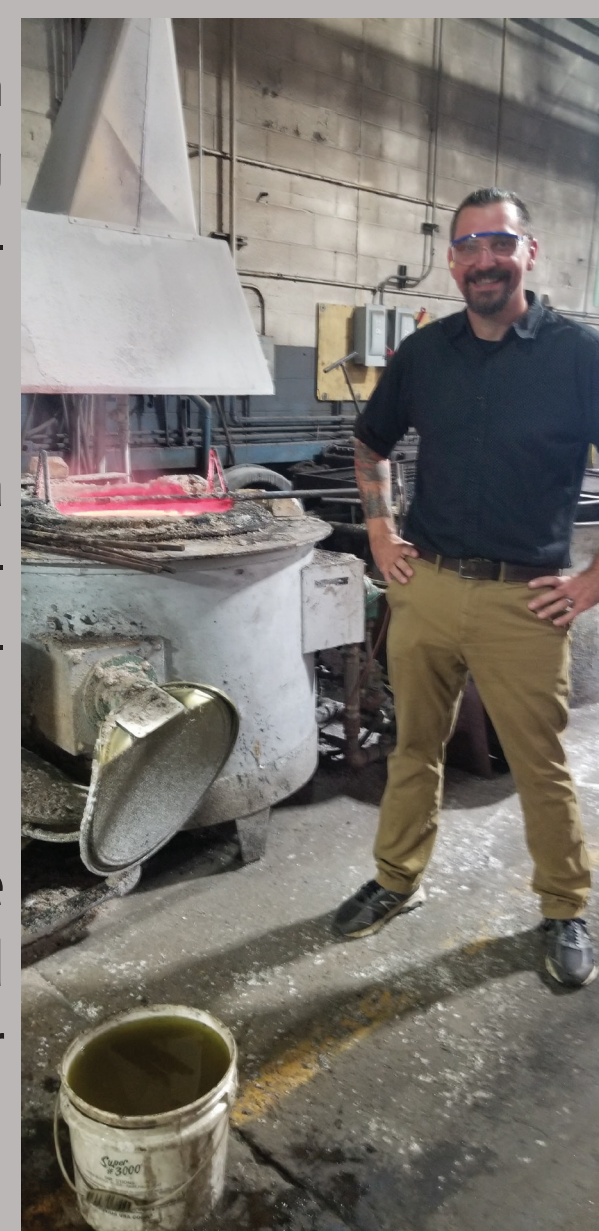
The samples were cool to the touch after ten (10) seconds of quenching and were placed in the tempering furnace for one hour.

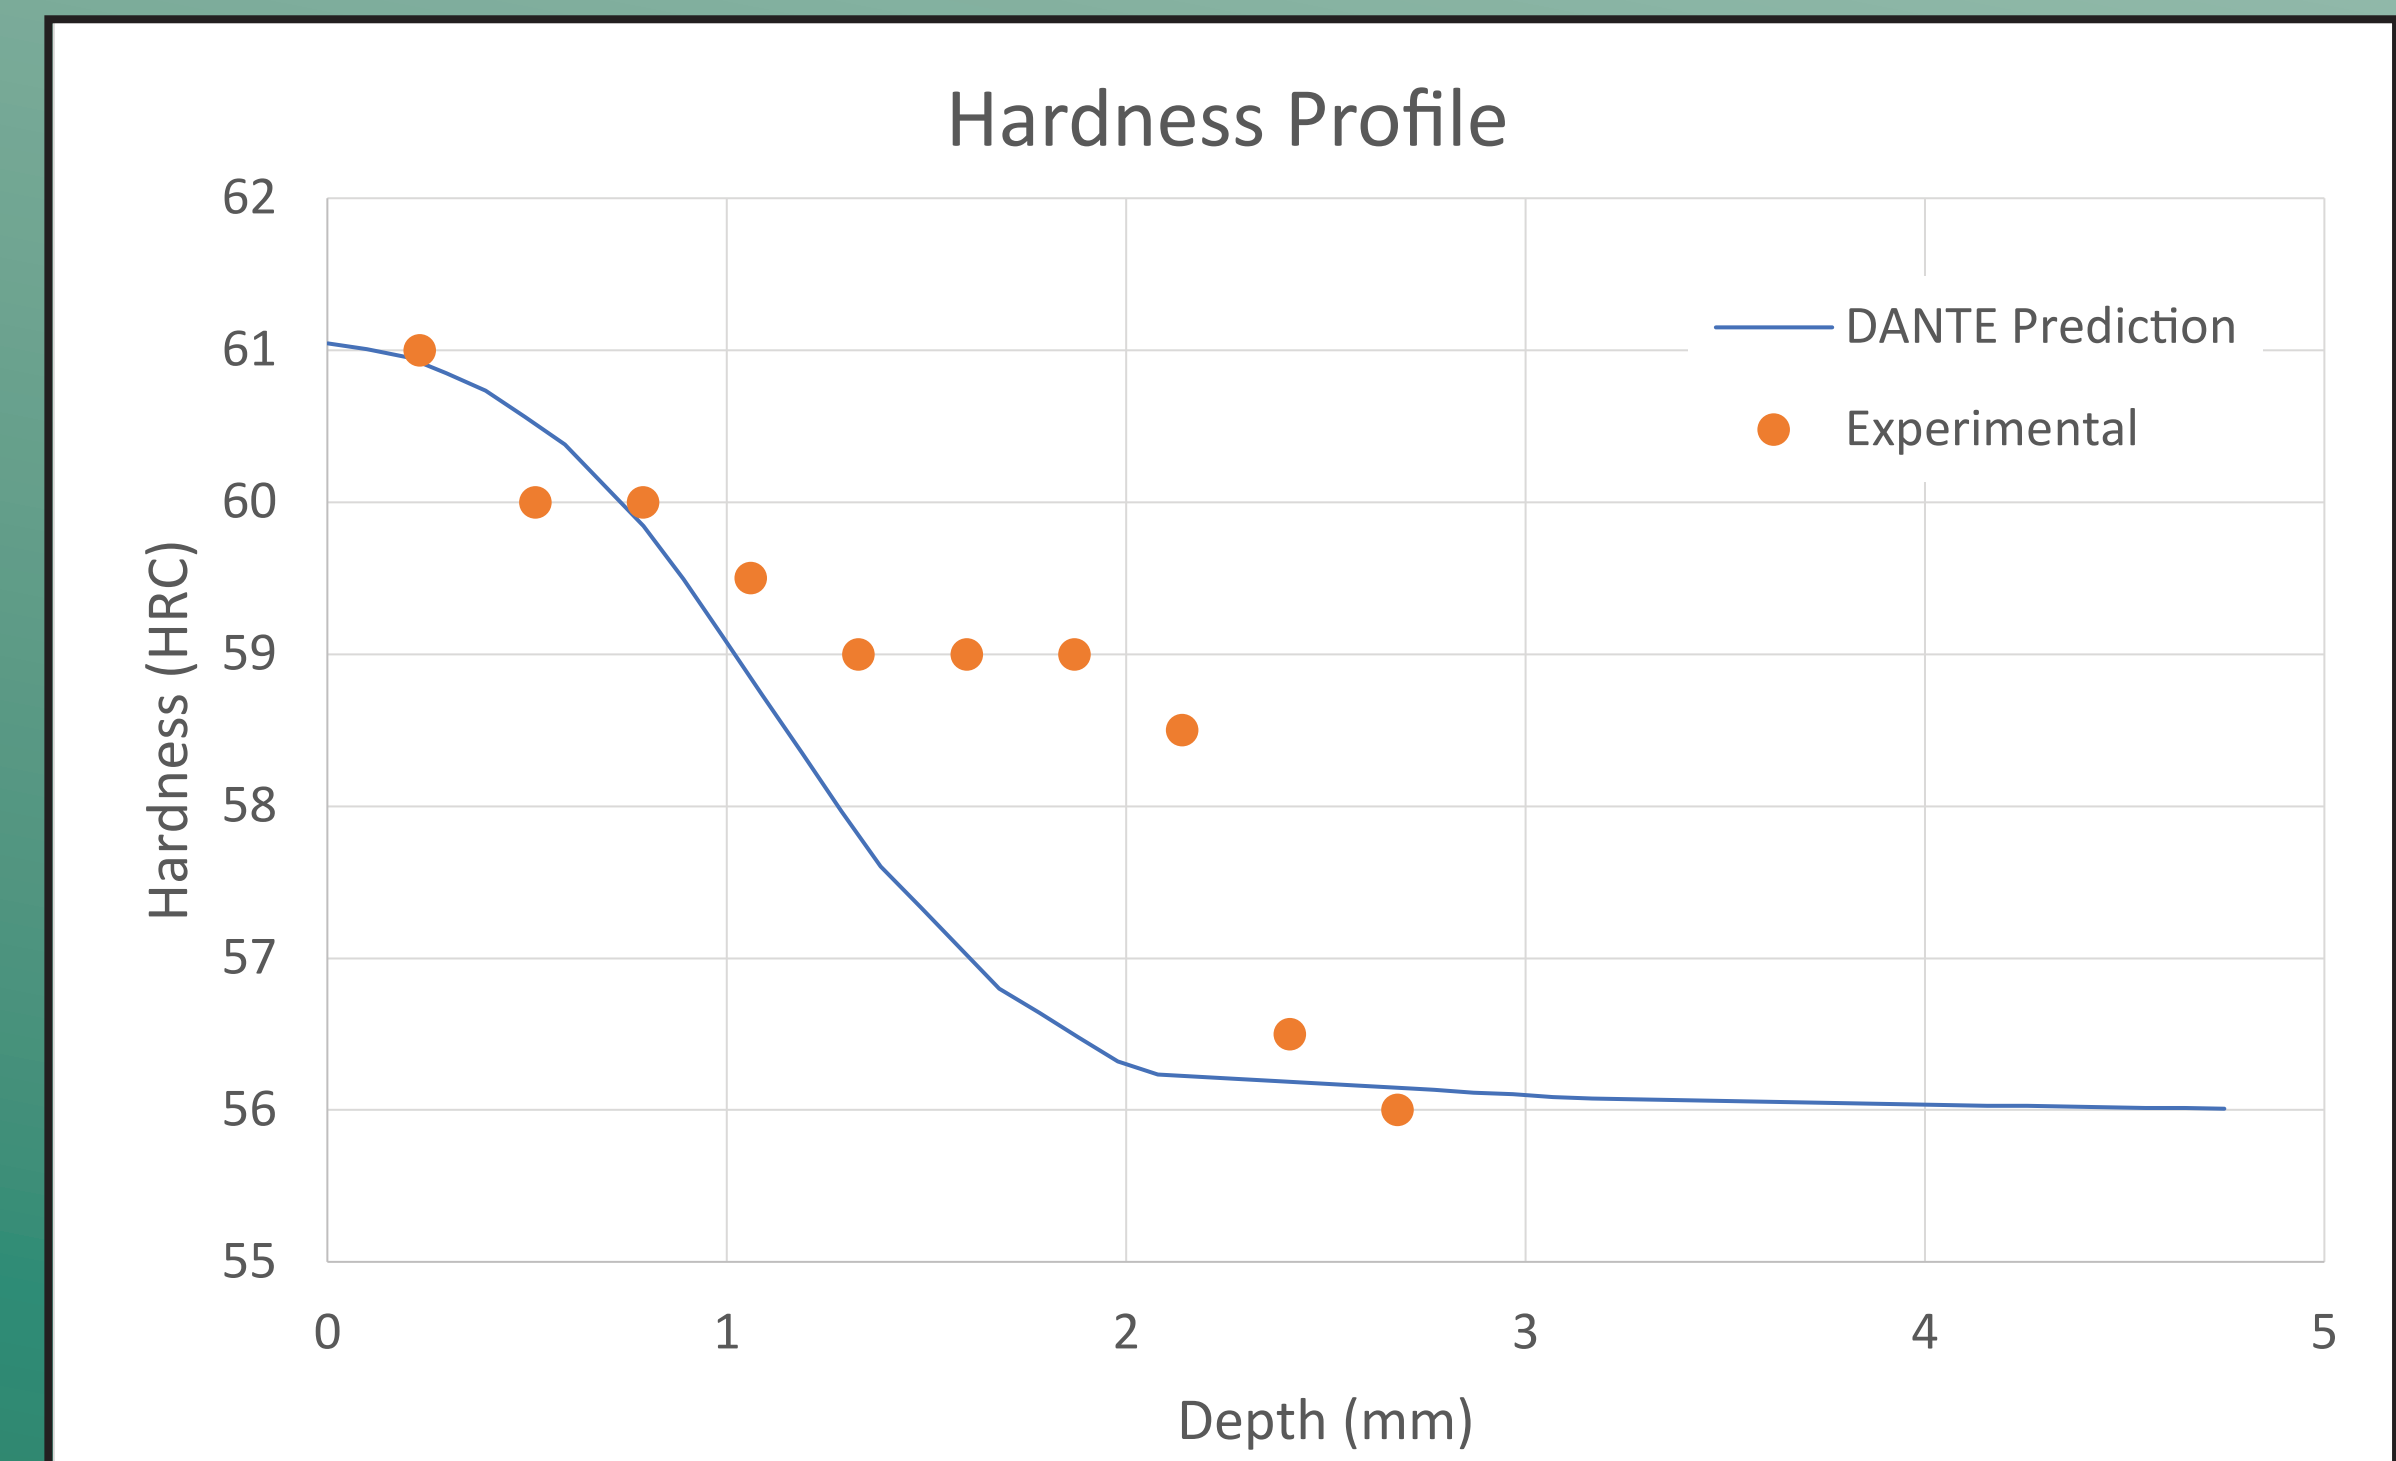
After polishing, hardness measurements were taken using the Vickers hardness tester at CSU. Ten measurements were taken from surface to core, at approximately 0.3mm distance between each, providing the hardness profile to the left. The overall location of each measurement is pictured in black and white to the upper right and in color below the profile to the left.

The carbon case is clearly shown in the color micrograph to the bottom left. This darker color can be seen from the surface to just after the sixth hardness measurement, confirming the penetration depth is just over 1.5mm (0.060").
