<p>WATER & WETLAND LAKE, POND & WETLAND MANAGEMENT</p>	<p>ENVIRONMENTAL SCIENTIST: JAMES LACASSE JAMES@WATERANDWETLAND.COM C: (774) 276-6098</p> <p>CALL/TEXT WITH ANY QUESTIONS!</p>	 
---	---	---

FIELD NOTES SUMMARY

Customer: City of Lynn
Pond Name: Goldfish Pond
Site Location: Lynn, MA
Date: 5/21/24

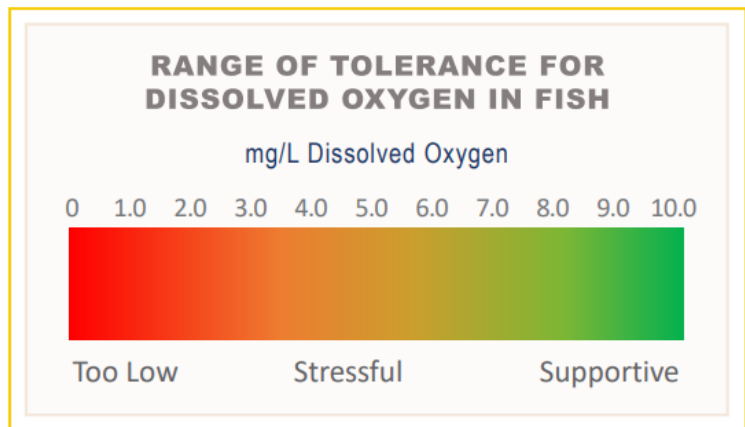
While on-site, dissolved oxygen (DO) and temperature readings were collected using a calibrated YSI meter with optical sensor. Dissolved oxygen is the amount of oxygen in water that is available to aquatic organisms. DO is necessary to support fish spawning, growth, and activity. Tolerance varies by species, but the figure below provides a general range of fish tolerance (Source: epa.gov). Dissolved oxygen can be affected by

many outside factors, such as: temperature, time of day, and pollution. Dissolved oxygen levels are typically lowest early in the morning. Healthy water should generally have concentrations of about 6.5-8+ mg/L.
