FIELD NOTES SUMMARY

Customer: City of Lynn (Goldfish Pond)

Site Location: Lynn, Massachusetts

Date: 5/23/22, 3:30 PM

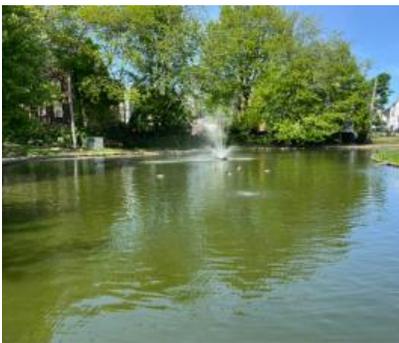
Upon arrival, a survey was conducted using visual observation paired with a standard throw-rake, as applicable. The first noticeable observation was the water color within the Pond as it appeared to look “light green” (Photo 1). A small microscopic algae bloom was documented. No vegetation was documented. Pollen and tree debris were collecting on the surface of the Pond, especially in the wind blown areas (Photo 2). The submersed aeration system was inspected and was running as normal following our early season calibration. One of the three fountains is still non-functional, the other two were inspected and were working as intended (Photo 3).

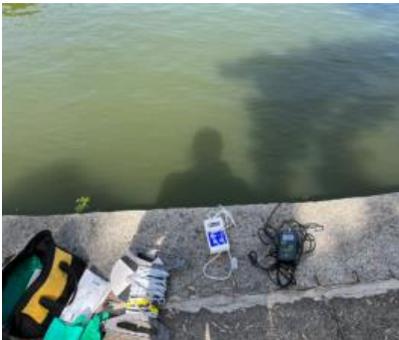
While on-site, basic water quality was collected using calibrated meters (Photo 4). The pH was 7.2, which is within a standard range for freshwaters and is considered neutral. The water temperature was consistent with other smaller waterbodies we manage in the area, and the dissolved oxygen was sufficient to support fish and wildlife. Water clarity was also assessed using a Secchi disk. A Secchi disk is a disk with alternating black and white quadrants. It is lowered into the water of a lake until it can no longer be seen by the observer. This depth of disappearance, called the Secchi depth, is a measure of the transparency of the water. The Secchi reading was 1’4”. An algae sample as well as water quality samples were collected from Goldfish Pond. The water quality samples included total phosphorus, soluble phosphorus, and E Coli. All samples were transported to a lab for further analysis.

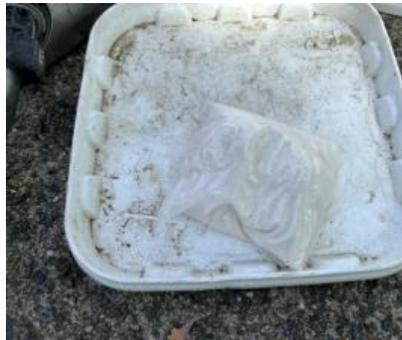
Based on the survey, a treatment was conducted for the control of microscopic algae. The liquid algaecide was applied using a calibrated backpack sprayer. This application methodology allows for even coverage within the treatment areas. There are no restrictions associated with this treatment. Bacteria packets were also applied to the Pond to help break down the muck while also improving water quality and clarity (Photo 5).
