FIELD NOTES SUMMARY

Customer: City of Lynn (Goldfish Pond)

Site Location: Lynn, Massachusetts

Date: 6/22/22, 11:10 AM

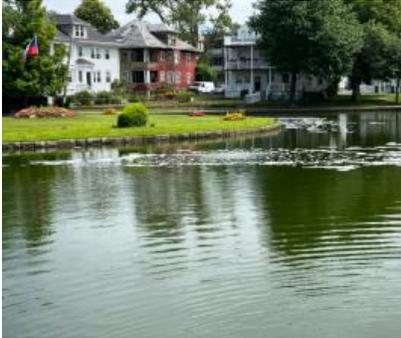
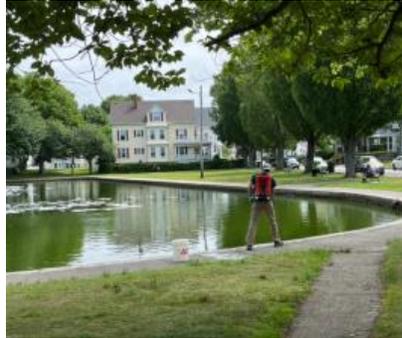
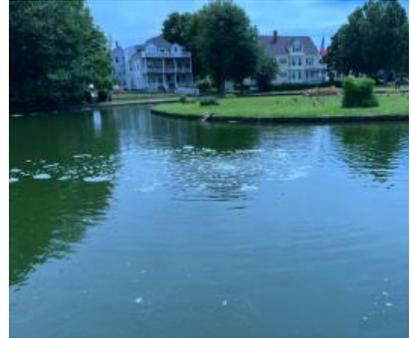
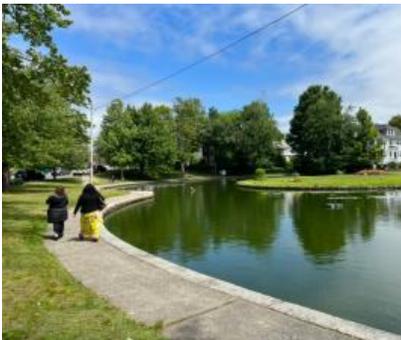
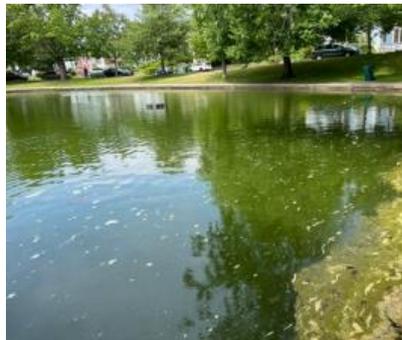
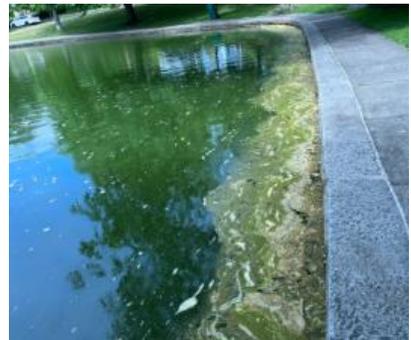
Photos

Upon arrival, a survey was conducted using visual observation paired with a standard throw-rake and handheld GPS/ArcGIS Field Maps, as applicable. The Pond appeared to have a “green” coloring, which indicated that there was a microscopic algae bloom occurring. The water level was noted as slightly below average. White “suds” or a “foam-like” substance was circulating around each aerator diffuser. The aeration system was running as normal while the fountains were not running. Microscopic algae was observed building up on the surface on the northern point.

As planned, and based on the survey, a treatment was conducted for the control of microscopic algae. The liquid algaecide (EarthTec) was applied via a calibrated backpack sprayer. This application methodology allows for even coverage within the treatment areas. An algae sample was also collected while on-site, this was properly preserved and submitted to the lab for analysis.
