FIELD NOTES SUMMARY

Customer: City of Lynn (Goldfish Pond)

Site Location: Lynn, Massachusetts

Date: 7/11/22, 11:10 AM

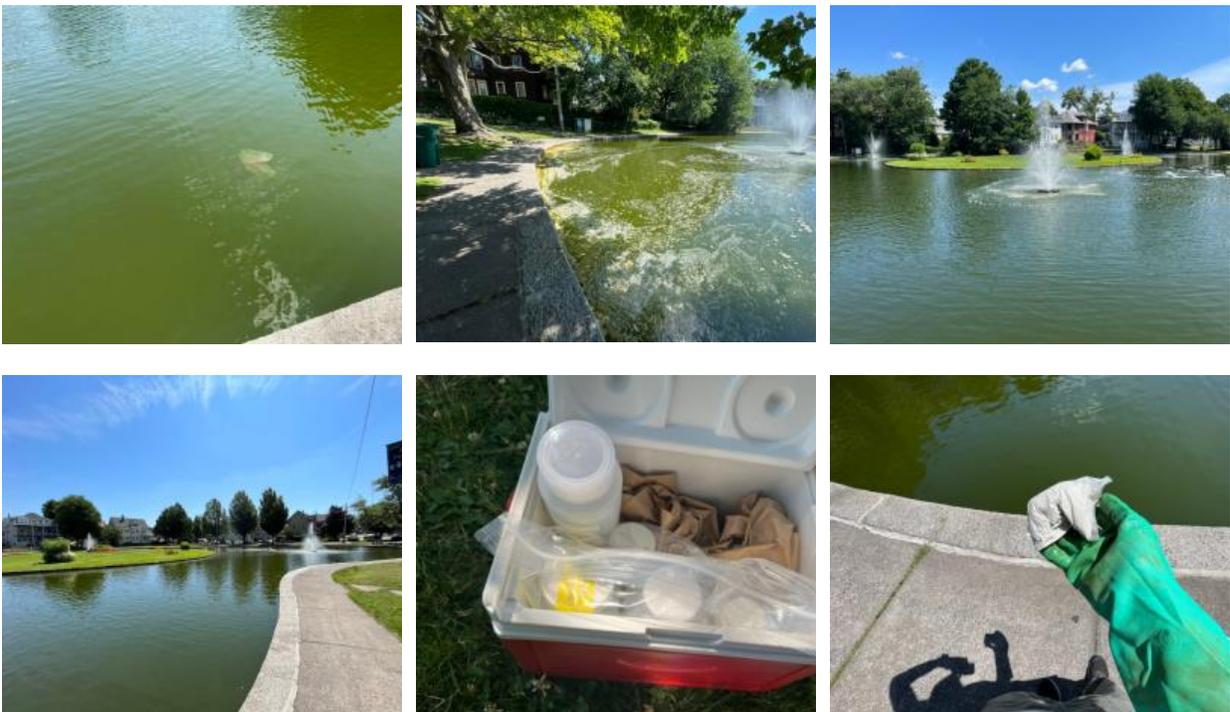
Photos

Upon arrival, a survey was conducted using visual observation paired with a standard throw-rake and handheld GPS/ArcGIS Field Maps, as applicable. The Pond appeared to look slightly less “green” in color compared to the previous site visit as conditions seemed to improve (although the Pond was documented with a slight green tint to the coloring during this site visit). A build up of microscopic algae/ tree debris was noted on the surface in the wind blown areas of the Pond. All three fountains were functioning and running for the first time this season. The aeration units were running per normal. Scattered debris was found within the Pond. Geese, ducks, and turtles were noted throughout Goldfish Pond. Water quality parameters and an algae sample were collected and transported to the lab for further analysis.

As anticipated, and based on the survey, a treatment was conducted for the control of microscopic algae. The liquid algaecide was applied using a backpack sprayer from the shoreline of the Pond. This application methodology allows for even coverage within the treatment area. Bacteria packets were also applied to help increase water clarity, to speed up the break down of muck and organic debris along the bottom, and help improve the overall health of the Pond.
