## FIELD NOTES SUMMARY

**Customer:** City of Lynn  
**Pond Name:** Goldfish Pond  
**Site Location:** Lynn, MA  
**Date:** 7/9/24

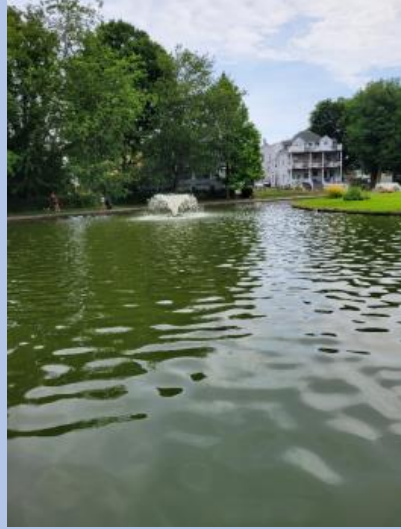
Photo 1

*Additional Notes from the Biologist*
Conditions were similar to what we'd anticipate at Goldfish Pond. A microscopic algae bloom was present; however, surface scums were not documented. Large populations of turtles were noted in the water, and the fountains were running well. Trash was observed within the water in various areas and was removed by our staff. Based on the inspection, an algaecide treatment was conducted. Bacteria was also applied to assist with the breakdown of organic material. Water samples were collected and sent to the lab for analysis.
