December 21, 2023

**Re: Lynn Ponds (Sluice Pond, Flax Pond, Floating Bridge Pond, and Goldfish Pond), Lynn, MA – 2023 Year End Report**

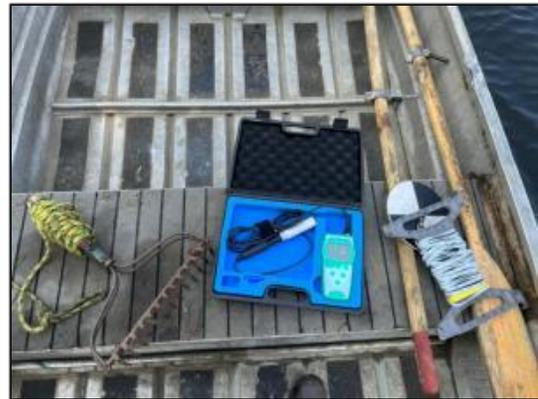
During each visit to the Ponds, a survey was conducted using visual observation paired with a standard throw-rake and handheld GPS/ArcGIS Field Maps, as applicable. Additionally, dissolved oxygen (DO) and temperature readings were collected throughout the season using a calibrated YSI meter with optical sensor (pictured in Figure 1). Dissolved oxygen is the amount of oxygen in water that is available to aquatic organisms. DO is necessary to support fish spawning, growth, and activity. Tolerance varies by species, but the figure shown provides a general range of fish tolerance (Source: epa.gov). Dissolved oxygen can be affected by many outside factors, such as: temperature, time of day, and pollution. Dissolved oxygen levels are typically lowest

Figure 1: Equipment and meters utilized during each site visit as applicable

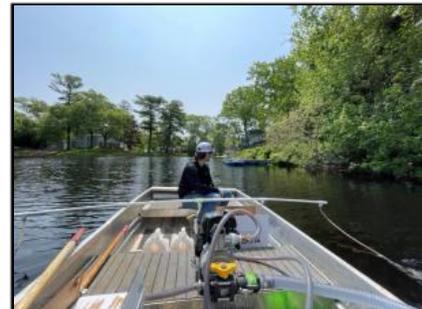
On May 23<sup>rd</sup>, Aquatic Biologist, Scott Conrade, and seasonal aquatic field assistant, Brian Sweeney, completed a site visit to Sluice Pond. The visit consisted of performing a survey, collecting basic water quality data, and conducting a treatment (treatment being conducted in Figure 5). Weather conditions during the visit were sunny and in the mid-60s.

Figure 5: Brian Sweeney looks on as the application is taking place.

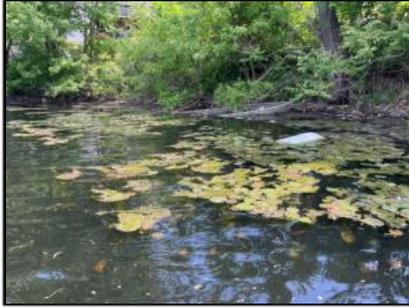
Upon arrival, a survey was conducted using visual observation paired with a standard throw-rake and handheld GPS/ArcGIS Field Maps, as applicable. Upon completion of the survey, curly-leaf pondweed was only present in the cove with the boat launch and the northwest cove of the Pond. Fanwort had not emerged in Sluice Pond yet; however, it should be germinating soon and will be targeted in a future treatment, based on the survey data. Aside from the curly-leaf pondweed, several native species were documented at non-nuisance levels. Waterlilies were also observed in low densities in various areas around the Pond. There was sparse filamentous algae that was caught up in these areas of waterlilies (conditions illustrated in Figure 6), however, the algae was not in high enough densities to warrant treatment at this time.

Figure 6: Filamentous algae, organic debris, and waterlilies at the surface of Sluice Pond

Based on the previous survey, the treatment was pre-scheduled for this date. As planned and further confirmed by the survey, a treatment was conducted for the control of curly-leaf pondweed. We also anticipate some impacts to lilies only within the treatment area. The liquid herbicide was applied using a treatment boat equipped with a calibrated sub-surface injection system. This application methodology allows for even coverage within the treatment areas. Prior to the treatment, the City and Association were notified and provided with the treatment poster. Immediately prior to treatment, neon pink posters were hung around the shoreline noting the treatment, affiliated water-use restrictions, and

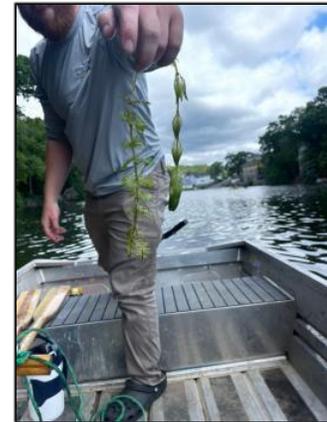
Figure 7: Aquatic Biologist, Scott Conrade, holds up a piece of fanwort.

Fanwort (documented in Figure 7) was found in various locations around the Pond in only trace densities. One of the locations was near the boat launch area and was likely where this species first entered the Pond. These areas will be treated during the next visit which will be bumped up to early July, as this will allow time for the proper notifications to be conducted. The start of a small planktonic algae bloom was also noted. Although not urgent, we anticipated copper sulfate to be applied at the same time as the fanwort treatment to stop the bloom in its tracks. Several fish species were documented during our survey including Pumpkinseed (*Lepomis gibbosus*), Bluegill (*Lepomis macrochirus*), Largemouth Bass (*Micropterus salmoides*), and even an extremely large White Koi (*Cyprinus carpio*). Two deceased ducks were documented in the lake in close proximity to each other, this is likely due to a predator.

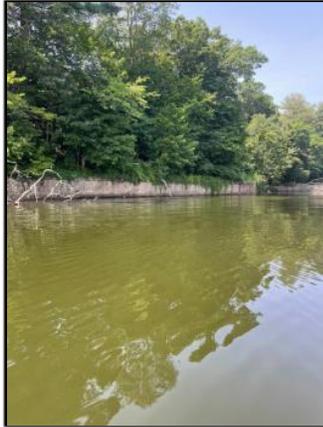
Figure 8: Microscopic algae bloom at Sluice Pond

Upon arrival to the site, a survey was conducted using visual observation paired with a standard throw-rake and handheld GPS/ArcGIS Field Maps, as applicable. The purpose of the survey was to confirm potential treatment areas and to evaluate the microscopic algae bloom. Upon arrival, it was documented that the start of a planktonic algae bloom was occurring (bloom conditions illustrated in Figure 8). There were also sparse filamentous algae mats observed as Water and Wetland navigated further out into the Pond. Patches of fanwort that were located during the last survey were treated in these localized areas. Plants documented during the survey were fanwort\*, waterlilies, duckweed (*Lemna sp.*), watermeal (*Wolffia*), common waterweed (*Elodea sp.*), planktonic algae, Japanese knotweed\*, multiflora rose\*, and filamentous algae. As mentioned previously, (\*) denotes an invasive species. Invasive species are non-native to the ecosystem and are likely to cause economic harm, environmental harm, or harm to human health. During the survey, the pH was checked using a calibrated meter and was 7.9 which is within a standard range and is considered neutral, however, leaning towards basic.

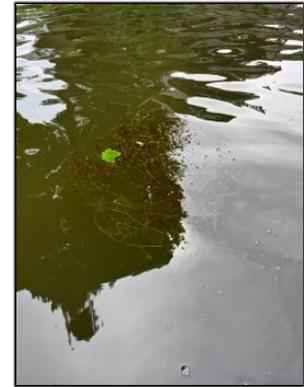
Figure 9: Macroalgae floating on the surface of Sluice Pond.

Upon arrival to the site, a survey was conducted using visual observation paired with a standard throw-rake and handheld GPS/ArcGIS Field Maps, as applicable. The purpose of this survey was to assess the efficacy of the treatments conducted during the last site visit. Since the Pond was experiencing a mild algae bloom, there was limited visibility, so rake tosses were thrown to assess any vegetation. Rake tosses revealed sparse densities of fanwort, chara (*Chara vulgaris*), bladderwort (*Utricularia sp.*), bushy pondweed (*Najas guadalupensis*), and thin-leaf pondweed. Other species noted included waterlilies, cattails (*Typha sp.*), Japanese knotweed, and multiflora rose. The fanwort population remaining was extremely trace as the previous treatment worked well.

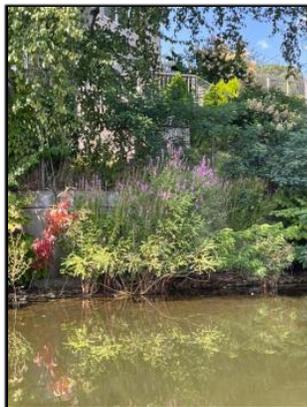
Figure 10: Purple loosestrife on the shoreline of Sluice Pond

A brief survey was completed in order to document vegetation species present and confirm the presence of microscopic algae. Plants documented during the survey were waterlilies, purple loosestrife (observed in Figure 10), Japanese knotweed, fanwort, muskgrass and microscopic algae. The treatment was completed successfully. Copper sulfate was mixed into an onboard mixing tank and injected into the water column via a calibrated subsurface injection system from a custom flat bottom jon boat. The copper sulfate was spread evenly throughout the treatment areas, which will provide the most effective treatment possible. The treatment was applied to half of the surface area of the Pond, as per the label restriction.

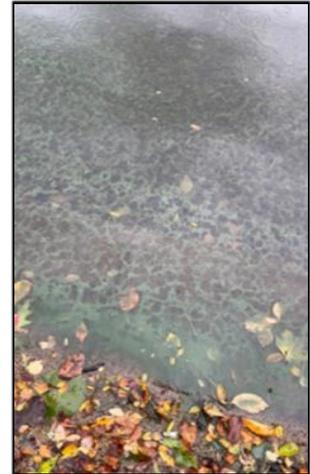
Upon arrival to the site, a survey was conducted using visual observation paired with a standard throw-rake and handheld GPS/ArcGIS Field Maps, as applicable. The purpose of the survey was to evaluate the effectiveness of the previous treatment in addition to assessing the 2023 aquatic management program and to help guide recommendations for the 2024 season. A minor microscopic algae bloom was noted, this was predominantly visible as windblown against shorelines (illustrated in Figure 11). It was late in the season so we anticipated this to die-off naturally; however, if selected, sampling could provide more information in terms of species and cell counts. Fanwort as documented in extremely low densities. This was likely regrowth from the previous treatment, which is common to see when using contact herbicides. GPS points were collected where fanwort was documented to assist with 2024 management. Japanese knotweed was documented in various locations around the shoreline. This should typically be managed although it likely extends onto private property. Aside from these notes, no nuisance species were documented. Dissolved oxygen was excellent. Other species documented during the site visit included water starwort, muskgrass, multiflora rose, white waterlilies, and cattails.

Figure 11: microscopic algae colonies

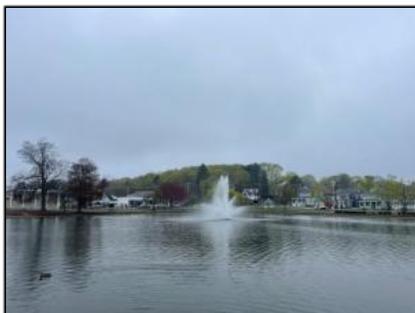
Figure 13: The fountain at Flax Pond

considered neutral. The fountain which was installed during our previous visit was inspected and was functioning as intended (pictured in Figure 13).

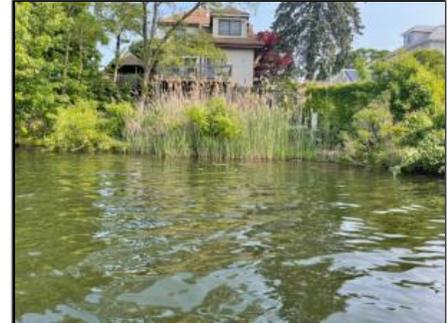
Figure 14: Phragmites at Flax Pond

Upon arrival, a survey was conducted using visual observation paired with a standard throw-rake and handheld GPS/ArcGIS Field Maps, as applicable. During the survey, several native pondweeds / aquatic plants were observed in multiple locations throughout Flax Pond. This included clasp-leaf pondweed (*Potamogeton perfoliatus*), thin-leaf pondweed, and waterlilies. Several small patches of common reed were also noted during the survey (documented in Figure 14). Some microscopic algae was noted, but not at a level which would warrant algaecide treatment at this time. Pollen was also noted collecting along the shoreline in several areas, especially in windblown areas. The fountain was inspected and was functioning normally.

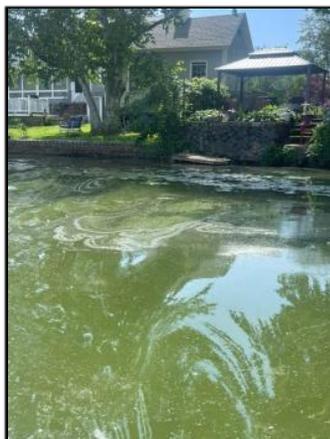
Figure 15: Planktonic algae bloom at Flax Pond

Upon arrival to the site, a survey was conducted using visual observation paired with a standard throw-rake and handheld GPS/ArcGIS Field Maps, as applicable. Plants documented during the survey were thin-leaf pondweed, white waterlilies, tape grass, curly-leaf pondweed, clasp-leaf pondweed, coontail (*Ceratophyllum demersum*), benthic filamentous algae, and microscopic algae. During the survey, the pH was checked with a calibrated meter and was 7.5 which is within the standard range and is considered neutral. It was extremely apparent that a planktonic algae bloom (bloom noted with Figure 15) was starting. Based on this, we planned for treatment in early July. This would allow time for the proper notifications to be completed prior to treatment. While some curly-leaf pondweed was documented it was in trace to sparse densities and appeared unhealthy. Additional species documented are all native and were not documented at nuisance densities. Waterlilies

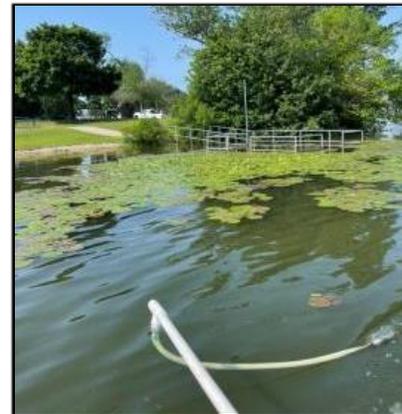
*Figure 16: Microscopic bloom being treated at Flax Pond*

Based on the survey results, a copper sulfate treatment was administered. Copper sulfate was mixed into an onboard mixing tank and injected into the water column via a calibrated subsurface injection system from a custom flat bottom jon boat. The copper sulfate was spread evenly throughout the treatment areas, which will provide the most effective treatment possible. The copper sulfate was applied to 1/2 of the Pond, as limited by the product label.

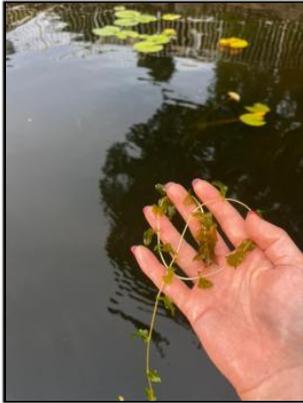
Figure 17: Clasp-leaf pondweed and waterlilies noted during the survey

Upon arrival to the site, a survey was conducted using visual observation paired with a standard throw-rake and handheld GPS/ArcGIS Field Maps, as applicable. The purpose of this survey was to assess the efficacy of last visits algae treatment. Compared to pre-treatment conditions, there has been a significant reduction in the severity of the algae bloom. There was still an evident bloom occurring, and it should be treated again next site visit. Additionally, there were several healthy populations of native species that were scattered around the Pond. Species noted during the survey were microscopic algae, tape grass, thin-leaf pondweed, common waterweed, clasp-leaf pondweed (pictured in Figure 17), purple loosestrife\*, white waterlilies (Figure 17), bladderwort, benthic algae, duckweed, southern water nymph, common reed\*, and Japanese knotweed\*. (\*) denotes an invasive species. In addition to the microscopic algae, there were also patches of benthic filamentous algae. The dominant native species that were observed included: tape grass, waterlilies, and clasp-leaf pondweed.

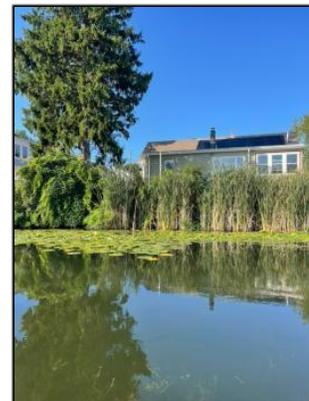
Upon arrival to the site, a survey was conducted using visual observation paired with a standard throw-rake and handheld GPS/ArcGIS Field Maps, as applicable. The survey was conducted to evaluate the health of the Pond and to confirm potential treatment areas. Species noted during the survey included white waterlilies, yellow waterlilies, clasp-leaf pondweed, common waterweed, southern water nymph, purple loosestrife\*, common reed\*, cattails, and Japanese knotweed\*. (\*) denotes an invasive species that was observed during this visit.

Figure 18: Waterlilies and cattails at Flax Pond

Based on the results of the survey, two separate treatments were performed during the site visit. First, a copper sulfate treatment was conducted. The granular algaecide was mixed into an onboard mixing tank and injected into the water column via a calibrated subsurface injection system from a custom flat bottom jon boat. The copper sulfate was spread evenly throughout the treatment areas, which provided the most effective treatment possible. The treatment was applied to 1/2 of the Pond, as limited by the product label. The next treatment was conducted for the control of nuisance level waterlilies. The liquid herbicide was applied using the small jon boat, equipped with a calibrated pump, which is used to target the nuisance lilies via foliar application methodology. The patch, pictured in Figure 18, was one of the areas controlled during the application. This method allows for even and precise coverage. Waterlilies are a native species, so the goal of the program was to scale back nuisance level lilies, but not eliminate all

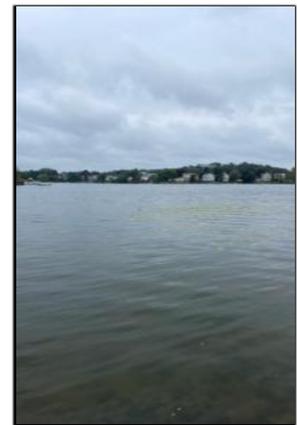
On September 25<sup>th</sup>, Aquatic Biologist, Scott Conrade, made a visit to Flax Pond. The purpose of the site visit was to assess the 2023 aquatic management program and to help guide recommendations for the 2024 season. Conditions during the site visit were mostly cloudy and with rain (see conditions in Figure 19). Due to the weather conditions, the survey heavily relied on rake tosses.

Figure 19: Overview of Flax Pond

Curly-leaf pondweed was found in several areas of the Pond. This was typical of this time of year, as curly leaf is a cold-water species and sprouts when the water temperatures cool. A plethora of native species were also observed during the survey; however, none were at nuisance levels. Invasive Japanese Knotweed was documented along the shoreline but likely was on private property. The microscopic algae also seemed to be at low abundance during this visit. It has greatly improved since the previous treatment. Other species documented during the survey were clasp-leaf pondweed, curly-leaf pondweed\*, white waterlilies, yellow waterlilies, common reed, southern water nymph, purple loosestrife\*, thin-leaf pondweed, benthic filamentous algae, microscopic algae, duckweed, watermeal, Japanese knotweed\*, and common waterweed. The (\*) denotes an invasive species.

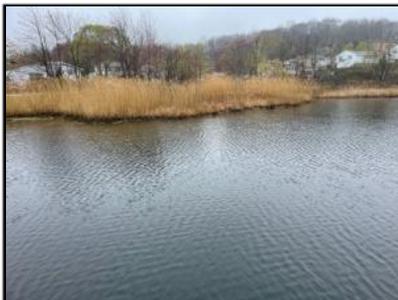
Figure 21: Overlooking the Western Basin, cattails and phragmites remain dormant

warrant treatment at this time. Common reed were noted around the East Basin, however it was still dormant at this time (illustrated in Figure 21). At the time of this survey, it was still early in the season. A follow-up survey was scheduled for May to document the most appropriate management and affiliated timing.

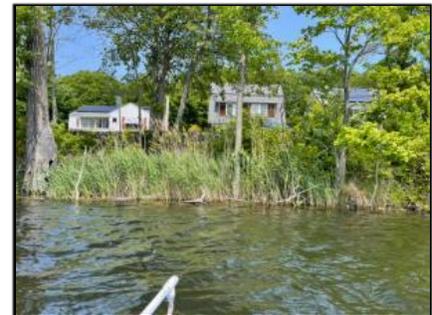
*Figure 22: Phragmites seen during the treatment at Floating Bridge Pond*

Upon arrival, a survey was conducted using visual observation paired with a standard throw-rake and handheld GPS/ArcGIS Field Maps, as applicable. In the Western Basin, sparse curly-leaf pondweed was still present, however the most dominant plant was fanwort. There was also a slight filamentous algae bloom occurring at the time of the visit. Overall, in the West Basin of the Pond, conditions were similar to the East Basin. There was however more Fanwort cover in the West Basin.

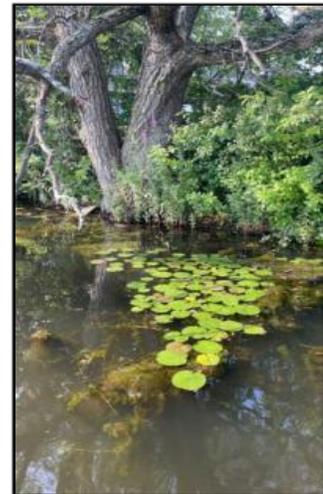
Upon arrival to the site, a survey was conducted using visual observation paired with a standard throw-rake and handheld GPS/ArcGIS Field Maps, as applicable. Plants documented during the survey were waterlilies (pictured in Figure 23), fanwort\*, coontail, filamentous algae, common reed\*, purple loosestrife, microscopic algae, and common waterweed. The (\*) denotes an invasive species. We noticed the start of an algae bloom during our survey. The bloom was mainly microscopic algae; however, there were mats of filamentous algae that were being formed in the shallower, more stagnant areas of the Pond. This was not a huge concern as it was a low percentage of the Pond. Fanwort was the dominant species in both basins, taking up the majority of the water column. The pH of the pond was checked using a calibrated meter. The pH was 7.9 which is fairly neutral, leaning towards basic.

*Figure 23: White waterlilies and Fanwort in Floating Bridge Pond.*

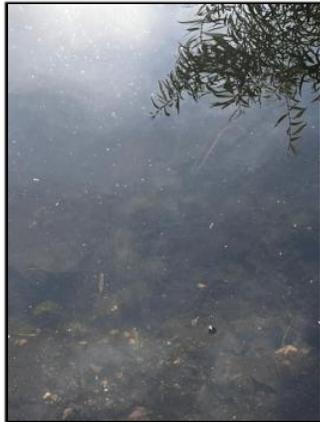
Figure 24: Fanwort just below the surface

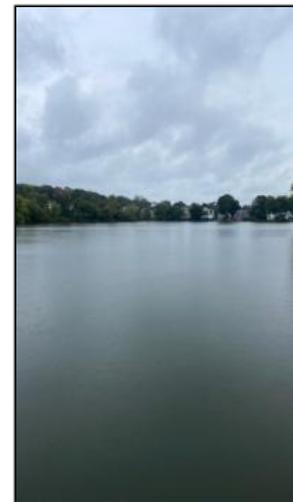
On September 25<sup>th</sup>, Aquatic Biologist, Scott Conrade, made a visit to Floating Bridge Pond (overview of the Eastern Basin in Figure 25). The purpose of the site visit was to conduct a survey to assess the overall 2023 aquatic management program and to help guide recommendations for the 2024 season. Conditions during the site visit were cloudy with occasional rain.

Upon arrival to the site, a survey was conducted using visual observation paired with a standard throw-rake and handheld GPS/ArcGIS Field Maps, as applicable. There was some fanwort observed in both basins, at low densities. This was likely regrowth from the previous treatment and was noted for next season. This can occur after a treatment due to increased availability of light and nutrients near the substrate. Overall, invasive species and nuisance species were greatly controlled through the 2023 program. There was also a minor microscopic algae bloom occurring at the time of the survey. Due to this, the survey mainly relied on rake tosses. Plants documented during the survey were common reed\*, benthic algae, cattails, fanwort\*, duckweed, watermeal, and microscopic algae. The (\*) denotes an invasive species.

Figure 25: Floating Bridge Pond on September 25th, 2023

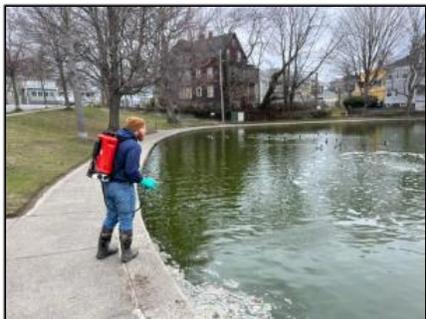
Figure 27: Scott Conrade, from Water & Wetland, treating with PAC

As planned, and based on the survey, a treatment was conducted targeting phosphorus in the water column as well as suspended solids. The liquid Polyaluminum Chloride (PAC) was applied by Aquatic Biologist, Scott Conrade, using a calibrated backpack sprayer (Scott treating the Pond in Figure 27). Phosphorus is the limiting nutrient driving nuisance algae growth. One pound of phosphorus can grow up to five hundred pounds of algae. PAC binds with the phosphorus in the water column, making it unavailable to the algae that is trying to grow from it. PAC also binds to other particles in the water to help increase water clarity.

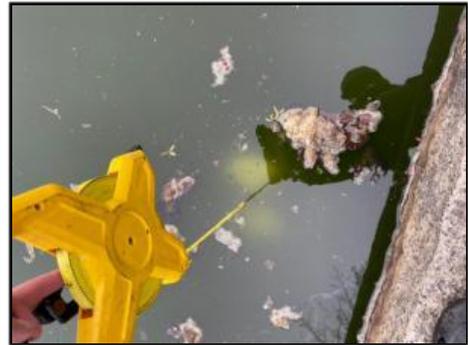
On April 17<sup>th</sup>, Aquatic Biologist, Scott Conrade, completed a site visit to Goldfish Pond. The visit consisted of performing a survey, collecting basic water quality data (see Figure 28), and conducting a treatment. Conditions during the visit were cloudy and slightly misting with temperatures around 45 degrees F.

Upon arrival, a survey was conducted using visual observation. An algae bloom was noted throughout the water column, as we are customary to seeing at Goldfish Pond. Foaming was noted on the surface due to subsurface aerators. This is typically from the protein matrix that algae produce as they grow. You will often see this in moving water, such as waterfalls and streams, as foam that accumulates in the area.

Figure 28: Secchi depth being measured at the Pond

Based on the survey, a liquid algaecide was applied to the Pond for the control of microscopic algae. The algaecide was applied utilizing a calibrated backpack sprayer from the shore. This application methodology allows for even coverage throughout the management areas. A liquid bacteria/enzyme product was also applied to the Pond at label rates. We applied this product to bind phosphorus and to hopefully help with the "foaming."

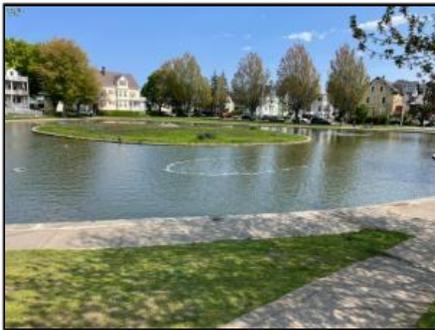
Figure 29: Overview of Goldfish Pond

On May 8<sup>th</sup>, Aquatic Biologist, Scott Conrade, completed a site visit to Goldfish Pond (overview of Goldfish Pond pictured in Figure 29). The visit consisted of performing a survey, collecting basic water quality data, applying beneficial bacteria, and conducting a treatment. Conditions during the visit were sunny and 72 degrees.

Upon arrival, a survey was conducted using visual observation paired with a standard throw-rake and handheld GPS/ArcGIS Field Maps, as applicable. No plants were noted at this time, however, a planktonic bloom occurring which is typical of Goldfish Pond (conditions documented in Figure 29). Conditions were noticeably

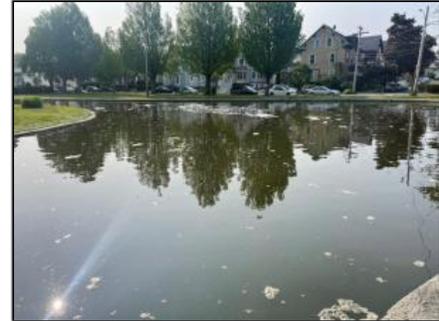
Upon arrival, a survey was conducted using visual observation. Goldfish Pond looked better than it had previously. This can be seen in Figure 30, as the watercolor is not as green as it has been in the past. The water clarity has increased since the last visit, up to 11in, and we hope to continue that trend through various treatments, bacteria applications, etc. The beneficial bacteria that was applied was to help with the phosphorus that was being released from the die-off of the algae bloom that was occurring. This product does not help with muck removal.

Figure 30: Microscopic algae bloom noted within the Pond

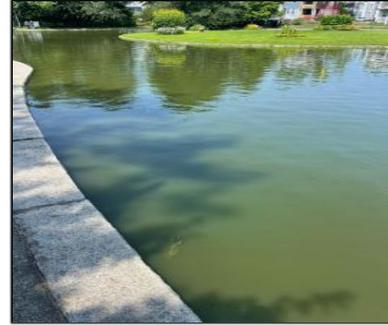
lack of sunlight that penetrates through the water column because of the algae that has been present. The pH of the pond was also measured during the survey. The pH was measured with a calibrated meter and was 7.7 which is neutral and within a standard range for freshwater. In addition to these in water conditions, it was noted that a large population of waterfowl were present at the Pond at the time of the survey.

Figure 33: Microscopic algae bloom occurring at Goldfish Pond.

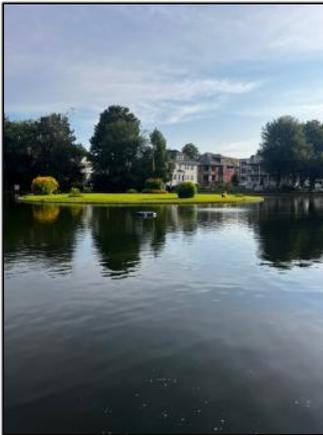
Figure 34: New fountains in place at Goldfish Pond Park

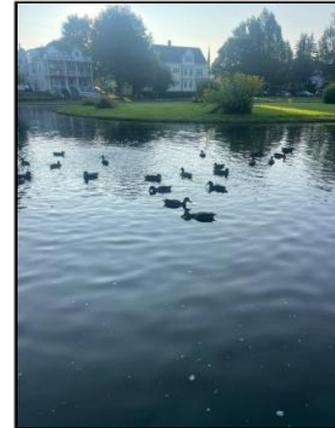
On August 24<sup>th</sup>, Aquatic Biologist, Scott Conrade, and Aquatic Field Assistant, Brian Sweeney, made a visit to Goldfish Pond. Upon arrival to the site, a survey was conducted using visual observation paired with a standard throw-rake and handheld GPS/ArcGIS Field Maps, as applicable. Only microscopic algae were present at the time of the survey. No invasive species were detected at this time. Monitoring will continue for these species, as there was a high population of waterfowl present at the time of this visit (noted in Figure 35).

*Figure 35: Numerous waterfowl on Goldfish Pond*

Another treatment was conducted for the control of microscopic algae. The liquid contact algaecide was applied utilizing a calibrated treatment backpack sprayer from shore. This bloom was likely due to the increased nutrients from the large flock of waterfowl that were present at the time of the visit (see Figure 35). Waterfowl can add a lot of nutrients to the ecosystem as they stay in the area. Beneficial bacteria packets were applied.

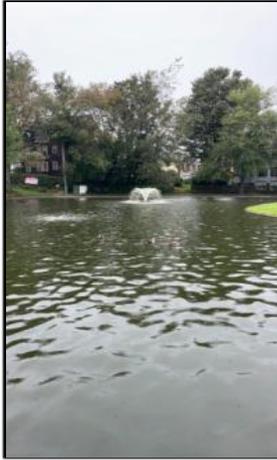
*Figure 36: New fountain and an aerator at Goldfish Ponds*
