# OLIVER LAKE WATERSHED DIAGNOSTIC STUDY

Arion Consultants

# OLIVER LAKE WATERSHED: DATA COLLECTION & MAPPING

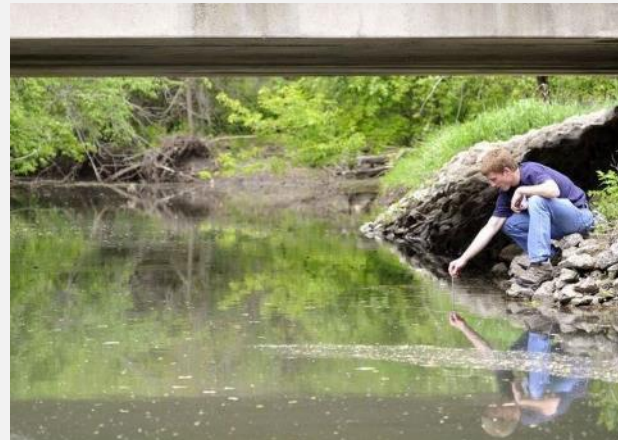
## TASK 2: TRIBUTARY AND LAKE DATA COLLECTION

- Storm Flow Stream Sampling (12 sites)
- Stream habitat and aquatic bug sampling (7 sites)
- In-lake monitoring (1 time – deepest point all three lakes)
- Watershed inventory – map concern areas and identify potential solutions

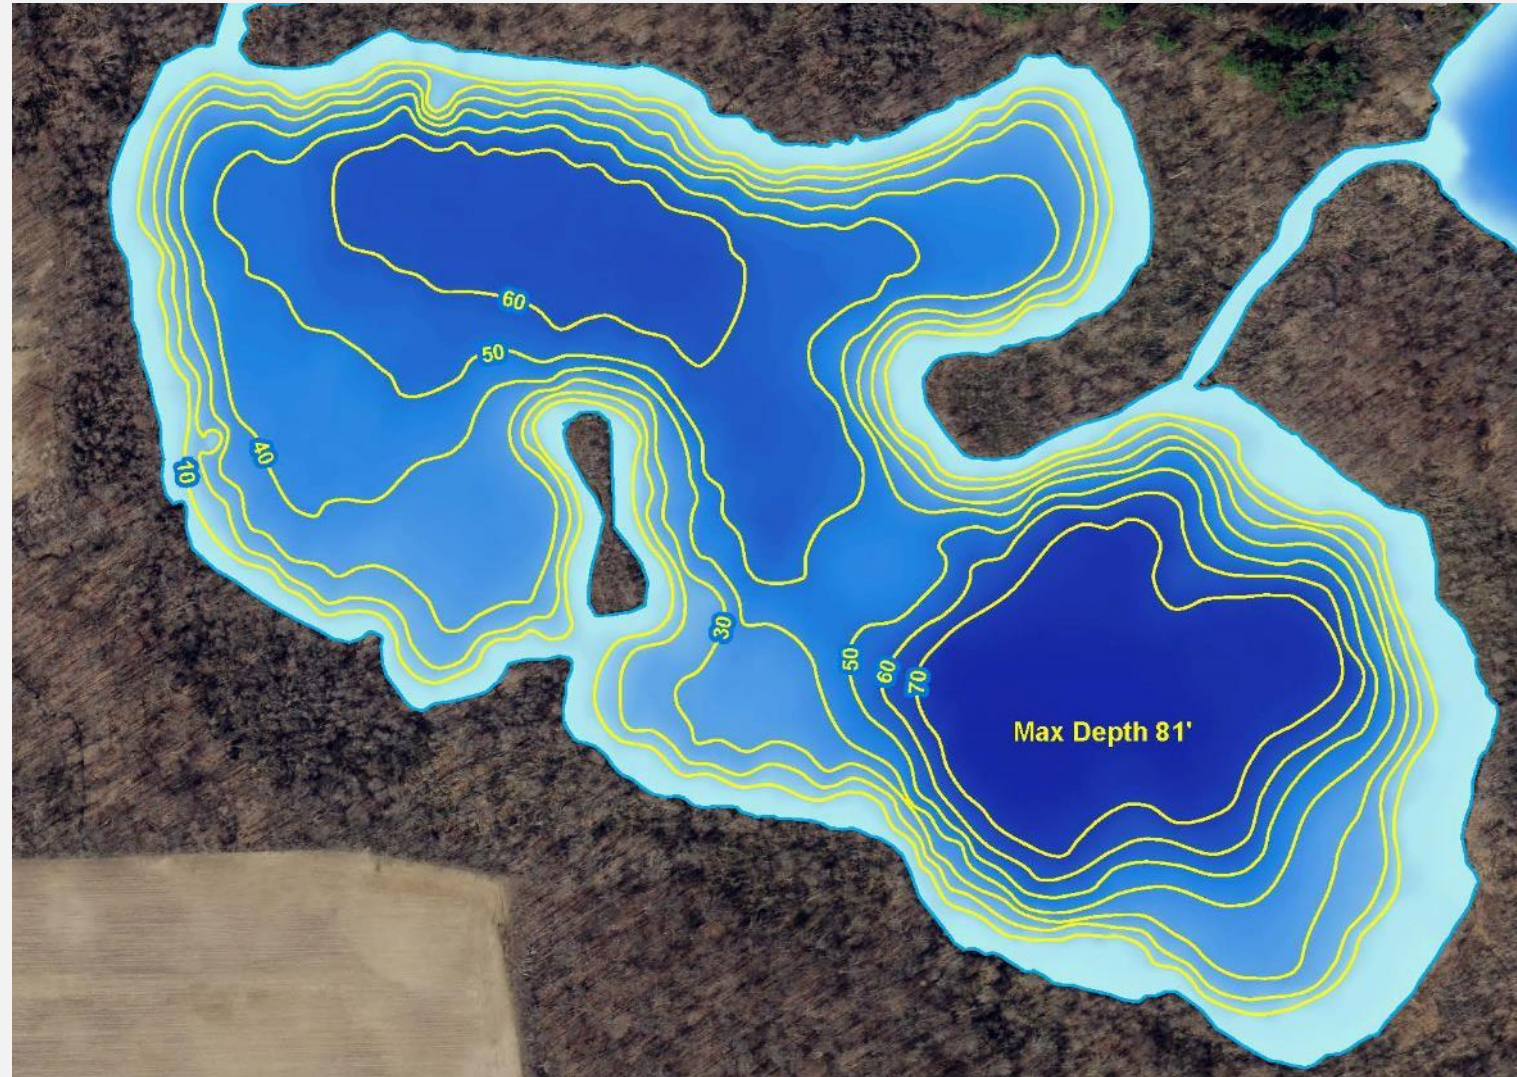
# OLIN LAKE

- 394 acres
- 81 feet max depth (2018); 82 feet (1956)
- 38 feet mean depth

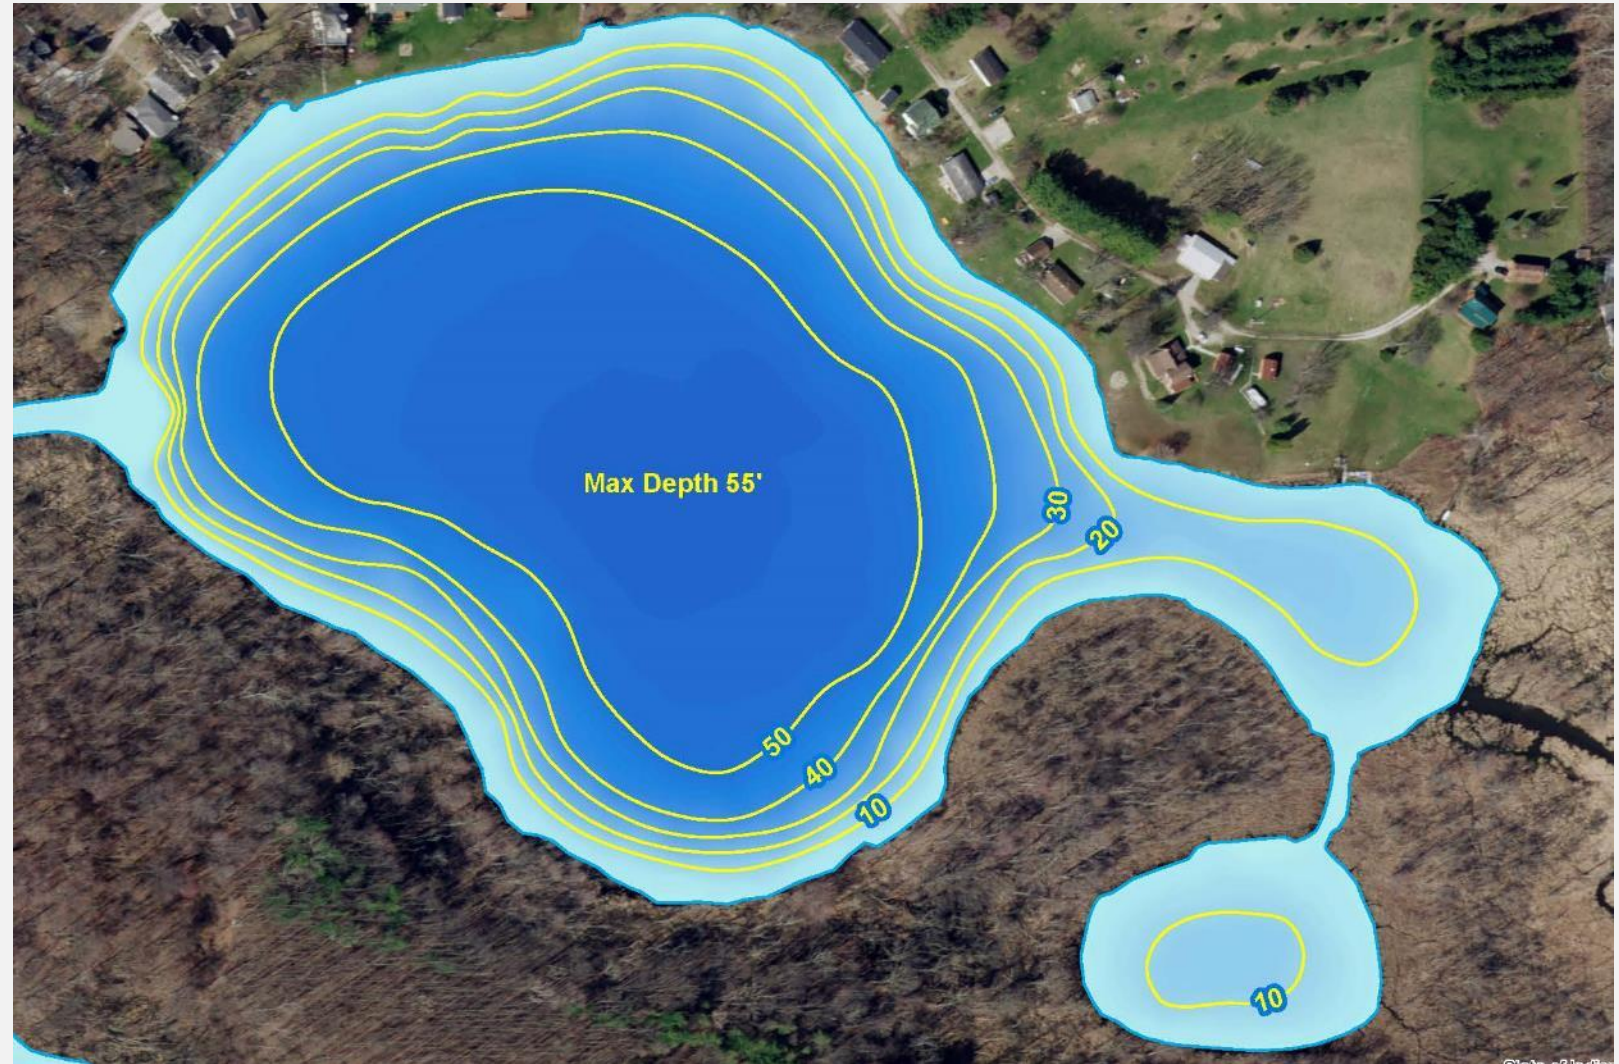
# MARTIN LAKE

- 26 acres
- 55 feet max depth (2018); 56 feet (1956)
- 34 feet mean depth

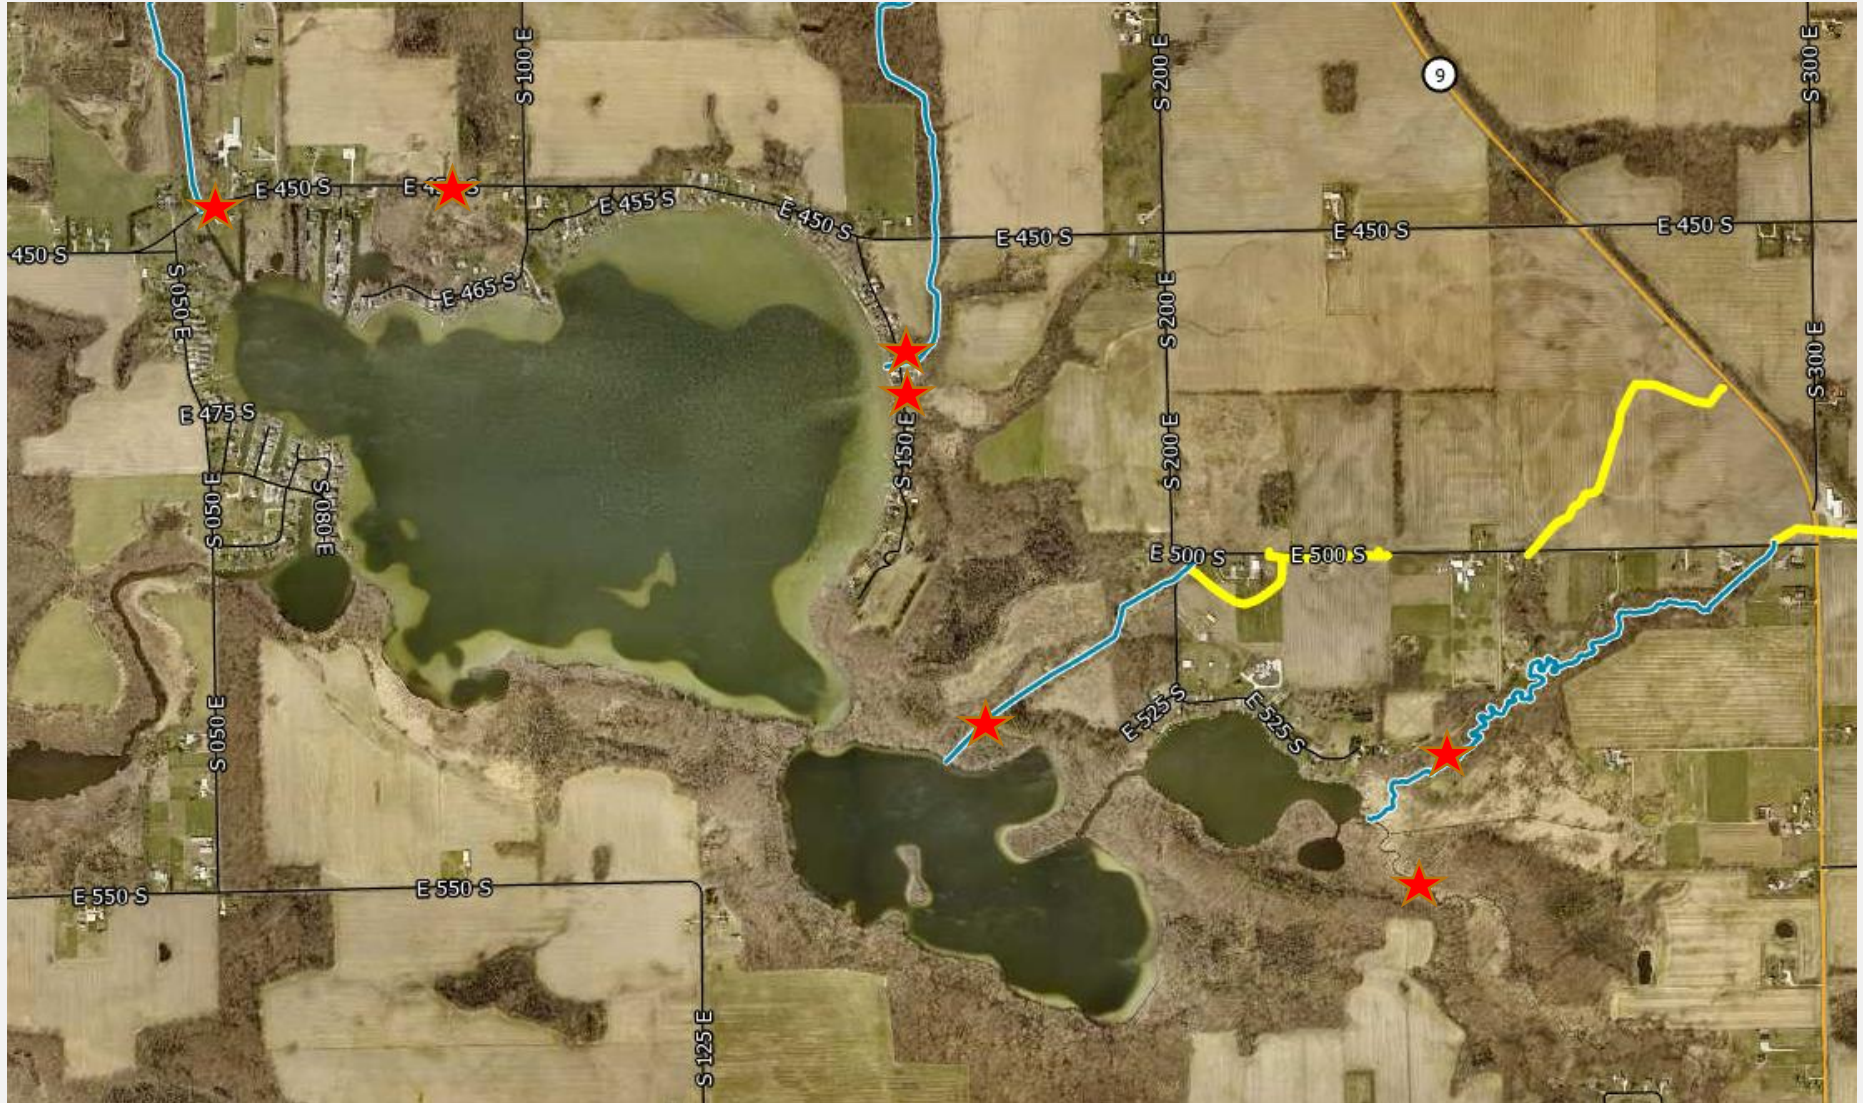
# OLIVER LAKE WATERSHED TRIBUTARIES

## Tributaries (Oliver):

- Dove Creek/Colwell Drain
- Unnamed (CR 450 S)
- Bert Hart Drain
- Winling Creek

## Tributaries (Olin):

- Stoner Drain

## Tributaries (Martin):

- Truman Flint Drain
- Broughton Drain

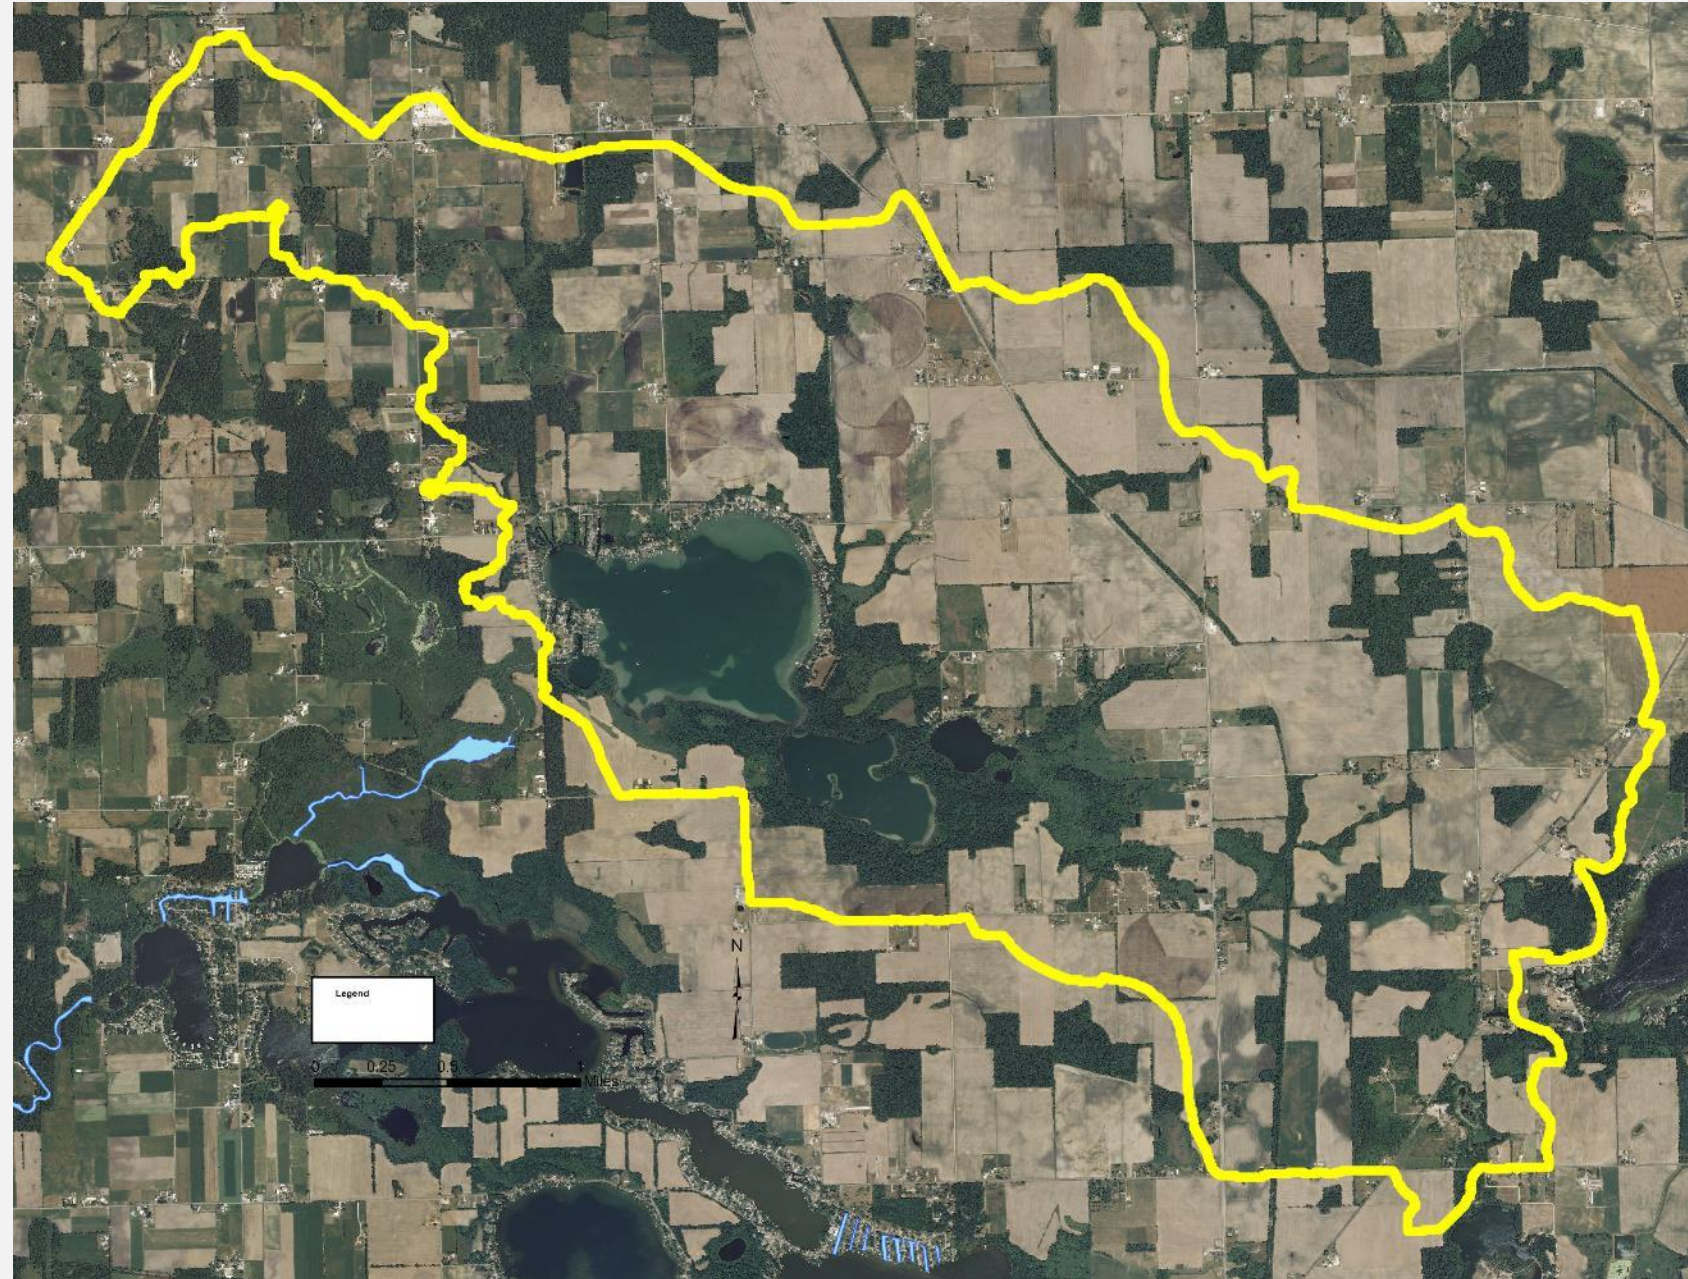
# OLIVER LAKE WATERSHED

- 7,268 acres
- Watershed area: Lake area =  
Oliver: 17.5:1  
Olin: 34:1  
Martin: 112:1

(For Oliver Lake ~18 acres of watershed for each acre of lake)

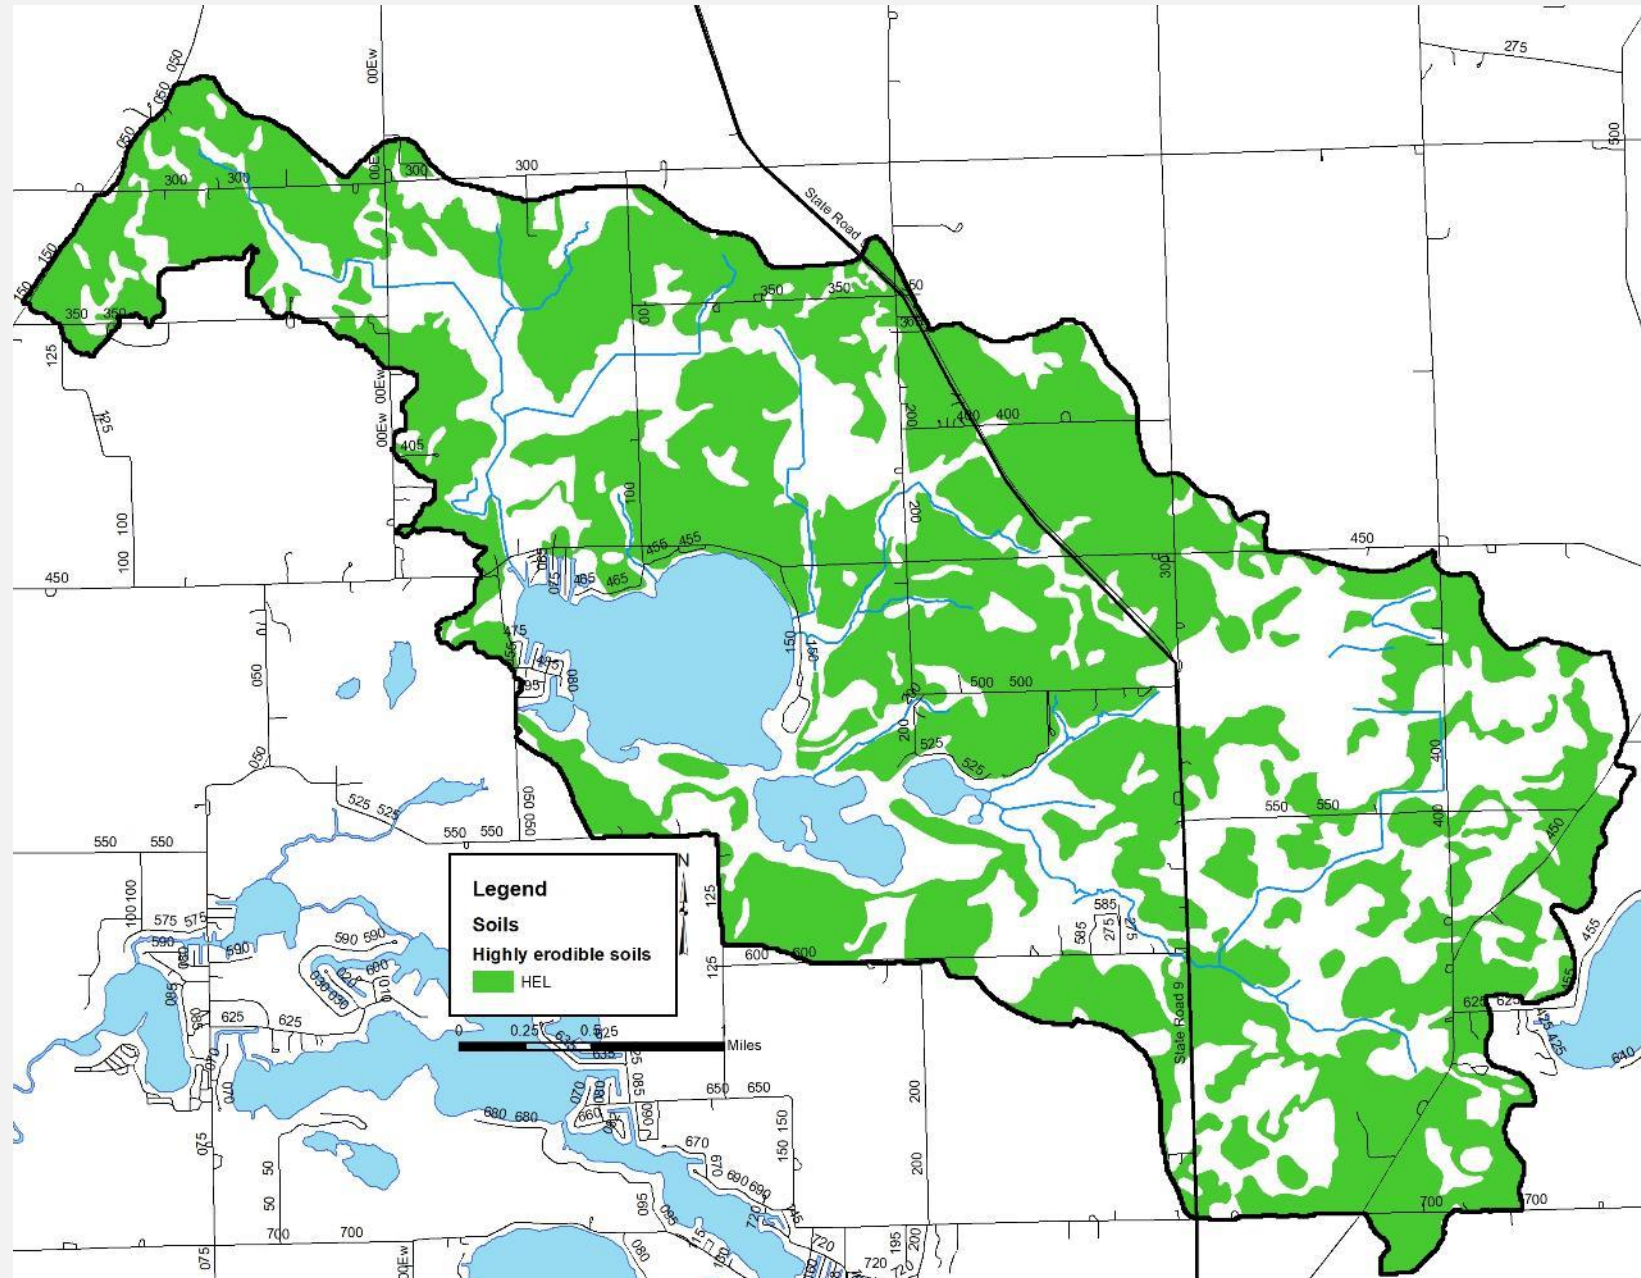
# SOIL ERODIBILITY

- 3,945 acres or 54% highly erodible

2008 diagnostic study:

- 15 acres highly erodible (0.2%)
- 519 acres potentially highly erodible (8%)
