# LEVEL 2 REPLACEMENT RESERVE REPORT FY 2024 BETHANY PROPER TOWNHOMES

# REPLACEMENT RESERVE REPORT

## BETHANY PROPER TOWNHOMES

April 28, 2023

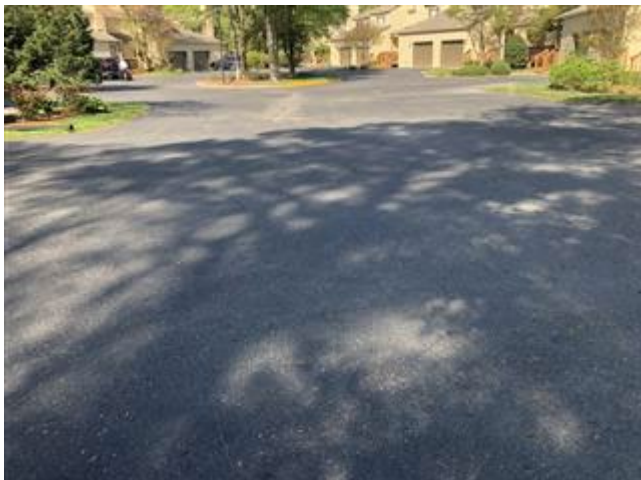
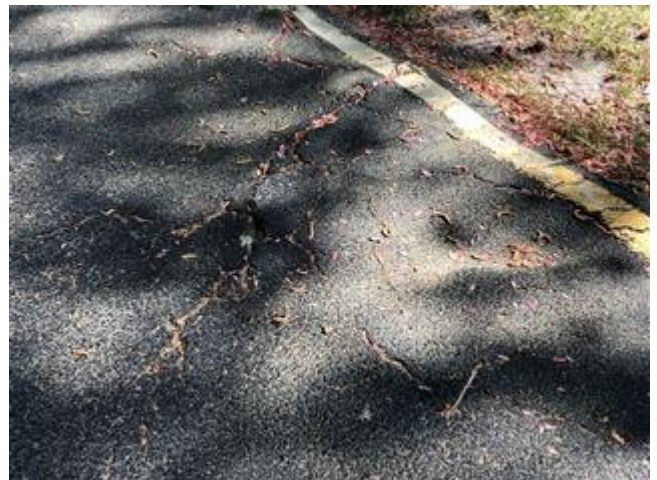
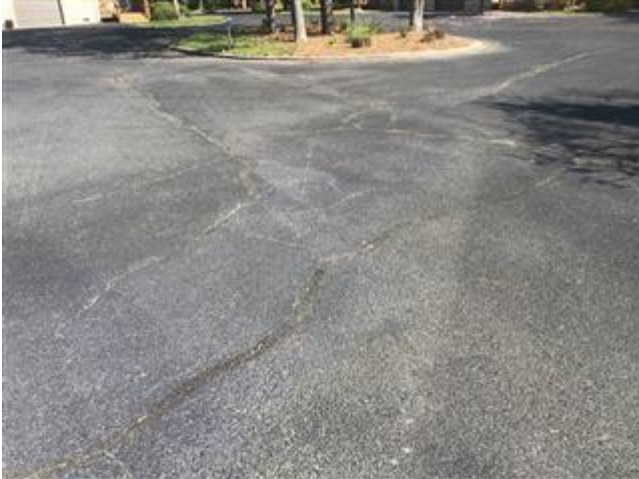
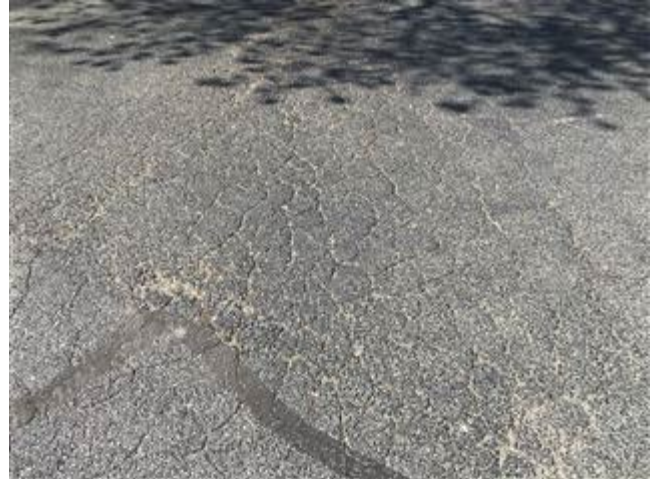
**Asphalt Pavement.** The Association is responsible for the courts and parking areas within the community. Other roadways are maintained by the City, County, or other municipality. In general, the Association's asphalt pavements appear to be in fair condition.

The Defects noted include the following:

- **Open Cracks.** There are multiple locations where open cracks allow water to penetrate the asphalt base and the bearing soils beneath. Over time, water will erode the base and accelerate the deterioration of the asphalt pavement. If cracks extend to the base and bearing materials, remove the damaged areas, and replace defective materials. As a part of normal maintenance, clean and fill all other cracks.

For seal coating, several different products are available. The older, more traditional seal coating product is paint. They coat the surface of the asphalt, and they are minimally effective. However, the newer coating materials, such as those from Total Asphalt Management, Asphalt Restoration Technologies, Inc., and others, are penetrating. They are engineered, so to speak, to 're-moisturize' the pavement. Asphalt pavement is intended to be flexible. Over time, the volatile chemicals in the pavement dry, the pavement becomes brittle, and degradation follows in the form of cracking and potholes. Re-moisturizing the pavement can return its flexibility and extend pavement life.

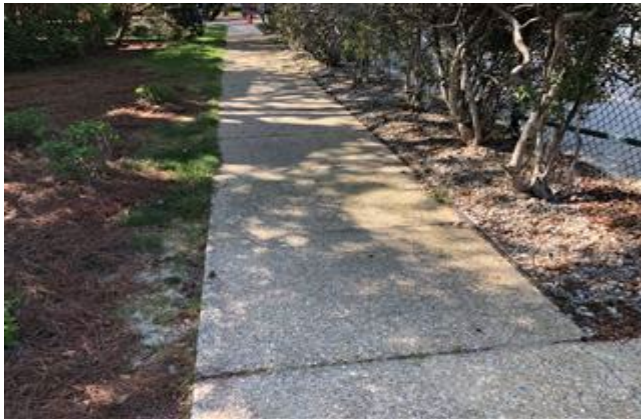
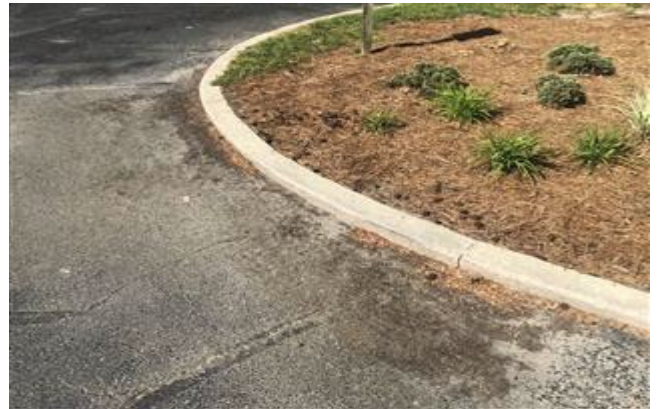
**Concrete Work.** The concrete work includes the community sidewalks, leadwalks, curbs, and gutter as well as other flatwork. The overall condition of the concrete work appears to be good.

The standards we use for recommending replacement are as follows:

- Trip hazard, ½ inch height difference.
- Severe cracking.
- Severe spalling and scale.

Because it is highly unlikely that all of the concrete components will fail and require replacement in the period of the study, we have programmed funds for the replacement of these inventories and spread the funds over an extended timeframe to reflect the incremental nature of this work.

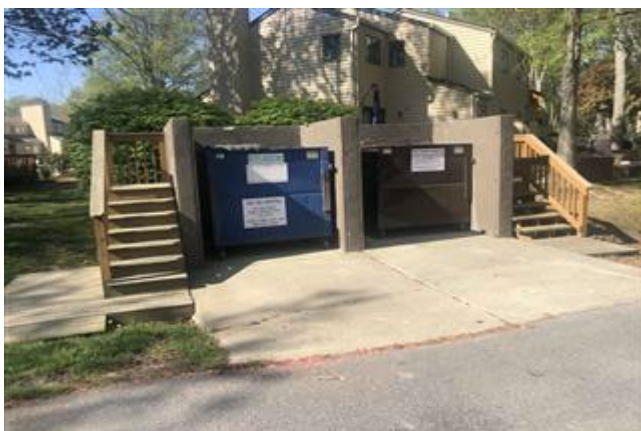
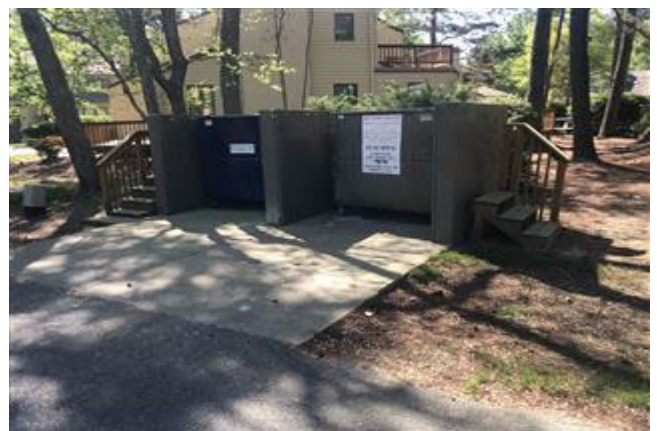
**Trash Corrals.** The community has 4 trash corrals at various locations. Trash corrals include a concrete pad and enclosures that are constructed from concrete block, which appears to be in good condition.

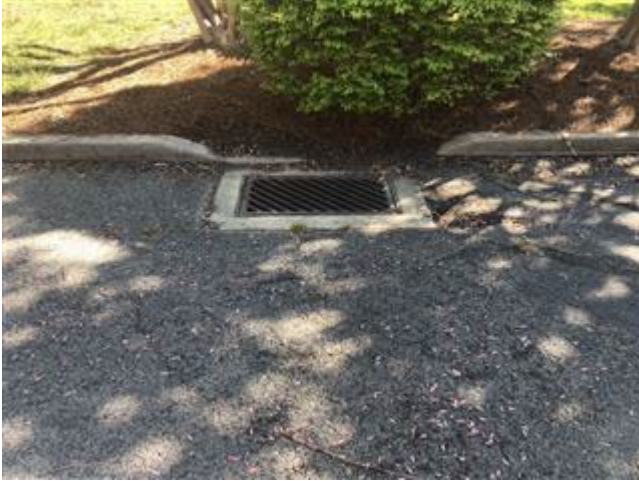
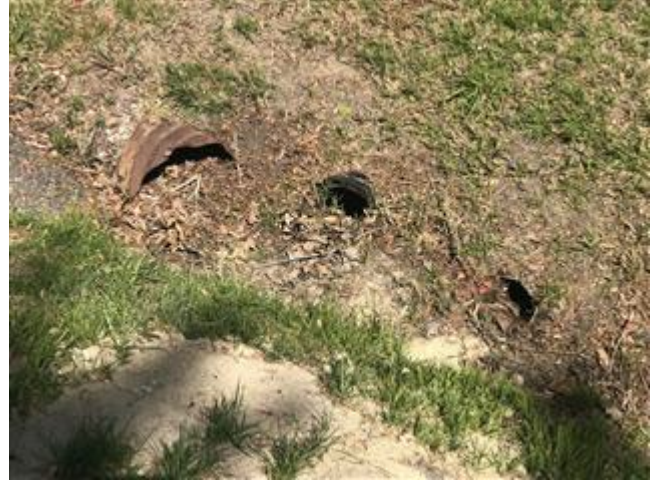
**Underground Utilities.** The Association is responsible for the underground utility line maintenance and replacement, including the stormwater management pipes.

Engineering drawings were not used in the determination of these underground components. Instead, we have provided an estimate of the approximate replacement costs based on our experience with other facilities of similar size and configuration. The inspection and evaluation of underground lines and structures are beyond the scope of work for this study.

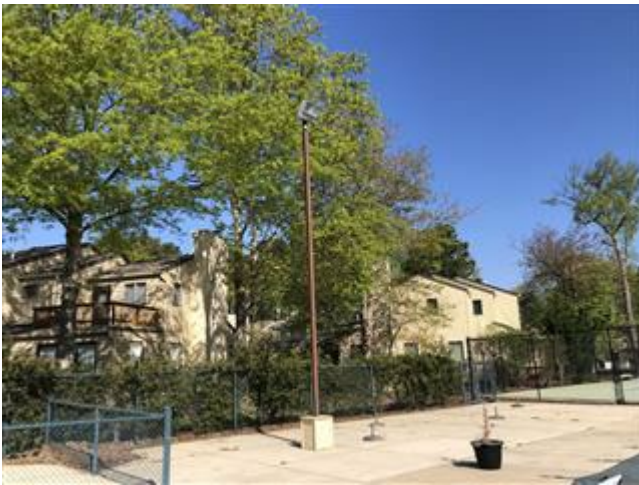
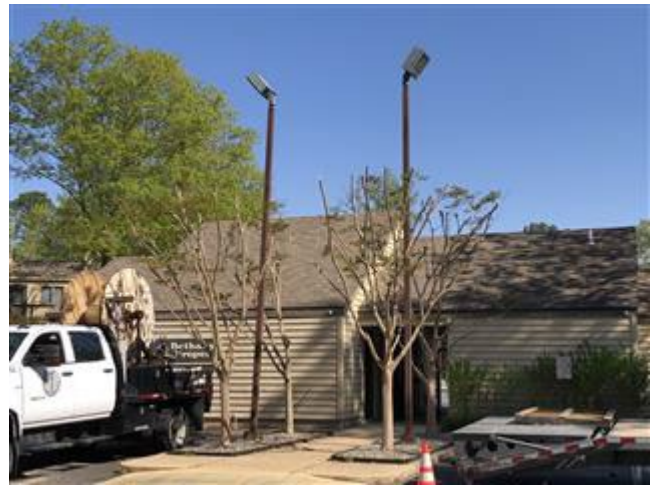
**Site Lighting.** The Association is responsible for the operation of the facility's lighting at the pool house. The lights were not on at the time of our site visit, but we understand they remain in good operating condition.

This study assumes the replacement of the light fixtures every 15 to 20 years, and pole replacement every 30 to 40 years. When the light poles are replaced, we assume that the underground wiring will also be replaced.

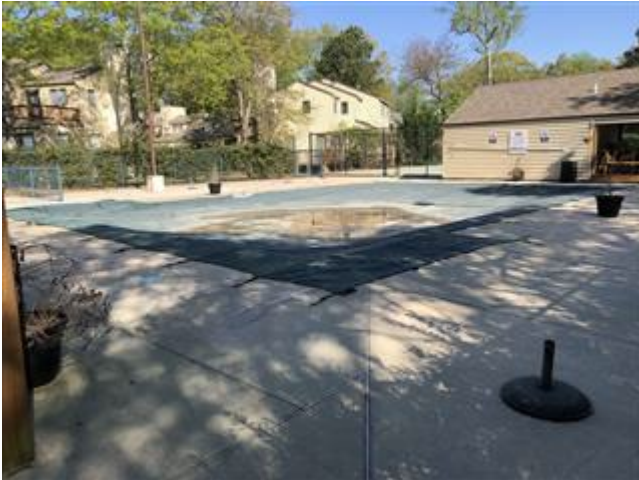
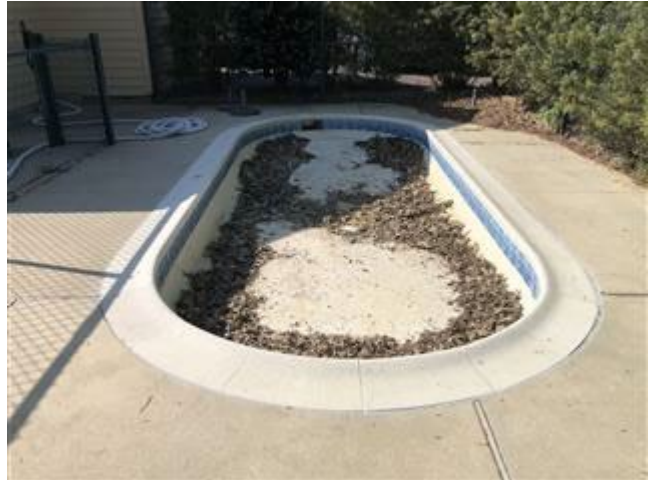
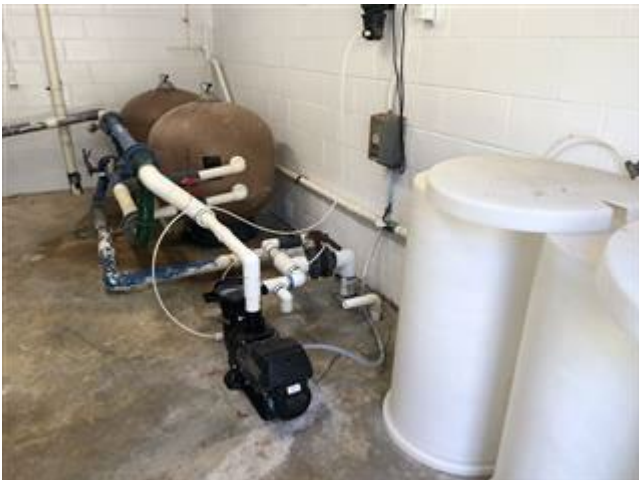
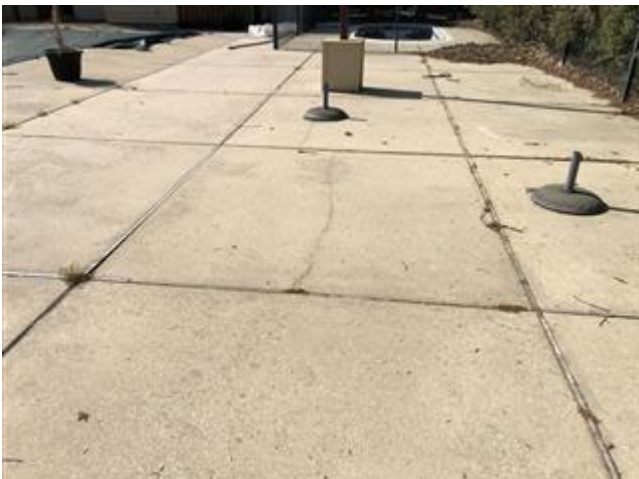
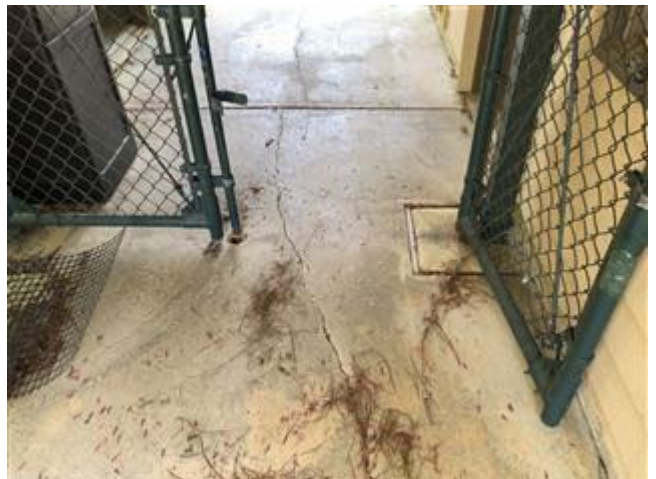
**Swimming Pool.** The community operates an outdoor pool and a wading pool of concrete construction. Listed below are the major components of the pool facilities:

The pool was winterized at the time of inspection and is reported to be in fair condition.

- **Pool Shell.** The shell for the swimming pool appears to be in good condition.
- **Pool Deck.** The pool has a concrete deck, and the overall condition of the deck appears to be in fair condition with areas of cracking.

- **Whitecoat.** The pool whitecoat appears to be in fair condition. We have assumed a service life of eight to ten years for the pool whitecoat.
- **Waterline Tile.** The waterline tile appears to be in good condition. We have assumed that the waterline tile will be replaced or restored when the pool is whitecoated.
- **Coping.** The pool is edged with masonry brick coping. The coping appears to be in good condition.
- **Pump and Filter System.** The filter system appears to be in good operating condition.
- **Pool Fence.** The swimming pool is enclosed by a chain link fence that appears to be in fair condition.

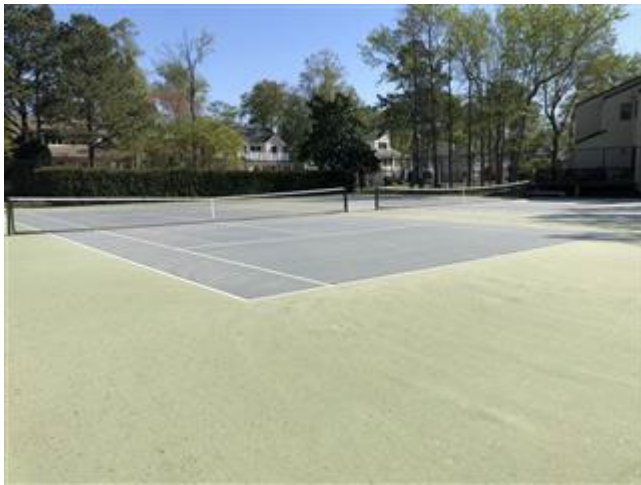
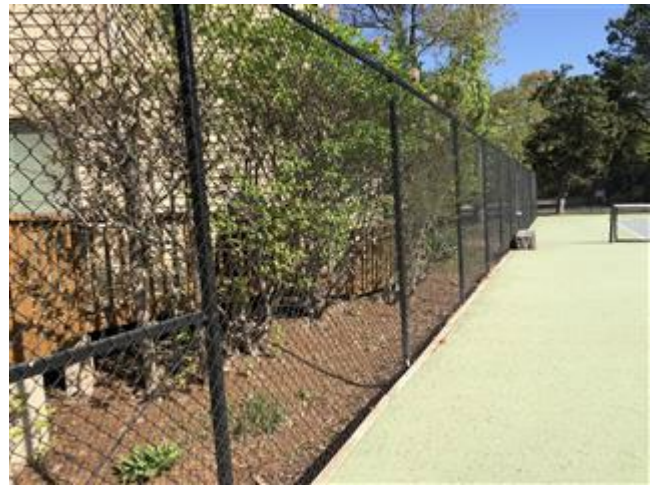
**Tennis Courts.** The community maintains multiple tennis courts. The overall condition of these courts appears to be good.

Listed below are the major components of the tennis court facilities:

- **Asphalt Pavement (base layer).** We have assumed a service life of 20 to 30 years for the asphalt base layer.
- **Color Coat (surface layer).** Annual cleaning is recommended to maintain the surface of the court. The base of a tennis court is subject to cracking and low spots known as "birdbaths" that can occur from weather and earth movement. A program to address cracks as they appear will help to prolong the useful life of the color coat. We have assumed a service life of five to ten years for the color coat.

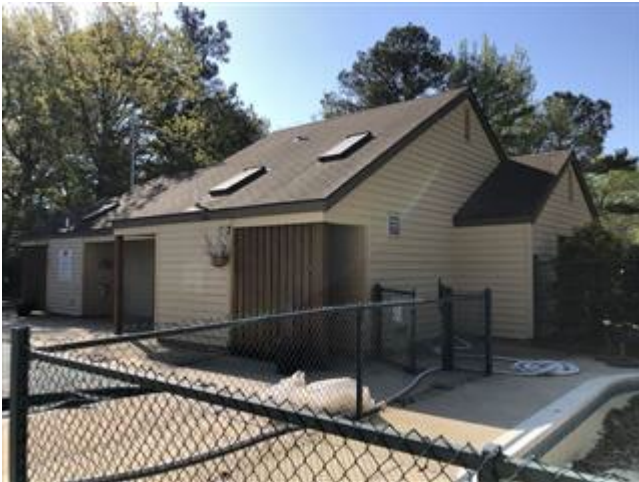
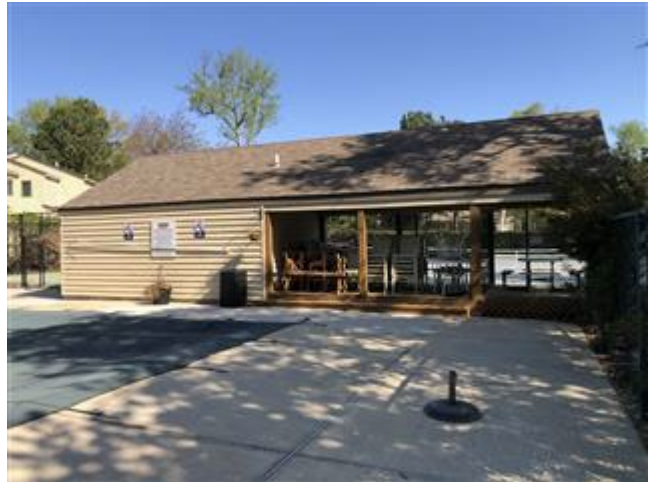
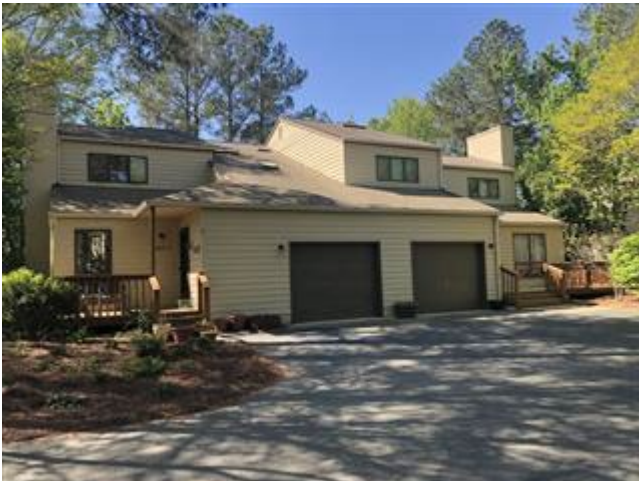
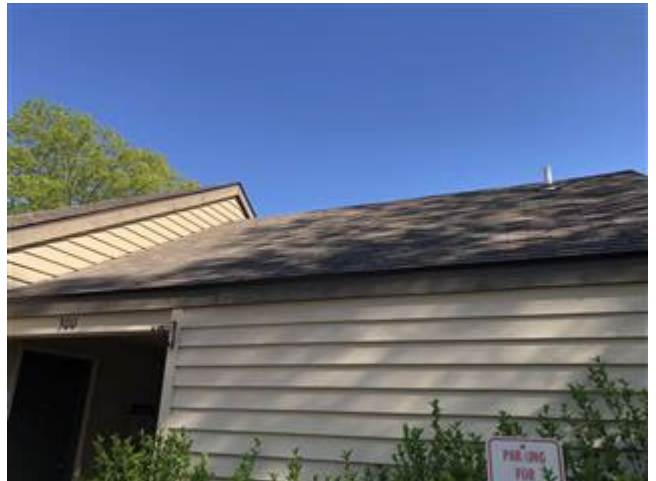
Asphalt shingle roofs can have a useful life of 20 to 50 years depending on the weight and quality of the shingle. Weathered, curled, and missing shingles are all indications that the shingles may be nearing the end of their useful life.

Annual inspections are recommended, with cleaning, repair, and mitigation of vegetation performed as needed. Access, inspection, and repair work should be performed by contractors and personnel with the appropriate access equipment who are experienced in the types of roofing used for the facility.
