## Featured Technical Topic Summary FGI Monthly Members Meeting Friday, June 6, 2025

### **TOPIC: Sediment Removal from Geomembrane Lined Containment Ponds**

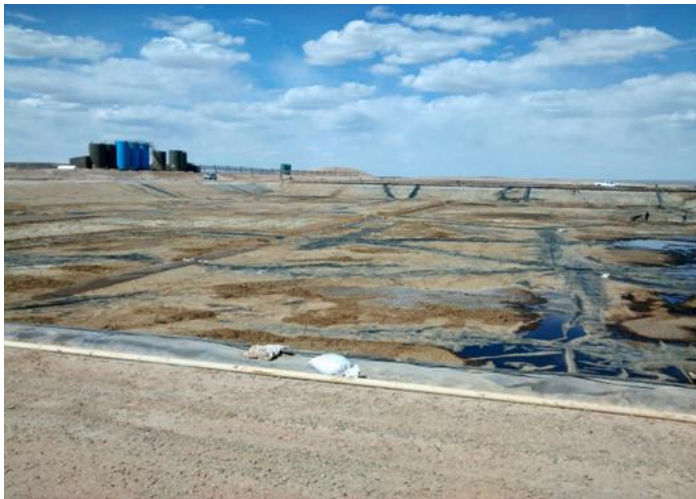
Wyoming - Sediment in pond bottom after removal of water for primary geomembrane repairs; pond operational for seven years before repairs.

- Neil Nowak of WSP started this discussion with a project in Wyoming that was containing a liquid with 13,000 to 66,000 ppm total dissolved solids (TDS). The containment pond has a 60 mil HDPE primary geomembrane, but it was leaking. The leakage was observed in the leak detection zone so a deep-water survey was conducted with the pond full of liquid. The survey identified several leaks. As a result, sediment (see left photo below) had to be removed to fix some leaks found by an electrical leak location survey (see right photo below). Plastic shovels and low-pressure power washing was used to remove the sediment. The sediment was wheelbarrowed to the top of the slope instead of using equipment. It was suggested to use a reinforced geomembrane to reduce wrinkles to make repairs easier. Wrinkles can also make leak location surveys difficult.

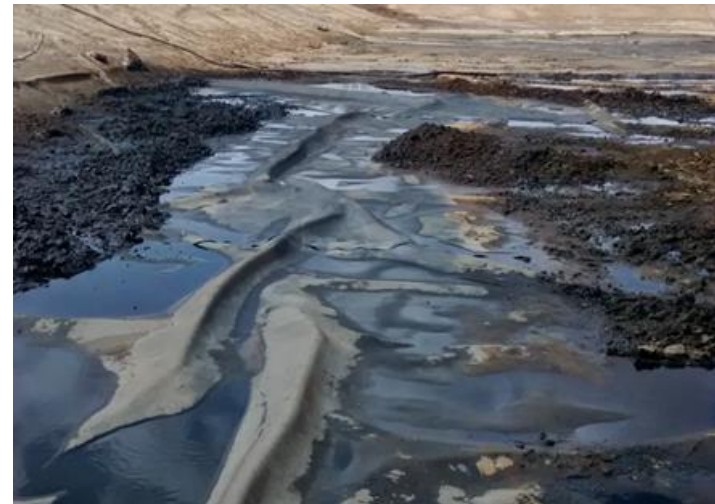
Sediments removed carefully by hand using plastic shovels and low-pressure power washer, then wheelbarrowing the sediments to the top of the pond.

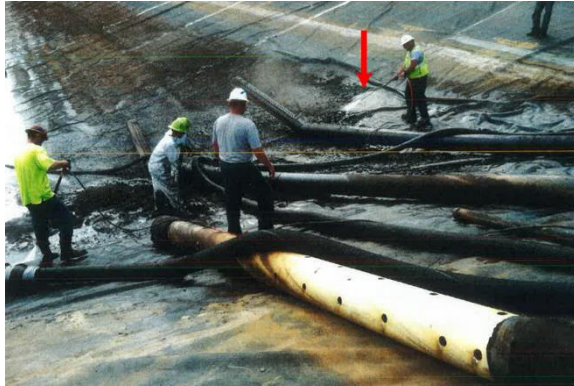
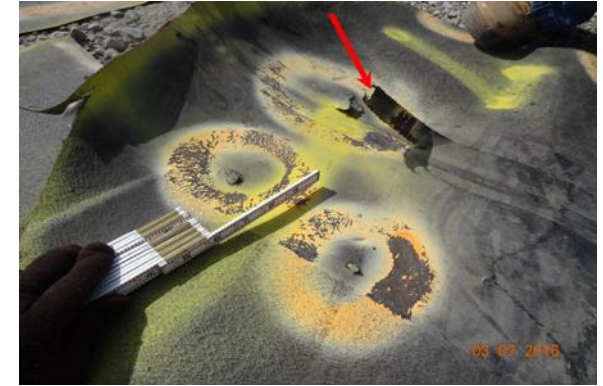
- Tim Stark shared some photos of geomembrane damage that can be caused by pressure washing (see red arrow in right photo below), metal shovels, and hoses being placed directly on the geomembrane. Pressure washing and shovels damaged seam flaps (see red arrow in left photo below). It is recommended that high-pressure power washing should not be used on the surface of a geomembrane, but a slow water flow can be used.

- No metal shovels and high pressure power washing to move sediment
- Use brooms or rubber squeegees to push sediment
- No equipment operating directly on the geomembrane

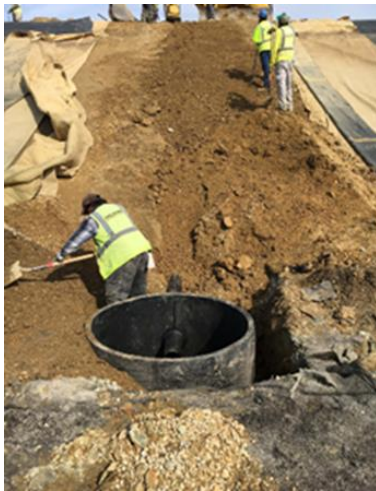
- Todd Harman of Hallaton described installation of a buried sump system so pressure washing, and equipment was not needed to remove sediment for a containment pond. The benefit of this system is sediment could be pushed with a broom into the sump so no equipment or pressure washing had to access the top of the geomembrane. Photo #1 below shows installation of a large diameter HDPE pipe to serve as the sump. Photo#2 shows a pipe drilled into the sump so the sediment can be vacuumed to the top of the slope with a vacuum truck. Photo #3 shows a trench for the vacuum pipe to be placed from the sump to the top of the slope. Photo #4 shows the sump backfilled with soil and ready for geomembrane to be placed and connected to the large diameter HDPE sump pipe.
