Aquatic Vegetation Monitoring and Management of the Invasive Weed Hydrilla

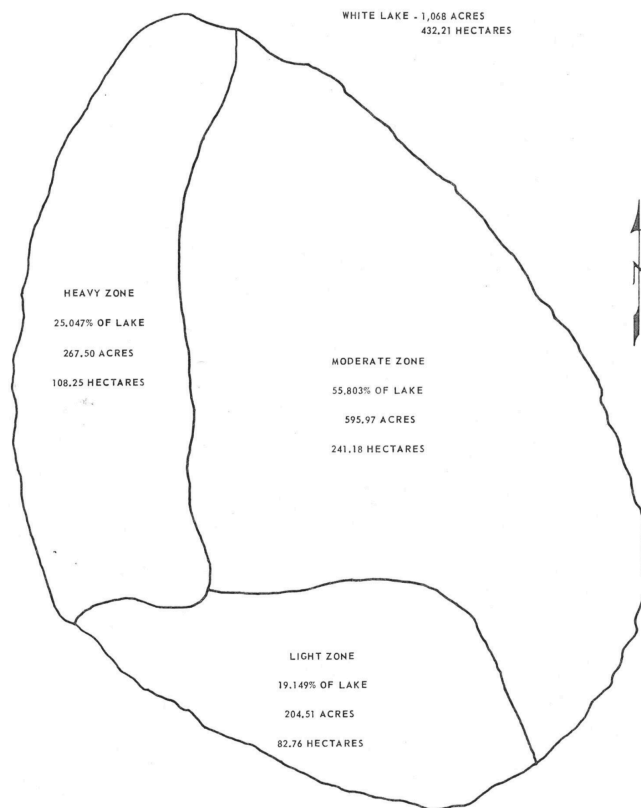
Figure 1. Relative abundance zones for aquatic vegetation in White Lake, from Nichols 1979 Wildlife Resources Commission Report on White Lake.

Survey work in 1978-79 indicated that densities of vegetation varied noticeably in different regions of the lake, with the primary species being the bladderwort Utricularia and the spikerush Eleocharis, both of which are low-growing (1 to 8 inches in height) (Nichols, 1979).

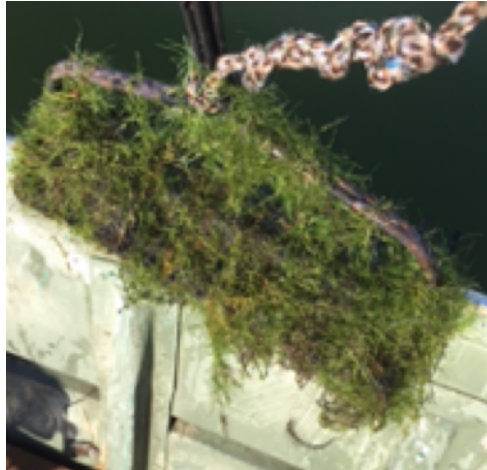
2017

A 2018 survey of White Lake found the biomass of aquatic vegetation was much lower than in 2017; this was best illustrated by comparison photos included with the survey report that year:

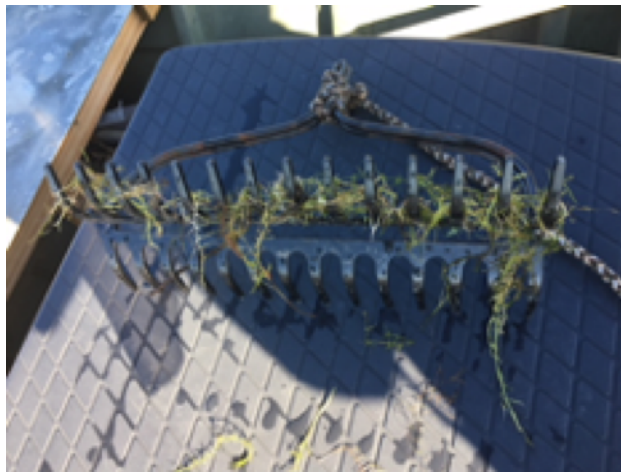
2018

Only one Hydrilla plant was found as part of the survey (a tuber with sprouted growth), although several plants were found growing adjacent to the marina boat ramp at the northern lakeshore (2018 NCSU Aquatic Vegetation Survey Report). The rare Myriophyllum tentellum was found in more locations than in previous surveys, generally in shallower areas, along with the spikerush Eleocharis baldwinii. Overall lake conditions changed as a result of a low-dose alum treatment in May of that year, which resulted in lower pH levels, lower water-column phosphorus levels, and elimination of filamentous cyanobacteria (which resulted in gradually improving water

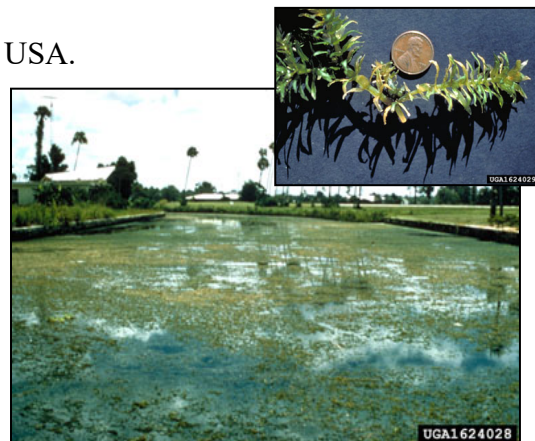
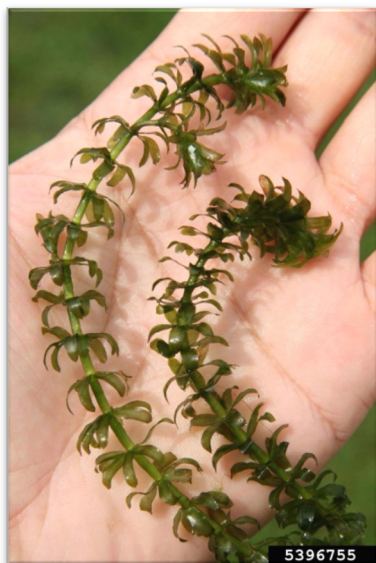
Scientific Name: *Hydrilla verticillata* (L.) F. Royle

Description: A submersed, rooted aquatic plant that can grow at depths of 20'. **Stems** slender branched, up to 25' long. **Leaves** strap-like and pointed, in bottle-brush whorls of 3-8, up to 0.8" long, 0.1" wide, with serrated margins. **Leaf midribs** reddish in color, undersides with small sharp teeth. **Flowers** tiny, white, with 6 petals, on long stalks. **Reproduction** occurs sexually through the production of seeds, and also vegetatively by fragmentation of the stem, or by sprouting of axillary turions (in the leaf axils) and subterranean tubers (attached to the roots).
