White Lake Management Plan Attachment C:

This background information on geology, hydrology, the watershed and water budget includes information that has been presented at public workshops held at White Lake Town Hall in 2019.

White Lake: One of the Bay Lakes

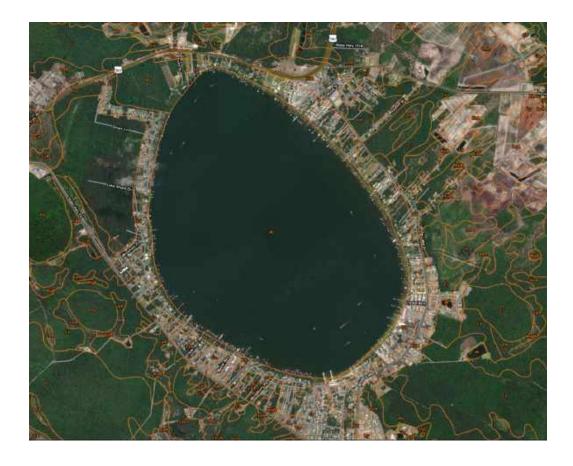
Figure 9. Soils map overlay for the region around White Lake, from the Bladen County 1983 Soil Survey, USDA Soil Conservation Service.

The minor soil series include the Lynn Haven-Pamlico-Leon series; these soils are found on the broad flats and within Carolina Bays and are poorly drained to very poorly drained. Permeability ranges from moderate to rapid, while available water capacity is low. The seasonal high-water table is at or near the surface for long periods from winter to early spring (or in the case of the sandy and organic Pamlico soils, for most of the year). A second minor soil series is the Roanoke-Wahee; Roanoke soils tend to be poorly drained with a seasonal (winter to spring) high water table depth of 0 to 1 foot, while the Wahee soils are somewhat poorly drained with a seasonal water table depth of 0.5 to 1.5 feet (USDA NRCS 1985). The updated soils map (Fig.9) shows a finer scale in comparison to Fig. 3)

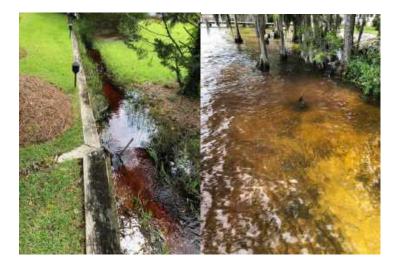
Figure 13. Left photo shows the NC DOT drainage ditch at 580 White Lake Drive after a rainfall event; right photo taken at the lakeshore at the same location, on the same date (June 27, 2018). Total rainfall for the month of June 2018 was 10 inches (Table 2).

Surface water inflow to the lake after rainfall events has been noticeable as it is tea-colored water from wetland areas around the lakeshore (noted also in Frey 1949). Much of the present-day runoff (which has a pH of 3.9-5.5) occurs on the eastern side of the lake and has been directed to the lake via two drainage ditches with culverts under White Lake Drive that drain approximately 50 acres on the east side of the road (Fig. 13).

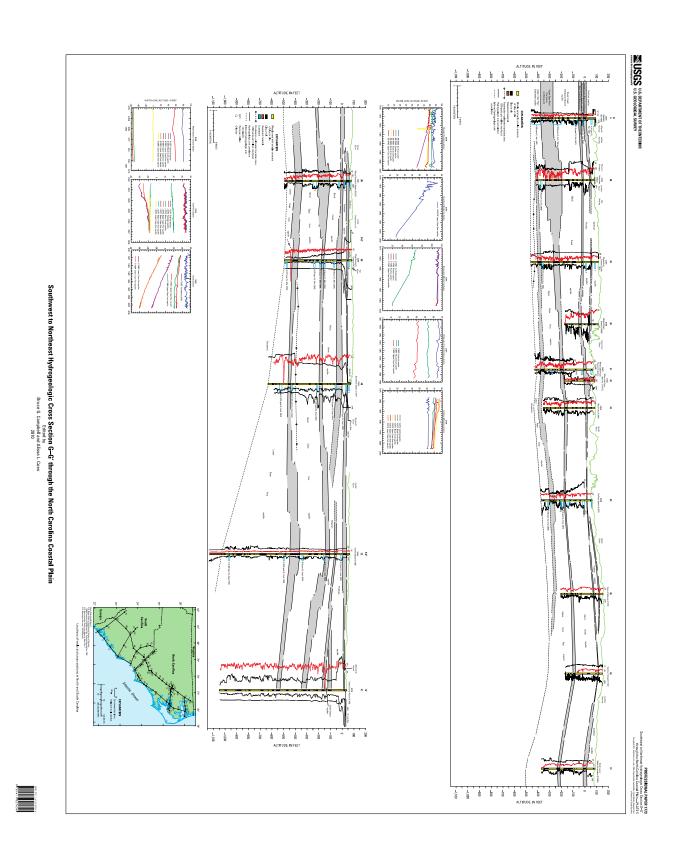
Plate 5, G-G' from: Campbell, B.G., and A.L. Coes (eds.). 2010. Groundwater availability in the Atlantic Coastal Plain of North and South Carolina. U.S. Geological Survey Professional Paper 1773 241 p., 7 pls. (the report's plates are on a cd, included with the hard copy).
