White Lake Background Information

White Lake: One of the Bay Lakes

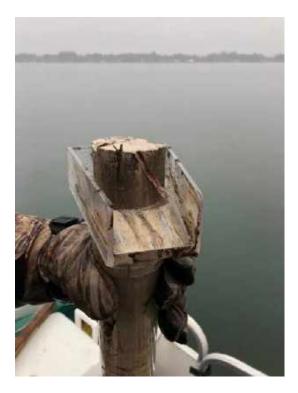
Figure 1. Clay layer found at around 15 cm depth in a sediment core taken at White Lake, February 12, 2019.

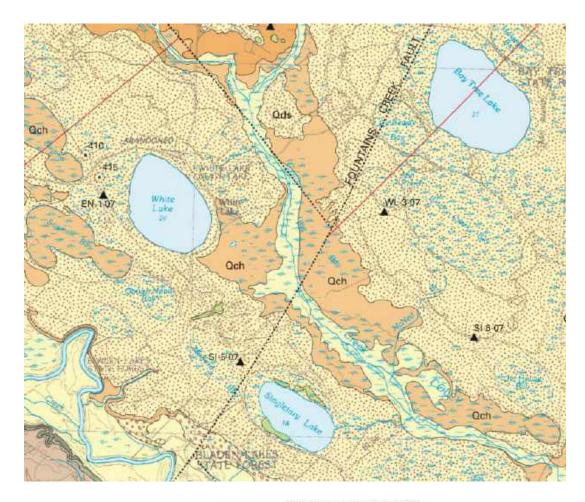
Figure 2. Close-up of a section of the surficial geologic map of the Elizabethtown 30' x 60' quadrangle, North Carolina. Pinehurst Formation (Qds) surrounds White Lake, with Chuckatuck Formation (Qch) also in the area. Weems and Lewis (2011), US Geological Survey Report 2011-1121.

In describing the geological features of the area around Elizabethtown, Weems et al. (2011) noted that the Carolina Bays are associated with "windblown sand deposits on which are grown abundant crops of blueberries". The deposits around White Lake are associated with the late Pleistocene (Pinehurst Formation, age mostly 80 to 10 ka; Markewitch and Markewich 1994) with deposits from the middle Pleistocene nearby (Chuckatuck Formation, age about 450 to400 ka; Weems and Lemon 1993). With respect to the formation of the Bays, Weems et al. (2011) describe the process from a geological perspective: "Where sand sheets are widespread, the winds that formed them also created many of the most obvious landforms—the Carolina bays. Where bays sit directly on older terrace surfaces that have thick, clay-rich weathering profiles, the underlying clayey soils block downward water percolation and thus allow the bays to become swamps or natural lakes." Figure 1 shows a clay layer in White Lake bottom sediments and Figure 2 shows a close-up of a portion of a surficial geological map of the region.

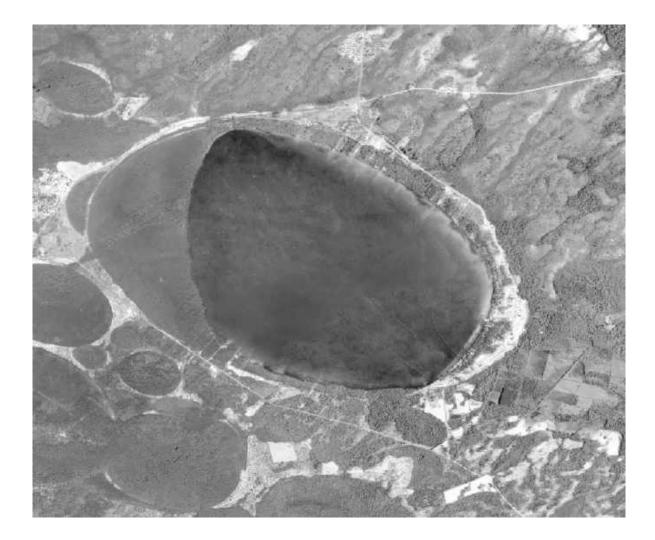
Figure 3. White Lake in 1938, a digitized assembly of multiple original aerial photographs taken by the US Department of Agriculture (Friends of Mountain to Sea Trail provided the digital update). The 1938 USDA originals were used in the morphometric studies by Frey (1949).

Also notable in this photograph are the natural features around the lake, particularly the wetlands that are part of the original bay in the northwest, and smaller bays in the southwest. The lake outlet, Turtle Cove, appears as a relatively wide area that is distinguished by vegetation differences (Fig. 3).

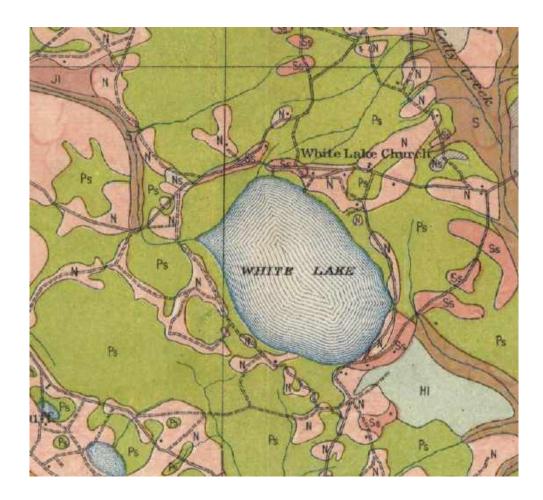
Figure 4. Detail from original 1914 "Soil map, North Carolina, Bladen County sheet" in the North Carolina State Archives, accessed from <u>https://web.lib.unc.edu/nc-maps</u>.

One of the oldest maps of the White Lake area is a 1914 Bladen County Soils map, which indicates the Turtle Cove outlet beginning as a relatively wide region along the western shoreline (Fig. 4). There is no defined inlet to the lake.

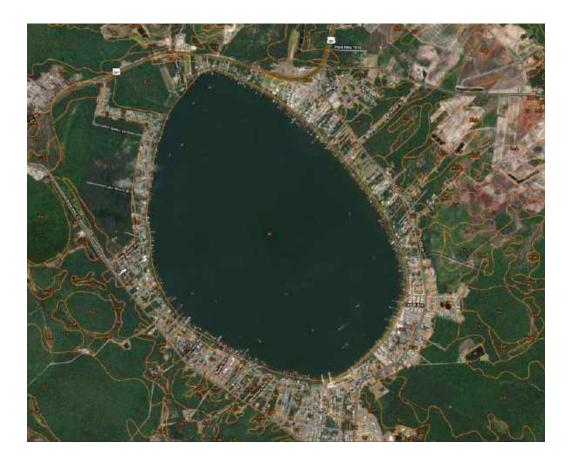
Figure 5. Soils map overlay for the region around White Lake, from the Bladen County 1983 Soil Survey, USDA Soil Conservation Service.

The minor soil series include the Lynn Haven-Pamlico-Leon series; these soils are found on the broad flats and within Carolina Bays and are poorly drained to very poorly drained. Permeability ranges from moderate to rapid, while available water capacity is low. The seasonal high-water table is at or near the surface for long periods from winter to early spring (or in the case of the sandy and organic Pamlico soils, for most of the year). A second minor soil series is the Roanoke-Wahee; Roanoke soils tend to be poorly drained with a seasonal (winter to spring) high water table depth of 0 to 1 foot, while the Wahee soils are somewhat poorly drained with a seasonal water table depth of 0.5 to 1.5 feet (USDA NRCS 1985). The updated soils map (Fig.5) shows a finer scale in comparison to Figure 4.

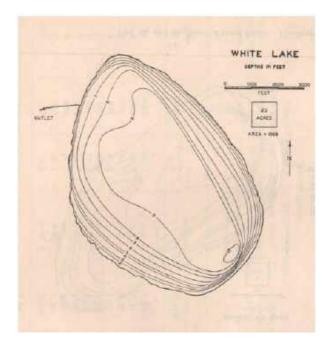
Figure 6. Bathymetric map of White Lake by Frey (1949); depth contours are marked in feet. The maximum length of the lake was measured as 1.81 miles. The outlet on the west side is Turtle Cove, in its original location. Scan of original reprint.

Frey noted that White Lake had "the most nearly regular basin of any of the lakes examined" with broader terraces on the eastern and western shorelines gradually sloping towards the deeper region of the lake (Fig. 6; Frey 1949).

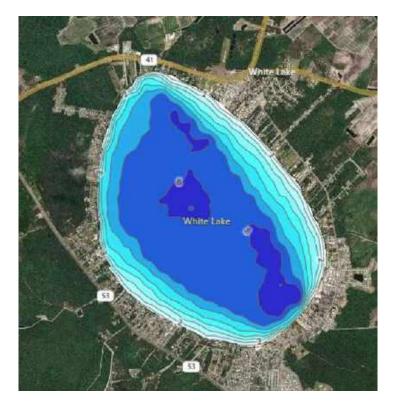
Figure 7. A bathymetric map of White Lake created from BioBase software, using depth measurements obtained with a Lowrance sonar receiver. The depth contours reflect conditions in 2019, when lake levels were approximately 1 foot lower than in 2017.

A more recent bathymetric map was created from 202 survey points (used in vegetation surveys of the lake), based on a 5.75 -acre grid pattern (NCSU 2017). It reflects conditions during summer low lake levels (Fig. 7).

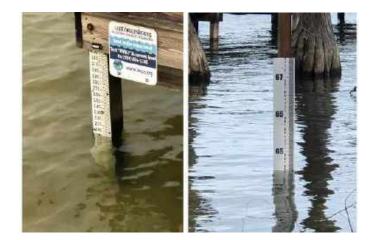
Figure 8. (Left) Lake level gauge installed by the Lake Observations by Citizen Scientists and Satellites program at the University of North Carolina-Chapel Hill, located at Goldston's Motel Pier (1608 White Lake Drive), and (right) lake elevation gauge installed by Walker Surveying Company at Turtle Cove. Elevations are given in the NAVD 88 Vertical Datum. Photos taken January 16, 2020.

An easily visible lake level gauge was installed in late 2018 on the Goldston's Motel Pier (eastern side of the lake, not far from Town Hall, by UNC-Chapel Hill personnel with the Lake Observations by Citizen Scientists program (www.locss.org), so it was possible to collect regular lake level measurements from this gauge in 2019. A second gauge, which reads lake elevations, was installed at Turtle Cove in January 2020 (Fig. 8). A comparison table was developed so that lake elevations can be determined from both gauges (Table 3).

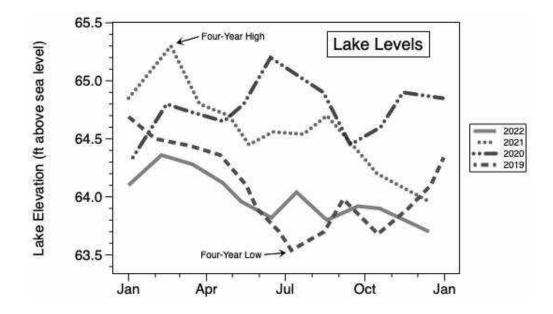
Figure 9. Lake elevation comparisons for the four-years 2019-2022, reported as feet above sea level using the NAVD 88 datum (which is one foot lower than the older NGVD 29 datum), for White Lake from 2019 through 2022.

The mean high-water level for the four-year period 2019-2022 is 64.85 feet above sea level NAVD 88 datum (Table 5). In September 2018, lake levels spiked after Hurricane Florence (although no elevation measurements were taken), while 2020 and 2021 levels exceeded 65 feet for brief periods (Fig 9).

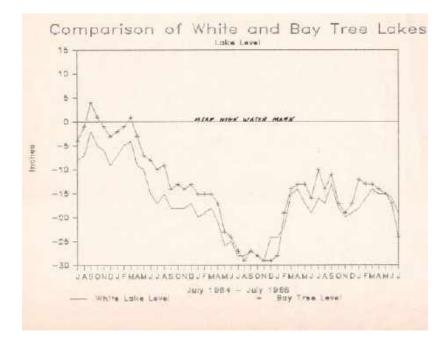
Figure 10. Lake level changes in White Lake and Bay Tree Lake from July 1984 to July 1988 (data recorded by State Parks personnel).

Lake level variation (high to low) in 1965 was 14.5", in 1966 was 10", and in 1967 was 10", while Frey [1949] noted a variation of 14" over the time he was working at the lake. A comparison graph of lake levels in White Lake and nearby Bay Tree Lake from 1984 to 1988 showed similar trends in each lake, although lake elevations (and therefore a mean high-water level) are different in each lake. Over the period in which levels were recorded, the total variation high to low in White Lake was about 25 inches, with highest lake levels in 1984 and low lake levels in much of 1986 (Fig. 10).

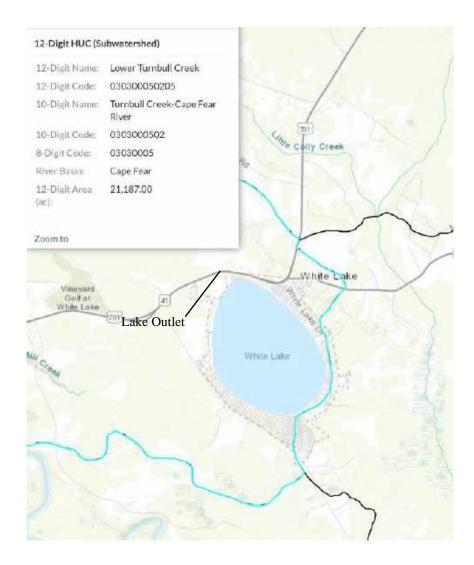
White Lake is in the Lower Turnbull Creek sub-watershed, the eastern boundary of which is delineated by the blue line to the right of the lake in the map below (and the Middle Colly Creek sub-watershed is to the east of the blue line). This sub-watershed includes 21,187 acres and is part of the Cape Fear River Basin. The White Lake outlet, Turtle Cove, located on the western lake shore, drains into Turnbull Creek, which flows west towards the Cape Fear River (Fig. 12).

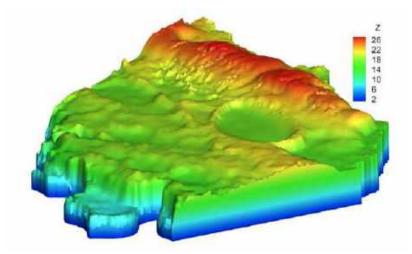
Watershed boundaries are determined by topography; topographic mapping can also be done with LIDAR (Light Detection and Ranging) using a near-infrared laser as well as position and orientation data from GIS to map land surfaces. A 3-D terrain model developed from 2013 LIDAR data shows the ridges (in red) that define the sub-watersheds (Fig. 13) (Shank and Zamora 2019).

Surface water flow in the Lower Turnbull sub-basin moves in a westerly direction from the higher ridge on the east, towards the Cape Fear River (the river channel is indicated in light blue in Fig. 13).

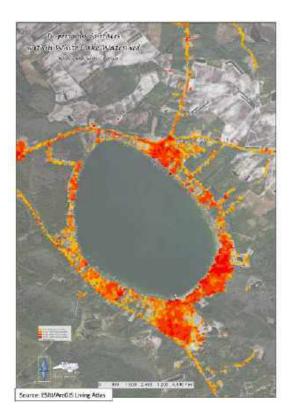
Figure 14. Impervious surfaces within the White Lake watershed in 2022, from the Lumber River Council of Governments.

Land uses within the sub-basin include urban (Town of White Lake; the amount of impervious surface is indicated in Fig. 14) and agricultural (primarily blueberry farming, with numerous confined animal feed operations in the region).

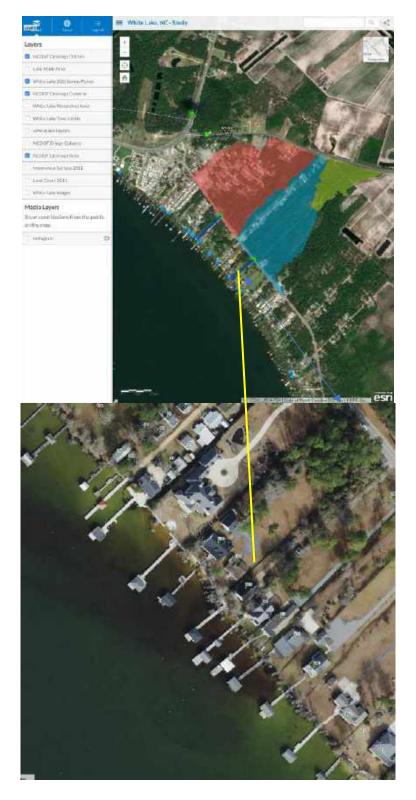
Figure 14. Top screen shot shows drainage area and location of two NC DOT drainage ditches on the eastern side of the lake (Lumber River Council of Governments 2019); bottom screenshot shows lower ditch at 580 White Lake Drive and the small plume of brown water along the lakeshore (<u>https://gis.bladenco.org</u>).

Surface water inflow to the lake after rainfall events has been noticeable as it is tea-colored water from wetland areas around the lakeshore (noted also in Frey 1949). Much of the present-day runoff (which has a pH of 3.9-4.5) occurs on the eastern side of the lake and has been directed to the lake via two NC Department of Transportation drainage ditches with culverts under White Lake Drive that drain approximately 50 acres on the east side of the road (Fig. 14).

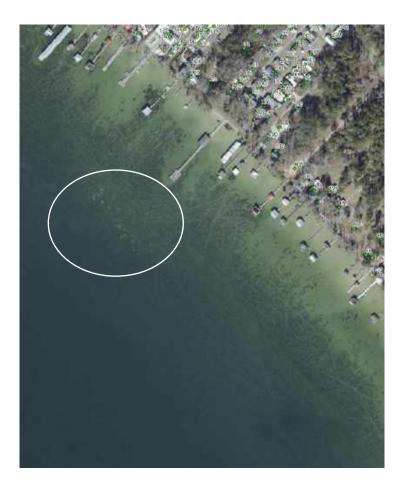
Figure 15. Screenshot of 2013 aerial photo of White Lake (<u>https://gis.bladenco.org</u>), showing the springs, which cluster around the 7-foot contour on the eastern shoreline. Rainfall in June and July of 2013 was very high.

White Lake has often been referred to as a spring-fed lake, as its clear waters have provided a view of lake bottom features, including areas along the sandy eastern shoreline which have suggested groundwater input. Some of these features have been consistent in shape and size over time (Fig. 15), while others have varied from year to year.

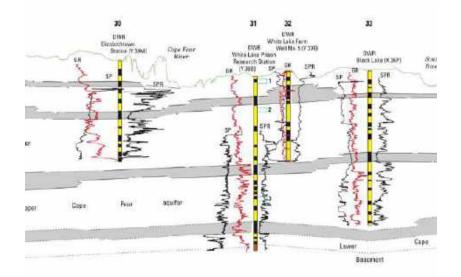
Figure 16. Close-up of a hydrogeological map of the area around White Lake, taken from Plate 5, Section G-G' in Campbell and Coes (2010). A pdf of this map is included in Appendix 1.

A relatively thin layer of clay, often referred to as hardpan lies below the land surface in places, at depths ranging from 5-20 feet (Campbell and Coes 2010). This is illustrated in the US Geological Survey hydrogeological map (Fig. 16), where clay layers are black bands, and sand layers are in yellow in wells near White Lake (31 and 32 in Fig. 16) (Campbell and Coes 2010).

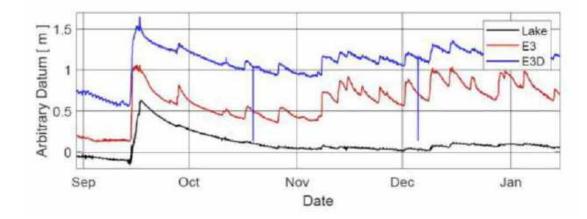
Figure 17. Groundwater levels at eastern shore well sites from August 2018 to January 2019; E3D indicates levels in a deeper well (below clay hardpan) while E3 indicates groundwater levels in a well situated above the clay layer. The black line indicates the lake level. Data from Shank and Zamora (2019).

The relationship between groundwater levels and rainfall was documented in 2018-9 by Dr. Chris Shank and Dr. Peter Zamora as part of a groundwater study of White Lake. Their team placed nested piezometers around the lakeshore, including sites on the eastern and western sides of the lake. A relatively thin layer of clay, often referred to as hardpan lies below the land surface in places, at depths ranging from 5-20 feet (Campbell and Coes 2010). A groundwater well situated below this clay layer on the eastern side of the lake (E3D; Fig. 16) showed an increase in level which mirrored the rise in a shallower well situated above the clay layer at this location (E3; Fig. 17). After the heavy rainfall from Hurricane Florence in September 2018 groundwater levels responded quickly, as did the lake level, which increased >25 inches (Fig. 17 [Shank and Zamora 2019]).

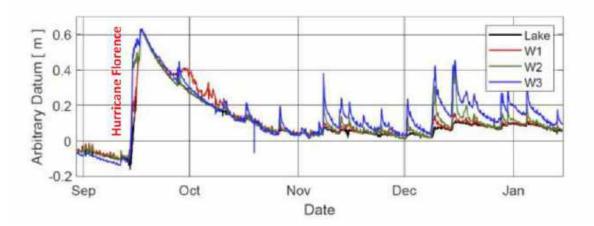
Figure 18. Groundwater levels at western shore well sites from August 2018 to January 2019; W1 is the shallow well closest to the lake and W3 is a shallow well furthest from the lakeshore, while W2 is a shallow well midway between W1 and W3 (each of these wells were situated above the clay layer). The black line indicates the lake level. Data from Shank and Zamora (2019).

The water table is generally closer to the surface on the western side of the lake, because of differences in topography and soil type, although there have likely been some hydrological changes over time due to development and associated clearing and filling activities. The change in water depths in shallow wells on the western shore also related to rainfall, but the increases were moderate by comparison to the eastern shore (Fig. 18, from Shank and Zamora 2019; W1 is the closest to the lake and most closely mirrors lake level).

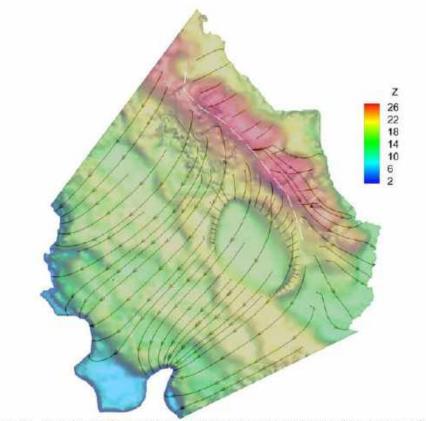
Figure 20. Plan view of 3-D numerical simulation showing groundwater flow lines. Dashed white line marks the flow divide: groundwater on the left side generally flows towards the Cape Fear River and groundwater on the right side generally flows towards Colly Creek. All flow lines begin at the terrain surface.

Figure 19. Simulation of groundwater flow lines, from Shank and Zamora (2019).

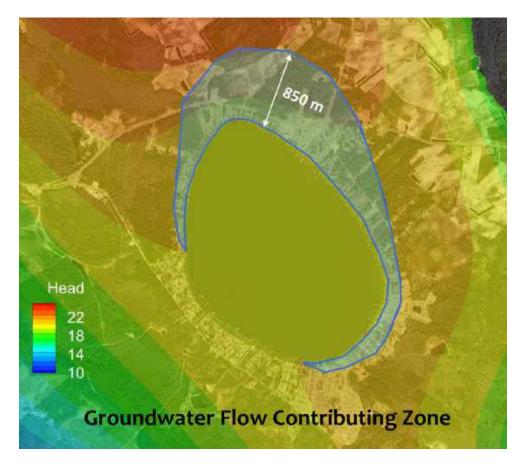
Figure 20. White Lake's groundwater contributing zone, from the Power Point presentation to the Town of White Lake, February 2019 by Chris Shank and Peter Zamora.

The higher the water table level is above the lake level, the greater the hydraulic gradient the driving force to move groundwater into the lake. Water table elevations rise because of rainfall (and fall when there is a lack of it). Shank and Zamora (2019) found groundwater flow generally moved in the same direction as surface water flow (Fig. 19) and their model delineated the lake's groundwatershed as an area smaller than the surface area of the lake (Fig. 20).

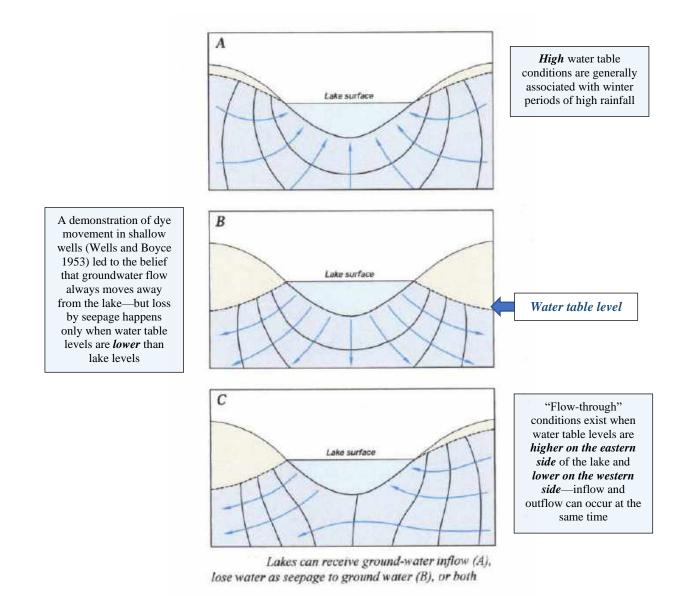
Figure 21. Reproduced from: Winter, T.C., W.H. Judson, O.L. Franke, and W.M. Alley. 1998. Ground water and surface water: a single resource. U.S. Geological Survey Circular 1139 <u>https://doi.org/10.3133/cir1139</u> Annotations in adjoining text boxes not in the original figure.

Groundwater flow interactions with White Lake are variable, depending on the dynamics between lake levels and water table levels. Shank and Zamora observed three types of conditions at different times during their 2018-19 study: flow-through, recharge, and discharge; these flow types have been described by various researchers, including Winter, Judson, Franke, and Alley in a 1998 publication (A-recharge, B-discharge, C-flow-through) at different times during their 2018-2019 study.

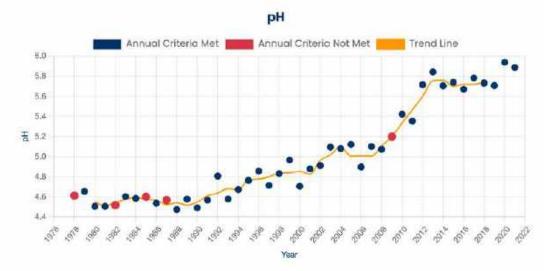
Figure 15. Annual rainfall pH at the National Atmospheric Deposition Program monitoring station NC35, Clinton, NC (<u>http://nadp.slh.wisc.edu/NTN/maps.aspx</u>).

The National Atmospheric Deposition Program (NADP) developed a National Trends Network (NTN) for measurements of wet deposition with the nearest monitoring station to White Lake being found in Clinton, NC. A graph of pH over time (Fig. 15) shows that rainfall was quite acidic (meeting the definition of acid rain, at around 4.5 standard units) before the year 1990, which corresponds to the lake pH during that period (pH levels of 4.6-4.8 measured in 1974 [Weiss and Kuenzler, 1976]). There was a relatively rapid increase over the period 2008-2013, with values since 2013 hovering around 5.8 SU. During the 2013 NC DEQ monitoring of White Lake, the lowest pH measured was 5.6 SU, a 1-unit increase from what was seen in 2008 (NC DEQ 2014) (Fig. 16).

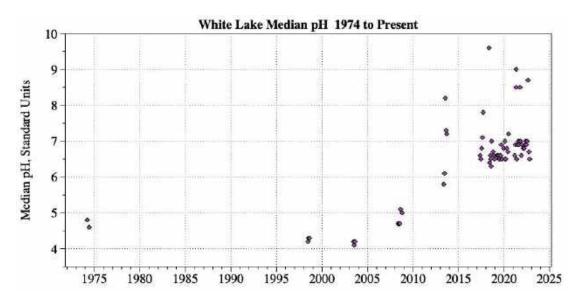
Figure 15. Median pH levels at White Lake. 1974 data from Weiss and Kuenzler (1976), 1998-2017 data from NCDEQ monitoring, 2018 to 2022 data from LIMNOSCIENCES monitoring.

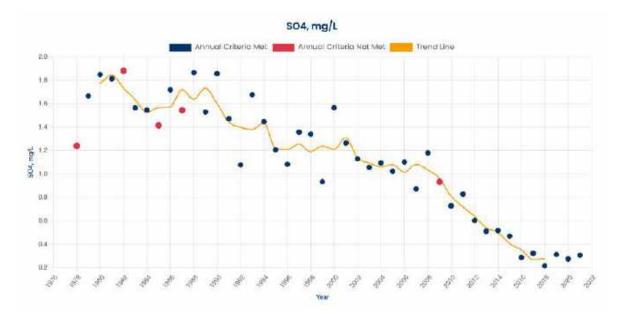
Figure 16. Annual SO4 concentration (measured as mg/L) at NC35, from the National Atmospheric Deposition Program monitoring station at Clinton, NC. <u>https://nadp.slh.wisc.edu/sites/ntn-NC35/</u>

The reduction in sulfate deposition shows the inverse trend of pH, as this is an acidic substance and the primary contributor to acid rain; reductions measured at Clinton have been greater than 80% since 1990 (Fig. 16).

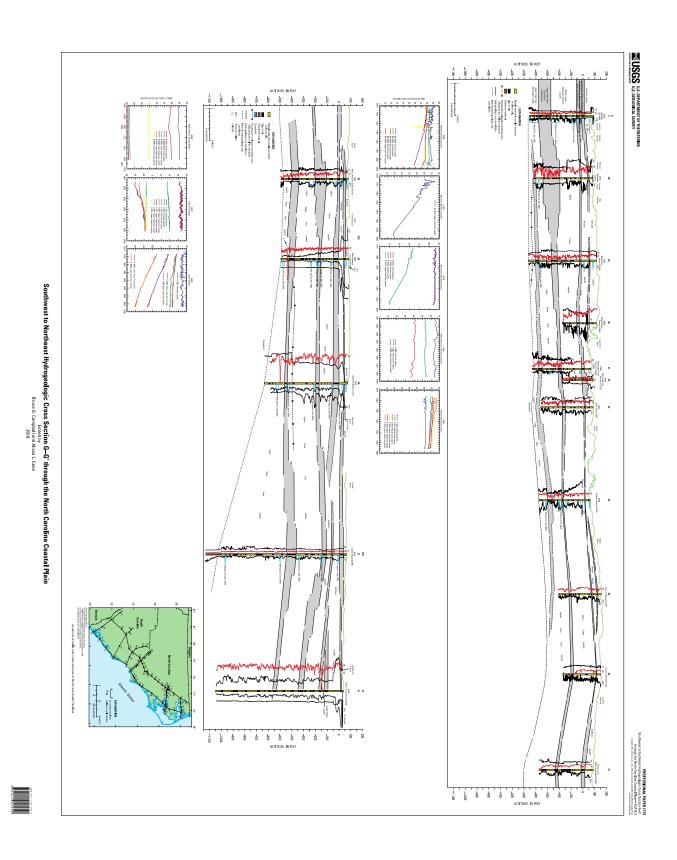
Appendix 2.

Plate 5, G-G' from: Campbell, B.G., and A.L. Coes (eds.). 2010. Groundwater availability in the Atlantic Coastal Plain of North and South Carolina. U.S. Geological Survey Professional Paper 1773 241 p., 7 pls. (the report's plates are on a cd, included with the hard copy).
