PART C: Examination of Lake Water Quality

General Characteristics of White Lake

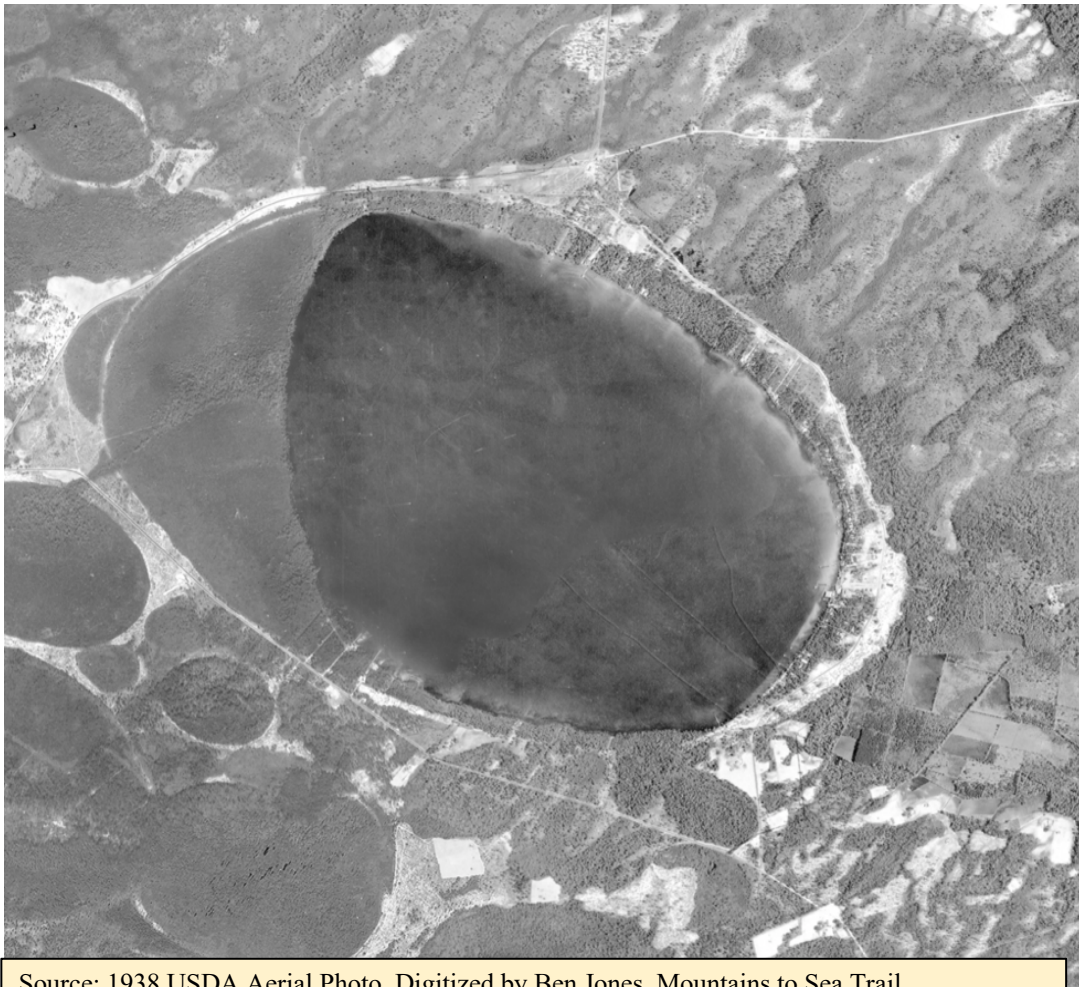
Figure 1. Visual characteristics of Carolina Bays - 1938 Aerial View of White Lake.

Source: 1938 USDA Aerial Photo, Digitized by Ben Jones, Mountains to Sea Trail

The first aerial views of the Bay Lakes here in eastern North Carolina were provided by US Department of Agriculture photography in 1938. Some of these photographs have been digitized and stitched together to provide clear views of what the lakes looked like 80+ years ago. **Figure 1** below is a photo from this collection. It shows the Carolina Bay characteristics—elliptical shape, NW-SE orientation, a sand rim—that are evident when viewed from the air. **Figure 2** is a current satellite view of White Lake and the immediate vicinity.

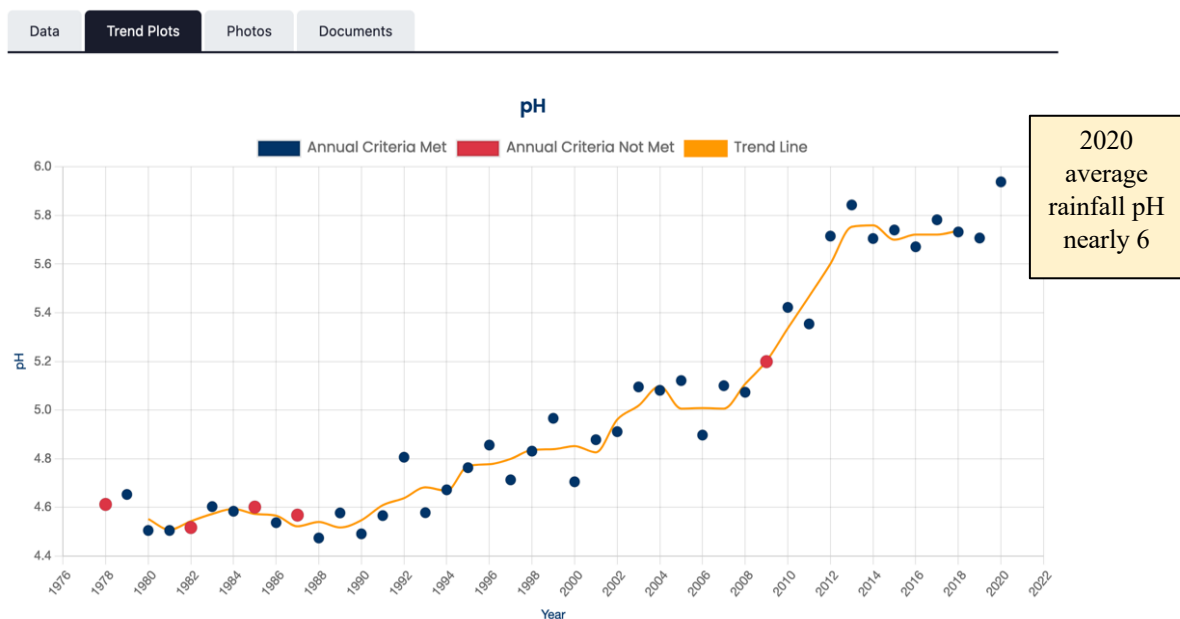
Site NTN NC35

Figure 6. Annual average pH of rainfall measured at the Clinton, NC NADP monitoring station through 2020. <https://nadp.slh.wisc.edu> (Accessed 1/4/22).

A graph of rainfall pH over time at this monitoring station (**Figure 6**) shows that rainfall was quite acidic (meeting the definition of acid rain, at around 4.5 standard units (SU)) before the year 1990. There was a relatively rapid increase in the pH over the period 2008-2013, with average annual values since 2013 hovering around 5.8 SU.

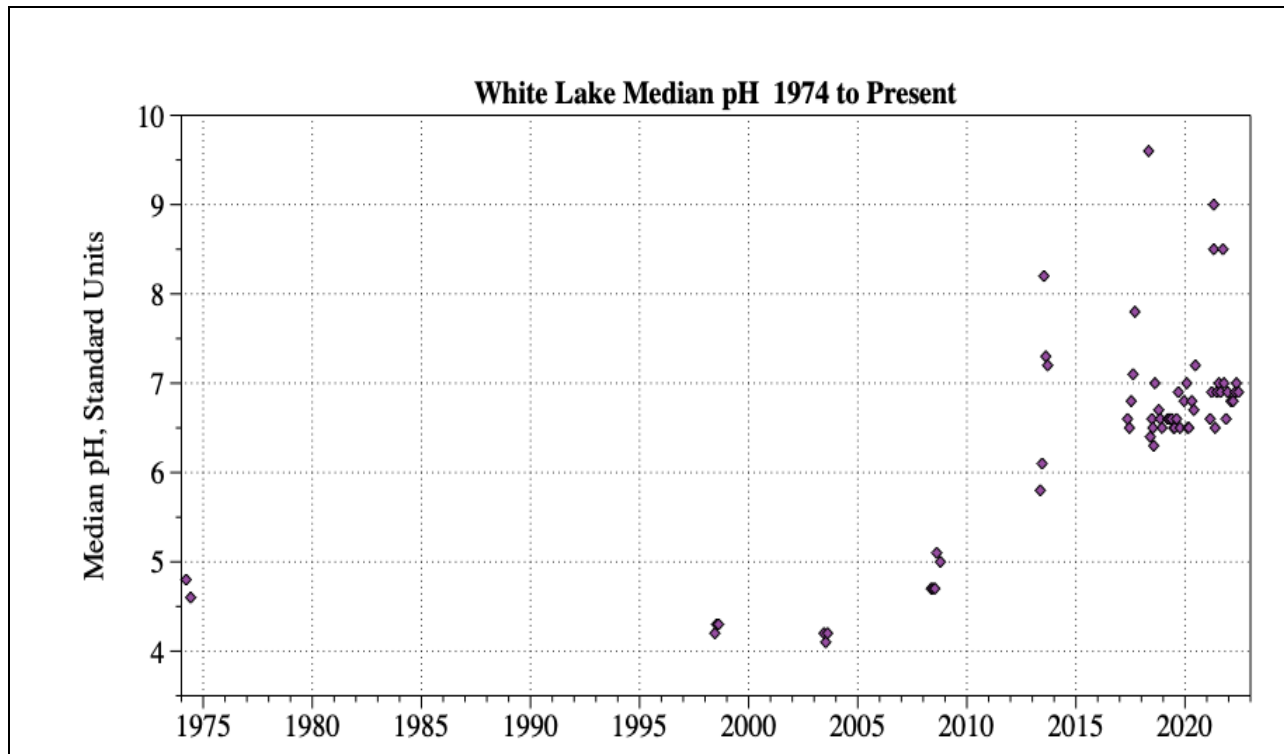
Figure 9. White Lake pH levels from 1974 (Weiss and Kuenzler 1976), 1998-2017 (NC DEQ), and 2018 to June 2022 (LIMNOSCIENCES).

During algal blooms, photosynthesis is high and increases in pH can be rapid; once the algae bloom subsides, pH levels decline to a range (6.5-7.0) that is shown as a cluster on the graph in **Figure 9**.

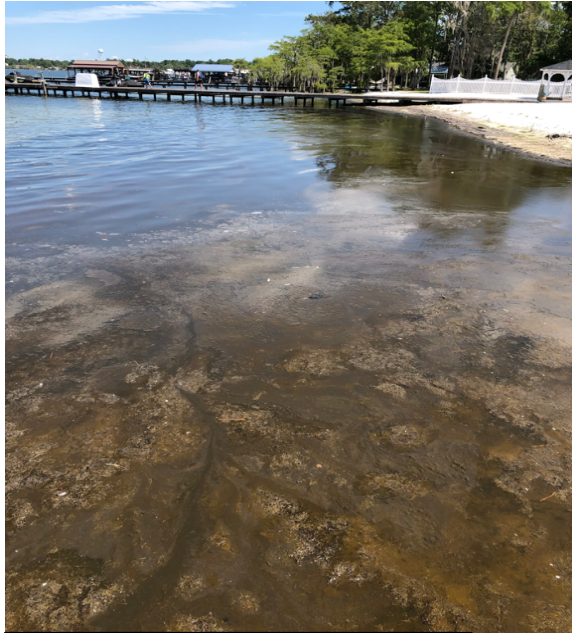
Figure 12. View of lakeshore at Lake Place condos, 8/18/22. The algae and vegetation clumps are coated in muddy sediments, and all this material can be churned up by boating activity.

Decaying algae and vegetation which accumulate along the shoreline is unsightly produces a strong, foul odor across a large area. (See **Figure 12**). In the summer of 2022, it was very evident that a large amount of muddy dark brown sediments were being stirred up from boating activity, in addition to the organic material (algae and vegetation).

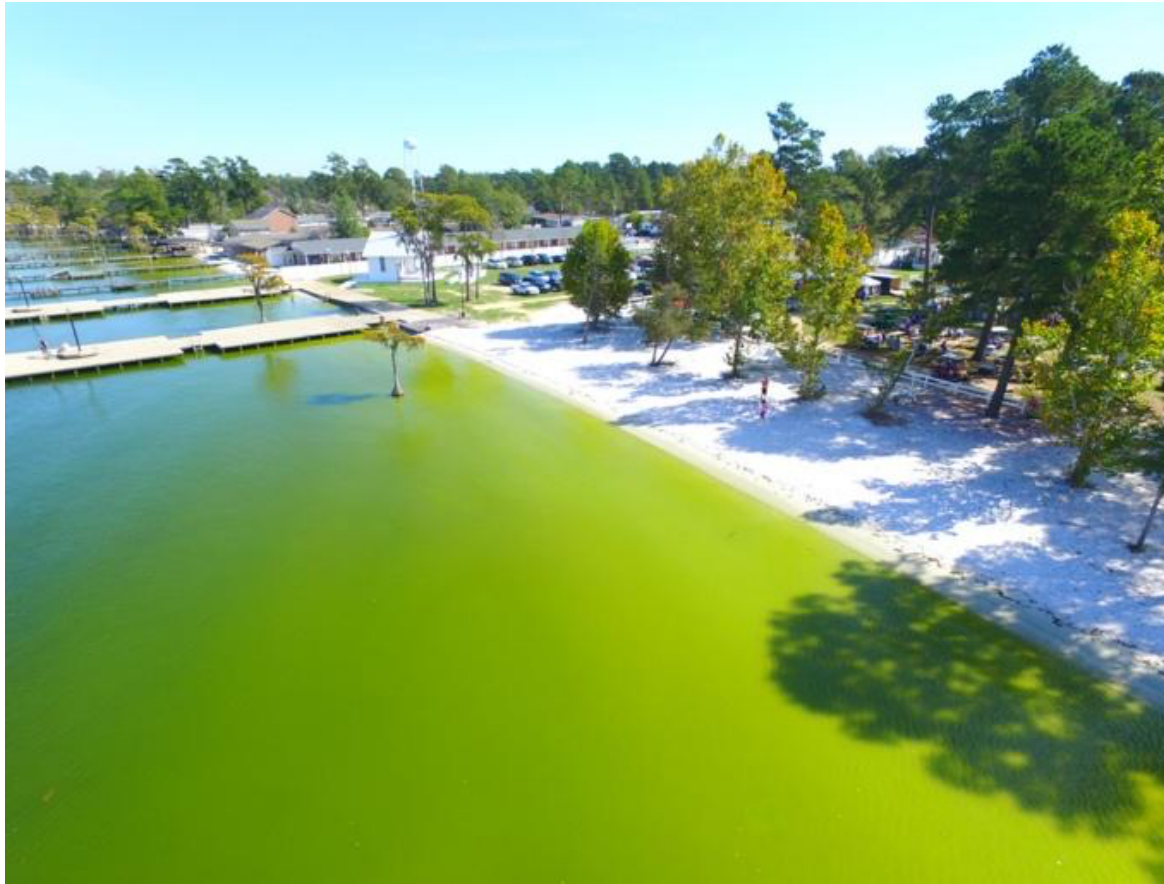
Figure 14. Aerial view of the cyanobacterial bloom at White Lake on October 21, 2017.

This “discoloration” generated a flurry of concerns from 2013 onward, which escalated considerably when a filamentous cyanobacterial bloom established a chokehold on the lake in late 2017, along with an infestation of the aquatic weed *Hydrilla* (which was found in most of the lake). **Figure 14** shows an aerial view of the 2017 bloom at White Lake, with the color of the water being a deep green due to the high concentrations of phytoplankton suspended in the water (the filamentous cyanobacteria).

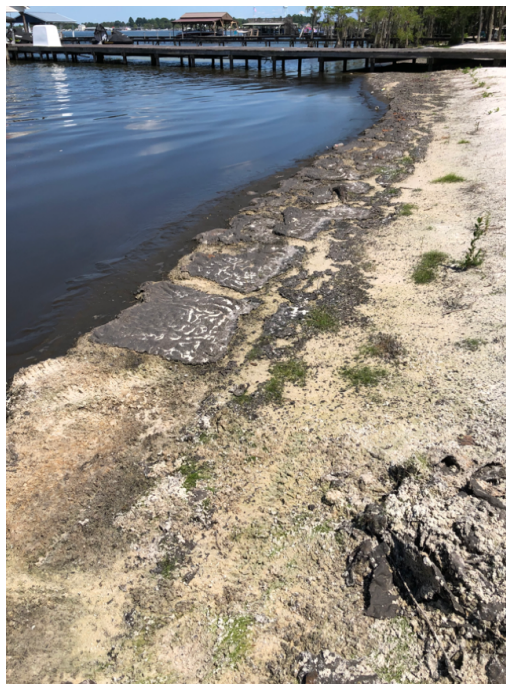
Figure 15. Muddy sediment and rotted vegetation awash on shore.

With smartphones, we can now document the changes in shoreline clarity over the course of a holiday weekend, and over the course of a summer, when boating use is highest. Conditions at Lake Place condos/Nathan's Cove have been monitored for several years, as it is one of the areas where material churned up from the lake bottom accumulates. This year (2022) has provided the opportunity to show how dramatic the change can be, as April and May clarity was excellent. By the end of the Memorial Day weekend, however, a swath of muddy sediments and vegetation was found along the lakeshore. The amount of material has continued to increase over the course of the summer (as it generally does), with conditions in August being very unsightly, overwhelming the efforts to rake up and remove what washes up on the sandy beach **Figure 15**.

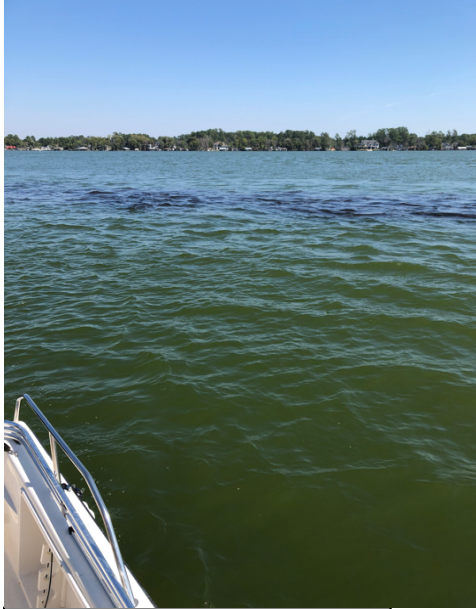
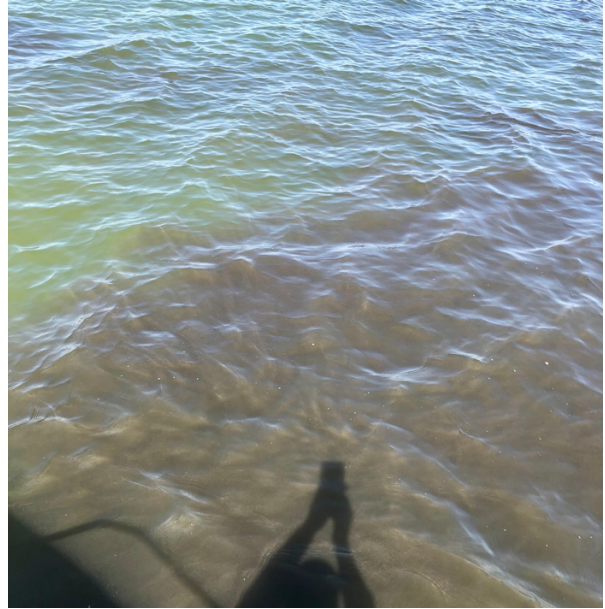
Figure 16 a and b. Dark sediment plume generated by a wake board boat (left), and a close-up of the plume (right). Photos taken September 28, 2021

During lake monitoring in late September 2021, a dark brown plume was seen down the middle of the lake, generated from a wake surfing boat. A water sample was collected

from the plume, and the phosphorus concentration was 2x the concentration of the other samples collected that morning. See **Figure 16** below.

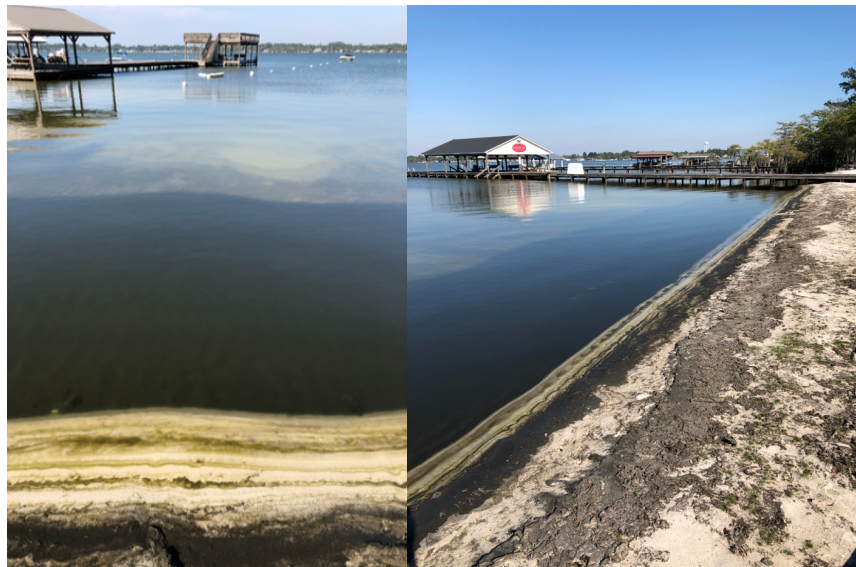
Figure 17a and b. (left) View in front of Lake Place on September 28, 2021; (right) view towards Nathan's Cove pier (the same location) on September 28, 2021.

The churned-up sediments, along with dislodged vegetation, migrate to shallow areas like Nathan's Cove/Lake Place, where they decompose and congeal, creating the unsightly and smelly mess for much of the summer and fall. See **Figure 17** below.
