# *McDaniel Street Cemetery Vision Plan*

A Cemetery Vision Plan summarizes the current conditions in a historic cemetery and outlines activities to be undertaken in the future. It is intended to serve as a guiding document as the cemetery owner prioritizes and attends to needs and desired improvements.

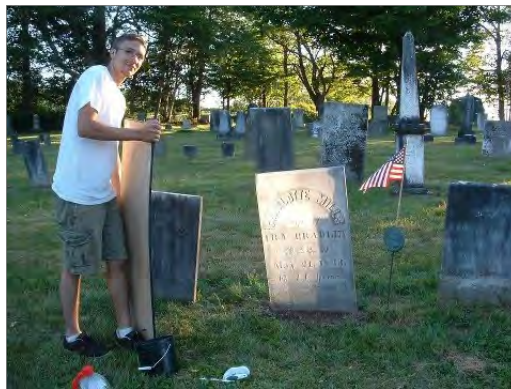
Inscriptions should, instead, be photographed; the ubiquity of smartphone cameras makes this easy and inexpensive today. Hard-to-read inscriptions can be illuminated with a flashlight or by reflecting sunlight onto the marker with a mirror. Directing light at the marker from different angles can help make inscriptions visible.

*Figure 9. An example of illuminating an inscription with a mirror (NCPTT)*

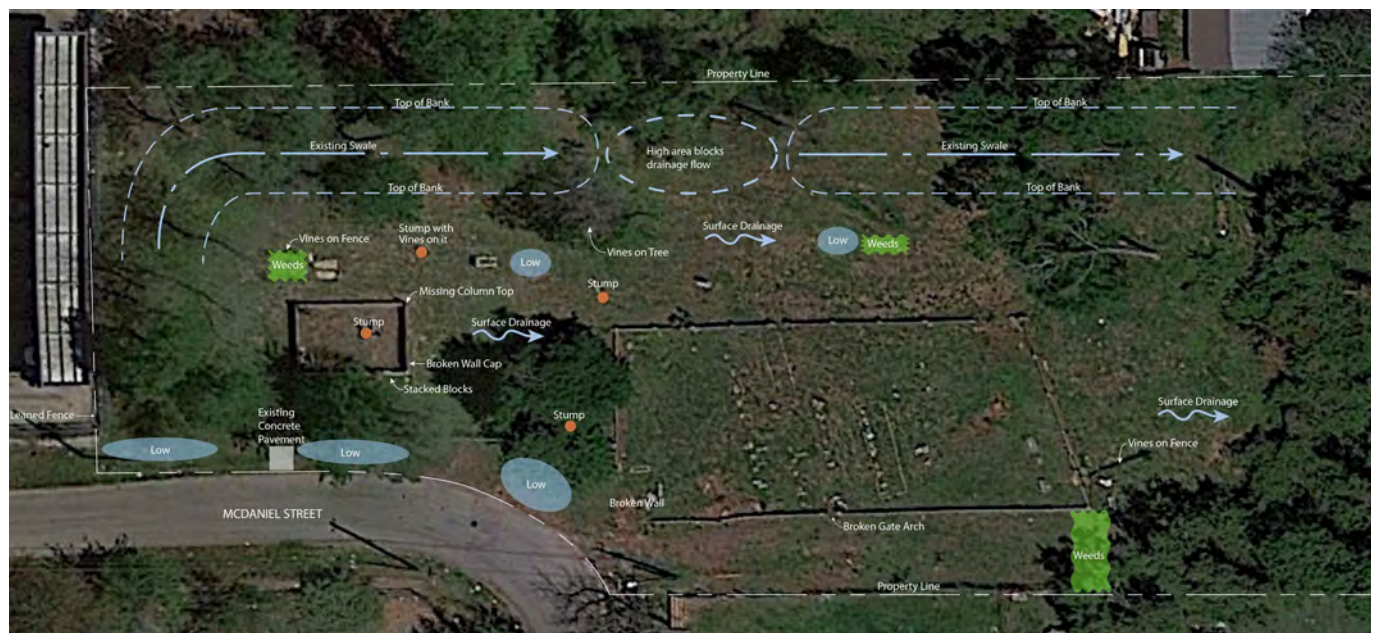
The drainage swale (too shallow to be a ditch) along McDaniel Street is uneven height and does not drain completely.

Figure 10. Site assessment plan by White Oak Studio/Kimley Horn (November 2022)

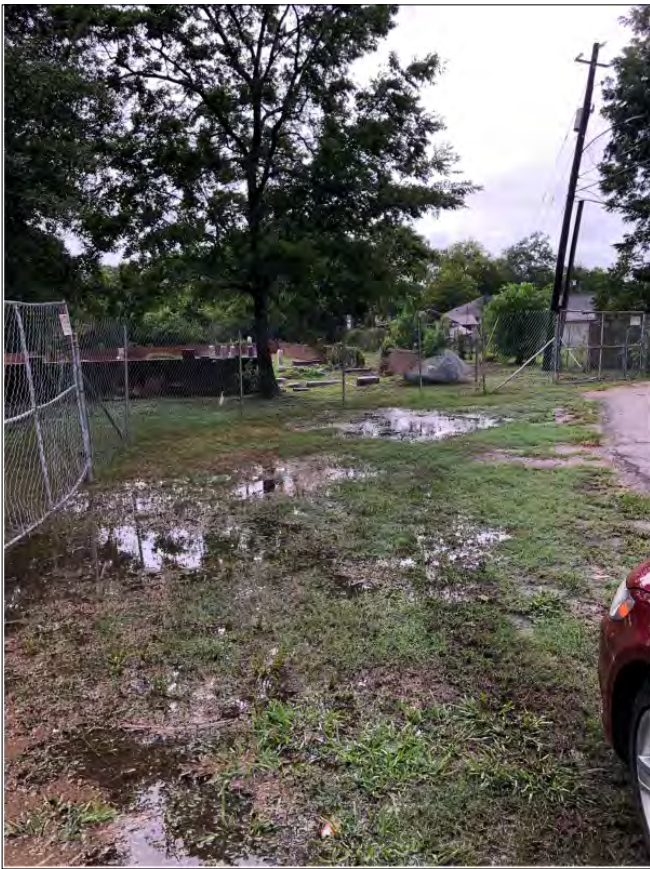
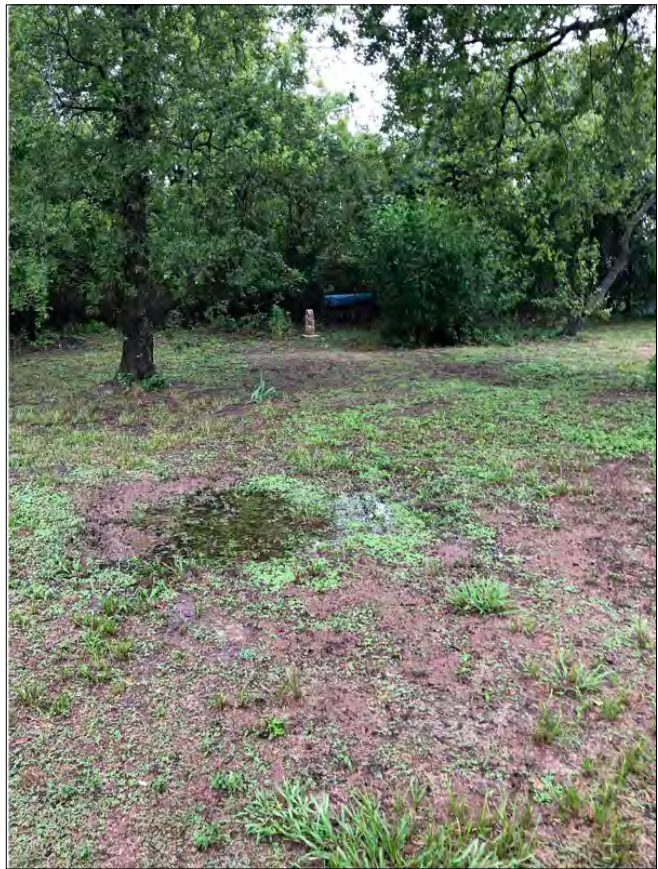
Figure 11. An uneven swale along street (left) and disconnected drainage swales at the north side of the property (right) result in short-term standing water (White Oak Studio/Kimley Horn)

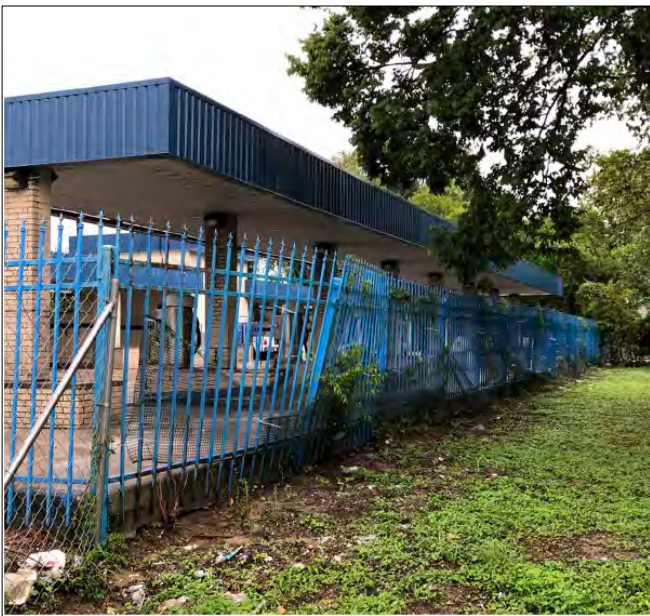
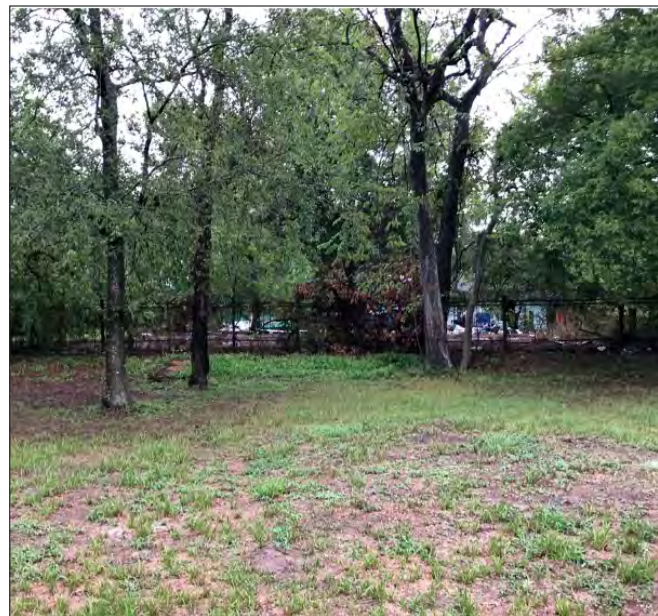
Figure 12. Unsightly neighboring properties include the car wash to the west of the cemetery (left) and an illegal dumping site to the northwest (right) (White Oak Studio/Kimley Horn)

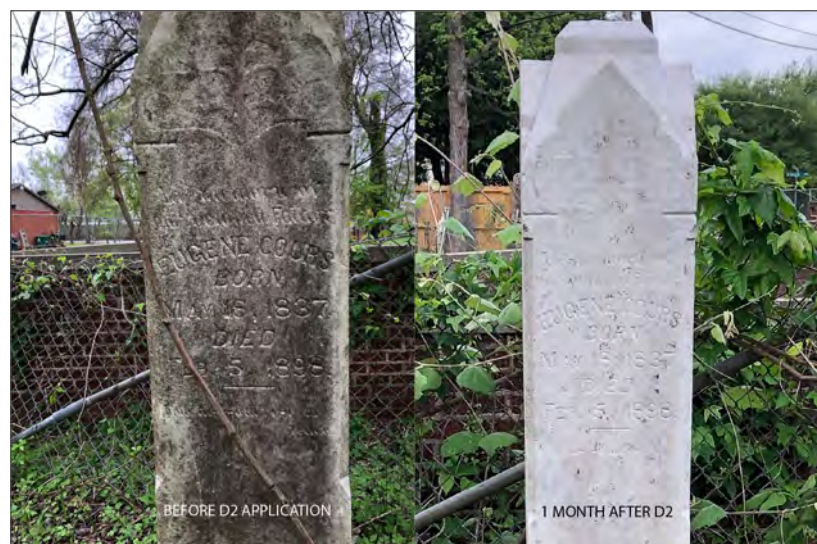
WCA also held a Cemetery Clean-up Day in March 2022, during which volunteers sprayed all of the grave markers in the cemetery with D/2 Biological Solution to remove biological growth and staining.

Figure 13. Example of before and after cleaning with D/2 in March 2022 (McDoux)

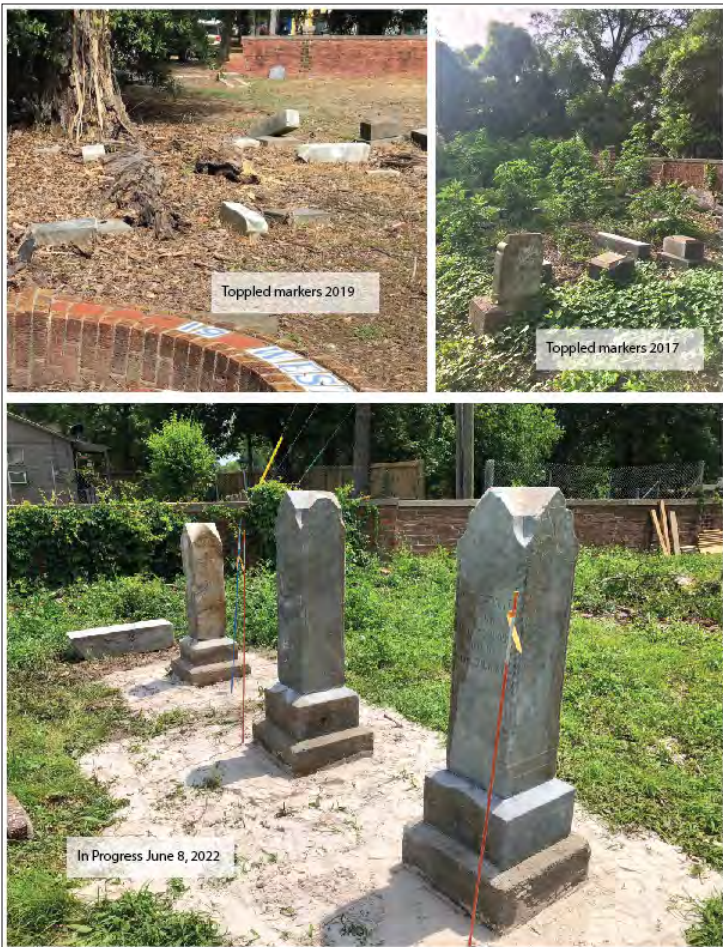
Figure 14. Examples of grave markers before and after resetting and repairs in 2022 (WCA, McDoux)

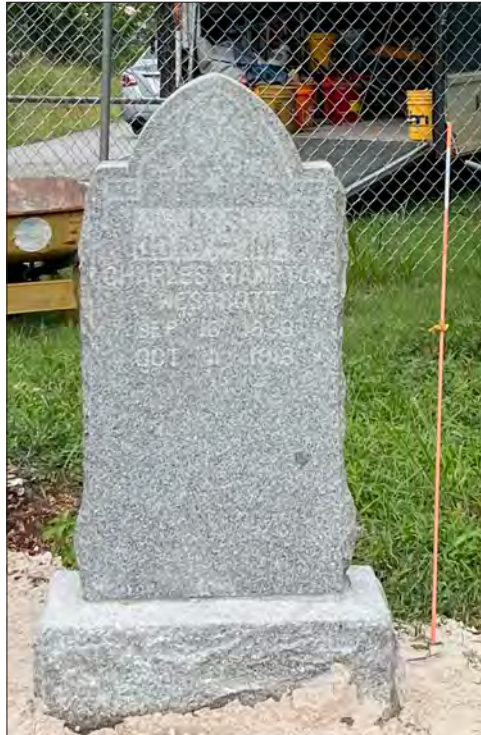
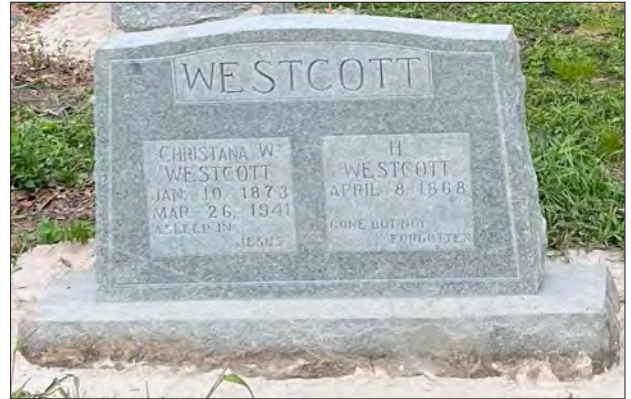
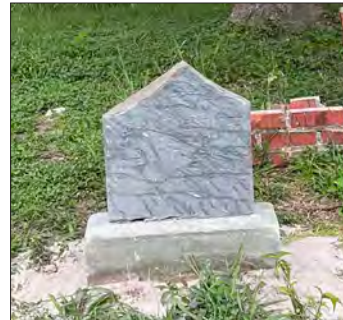
Unfortunately, during the marker resetting process in June 2022, a car missed the curve from eastbound McDaniel Street to southbound Schuller Road and drove through the security fence at a high speed, knocking several markers off their bases and damaging them (including breaking one in half).

*Figure 16. Westcott markers after resetting and prior to the car crash in June 2022 that dislodged and damaged them*

The driver fled the scene but was later identified by the license plate and bumper remaining in the cemetery. WCA filed an insurance claim to pay for the replacement of those markers.

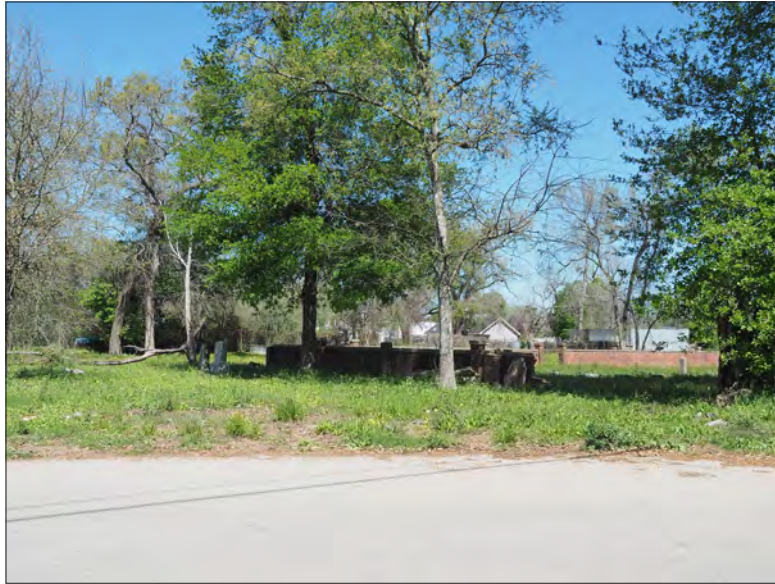
*Figure 19. This photo in 2020 shows the changes in tree cover since 2005 (McDoux)*

Photographs from the 1990s and 2005 show that the cemetery was much more wooded at that time. It is likely that many trees died in the severe drought experienced in Texas in 2010–2011, which killed millions of trees across the state. Some, but not all of the dead trees were removed, probably by volunteers.

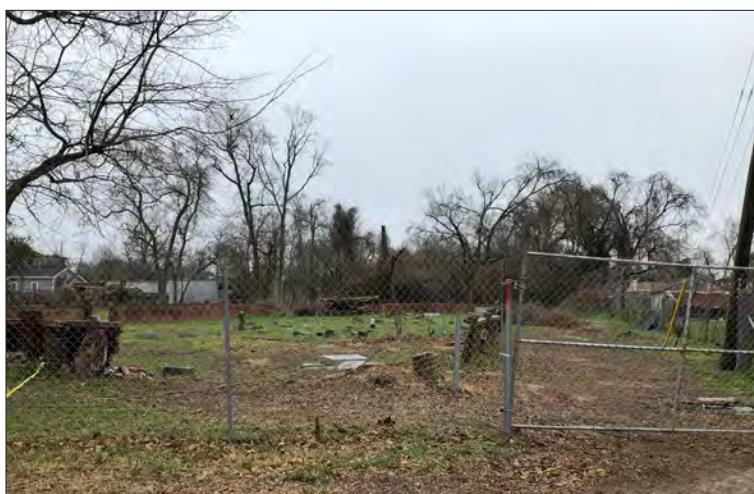
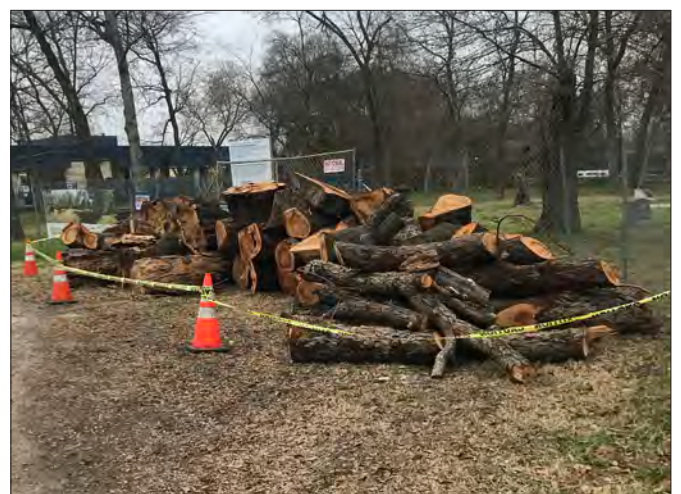
Figure 21. (Left) The Westcott Cemetery area after tree removal in 2021; (right) logs waiting to be removed from the cemetery (McDoux)

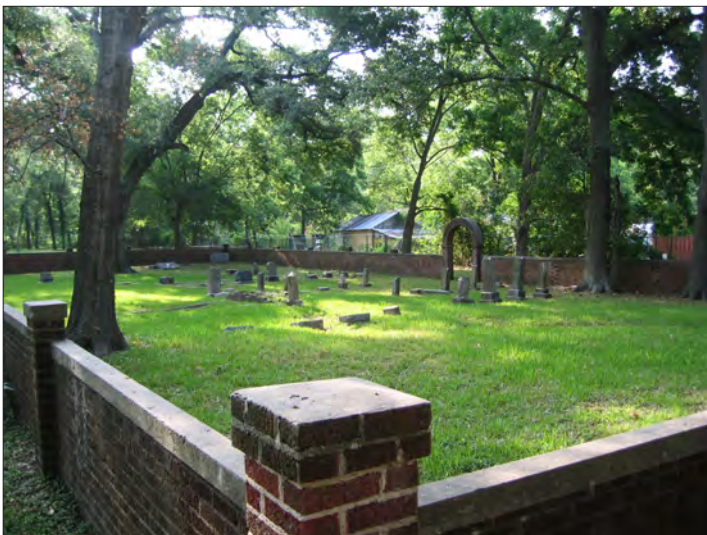
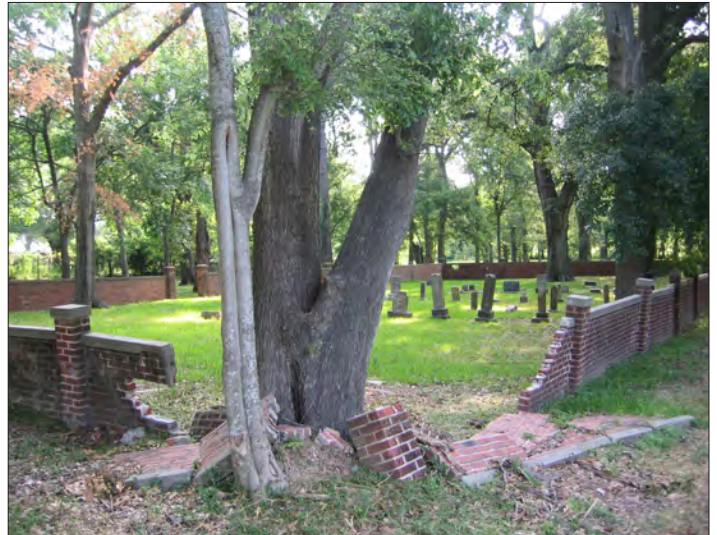
*Figure 24. The brick wall surrounding the Westcott Cemetery, as it appeared in 2005 (Texas Historical Commission)*

The wall has been deteriorating over the past 20 years and is now broken and falling down in many locations. The presence of large trees right next to the wall caused some displacement, but impacts from vehicles traveling east on McDaniel Street and missing the sharp curve undoubtedly caused additional damage. In fact, a car drove through an existing car-sized gap in the wall in 2022.

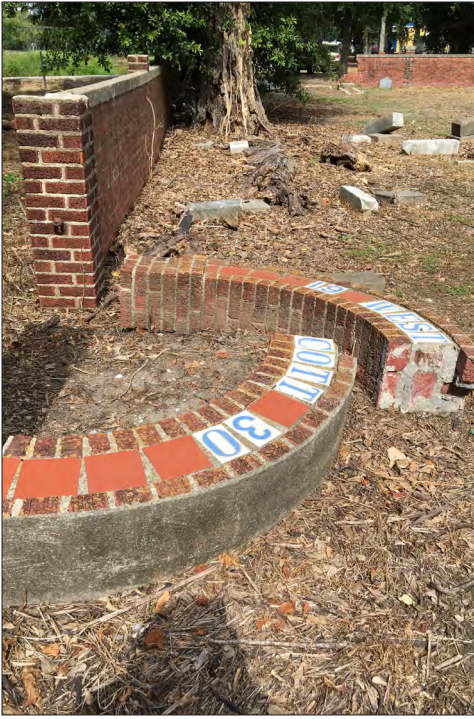
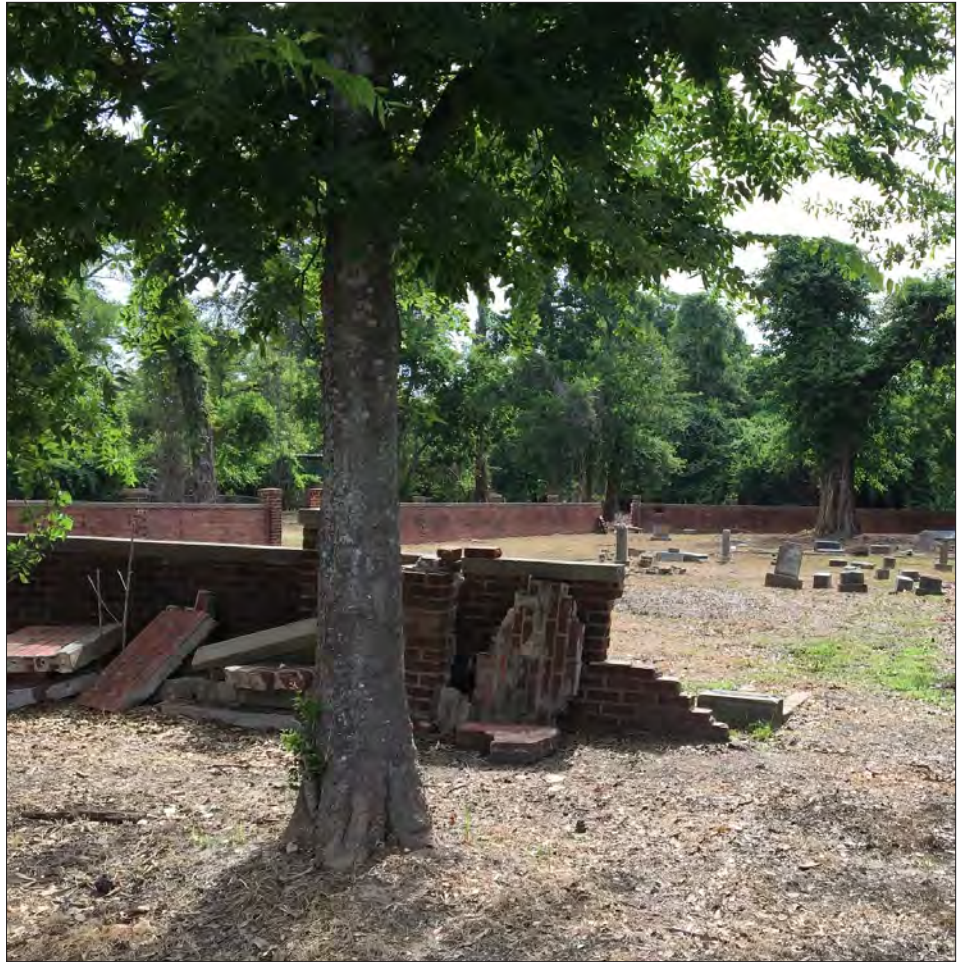
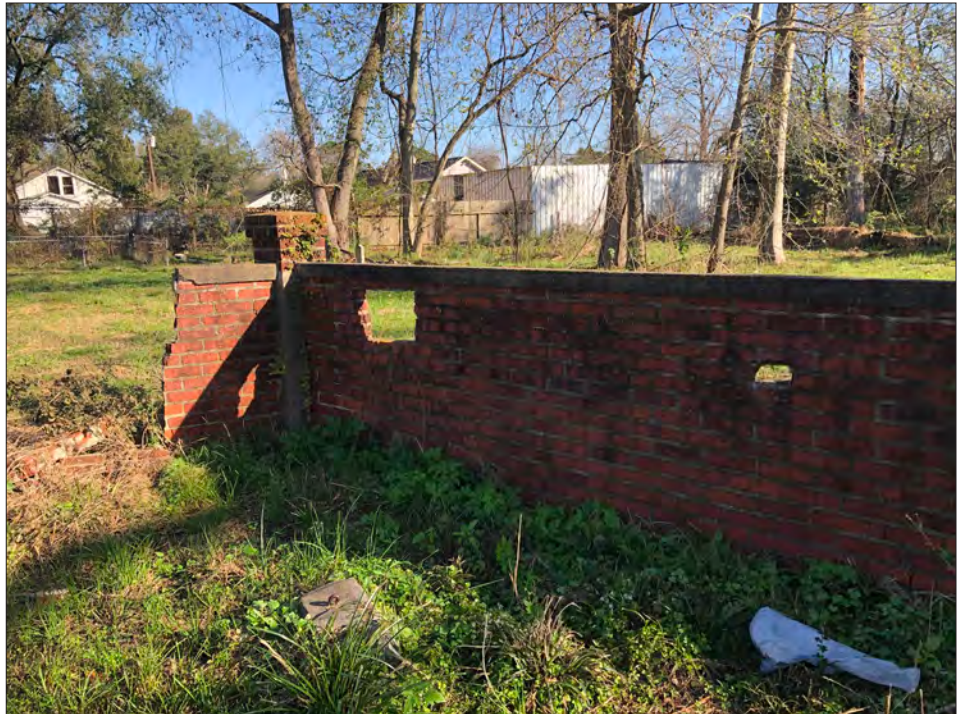
In discussions with the Architecture division of the Texas Historical Commission, former director Sharon Fleming agreed that the wall was poorly designed and that attempting to restore or repair it was unnecessary. Although the Texas Historical Commission has no oversight for McDaniel Street Cemetery, it was helpful to have their opinion on this matter.

Figure 25. Damage to the Westcott brick wall, including the toppled arch (McDoux)

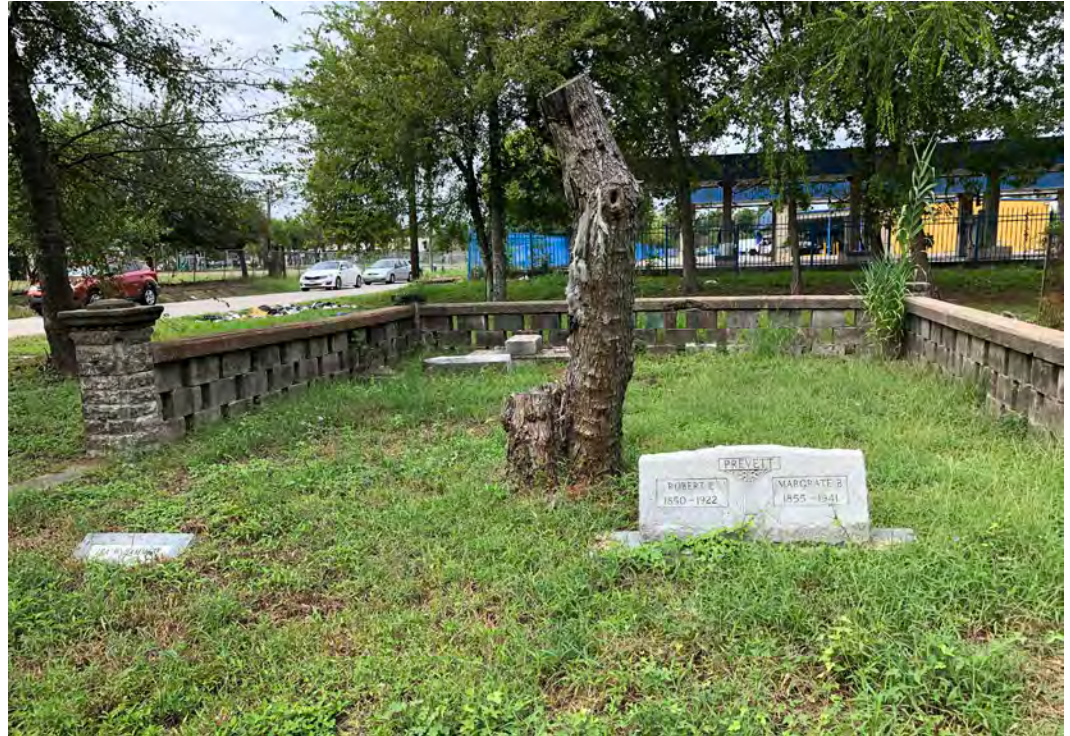
The Farmer Cemetery contains a small number of graves and is surrounded by a rusticated concrete block wall with blocks set in a screen fashion with gaps between them. The wall is approximately 30 inches tall and is topped with a sill that is now spalling in some places, revealing the internal rebar. Columns at the corners were topped with more elaborate concrete caps and finials in the same rusticated gray concrete, most of which have been knocked down by vandals. An opening in the south side of the wall provides pedestrian access. Some of the blocks have been removed on the south side of the wall, east of that opening. This wall has suffered relatively minimal damage and can be repaired.

*Figure 26. Farmer Cemetery, September 2020 (McDoux)*

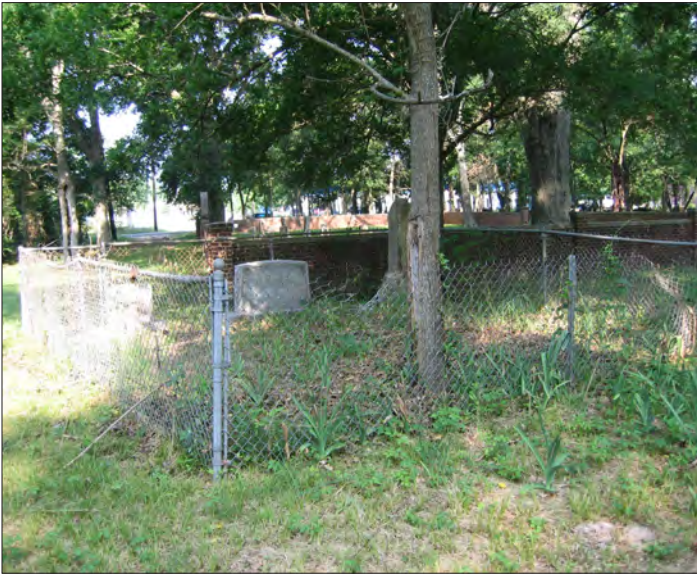
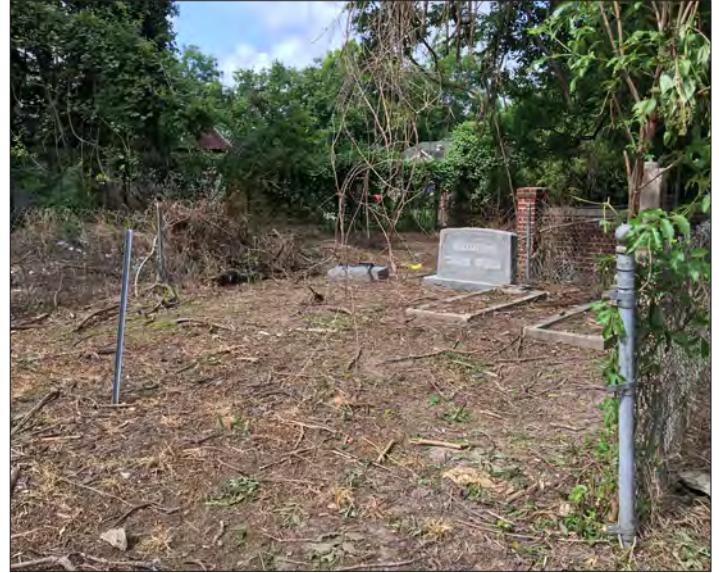
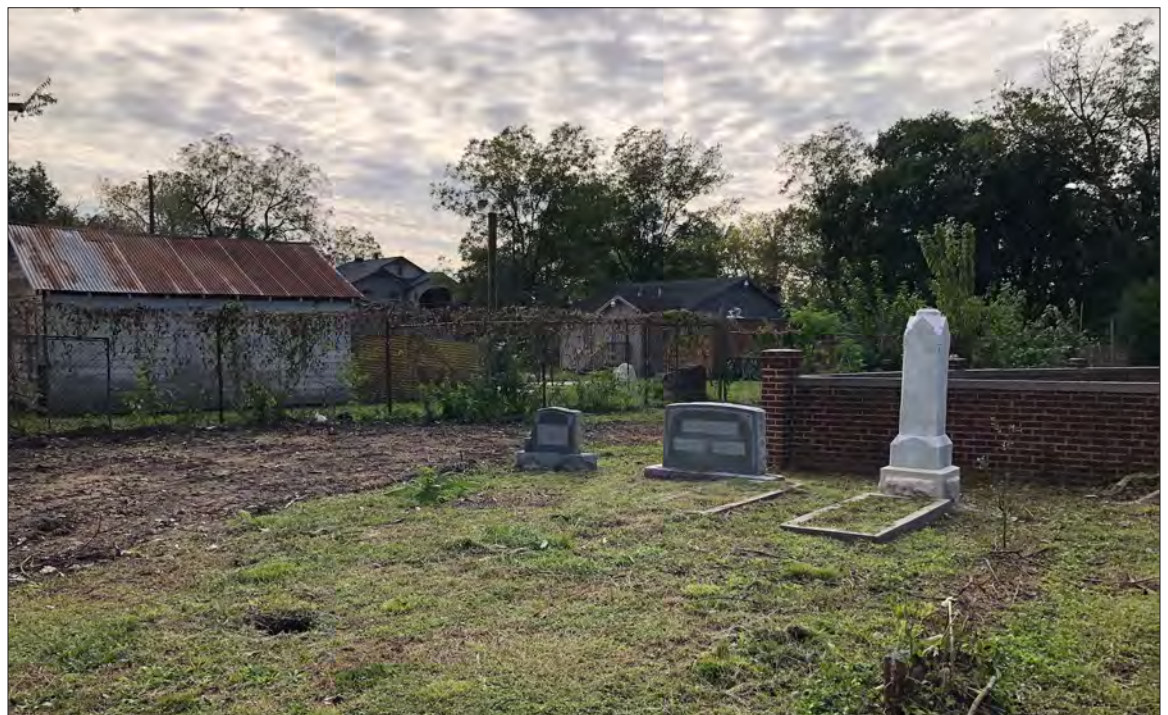
Both the Cours family plot and the Newton family plot were surrounded at some point in the past with chain-link fencing and a single entry gate; the Cours fence was torn down or damaged in some way and has now been removed, after its dimensions were recorded. That fence may be replaced with a different material and/or design at some point in the future.

*Figure 28. The Cours family plot, with fencing as it appeared in 2005 (above left); 2019 (above right), and 2022 following the removal of the rest of the fencing and poles (below)*

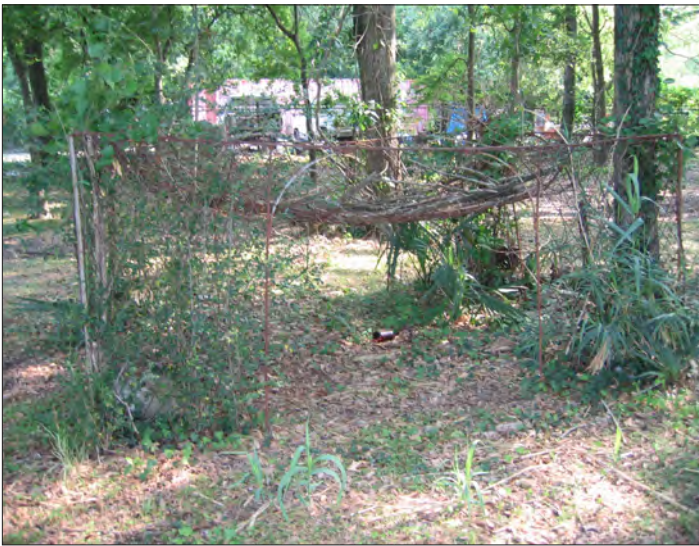
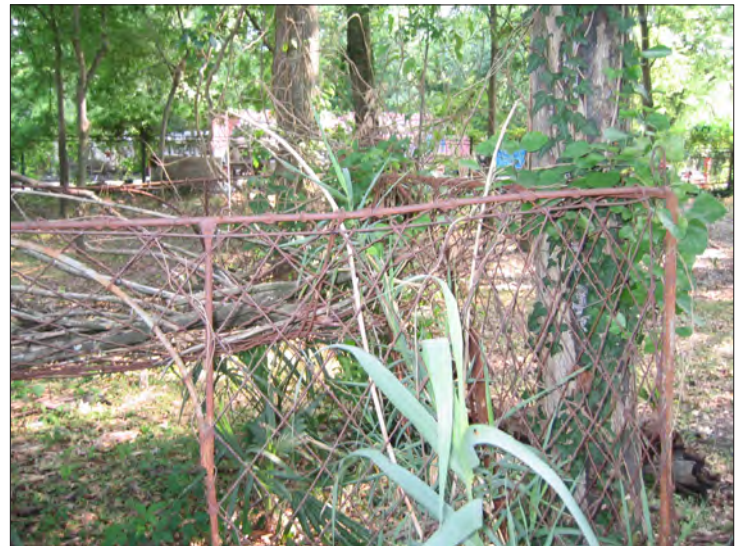
Similar heavy wire material was used to build a mortsafe-type structure over an unknown grave just outside the Farmer Cemetery wall. Mortsafes were typically used to prevent graverobbing and the theft of bodies for medical research and training. They were common in Scotland before 1830. Although the mortsafe's "roof" in McDaniel Street Cemetery has been bent (possibly by someone climbing on it) the original shape is still discernible.

Figure 29. "Mortsafe"-type structure next to the Farmer Cemetery, as it appeared in 2005 (Texas Historical Commission)

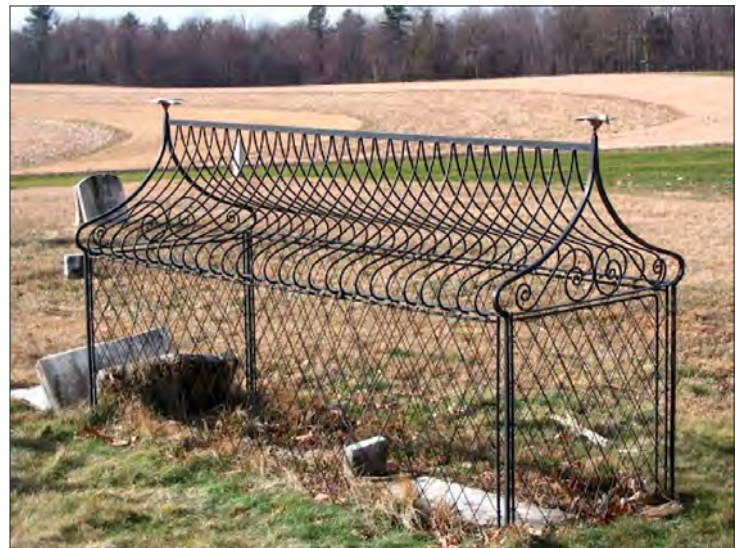
Figure 30. A traditional mortsafe in Pennsylvania

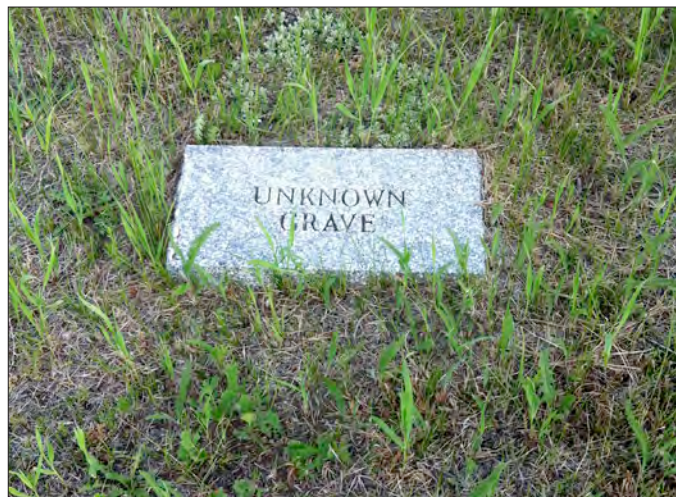
Figure 31. Example of a surface marker for a previously unmarked grave

- Continue cleaning grave markers, on an as-needed basis.
- Replace missing markers when the decedent is known and the location of their grave can be documented through photographs or the Westcott family marker map.
- Purchase and place small granite markers on all 32 unmarked graves. Markers might be inscribed with “Unknown” (as shown below) or “At Rest”.

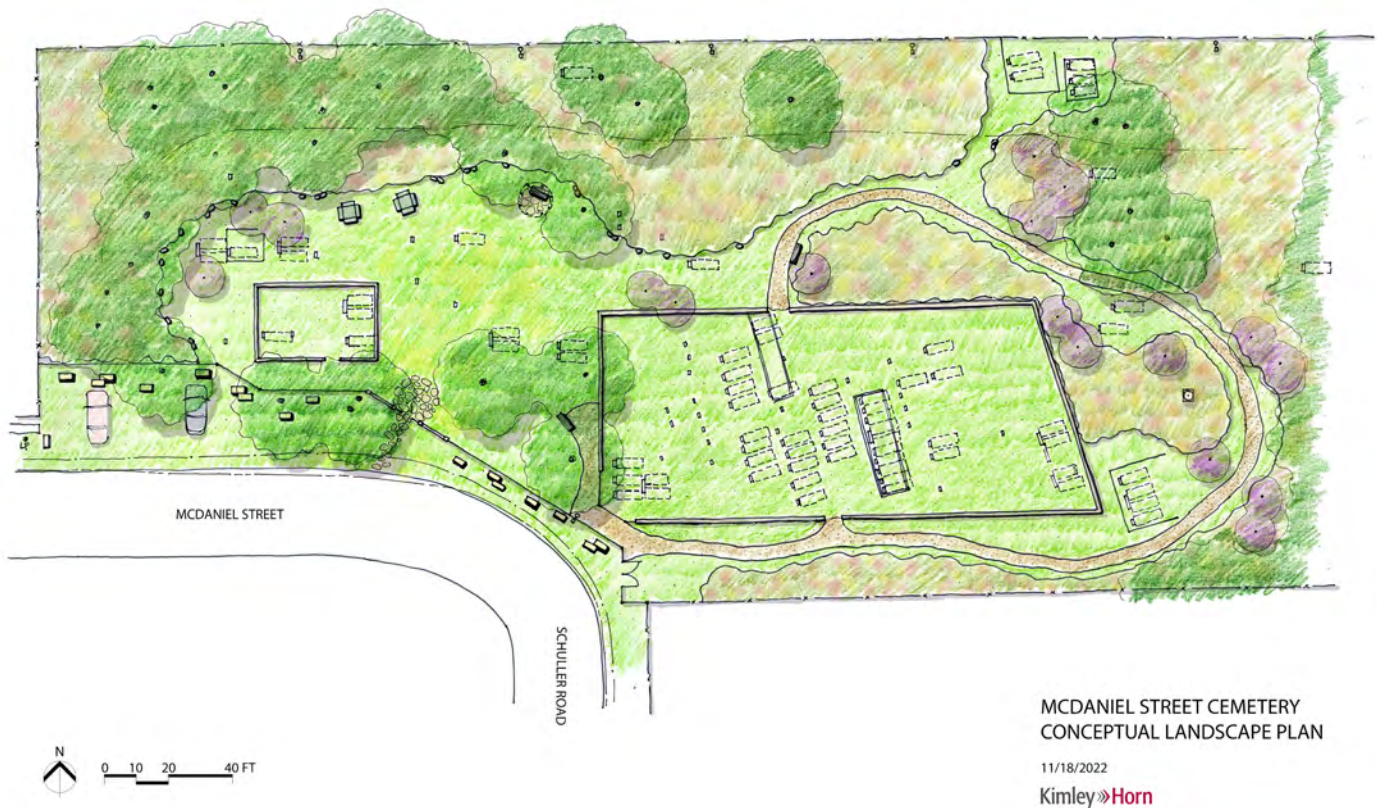
Figure 33. Conceptual landscape plan for McDaniel Street Cemetery

WOS has identified the following future work to be undertaken by WCA as funding becomes available:

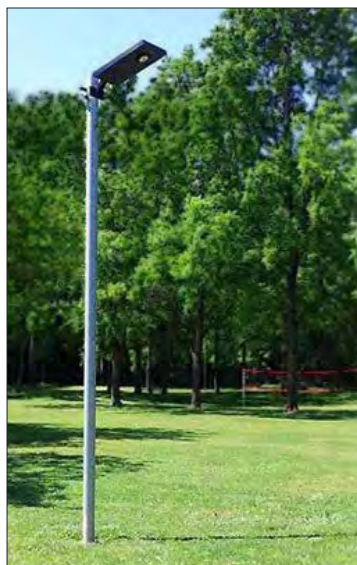
Figure 34. Example of solar light

1. Install six solar lights on poles with concrete footing.

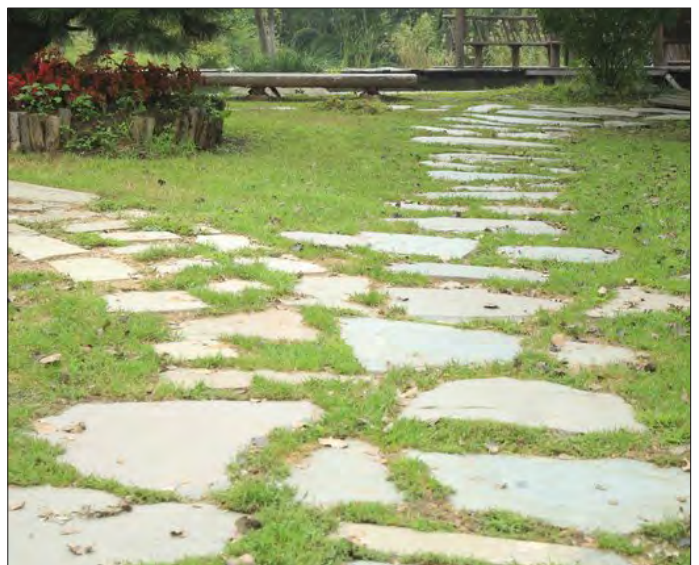
Figure 35. Flagstone pavers installed at ground level

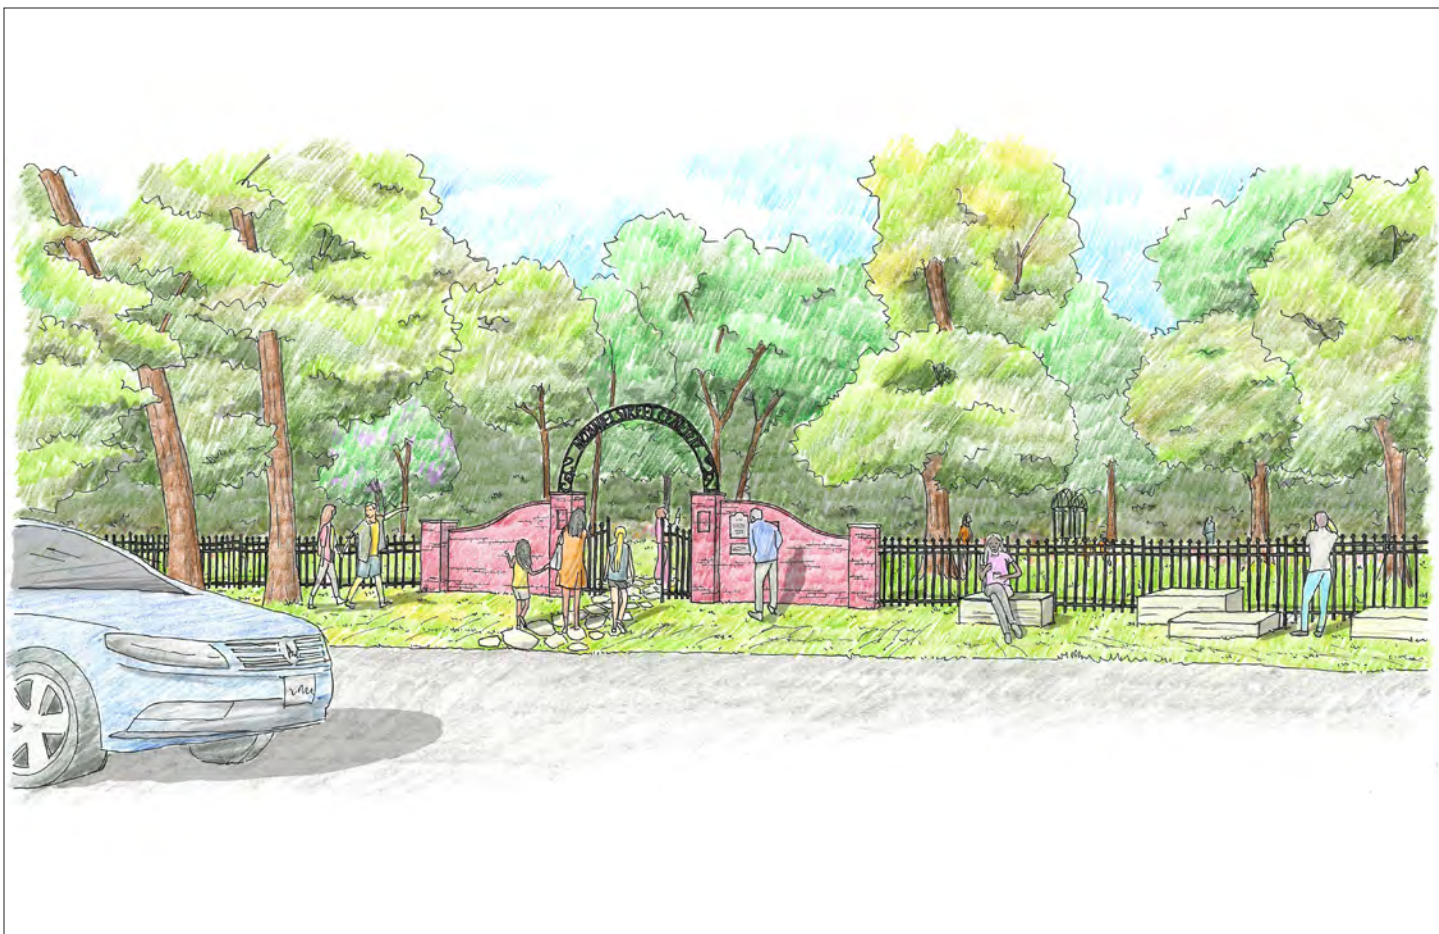
Figure 36. Rendering of the proposed new fence and entry gate with arch at McDaniel Street Cemetery

1. Install an ornamental metal picket fence and vehicle gate across McDaniel Street on south side of property. A fixed pedestrian entry gate will be flanked by brick columns and walls and topped with an ornamental metal arch.
2. Install six-foot black chain link fence around remaining perimeter of cemetery to secure property. Include a pedestrian gate (to remain unlocked) at the southeast corner to provide access to the wooded lot, per City of Houston requirements. Include a vehicle gate at the McDaniel Street "alley".
3. Install hoop wire ornamental fence across the southwest corner of the Westcott Cemetery.

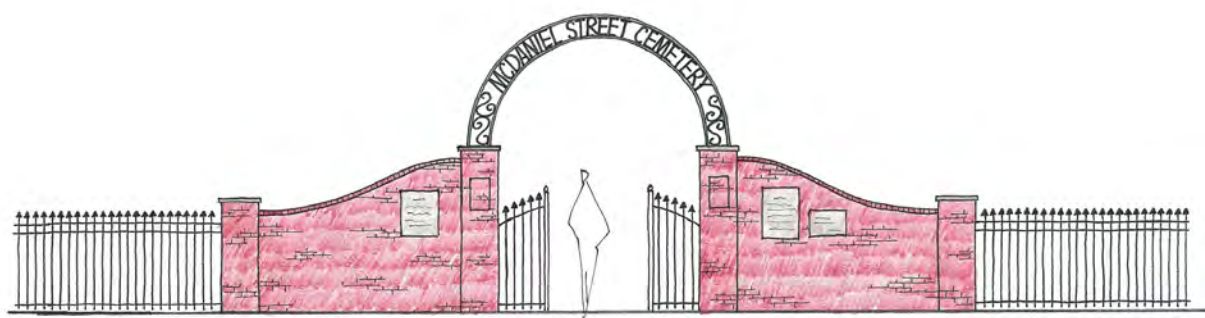
Figure 37. Another view of the proposed entry gate and fence

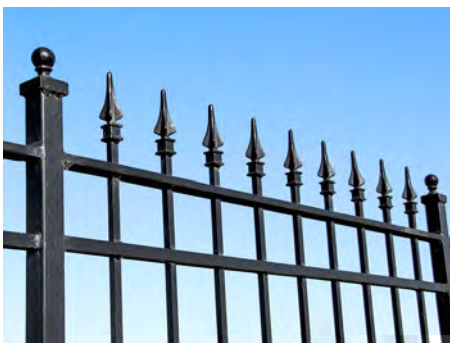
*Figure 39. Ornamental metal picket fence*

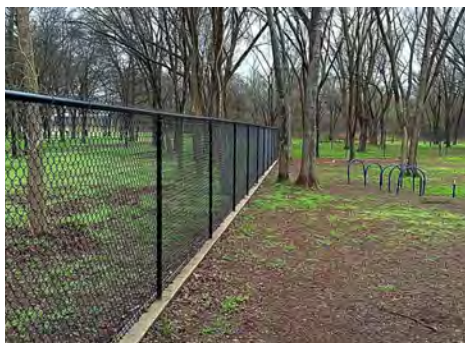
*Figure 40. Black chain-link fence*

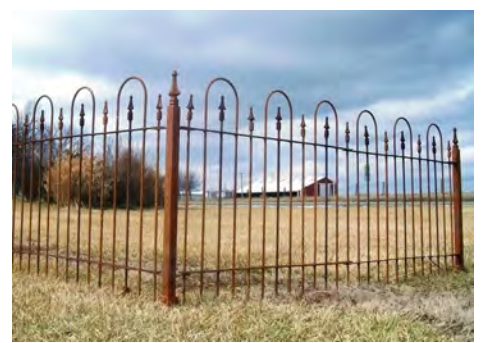
*Figure 41. Hoop wire ornamental fence*

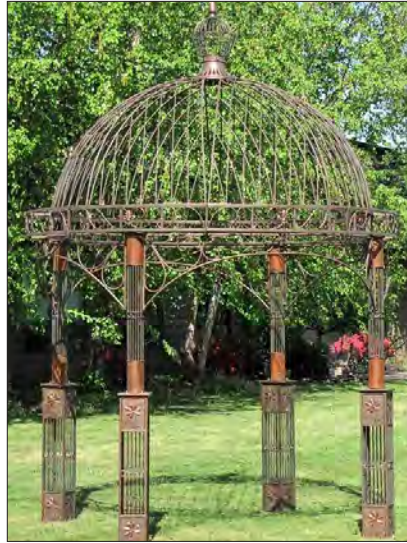
Figure 43. Example of a gazebo that would be appropriate for this cemetery

1. Install a metal gazebo as a point of interest to draw the visitor into the cemetery.

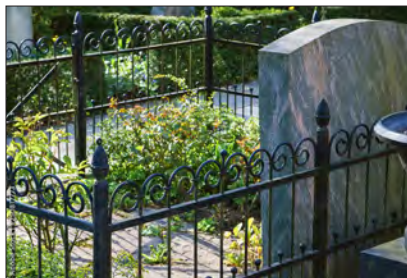
Figure 44. Example of fencing around small plot

We recommend selecting one type of ornamental metal picket fence with gate to replace the chain-link or iron rod/wire fences around these family or individual plots.
