Re: **Limited Cultural Resources Services**  
Bennett Building  
9300 Lee Avenue  
Manassas, Virginia  
59E-0132-0001

Froehling & Robertson, Inc. (F&R) conducted Limited Cultural Resources Services to support the proposed demolition of the Bennett Building on June 23 & 25, and August 8, 2026 located at 9300 Lee Avenue in Manassas, Virginia. To support Dewberry's cultural resources assessment, F&R screened for potential Civil War relics utilizing a magnetometer and subcontracted with a licensed ground penetrating radar (GPR) contractor to perform a GPR survey for potential grave sites in the footprint of the Bennett Building, the South Judicial Building Site Area (excluding the footprint of the Annex Building), and the North Area Parking Lot per the attached mapping.

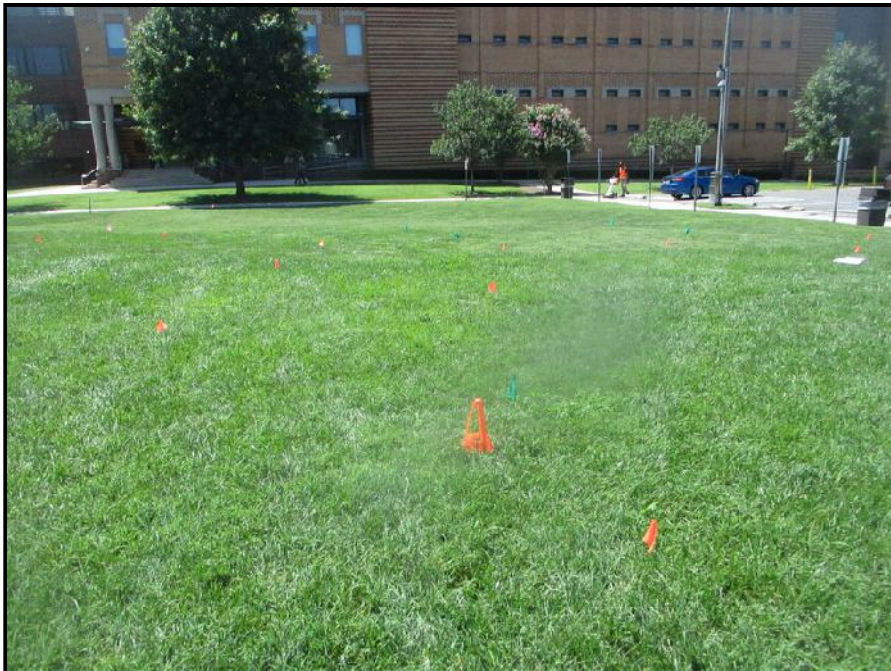
Photo showing an anomaly identified by GPRS within the Green Area.

Additional investigations under oversight of qualified archaeologists are warranted.

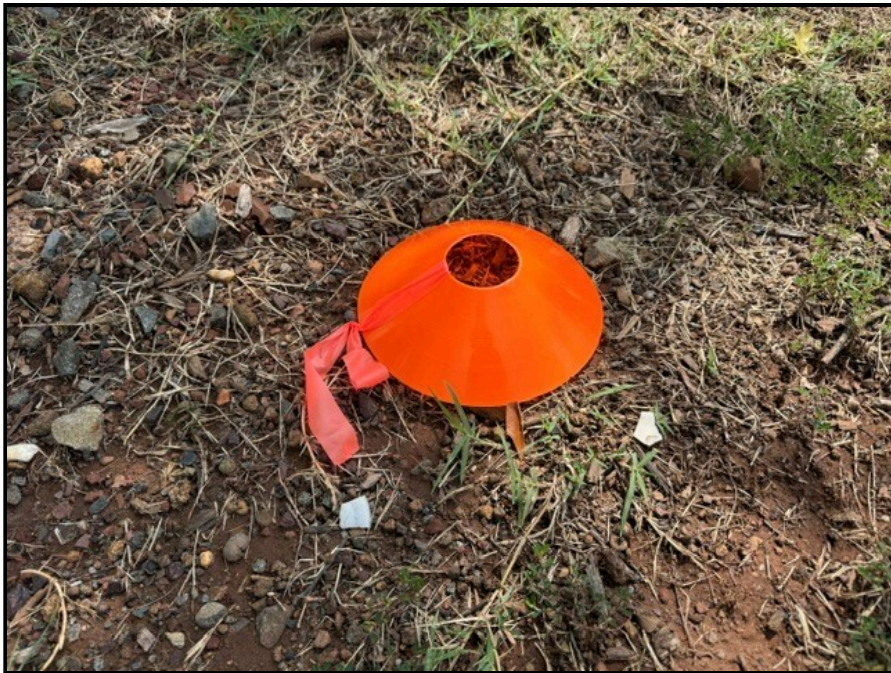
It should be noted that during scanning activities on July 25, 2026, potential artifacts of glass and pottery were observed at the surface of a landscaped area within the Red Area, and is marked on Figure 4 as an artifact point. This finding was communicated to the Dewberry Archaeologist for their internal project usage. Other potential artifacts were also observed at the surface in the southeast corner of the Red Area; however a data point was not collected at this location, but was verbally communicated to the Dewberry Archaeologist on-site.

Photo showing potential artifacts at land surface within the Red Survey Area.

- Potential artifacts of glass and pottery were observed at the surface of a landscaped area within the Red Area which is marked as an artifact point on the mapping attached. Other potential artifacts were also observed at the surface in the southeast corner of the Red Area; however a data point was not collected at this location, but was verbally communicated to the Dewberry Archaeologist on-site.

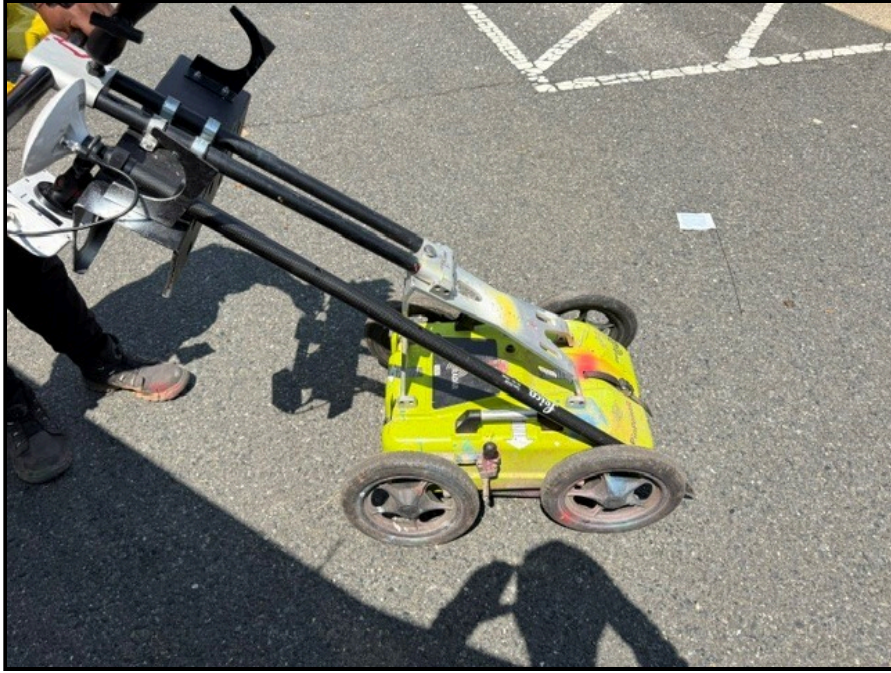
Photo showing the GPR cart utilized by the subcontracted GPR company.

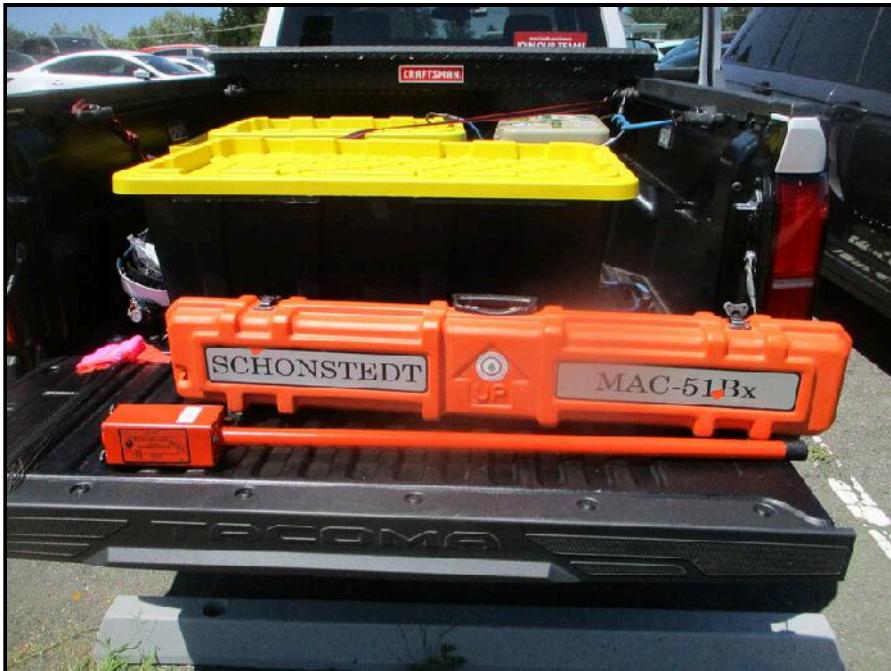
The magnetometer screening was performed utilizing a Schonstedt MAC-51B magnetometer. During the onsite screening, F&R traversed each project area, sweeping the magnetometer in a side-to-side motion for positive signals in an attempt to identify potential buried relics. When a positive signal was encountered, as indicated by the change in tone/sound produced by the magnetometer, a cone with flagging was placed at the location of the positive signal. A Trimble sub-meter GPS unit was utilized to collect coordinates of the positive signals. Onsite magnetometer activities were conducted with oversight from a Dewberry Archaeologist. F&R did not excavate or further investigate positive signals to determine their source. In addition, the signals do not provide information regarding the size, shape, or composition of the buried object.

Photo showing the magnetometer unit utilized by F&R during the assessment.

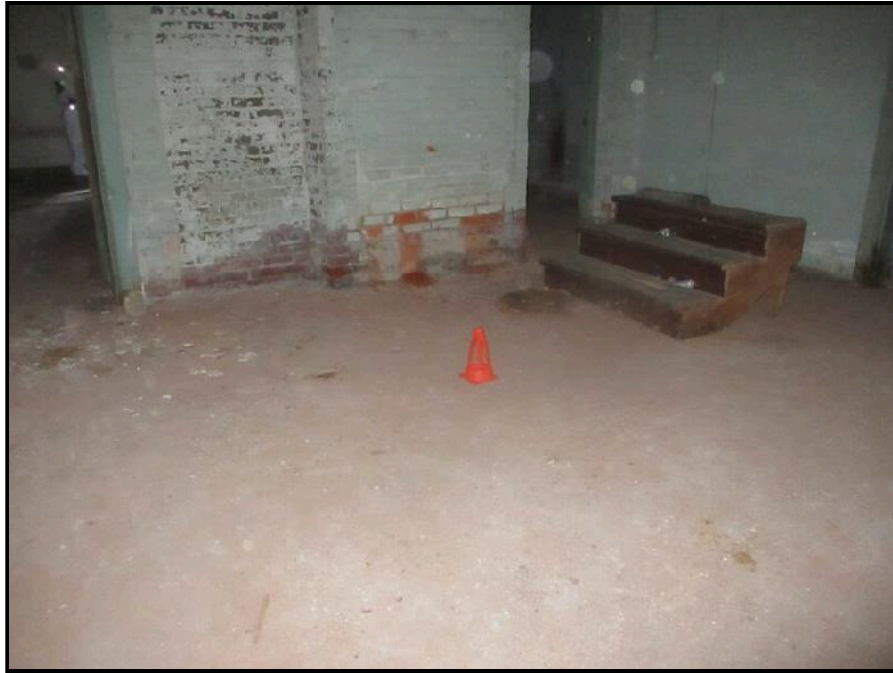
It should be noted that anomalies identified by the GPR Survey within the basement of the Bennett Building are not depicted in the attached mapping provided by GPRS due to GPS satellite obstruction from the building structure; therefore, the anomalies identified within the basement are depicted in the attached Bennett Building Basement Assessment Map developed by F&R. The GPRS Job Summary Reports are included as an attachment to this report. Refer to the attached mapping for their locations.

Photo showing a potential anomaly marked during the GPR survey in the basement of the Bennett Building.

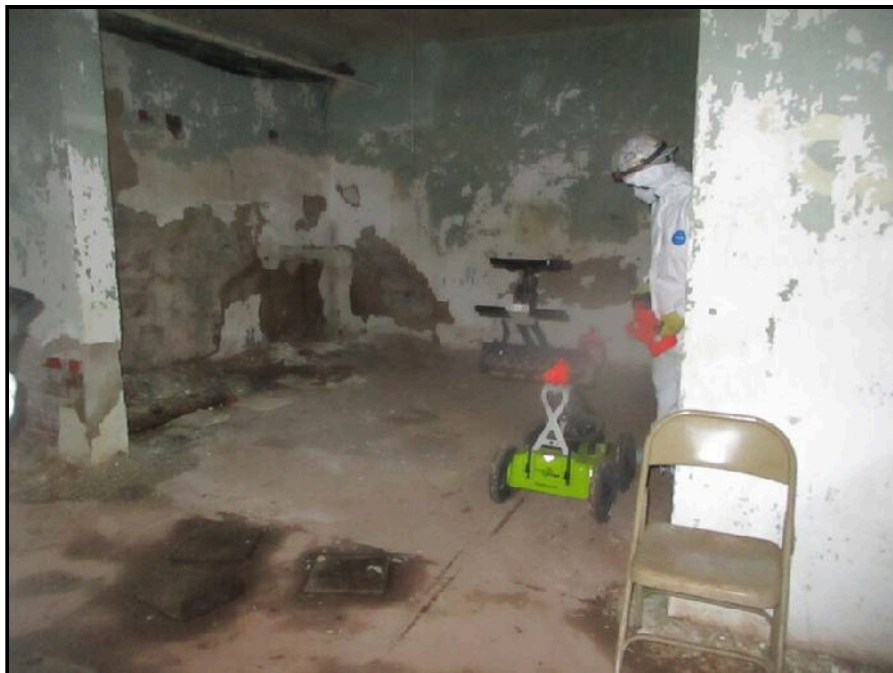
Photo showing a potential anomaly marked during the GPR survey in the basement of the Bennett Building.
