RESERVE ANALYSIS REPORT

Marina Village Condominium Association of Brevard, Inc.
Merritt Island, FL

Report Period: Jan 01, 2024 - Dec 31, 2024

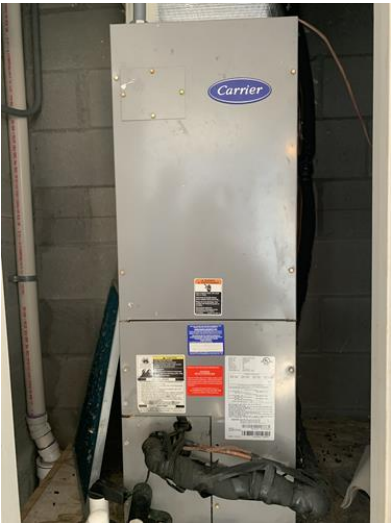
Air Conditioning Units Replacement - Phase 1			Maintenance / Operating
Useful Life	12 Year(s)	Replacement %	100.00%
Remaining Life	11 Year(s)	Quantity / Units	3 EA
Date in Service	2023	Unit Price	\$5,500.00 / EA
Effective Age	1	Current Cost	\$16,500
Source	Inspector	Inflation Rate	3.70%
GL Code		Starting Reserve Balance	\$0
Cost Center		Annual Fully Funding Requirement	\$0
Project Number		Fully Funded Reserve Balance	\$0
Owner		Annual Reserve Contribution	\$0

Description: Small size split air conditioning units service main floor elevator lobbies and the club house.

Notes: Small size HVAC units (1 to 5-ton range) are replaced on an ongoing as need basis and as a result, the life cycle can vary. However, for the purposes of this analysis a 10-year life cycle was established for the replacement of the units. An allowance is provided for replacement of all units.

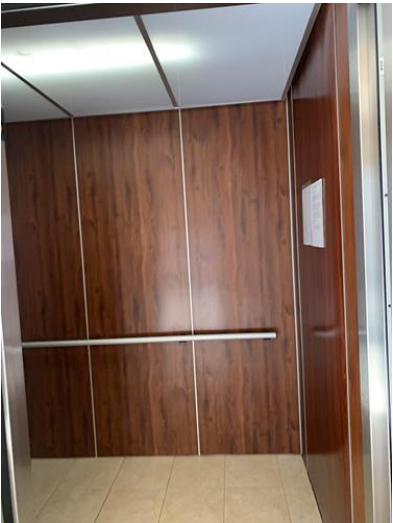
Elevator Cab Interior-bldg 540			Reserve Component
Useful Life	15 Year(s)	Replacement %	100.00%
Remaining Life	3 Year(s)	Quantity / Units	1 EA
Date in Service	2012	Unit Price	\$15,600.00 / EA
Effective Age	12	Current Cost	\$15,600
Source	Inspector	Inflation Rate	3.70%
GL Code		Starting Reserve Balance	\$5,019
Cost Center		Annual Fully Funding Requirement	\$1,040
Project Number		Fully Funded Reserve Balance	\$12,480
Owner		Annual Reserve Contribution	\$1,283

Description: Elevator interior Remodeling.

Notes: The cost and life cycle to remodel an elevator cab interior can vary depending on the cosmetic tastes and preferences of the Association. An allowance is provided to update the cab interior.

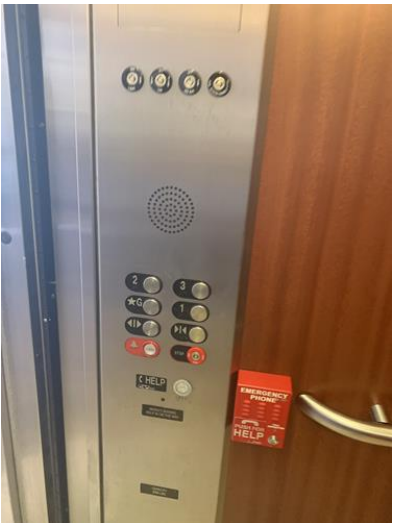
Elevator Cab Interior-bldg 550			Reserve Component
Useful Life	15 Year(s)	Replacement %	100.00%
Remaining Life	9 Year(s)	Quantity / Units	1 EA
Date in Service	2018	Unit Price	\$15,600.00 / EA
Effective Age	6	Current Cost	\$15,600
Source	Inspector	Inflation Rate	3.70%
GL Code		Starting Reserve Balance	\$2,510
Cost Center		Annual Fully Funding Requirement	\$1,040
Project Number		Fully Funded Reserve Balance	\$6,240
Owner		Annual Reserve Contribution	\$1,283

Description: Elevator interior remodeling.

Notes: The cost and life cycle to remodel an elevator cab interior can vary depending on the cosmetic tastes and preferences of the Association. An allowance is provided to update the cab interior.

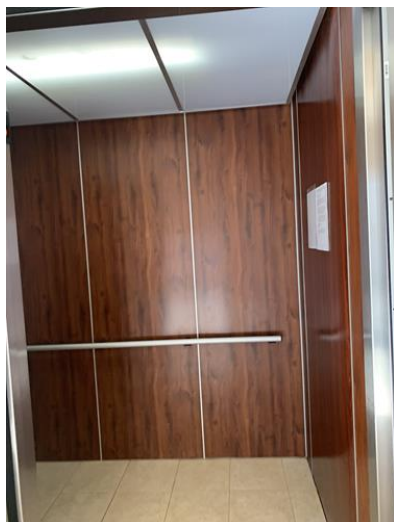
**Elevator Cab Interior-bldg 580***Reserve Component*

Notes: The cost and life cycle to remodel an elevator cab interior can vary depending on the cosmetic tastes and preferences of the Association. An allowance is provided to update the cab interior.

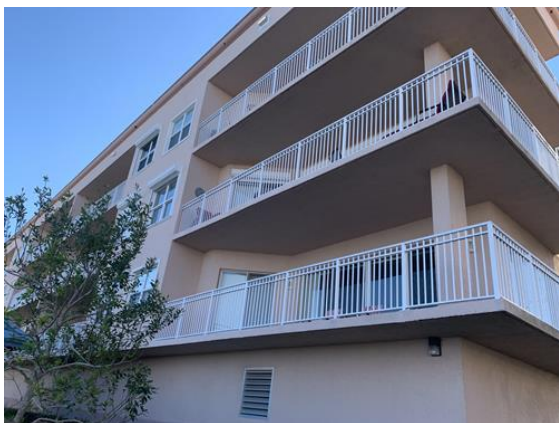
Description: Aluminum railings

Useful Life	15 Year(s)	Replacement %	100.00%
Remaining Life	15 Year(s)	Quantity / Units	2,967 LF
Date in Service	2023	Unit Price	\$12.91 / LF
Effective Age	0	Current Cost	\$38,315
Source	Contract	Inflation Rate	3.70%
GL Code		Starting Reserve Balance	\$0
Cost Center		Annual Fully Funding Requirement	\$2,554
Project Number		Fully Funded Reserve Balance	\$0
Owner		Annual Reserve Contribution	\$3,151

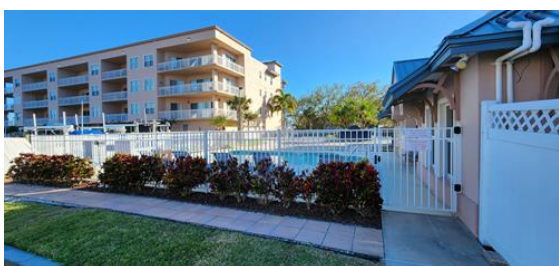
Description: Aluminum railing.

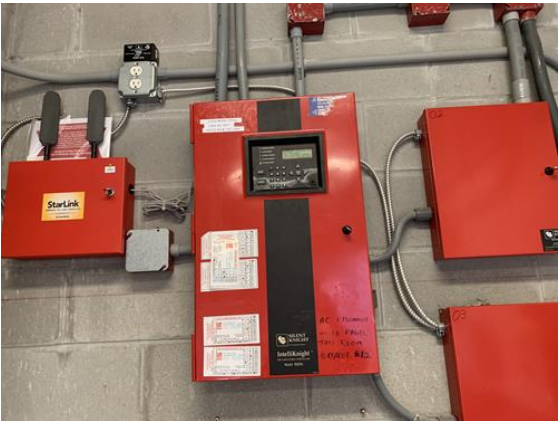
Fire Alarm and Detection System			Reserve Component
Useful Life	25 Year(s)	Replacement %	100.00%
Remaining Life	10 Year(s)	Quantity / Units	1 ALW
Date in Service	2008	Unit Price	\$83,200.00 / ALW
Effective Age	15	Current Cost	\$83,200
Source	Inspector	Inflation Rate	3.70%
GL Code		Starting Reserve Balance	\$20,077
Cost Center		Annual Fully Funding Requirement	\$3,328
Project Number		Fully Funded Reserve Balance	\$49,920
Owner		Annual Reserve Contribution	\$4,106

Notes: New innovations and improvements in technology may require that the fire alarm and detection system be updated every 20 to 25 years. Fire safety code and municipality ordinance changes may require system upgrade/modification; therefore, it is recommended that before any funding decisions are made a qualified life safety consultant evaluates and assess the fire alarm and detection system to determine more specific cost and period parameters. An Allowance is provided to upgrade the system.

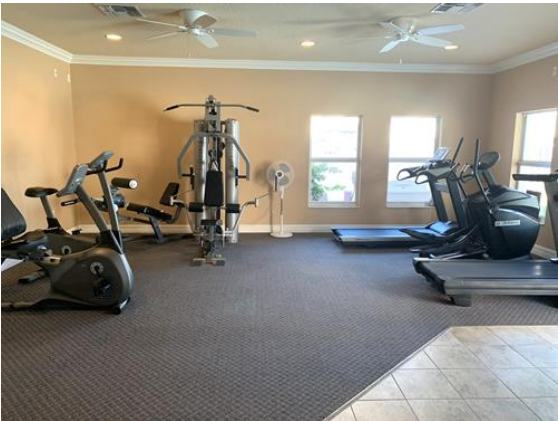
Gym Equipment Replacement			Maintenance / Operating
Useful Life	10 Year(s)	Replacement %	100.00%
Remaining Life	5 Year(s)	Quantity / Units	1 ALW
Date in Service	2016	Unit Price	\$26,520.00 / ALW
Effective Age	5	Current Cost	\$26,520
Source	Inspector	Inflation Rate	3.70%
GL Code		Starting Reserve Balance	\$0
Cost Center		Annual Fully Funding Requirement	\$0
Project Number		Fully Funded Reserve Balance	\$0
Owner		Annual Reserve Contribution	\$0

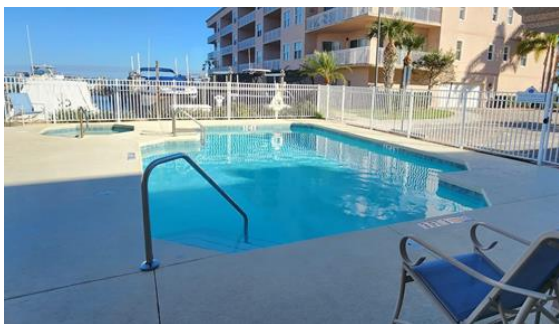
Pool and Jacuzzi Resurface

Notes: Assuming that proper design and installation was provided, and routine maintenance is performed, including proper chemical balancing, the interior surfaces of the swimming pool will require resurfacing on a 10-year cycle. The cost to refinish or resurface the interior of the swimming pool and jacuzzi will vary depending on the type of system selected. The allowance amounts provide for minor structural repairs and installation of new interior finishes.

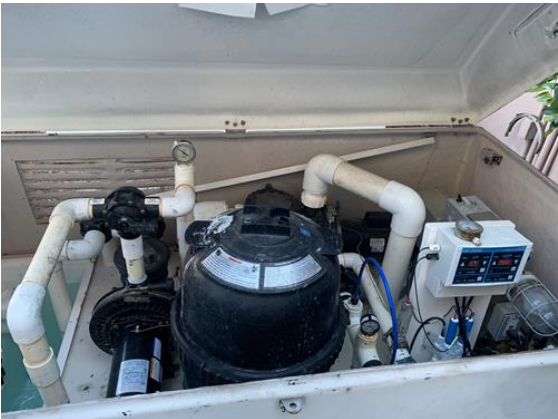
Swimming Pool Equipment			Reserve Component
Useful Life	10 Year(s)	Replacement %	100.00%
Remaining Life	7 Year(s)	Quantity / Units	1 ALW
Date in Service	2021	Unit Price	\$13,000.00 / ALW
Effective Age	3	Current Cost	\$13,000
Source	Inspector	Inflation Rate	3.70%
GL Code		Starting Reserve Balance	\$1,569
Cost Center		Annual Fully Funding Requirement	\$1,300
Project Number		Fully Funded Reserve Balance	\$3,900
Owner		Annual Reserve Contribution	\$1,604

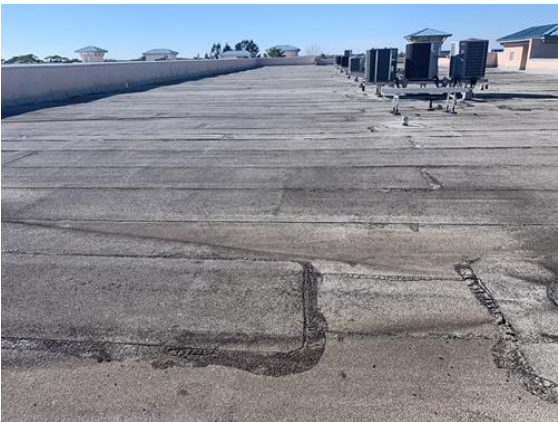
Flat Roof Single Ply-Bldg 540			Reserve Component
Useful Life	20 Year(s)	Replacement %	100.00%
Remaining Life	20 Year(s)	Quantity / Units	14,300 SF
Date in Service	2005	Unit Price	\$36.40 / SF
Effective Age	0	Current Cost	\$520,520
Source	Inspector	Inflation Rate	3.70%
GL Code		Starting Reserve Balance	\$0
Cost Center		Annual Fully Funding Requirement	\$26,026
Project Number		Fully Funded Reserve Balance	\$0
Owner		Annual Reserve Contribution	\$32,109

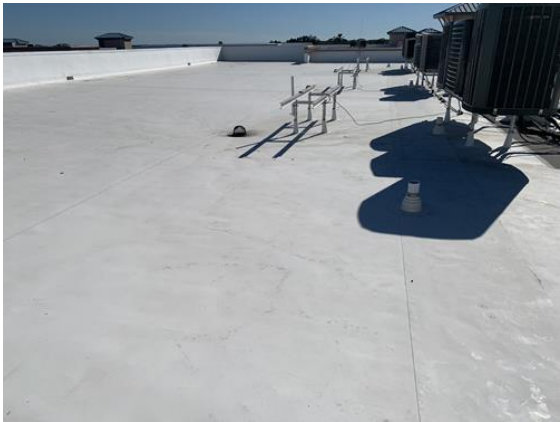
Flat Roof Single Ply-Bldg 550			Reserve Component
Useful Life	20 Year(s)	Replacement %	100.00%
Remaining Life	14 Year(s)	Quantity / Units	7,500 SF
Date in Service	2018	Unit Price	\$36.40 / SF
Effective Age	6	Current Cost	\$273,000
Source	Inspector	Inflation Rate	3.70%
GL Code		Starting Reserve Balance	\$32,939
Cost Center		Annual Fully Funding Requirement	\$13,650
Project Number		Fully Funded Reserve Balance	\$81,900
Owner		Annual Reserve Contribution	\$16,841

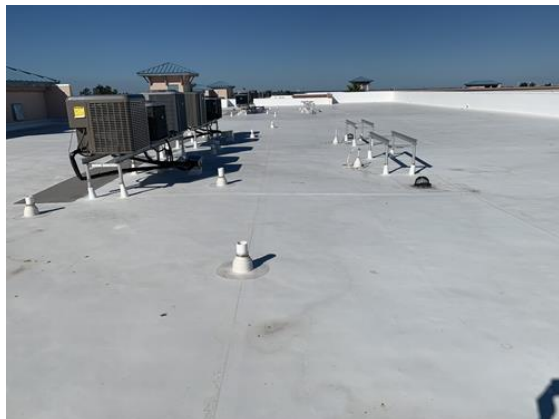
**Flat Roof Single Ply-Bldg 580***Reserve Component*

Notes: The useful life of roof systems will vary depending on the quality of the materials, method of installation and on the established maintenance plan. This report recommends that the Association budgets for ongoing roof service maintenance that includes periodic inspections and repairs. Special attention should be placed on inspection and repairs of flashings, pitch pans and roof penetrations. Service maintenance should be performed by a licensed roofing contractor. Roof maintenance is considered a building operating expense and it is not included in this report. Prior to replacing or performing any major repairs, the roofing system should be evaluated by a qualified licensed (architect/engineer) professional. The evaluation of the roofing systems should be to identify deficiencies including addressing inadequate slopes and the presence of moisture, and if required formulate appropriate repair or replace recommendations.

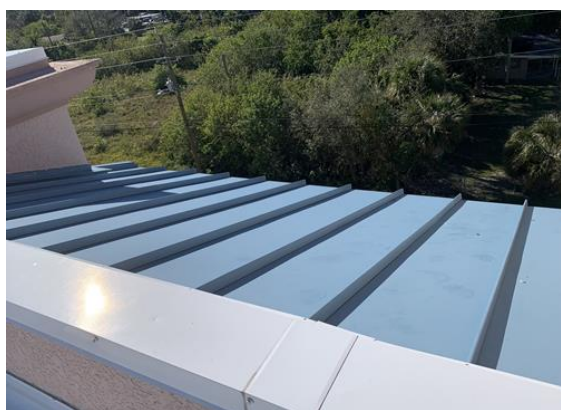
**Slope Roof-Bldg 540***Reserve Component*

Notes: Useful life and cost of roof system will vary depending on the quality of the system, method of installation, and regular maintenance. Prior to replacing or providing major repairs the roofs should be evaluated by an engineer or architect.

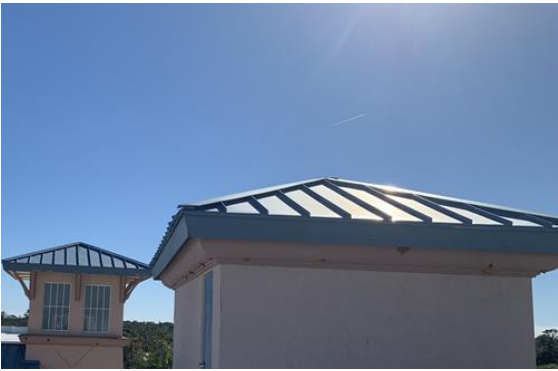
Slope Roof-Bldg 580			Reserve Component
Useful Life	25 Year(s)	Replacement %	100.00%
Remaining Life	15 Year(s)	Quantity / Units	1,324 SF
Date in Service	2007	Unit Price	\$26.00 / SF
Effective Age	10	Current Cost	\$34,424
Source	Inspector	Inflation Rate	3.70%
GL Code		Starting Reserve Balance	\$5,538
Cost Center		Annual Fully Funding Requirement	\$1,377
Project Number		Fully Funded Reserve Balance	\$13,770
Owner		Annual Reserve Contribution	\$1,699

Notes: Useful life and cost of roof system will vary depending on the quality of the system, method of installation, and regular maintenance. Prior to replacing or providing major repairs the roofs should be evaluated by an engineer or architect.

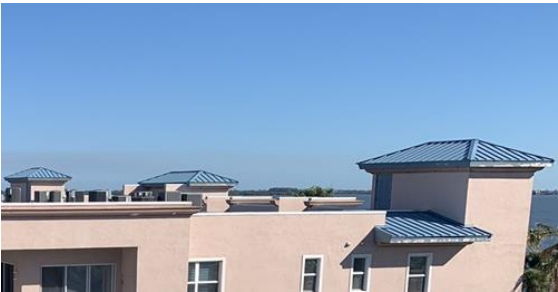
Slope Roof-Bldg 590			Reserve Component
Useful Life	25 Year(s)	Replacement %	100.00%
Remaining Life	10 Year(s)	Quantity / Units	1,601 SF
Date in Service	2006	Unit Price	\$26.00 / SF
Effective Age	15	Current Cost	\$41,626
Source	Inspector	Inflation Rate	3.70%
GL Code		Starting Reserve Balance	\$10,045
Cost Center		Annual Fully Funding Requirement	\$1,665
Project Number		Fully Funded Reserve Balance	\$24,976
Owner		Annual Reserve Contribution	\$2,054

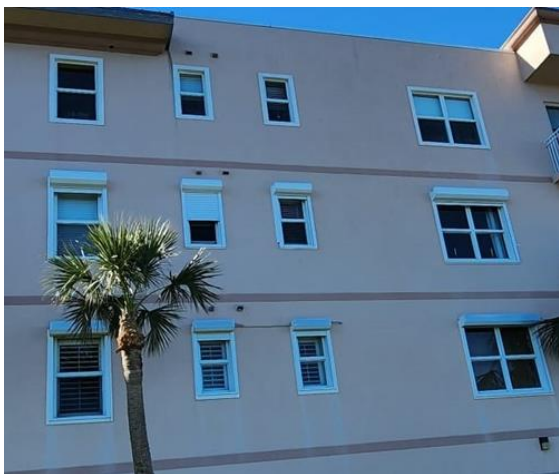
**Windows Replacement***Individual Homeowner Responsibility*

Description: Window system.
