# Uniform Mitigation Verification Inspection Form

| Owner Name: Marina Village Condo Association | | Contact Person: |
| Address: 550 S Banana River Dr | | Home Phone: |
| Year of Home: 2006 | # of Stories: 4 | Email: |

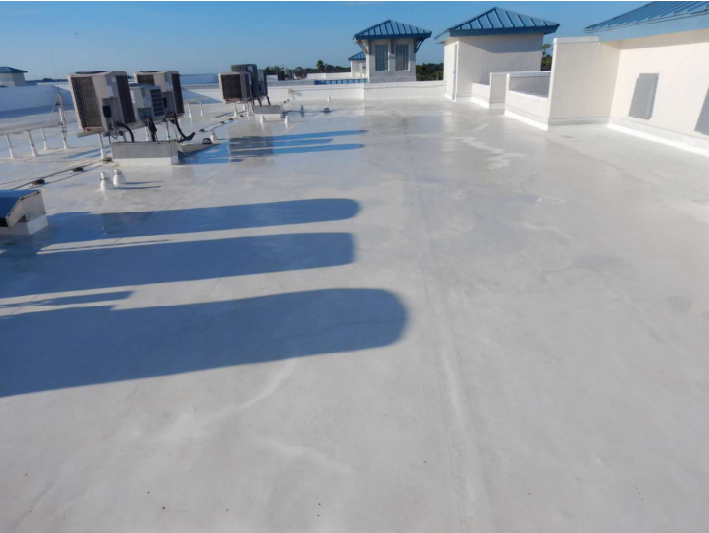
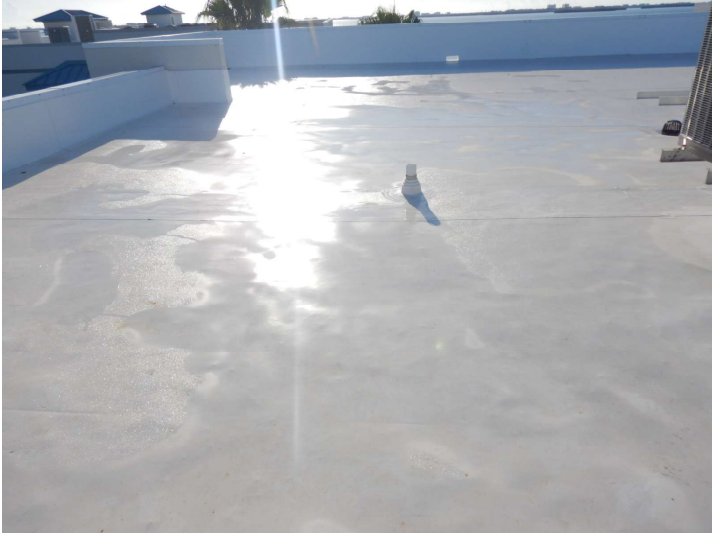
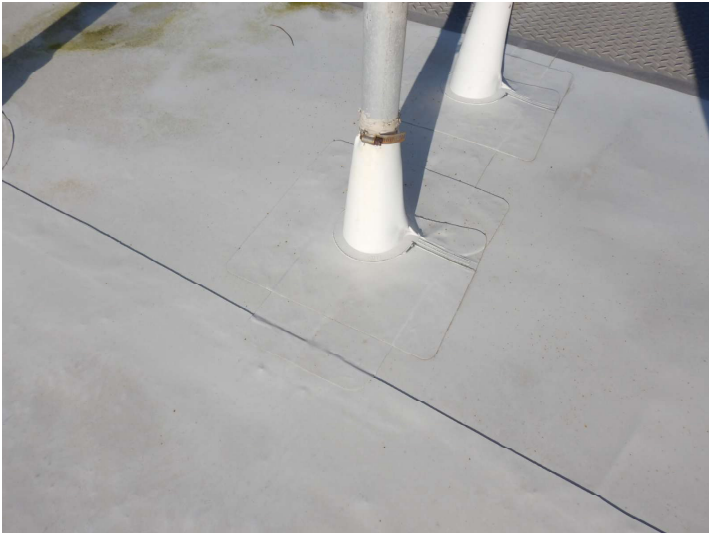
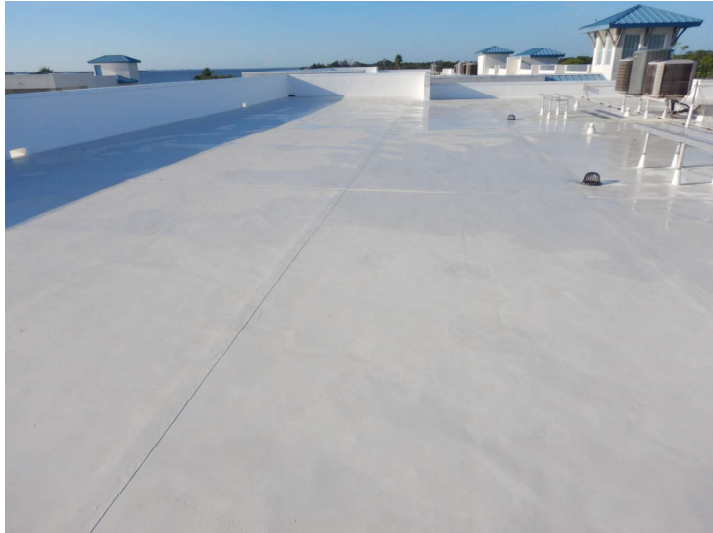
- ☐ A. Hip Roof      Hip roof with no other roof shapes greater than 10% of the total roof system perimeter.  
Total length of non-hip features: \_\_\_\_\_ feet; Total roof system perimeter: \_\_\_\_\_ feet
- ☒ B. Flat Roof      Roof on a building with 5 or more units where at least 90% of the main roof area has a roof slope of less than 2:12. Roof area with slope less than 2:12 \_\_\_\_\_ sq ft; Total roof area \_\_\_\_\_ sq ft
- ☐ C. Other Roof      Any roof that does not qualify as either (A) or (B) above.

Roof overview

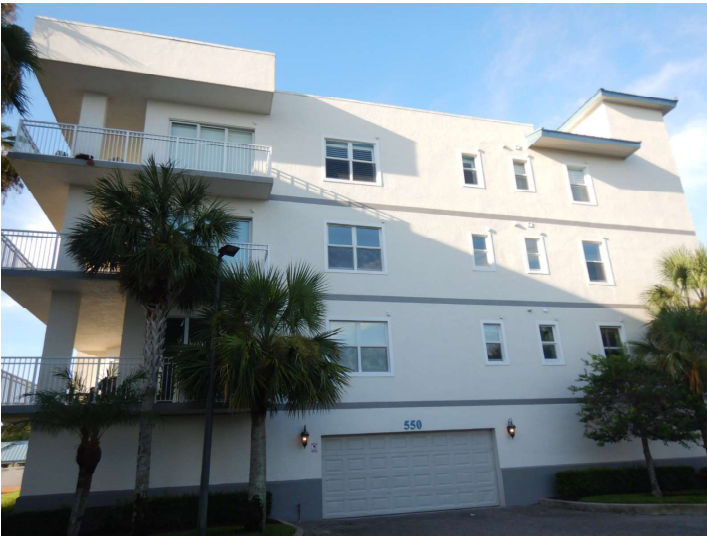
| Opening Protection Level Chart<br>Place an "X" in each row to identify all forms of protection in use for each opening type. Check only one answer below (A thru X), based on the weakest form of protection (lowest row) for any of the Glazed openings and indicate the weakest form of protection (lowest row) for Non-Glazed openings. | | Glazed Openings | | | | Non-Glazed Openings | |
|---|---|---|---|---|---|---|---|
| X | No Windborne Debris Protection | X | | | | X | X |

Non glazed garage opening

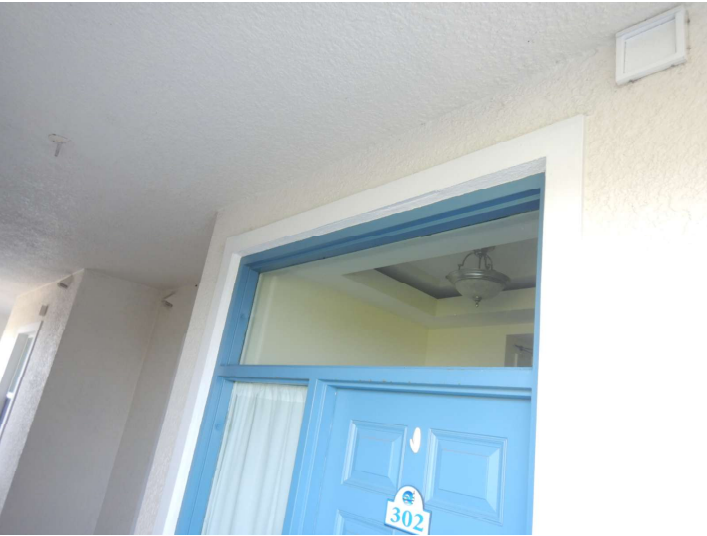
Glazed opening
