# Uniform Mitigation Verification Inspection Form

| Inspection Date: 05/31/2019 | | |
| Owner Name: Marina Village Condominium Association | | Contact Person: |
| Address: 550 S Banana River Dr | | Home Phone: |

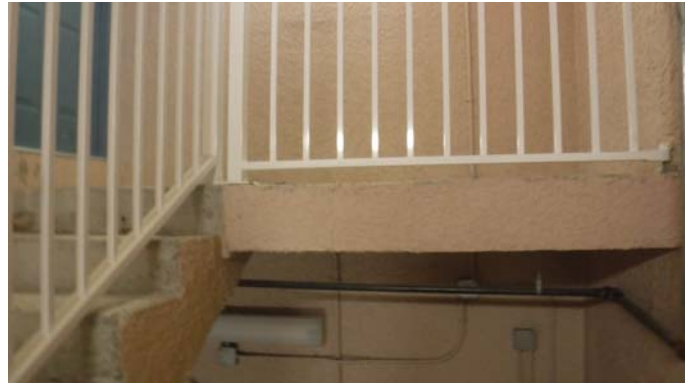
- ☒ D. Reinforced Concrete Roof Deck.
- ☐ E. Other: \_\_\_\_\_
- ☐ F. Unknown or unidentified.
- ☐ G. No attic access.

Concrete Roof decking

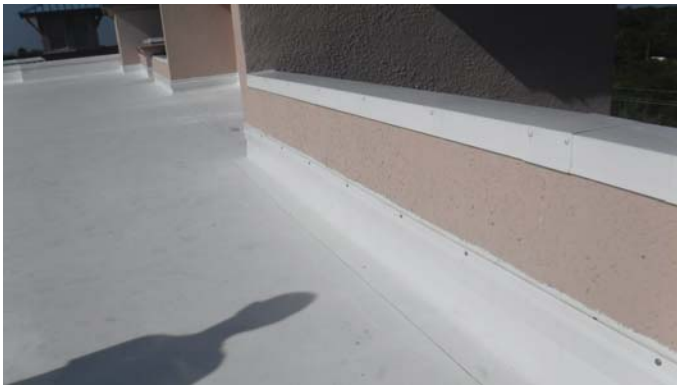
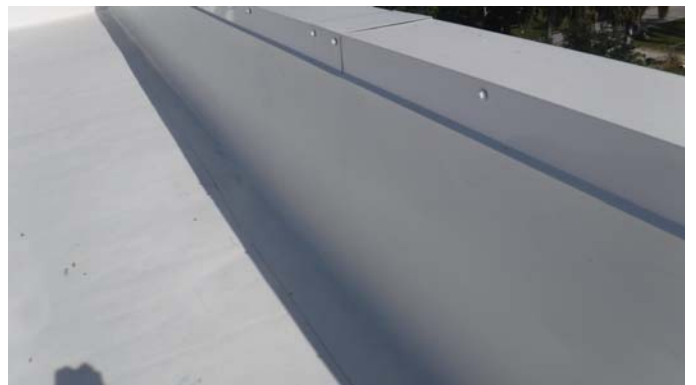
- ☒ E. Structural Anchor bolts structurally connected or reinforced concrete roof.
- ☐ F. Other: \_\_\_\_\_
- ☐ G. Unknown or unidentified
- ☐ H. No attic access

Structurally attached

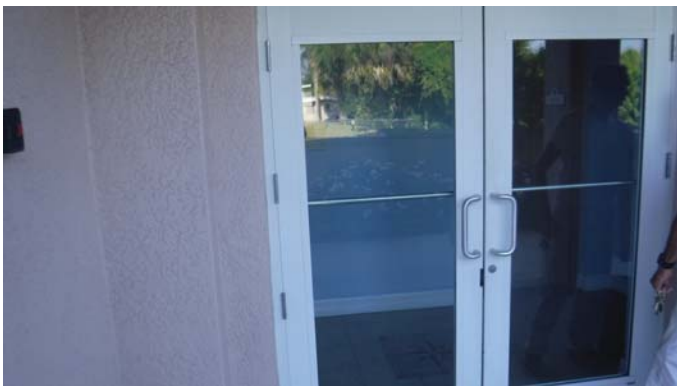
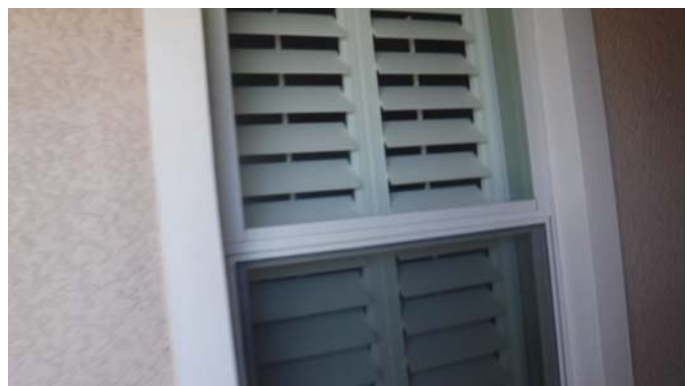
- ☒ **A. Exterior Openings Cyclic Pressure and 9-lb Large Missile (4.5 lb for skylights only)** All Glazed openings are protected at a minimum, with impact resistant coverings or products listed as wind borne debris protection devices in the product approval system of the State of Florida or Miami-Dade County and meet the requirements of one of the following for "Cyclic Pressure and Large Missile Impact" (Level A in the table above).

Glazed openings - impact rated

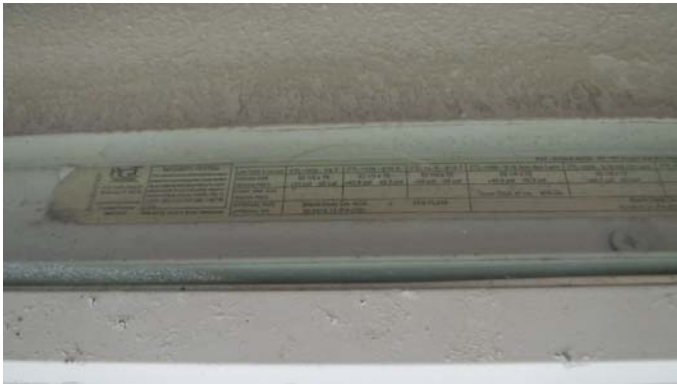
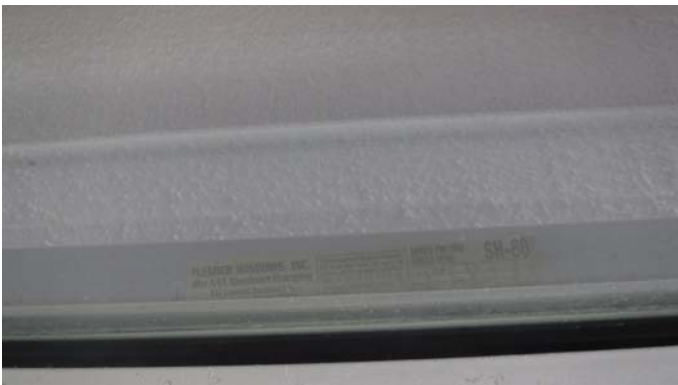
Window sticker

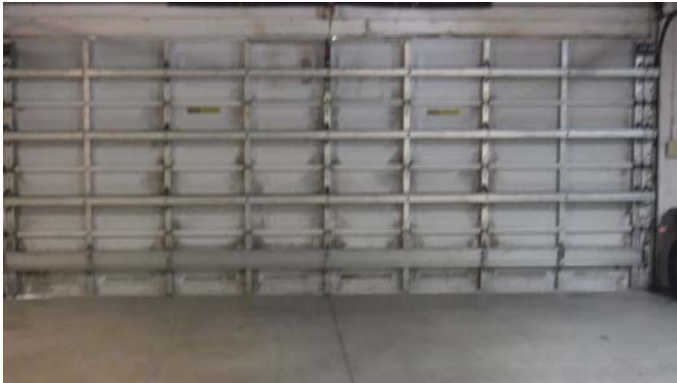
Garage door - impact rated

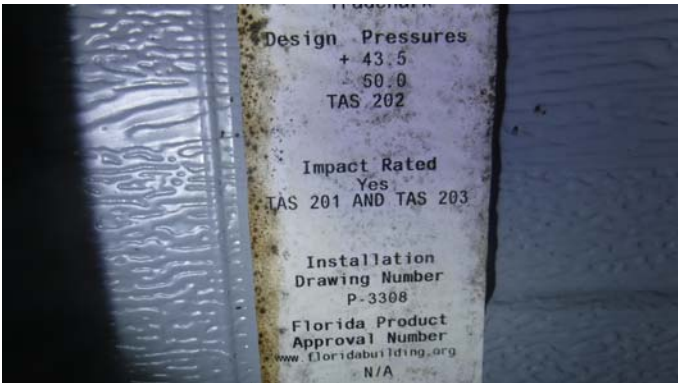
Garage door sticker

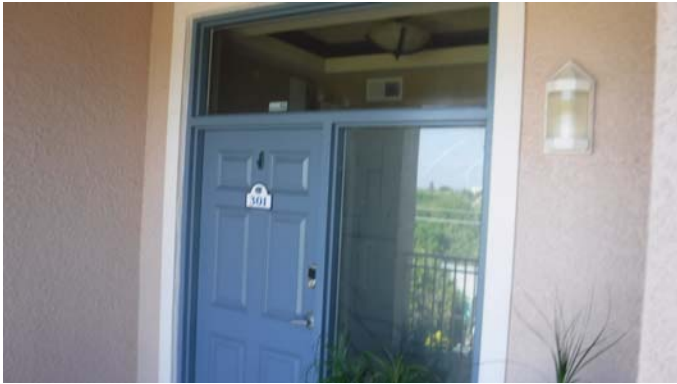
| Opening Protection Level Chart<br>Place an "X" in each row to identify all forms of protection in use for each opening type. Check only one answer below (A thru X), based on the weakest form of protection (lowest row) for any of the Glazed openings and indicate the weakest form of protection (lowest row) for Non-Glazed openings. | | Glazed Openings | | | | Non-Glazed Openings | |
|---|---|---|---|---|---|---|---|
| N | Opening Protection products that appear to be A or B but are not verified | | | | | X | |

- ☐ A.1 All Non-Glazed openings classified as A in the table above, or no Non-Glazed openings exist
- ☐ A.2 One or More Non-Glazed openings classified as Level D in the table above, and no Non-Glazed openings classified as Level B, C, N, or X in the table above
- ☒ A.3 One or More Non-Glazed Openings is classified as Level B, C, N, or X in the table above

Non-glazed - not verified

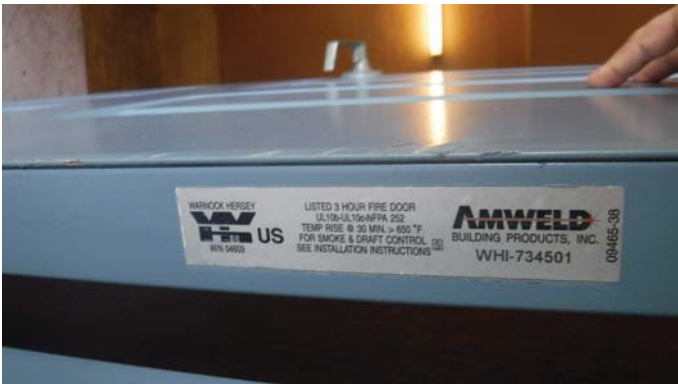
Non glazed sticker - fire rating only label
