Hope and Carton Hill Road Management Plan

January 2013

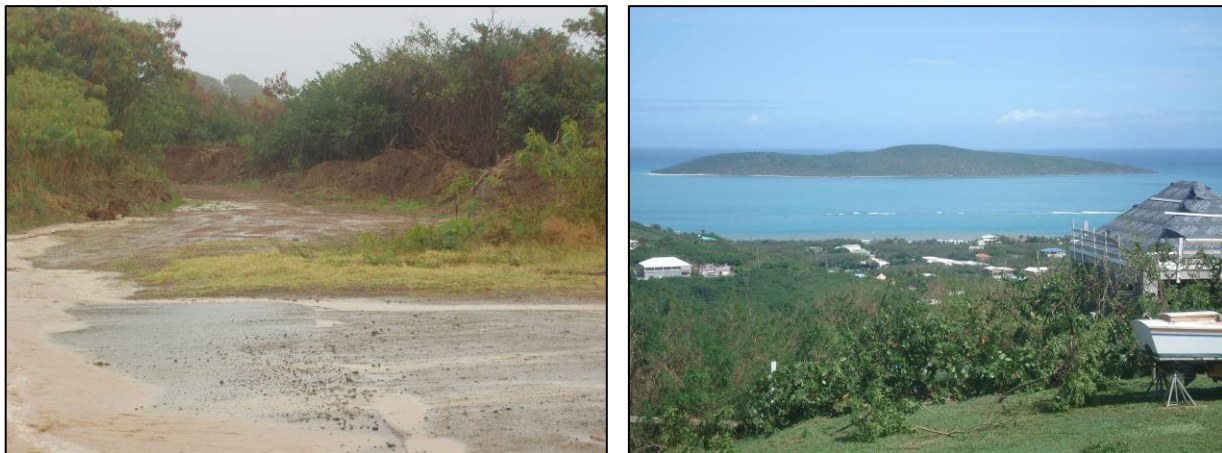
Figure 2. Sediment plume discharge into Solitude Bay, St. Croix, USVI (photo on right) from sources such as the Hope and Carton Hill road network (photo on left) after Hurricane Omar in 2008.

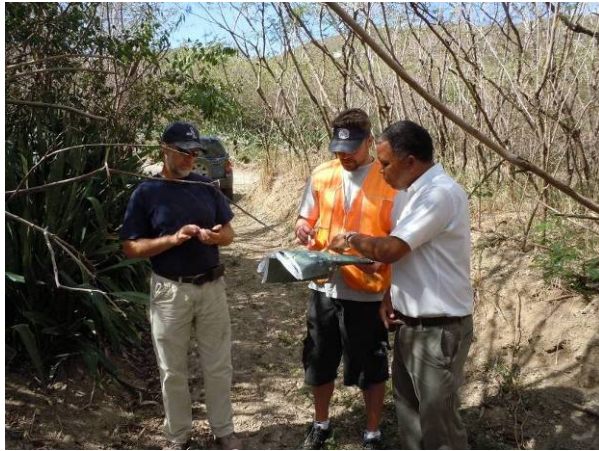
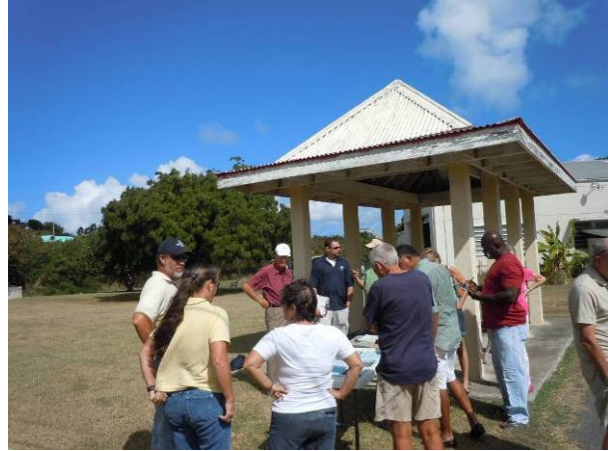
Figure 3. Initial site assessment (left) and neighborhood meeting at the Cotton Valley Fire Station (right), both conducted in March 2012.

In March 2012, HW conducted a site assessment of the Hope and Carton Hill road network with some of the residents (Figure 3). During the assessment, HW identified drainage flow paths and potential opportunities for stormwater management and road stabilization projects, as well as possible areas for implementation of a rain garden demonstration project. In addition, HW conducted two stakeholder meetings (in March and October) with representatives of the local Homeowners Association (HOA), as well as with interested residents, to discuss specific problem locations and restoration ideas (Figure 3). This road management plan was developed from both field findings and stakeholder input.

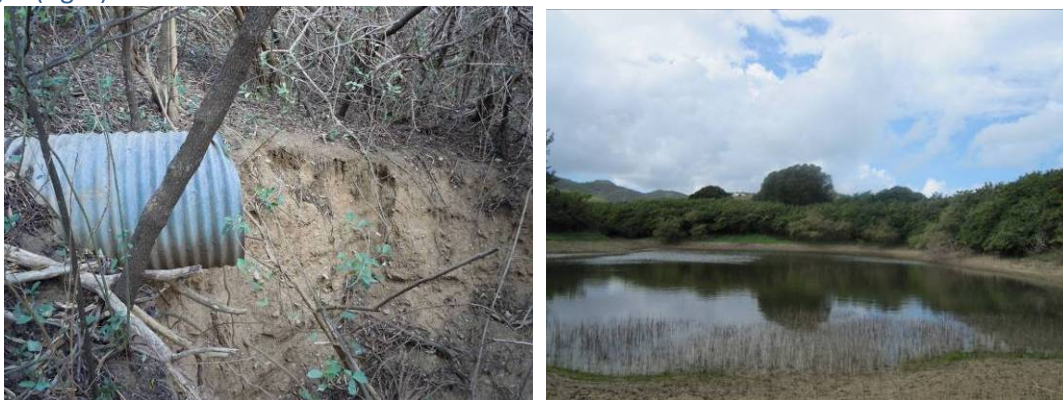
Figure 4. Large scour hole in the main gut, downstream of the 30-inch culvert under Pony Club Trail at entrance of Hope and Carton Hill (left). Further downstream, a large pond provides storage and habitat in the gut (right).

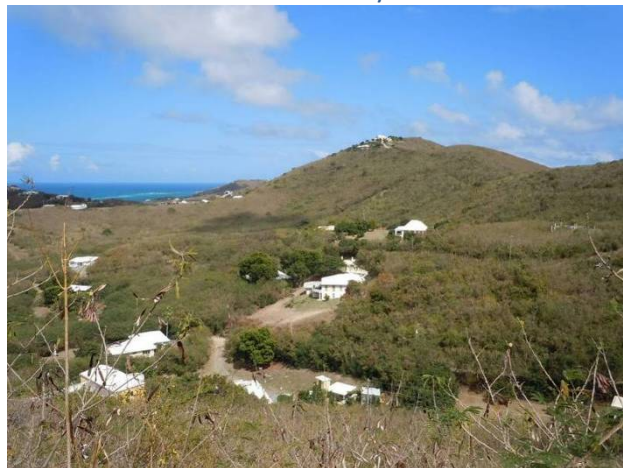
Figure 5. While the Hope and Carton Hill neighborhood is not densely developed and is well-vegetated, poor planning and lack of consideration for drainage and stormwater management has led to it being one of the leading sources of sediment in the Solitude Bay Watershed.

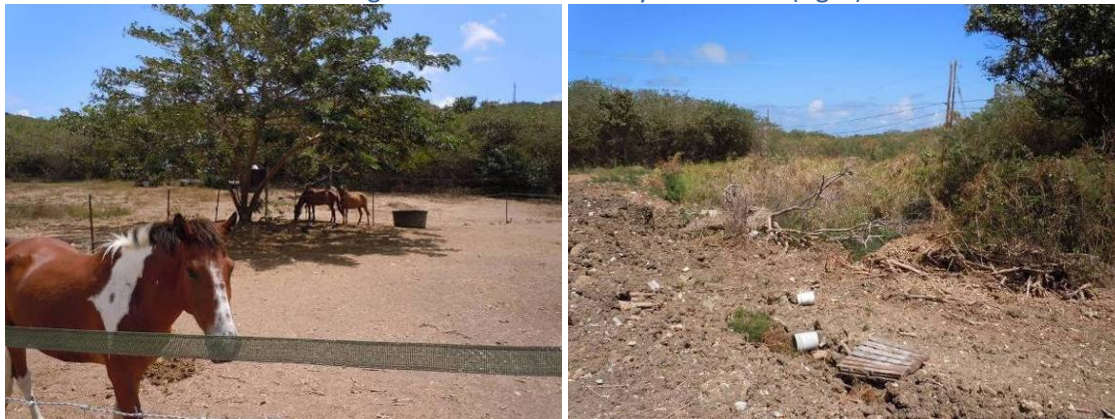
Figure 6. Horses are currently kept in pastures directly in the gut (left), and a small pond that had existed near the entrance to the neighborhood has recently been filled (right).

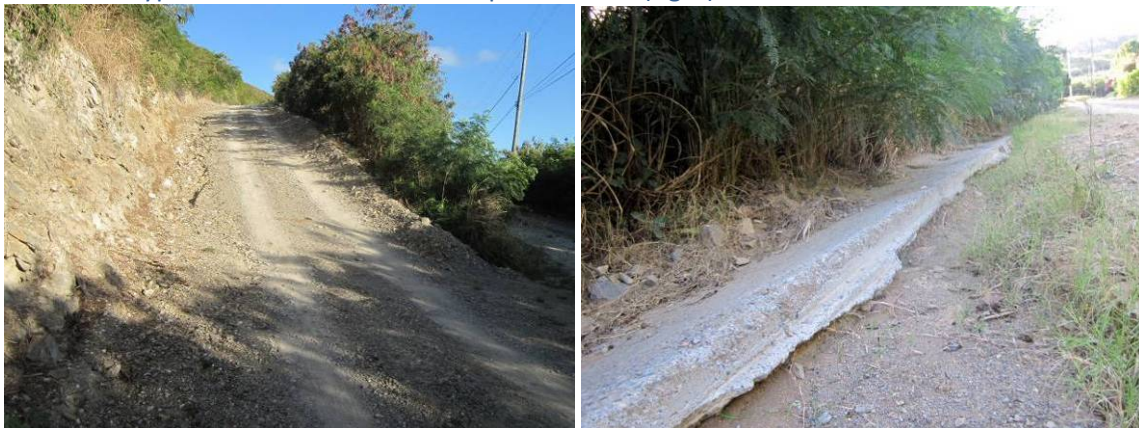
Figure 7. Roads in the Hope and Carton Hill Neighborhood are unpaved and very steep (left). Runoff from this road bypasses and undermines the paved swale (right).

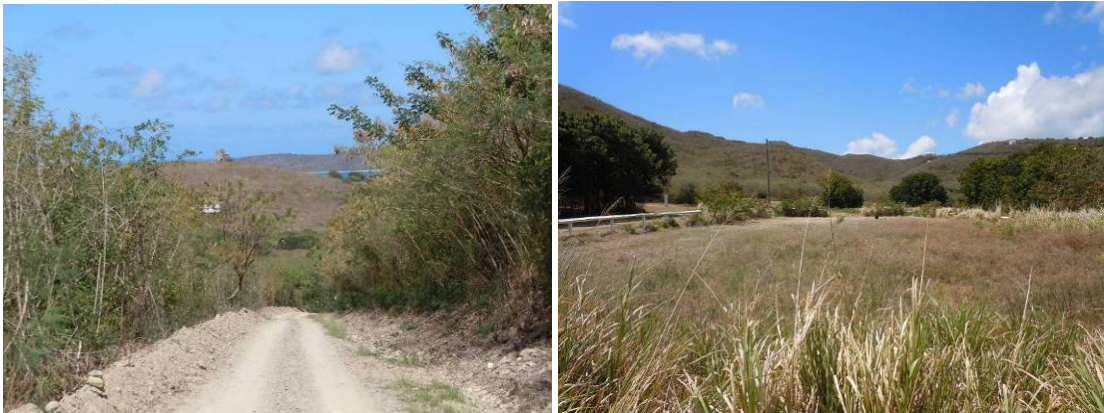
Figure 9. Pony Club Trail is very steep with an extremely eroding ditch on the inside (eastern) slope (left). The flat area between Pony Club Trail and the gut is currently used as a practice corral for the pony club (right).

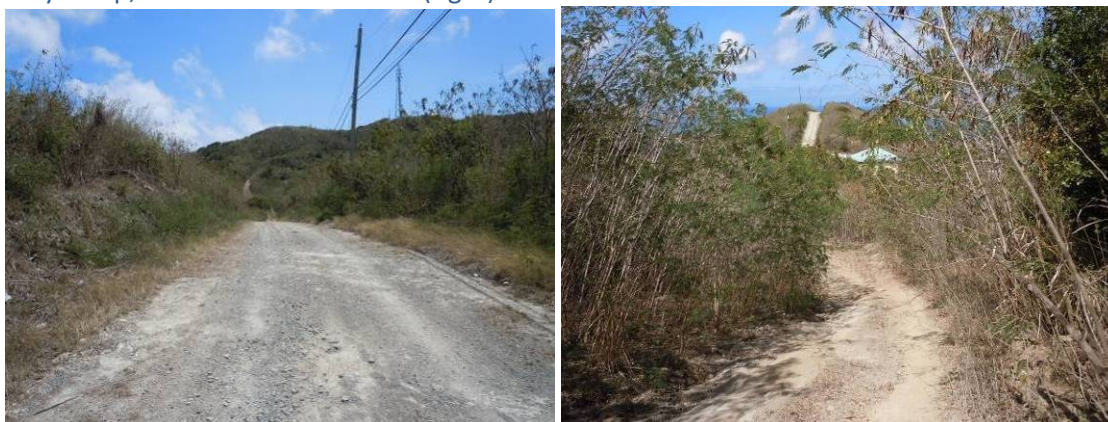
Figure 10. Coral Reef Trail in this area runs along the top of a ridge (left); this photo is looking down the extremely steep, eroded cell tower road (right).

Station	Associated Road Segment(s)	Description	Site Photo
6 – Cell Tower Road	2	<ul style="list-style-type: none"> Install waterbars/water trenches all along the cell tower road to direct runoff into the surrounding vegetation rather than let it concentrate on the road and cause downstream flooding and sediment problems.

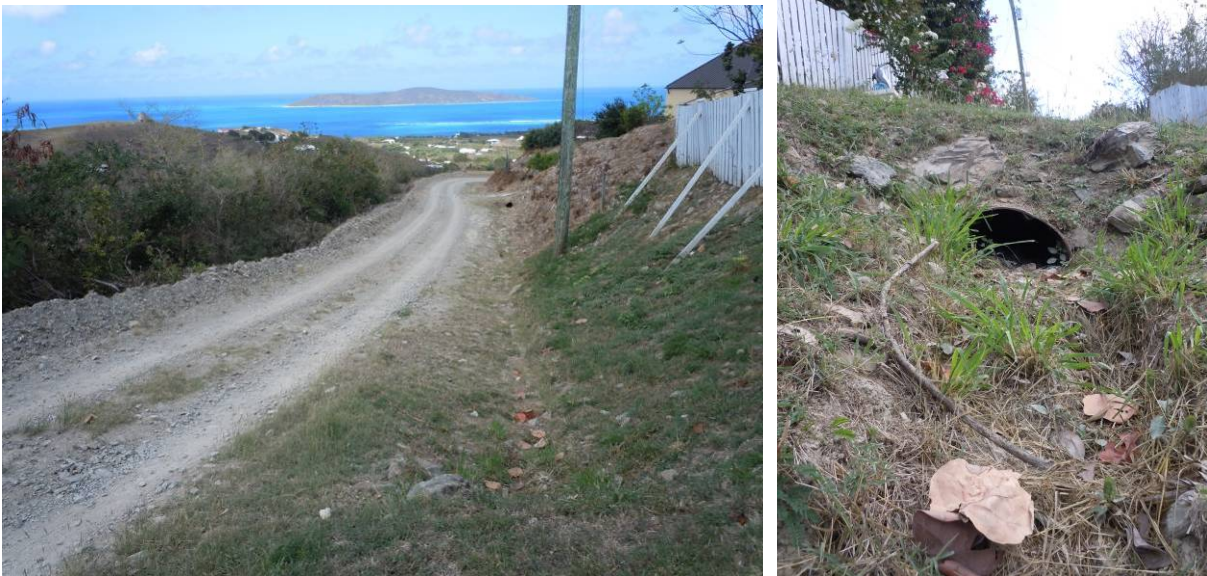
This section of Coral Reef Trail is extremely steep and is graded such that road runoff collects along the inslope, creating an eroded ditch along the whole segment (over 0.5 mile). There are two clogged/damaged 18-inch culverts under driveways along the upper portion of this segment (Figure 11). The roadside ditch along the last portion of this segment (near upper Divi-

Figure 11. Coral Reef Trail in this area is very steep (left) with damaged/clogged driveway culverts (right).

7 – Upper Coral Reef Trail Step Pools	3	<ul style="list-style-type: none"> Replace the existing damaged 18-inch corrugated metal driveway culverts with larger (at least 24-inch pipe), sturdier pipe with riprap on the downstream ends to prevent/reduce scour. Install six (6) waterbars to divert runoff into an enlarged swale along the inside of road. Use four (4) in the upper 200 feet of this section of Coral Reef Trail (which has a 20% slope) and two (2) more in the lower 200 feet (which has a slope of 10%). Consider water “trenches” for the four upper waterbars given steeper slope. Create step pools to slow flow and trap sediment.

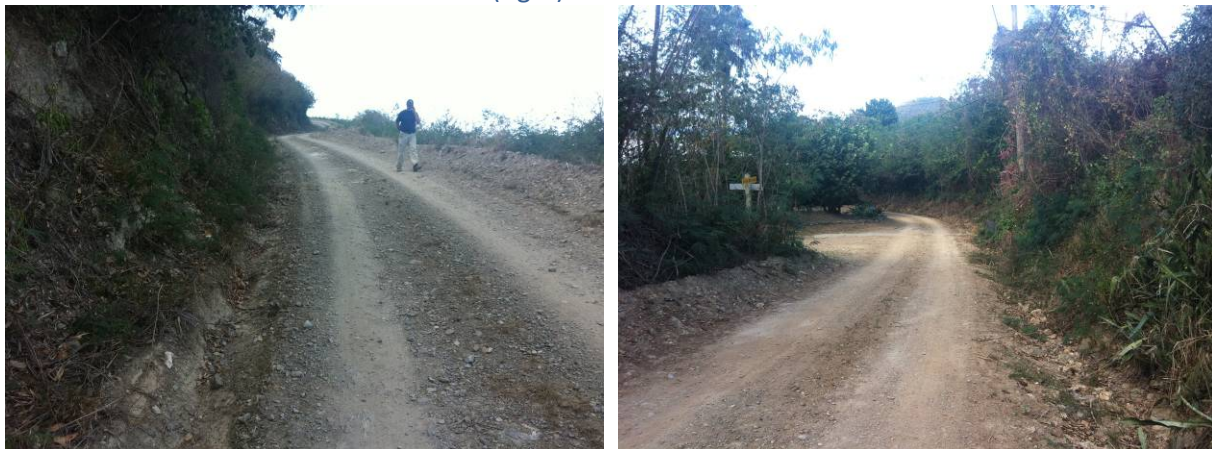
Figure 12. In some areas, the road has been graded down to the bedrock (left) with an eroding ditch on one side and earthen berm on the other (right).

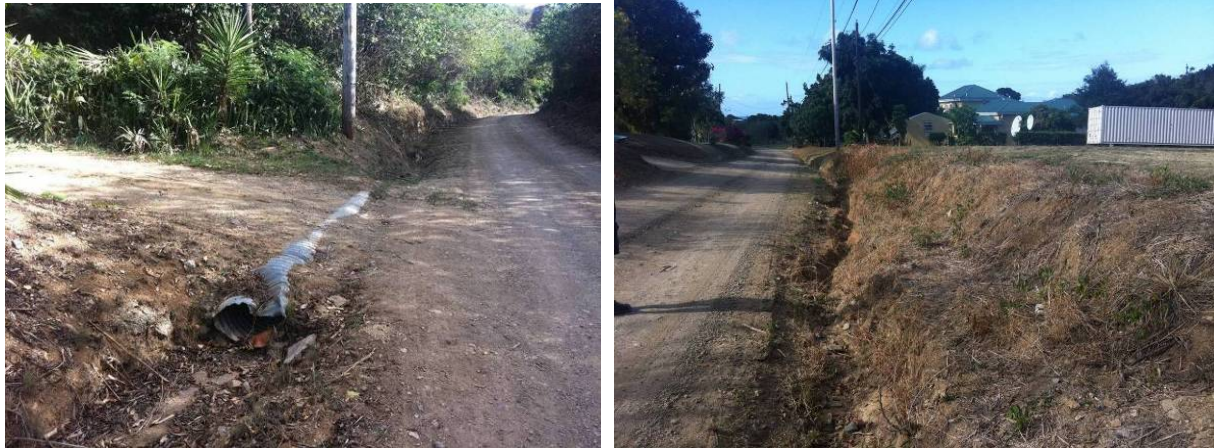
Figure 13. Damaged driveway culvert (left) and the eroding ditch serving as the gut (right).

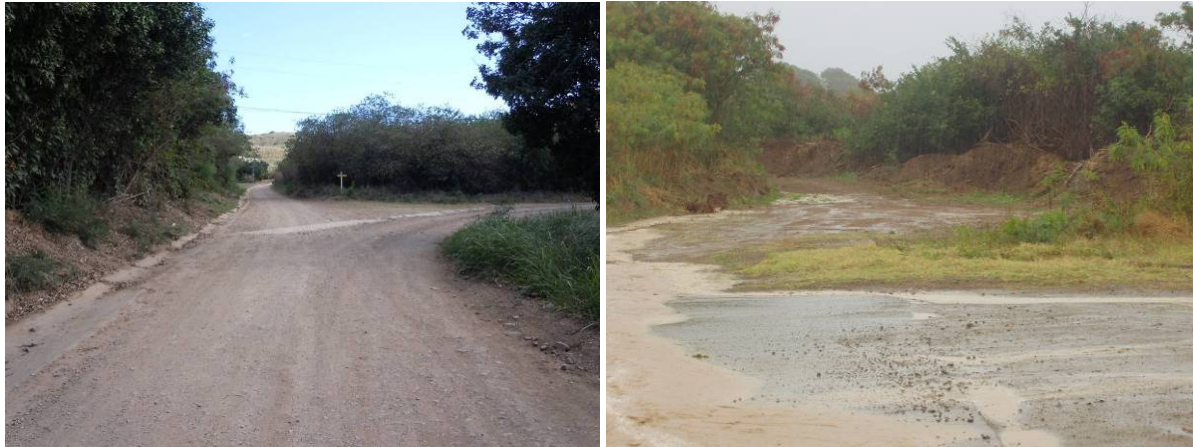
Figure 14. Shallow, paved swales at the downgradient end of Segment 4 (left), and a manmade drainage path created to help runoff reach the main gut – note piles of sediment exposed to runoff (right).

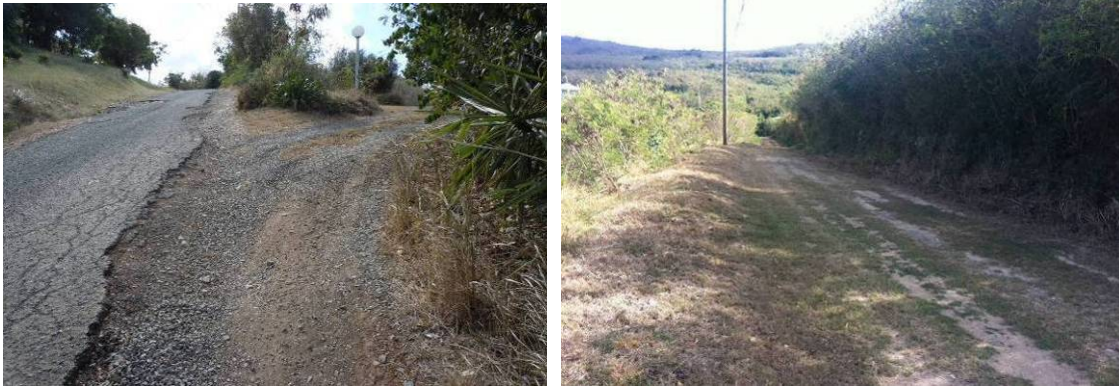
Divi-Divi Trail starts and ends on Segment 4, Coral Reef Trail. The first portion of the road (nearest the neighborhood entrance) climbs steadily uphill to the west, with an eroding paved swale on the south side of the road. The upper, steepest portion of this stretch was paved with asphalt at some point, which is now broken up and creating more drainage issues along the edges (Figure 15). The road then takes a sharp curve back towards the east, where there is another stretch of broken asphalt. A low point in the road coincides with two driveways (for Lots 46 and 60). The road continues on to the south where there is a long stretch (~1,000 ft) where runoff ponds along the inslope due to flatter slopes, rather than eroding a ditch. The road surface in this area even has some grass cover (Figure 15).

Figure 15. Broken asphalt along Divi-Divi Trail (left), and a grassy section of the road where the slope is flatter, little erosion has occurred, and some evidence of ponding was observed (right).

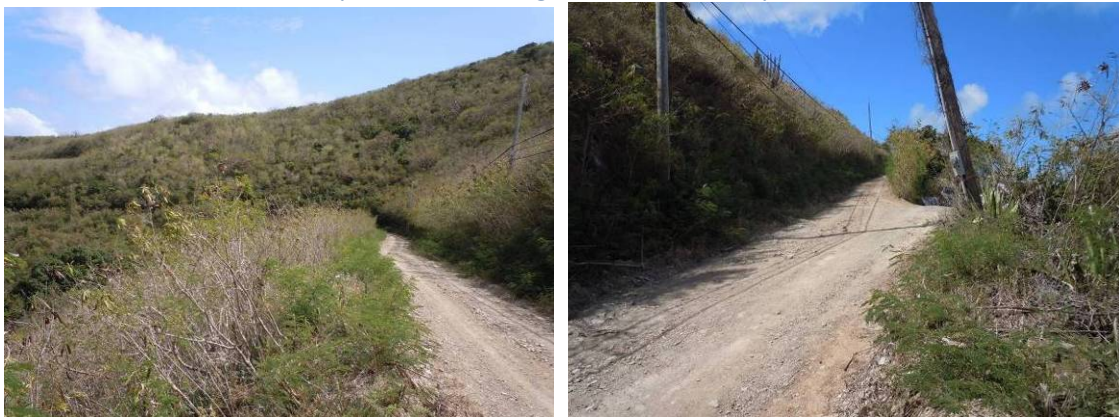
Figure 16. Yellow Cliff Trail is steep with an eroding ditch on the inslope.

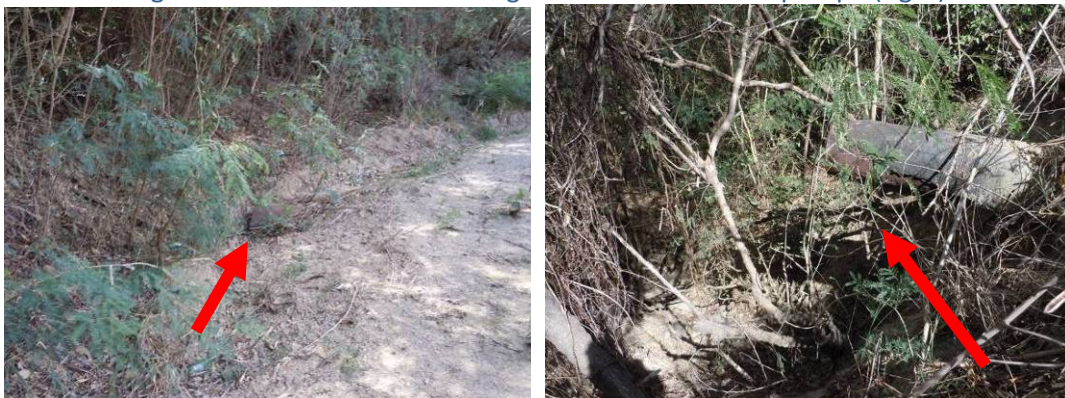
Figure 17. The upgradient end of the culvert is clogged with sediment, severely reducing its capacity (left), and the downgradient end has created a large scour hole on a steep slope (right).

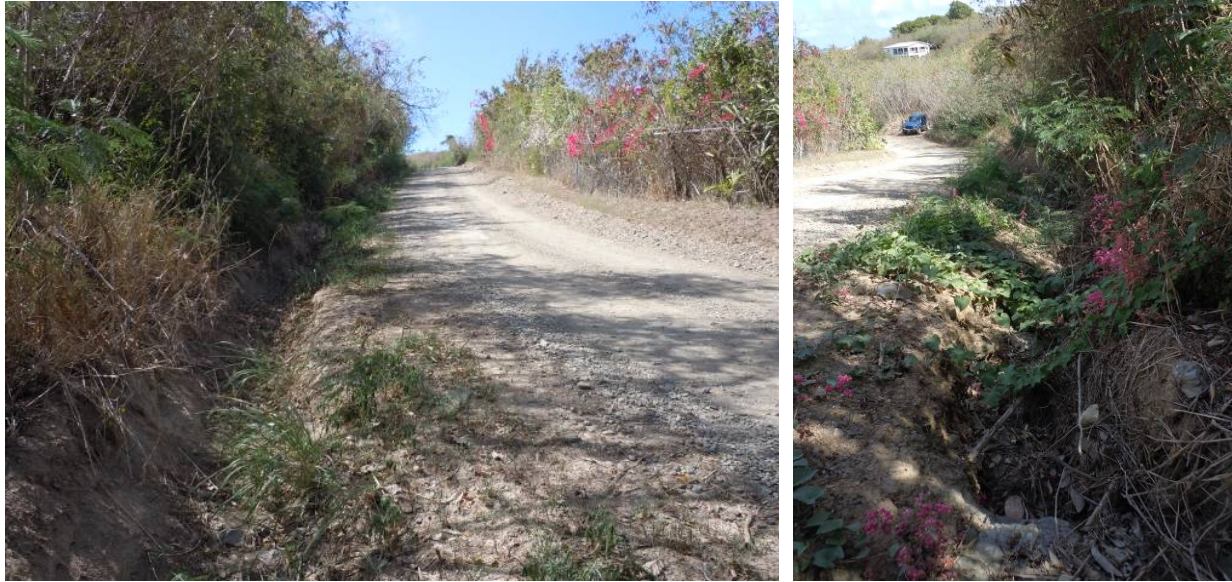
Figure 18. Looking uphill and downhill along the steep portion of this segment; the eroding ditch on the inslope is evident.

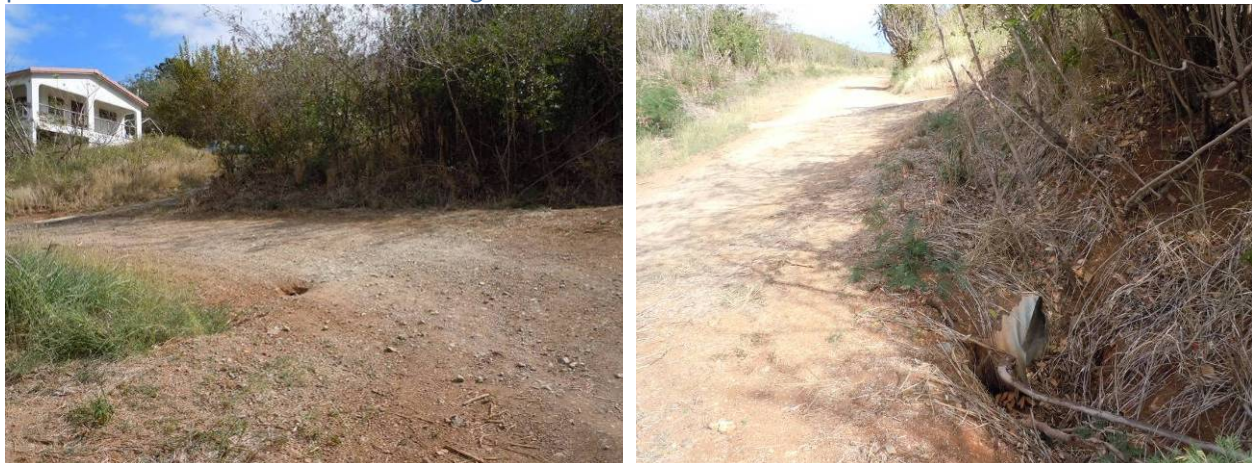
Figure 19. Clogged and damaged 24-inch corrugated metal culvert that carries runoff from the south portion of Hibiscus Circle across to the gut.

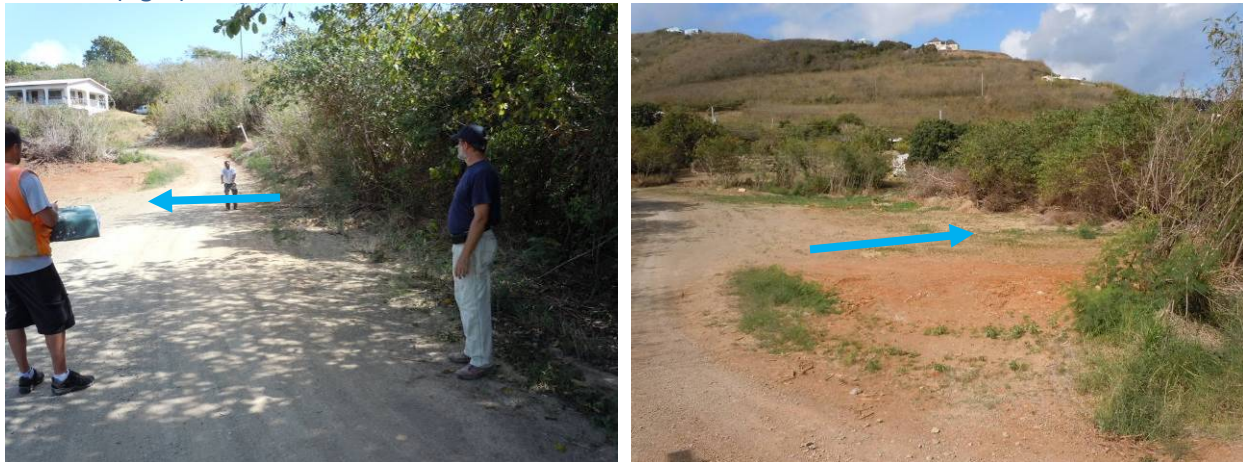
Figure 20. The gut flows over Yellow Cliff Trail at this location (left); the maintenance contractor has cleared the private lot in this area in an attempt to better accommodate gut flows to prevent flooding of the road (right). Flow arrows shown in blue.

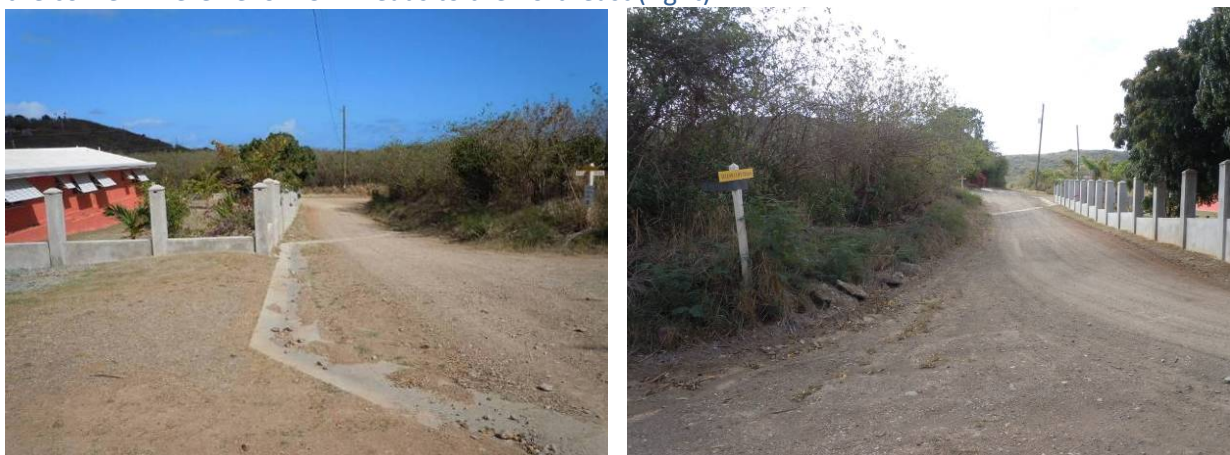
Yellow Cliff Trail continues on past the intersection with Hibiscus Circle, where there are three connected sections of paved swale for runoff (Figure 21). The road then forms a “T,” with a short section going west toward the neighborhood entrance, and the other section heading east/northeast towards a gut crossing. This gut flows under the road via two 24-inch corrugated metal culverts that are in relatively good condition with little blockage and only slight scouring at the downstream end. The upstream end is a depression that dries out in the dry season. While these culverts are not currently a significant problem, issues could arise if the upstream watershed (60 acres with very little development) becomes more developed. This gut flows into the large pond discussed in Section 2.1.

Figure 21. Shallow, paved swales at intersection with Hibiscus Circle (left), and the eroded ditch along the corner where Yellow Cliff heads to the northeast (right).

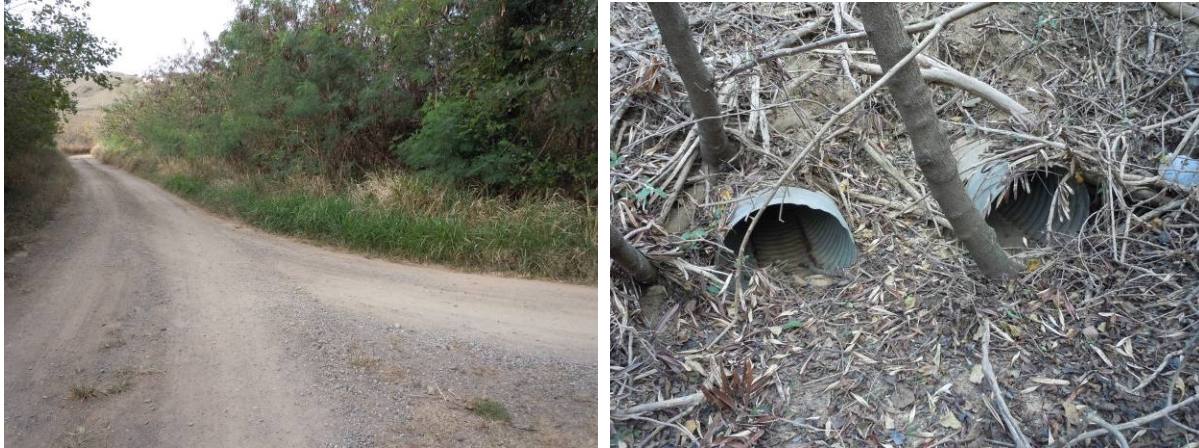
Figure 22. Portion of road that crosses the gut to the northeast (left), and the two 24-inch corrugated metal culverts at the gut crossing (right).

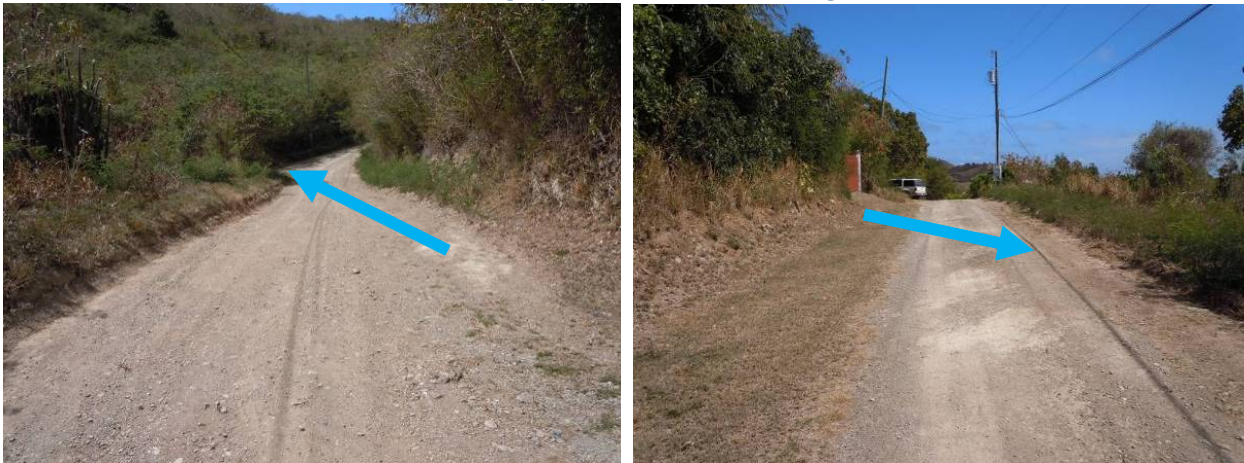
Figure 23. The first low point along Ginger Thomas Trail is shown here looking downhill to the southwest (left); the same stretch of road, but looking uphill to the northeast (right).

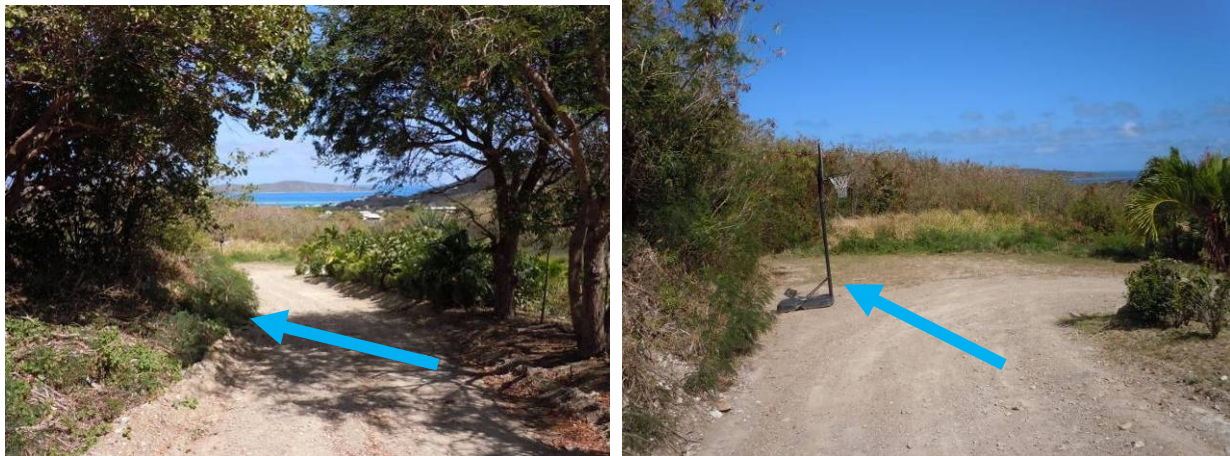
Figure 24. Runoff from the last portion of Ginger Thomas Trail flows to the western side of the road (left), towards the flat turnaround area where there were some signs of ponding (right).

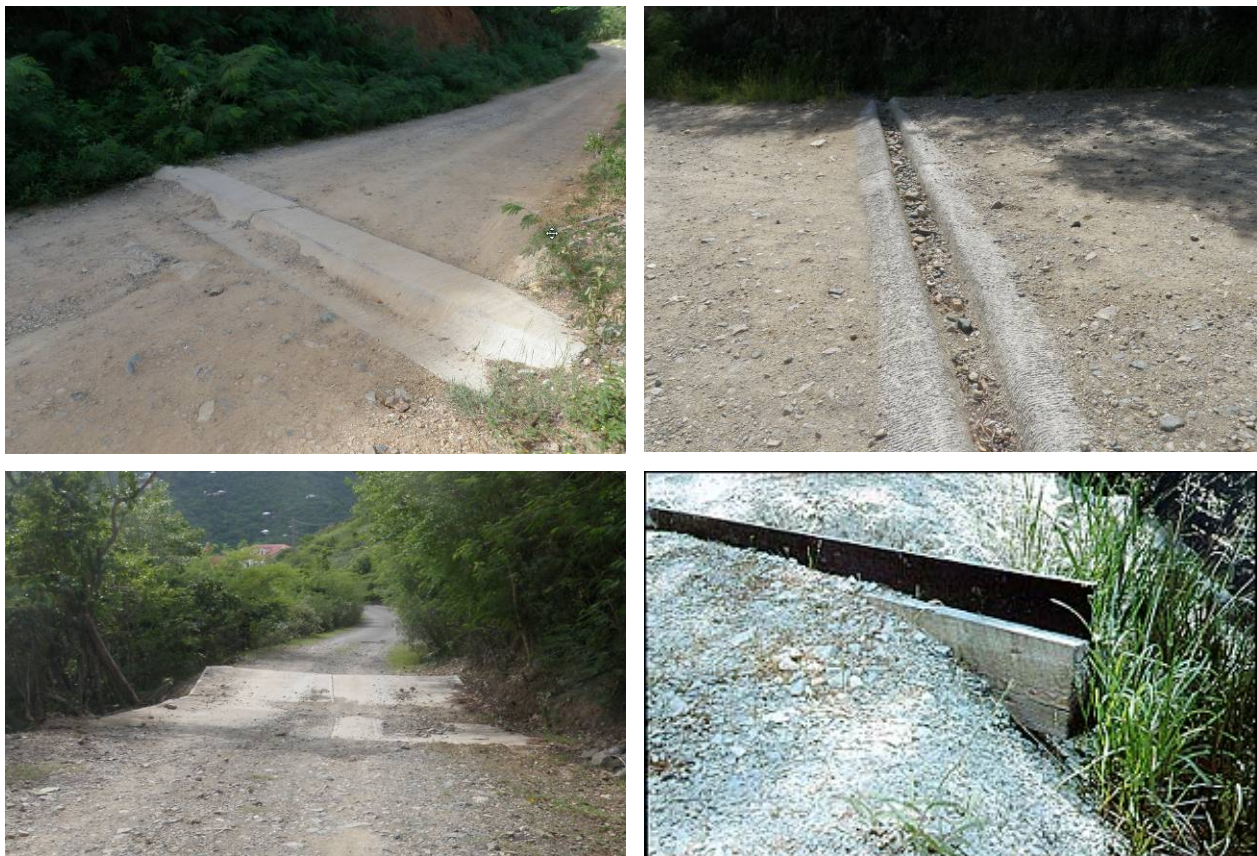
Figure 27. Waterbars (top left), open top culverts (top right), and dips (bottom left) installed by Coral Bay Community Council can have different design variations, but serve to divert surface flows off the road before erosion occurs. Deflectors (bottom right) are an alternative design (USDA). These practices should be spaced according to road slope, discharge to stabilized outlet, and be routinely maintained in order to function properly.

Unpaved road surfaces are subject to erosion and deterioration at a much faster rate than paved roads. If roads are intended to remain unpaved permanently, then it is important to incorporate design features that reduce the length of time stormwater is in contact with the road surface (i.e., get water off the road surface at frequent intervals before it concentrates and becomes erosive). There are a number of structures that can be used to manage drainage on unpaved roads that have evolved from efforts to stabilize logging roads and trails including: waterbars, dips, deflectors, cross drains, and culverts (Figure 27). More information on many of these practices can be found at www.fs.fed.us/eng/pubs/pdf/BAERCAT/lo_res/Chap_4.pdf.

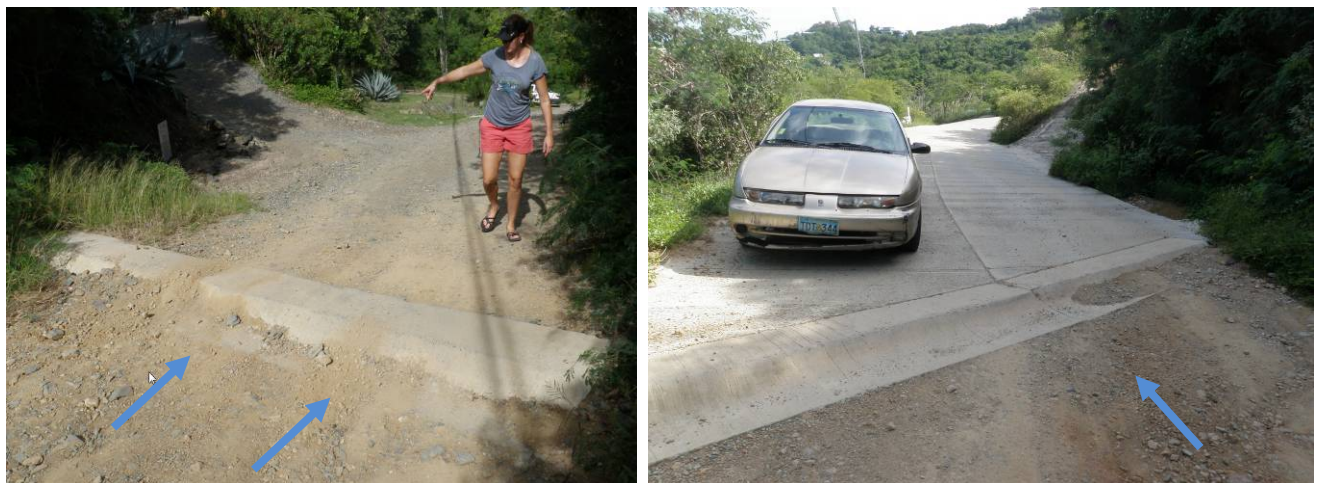
- Pitch the waterbar so that the outlet end is at least 3 inches lower than the upper end (~3% slope). The improper angling and pitch can reduce self-cleaning of sediment accumulated in the swale portion of the waterbar.

Figure 29. Proper angling and pitch of waterbar will help keep sediment from accumulating in swale

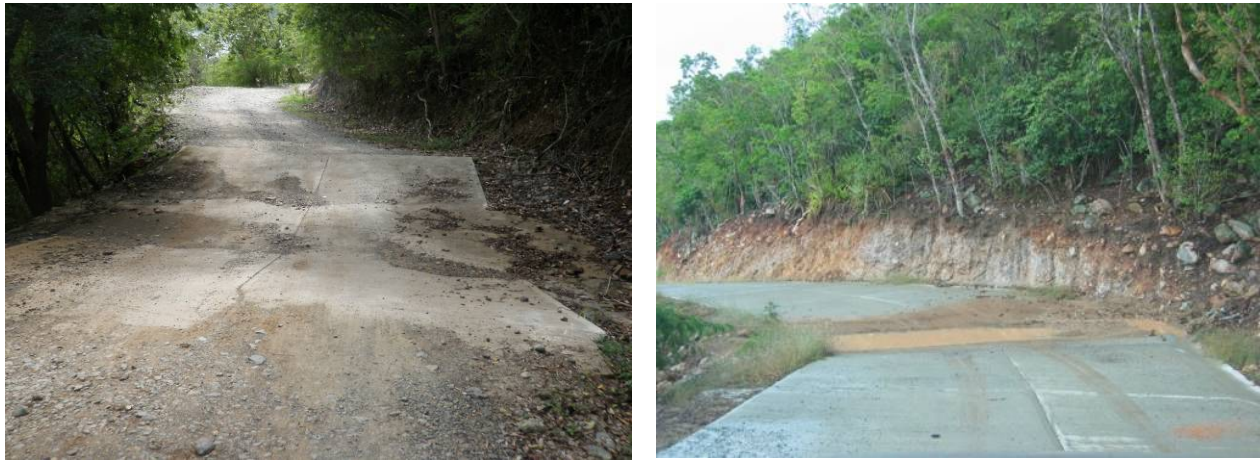
Figure 31. Dip schematic for unpaved roads (USDA, 2006 and Wisconsin Dept. of Natural Resources).

Broad dips are commonly used as an alternative to waterbars. They are easier to drive over and can convey water from the road surface as well as from roadside ditches. They are fairly common on flatter, paved roads in the USVI, but have also been used in unpaved situations (Figure 30). They can be constructed from concrete or stone and should be spaced according to slope (see Table 2). The broad dip and outlet pad help to maintain sheet flow (rather than concentrated) discharge. In unpaved situations, it is important to incorporate a sediment trap or other feature at the outlet location to collect sediment. This must be maintained on a routine basis.

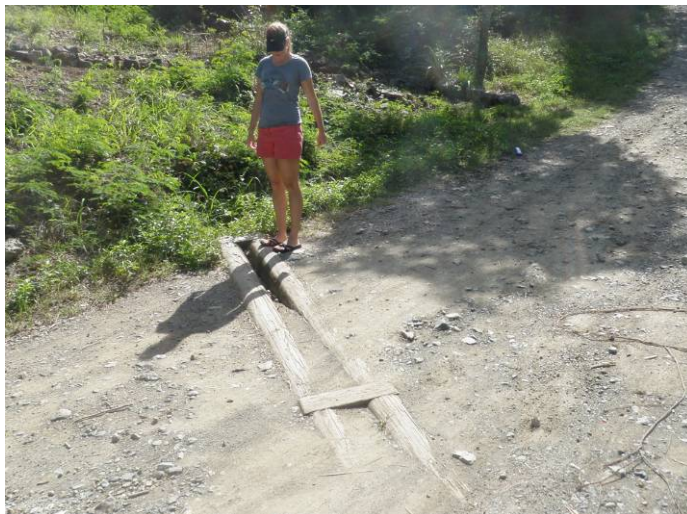
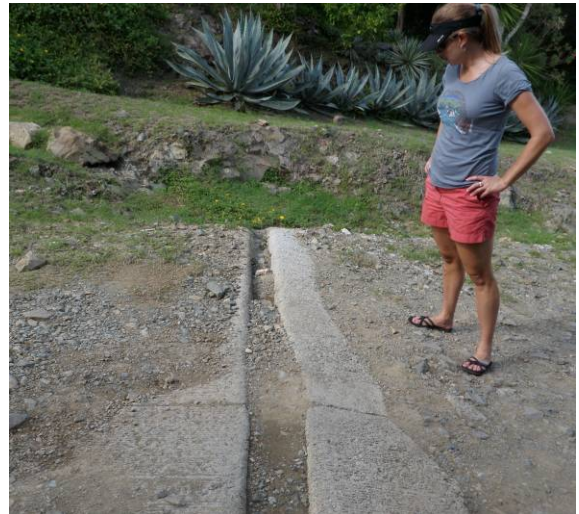
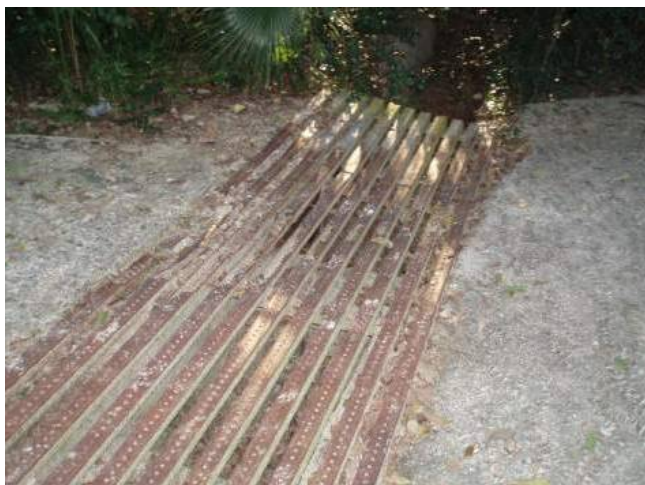
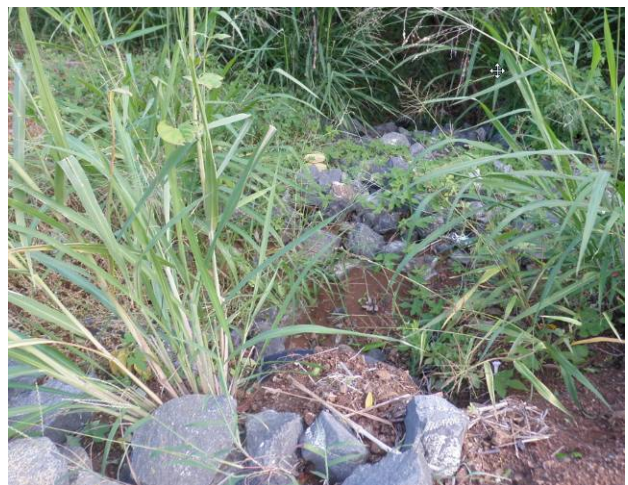
Figure 33. Open top-culverts have to be designed for maintenance access. The spacing should be wide enough to fit a narrow shovel. Top left and right photos here show clogged practices with reduced functionality. The grated cross-drain (bottom left) works on paved surfaces, and the grate can be lifted for easy cleaning. Be sure to provide outlet protection (bottom right) and remove deposited sediment on a regular basis.

Like waterbars, the open-top culverts are relatively inexpensive and can be installed with hand tools on site. They permit easy movement of vehicles, but require frequent maintenance to keep them in good working order. Clean soil, rock, and other debris frequently from open-top culverts to prevent clogging. Consider locating open-top culverts below a series of waterbars or below paved sections to help prevent sediment from clogging trenches.

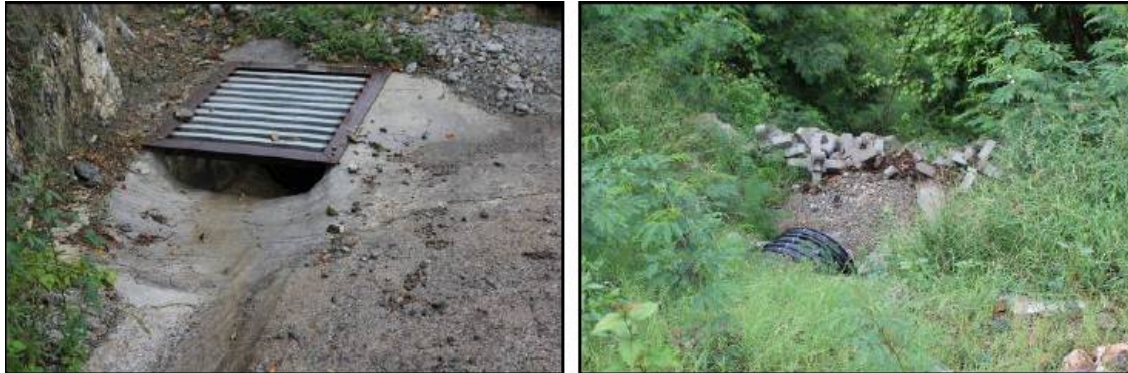
Figure 34. A drop inlet and culvert installed as a road improvement project in Coral Bay (Source CBCC).

In some locations in Hope and Carton Hill, we recommend installing a drop inlet structure and a 12-24 inch culvert to collect and convey runoff from the roadside swale across the road to discharge at a stable outlet on the outsloping road face (Figure 34). An optional sump can be included in the box structure to help trap sediment. Consideration needs to be given to the size and shape of the inlet (open slot on the side or grated) to prevent debris (mostly rocks) from entering system. Ditches may also need to be excavated to accommodate structures, or to create a sediment/debris trap just uphill of the inlet. It is important to be sure the outlet is stabilized.

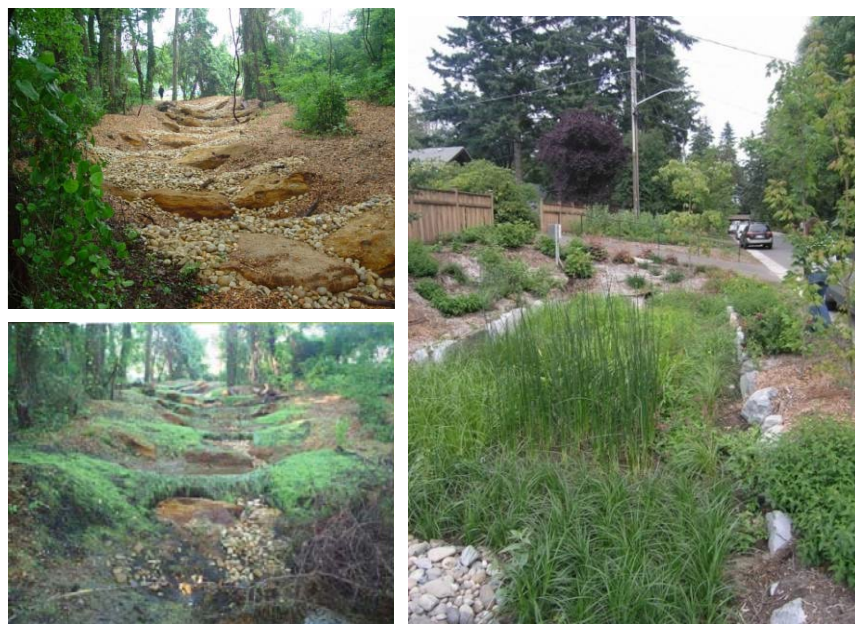
Figure 38. Photos showing stepped conveyance systems in channel from Anne Arundel County, MD (two photos on left), and a linear bioretention facility along a residential street in Seattle, WA (on right)

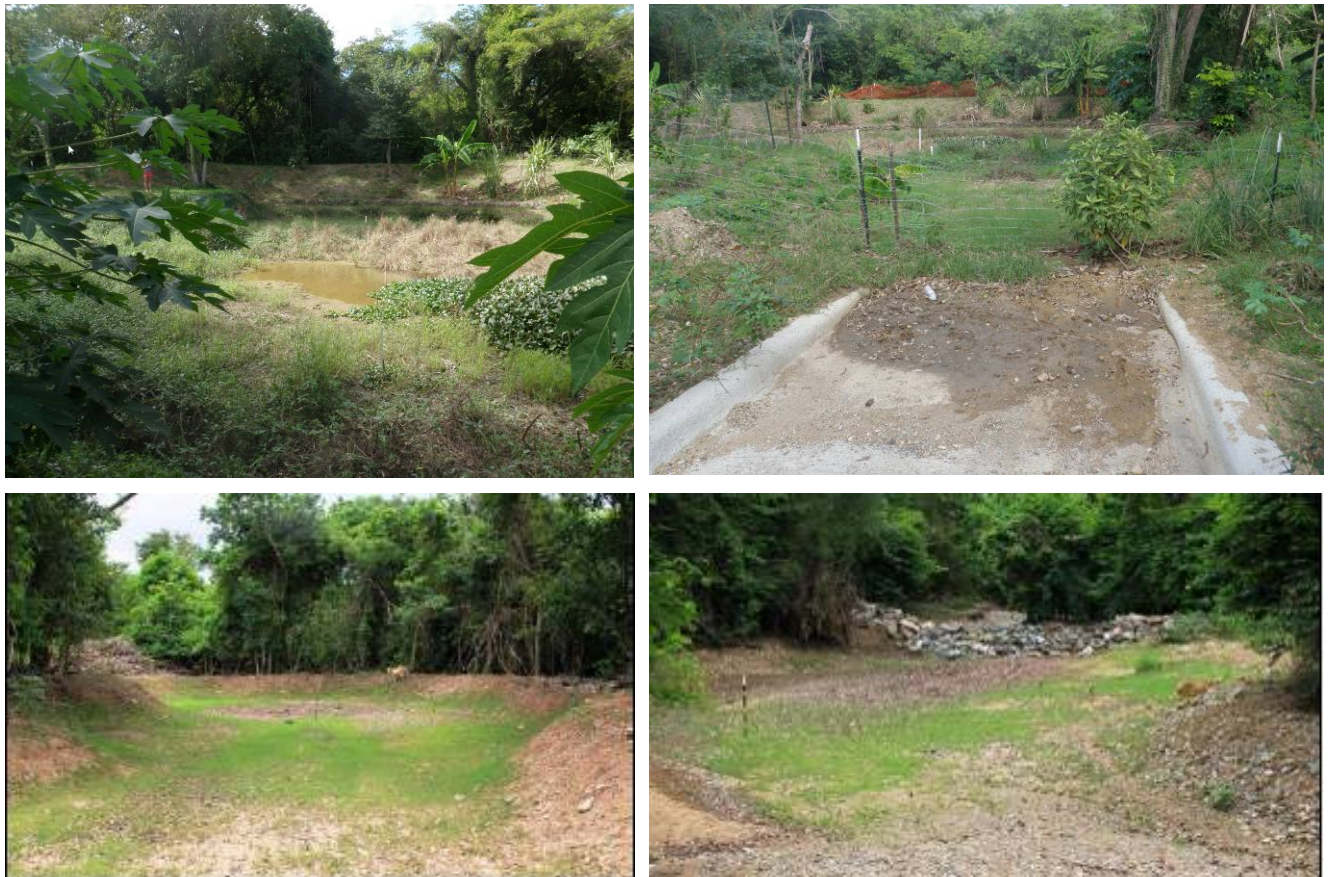
Figure 39. Wet vegetated pond retrofit in Coral Bay that manages runoff from Kingshill Road. Sediment accumulation is evident in the paved flume from the road leading to the practice (Top). The facility is being monitored to determine how much sediment is collected. Infiltration/sediment basin constructed in Carolina drainage in Coral Bay (Bottom, photos courtesy of CBCC).

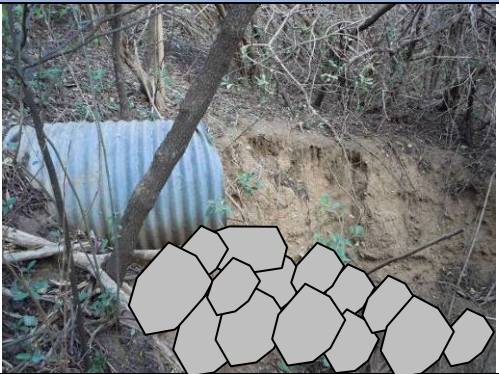
Station	Associated Road Segment(s)	Description	Site Photo
1 – Pony Club Trail Gut Crossing	1	<ul style="list-style-type: none">• Replace undersized culvert with one or more culverts to ensure safe passage of gut flow without overtopping the roadway during the 25-year storm.• Stabilize and restore the downstream scour hole with rock and vegetation to reduce erosion.• Reduce/eliminate the practice of pushing sediment from the roadway into the gut in this location.

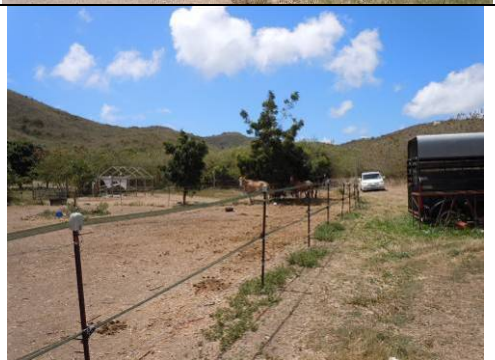
3 – Pony Club Gut Restoration	1	<ul style="list-style-type: none"> Move Pony Club activities out of the gut to reduce erosion and water quality impacts (e.g., bacteria and nutrients), as well as to reduce safety concerns during large storms. Upland property appears to be available further to the west. Restore gut capacity and vegetation.

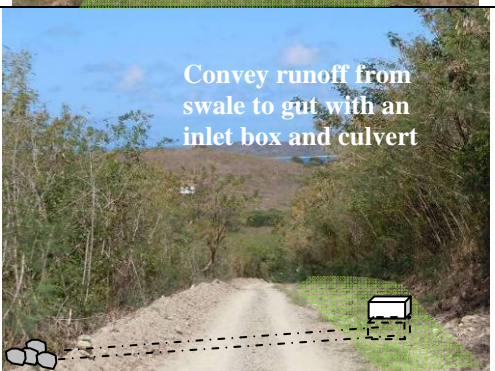
5 – Upper Pony Club Trail	1	<ul style="list-style-type: none"> Create a stabilized swale with step pools along the inslope. Install inlet box/pipe structures to convey runoff to outlets in stormwater (sw) easements created along property lines; design outlet for energy dissipation and flow distribution across forested slope. The lots to the west are laid out along a gut. These parcels should be preserved if possible; if not, development should occur in a way that preserves the capacity of the gut.

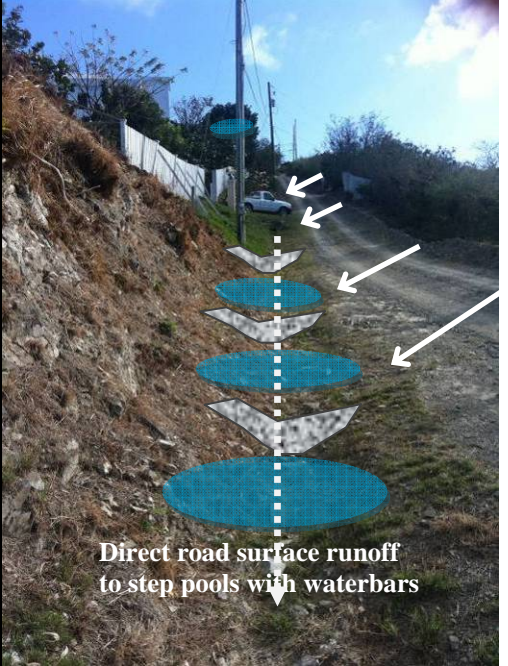
<p>Direct road surface runoff to step pools with waterbars</p>

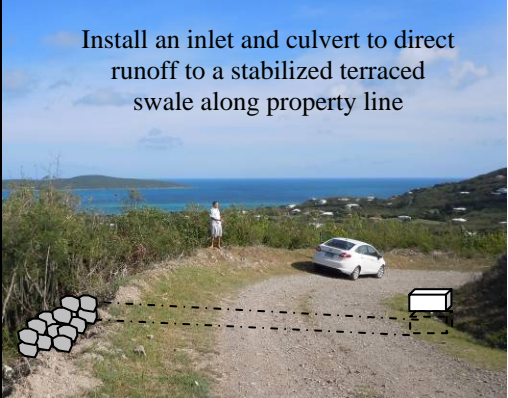
8 – Upper Coral Reef Trail Terraced Swale	3/5	<ul style="list-style-type: none"> Install inlet box/pipe structure to collect and carry flows from inside ditch to discharge into a stabilized terraced swale down the outer slope along the property line. Need to establish a sw easement here. Size the pipe for 25-year storm event. Requires installation and maintenance of upslope controls at Station 7.

<p>Install an inlet and culvert to direct runoff to a stabilized terraced swale along property line</p>

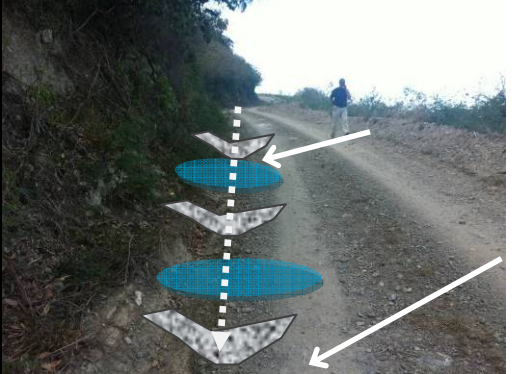
Station	Associated Road Segment(s)	Description	Site Photo
9 – Middle Coral Reef Trail	3	<ul style="list-style-type: none"> Enlarge and stabilize existing swale on inslope of road. Install waterbars/trenches to deflect runoff into inside swale. Install check dam(s) in swale to create step-pools to help reduce velocity and trap sediment.

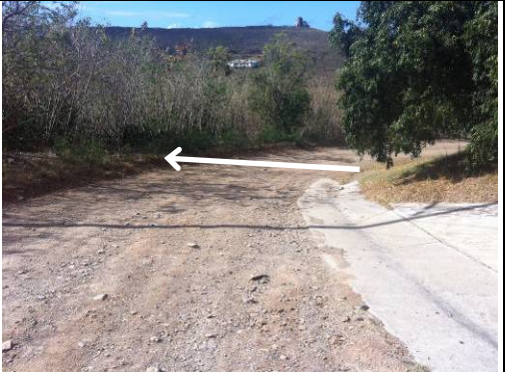
Station	Associated Road Segment(s)	Description	Site Photo
13 – Divi-Divi Waterbar	5	<ul style="list-style-type: none"> Install a waterbar at the base of the existing concrete swale to direct runoff down the forested slope. Ensure flow is dissipated non-erosively down slope using stone and/or a level spreader. Evaluate broken asphalt just upgradient of this location; remove if necessary.
