Hope and Carton Hill Road Management Plan

January 2013

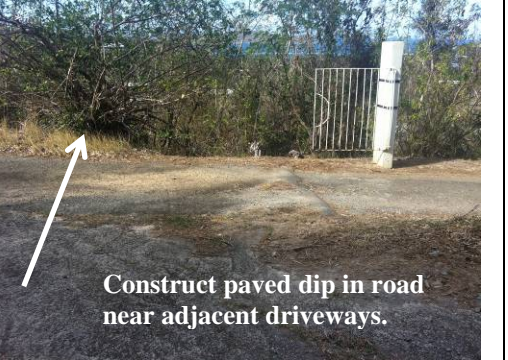
14 – Divi-Divi SW Storage Practice	5	<ul style="list-style-type: none"> Use paved dip to convey runoff from Station 8 across Divi-Divi Trail into a large stormwater storage basin in Lot 47. This lot would need to be preserved for stormwater purposes. Discharge any overflows via a stormwater easement along the property line between Lots 49 and 50 to the swale at Station 11.

<p>Construct paved dip in road near adjacent driveways.</p>
15 – Divi-Divi Bioswale	5	<ul style="list-style-type: none"> Create a vegetated swale to reduce the existing ponding that occurs on this flatter stretch of road. Direct any overflows along a stormwater easement to the swale created for Station 10. This runoff can be conveyed either by open channel or pipe, depending on site conditions at the time of construction.

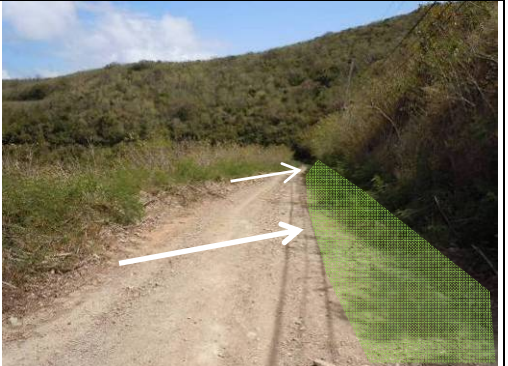
16 – Upper Yellow Cliff Trail	6	<ul style="list-style-type: none"> Enlarge and stabilize the existing eroding swale using vegetation and check dams to slow runoff and reduce erosion. Use waterbars to direct runoff into the swale every 80 feet based on the existing roadway slope of ~10%.

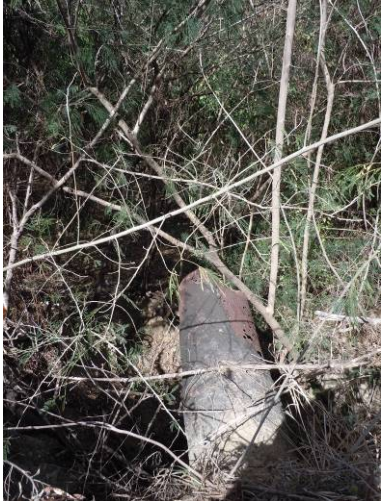
Station	Associated Road Segment(s)	Description	Site Photo
17 – Yellow Cliff Culvert	6	<ul style="list-style-type: none"> • Replace damaged culvert and construct stabilized inlet that is easy to maintain and will prevent clogging. • Construct a stabilized, terraced swale at the culvert outlet. This culvert discharges through Lot 105; this lot should be preserved for stormwater management.

Figure 17. The upgradient end of the culvert is clogged with sediment, severely reducing its capacity (left), and the downgradient end has created a large scour hole on a steep slope (right).

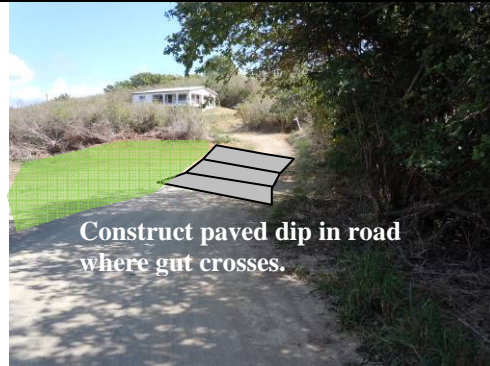
19 – Yellow Cliff Gut Restoration	7/4	<ul style="list-style-type: none"> • Construct a paved dip in the road where the gut crosses Yellow Cliff Trail. • Restore cleared gut area, ensuring sufficient capacity. • Create stormwater storage areas on either side of restored gut for easy maintenance. • The lots located in the gut both upstream and downstream from this crossing should be preserved such that development never compromises the gut capacity.

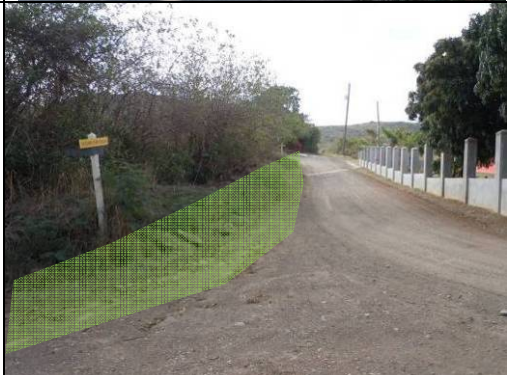
20 – Lower Yellow Cliff Trail	8	<ul style="list-style-type: none"> • Enlarge and stabilize existing drainage swales, increasing their capacity and reducing erosive potential by using check dams and vegetation.

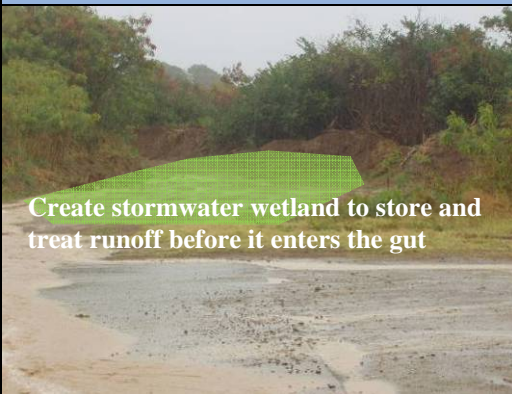
Station	Associated Road Segment(s)	Description	Site Photo
21 – Neighborhood entrance	8/1	<ul style="list-style-type: none"> Create a large constructed stormwater wetland with a sediment forebay for easy maintenance. This stormwater storage practice will slow and treat the runoff before it flows into the gut. Note: If other, upstream stations are not constructed first, this storage facility should be sized to, at a minimum, safely convey the runoff from the full 130-acre drainage area. Ownership needs to be confirmed, and the land preserved if possible.

<p>Create stormwater wetland to store and treat runoff before it enters the gut</p>
22, 23 – Ginger Thomas Trail	9	<ul style="list-style-type: none"> Create small stormwater storage practices, such as bioretention areas, in the road layout. Consideration would need to be given to any future development plans/expansion of existing roadways.

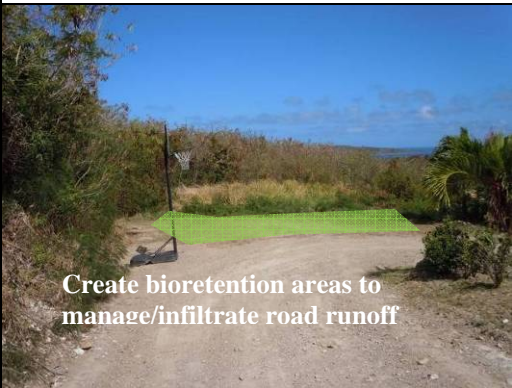
<p>Create bioretention areas to manage/infiltrate road runoff</p>

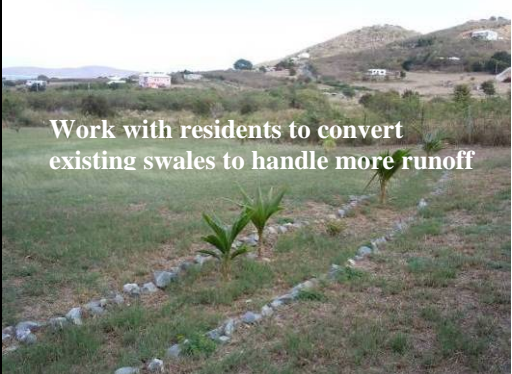
24 – Hibiscus Circle 1	10	<ul style="list-style-type: none"> Convert swales built by residents into larger, vegetated bioswales that can handle more flow. Install waterbars to ensure road drainage reaches swale. Need to establish a sw easement here.

<p>Work with residents to convert existing swales to handle more runoff</p>
25 – Hibiscus Circle 2	10	<ul style="list-style-type: none"> Convert a portion of this wide road into a vegetated bioswale (2-3 feet deep, 8-10 feet wide) to reduce erosion and ponding issues. Use check dams where needed. Use waterbars where necessary to direct road runoff into swale. Specifically, install a waterbar at the downstream edge of the paved intersection. Discharge any overflows into the eastern gut via a stabilized channel in a stormwater easement between Lots 24 and 25.

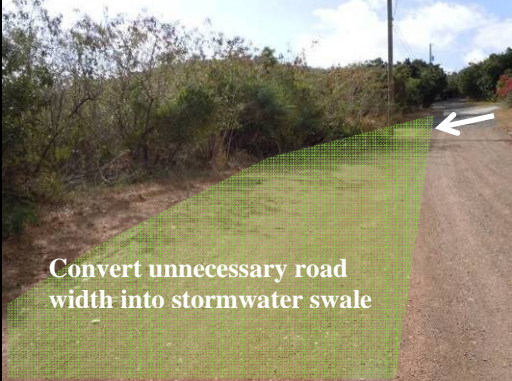
<p>Convert unnecessary road width into stormwater swale</p>
<p>◄◄◄ indicates direction of runoff; ◄ is a waterbar with arrow showing direction of flow; --- is location of underground pipe; ■ represents a step pool; ■ is a vegetated swale or storage practice</p>

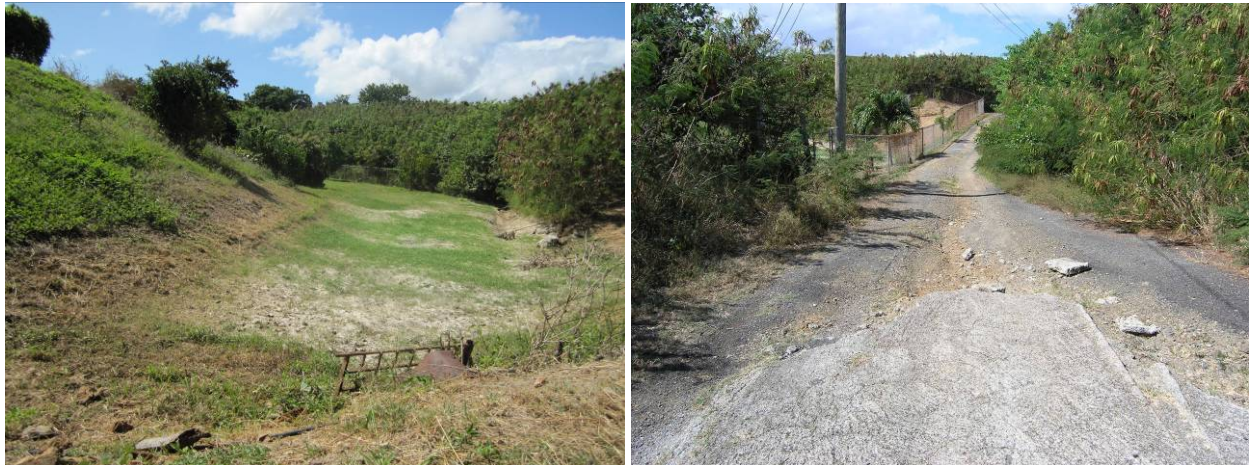
Figure 43. Gut downstream from large pond with two damaged/clogged culverts (left); the deteriorating road at the gut crossing (right).

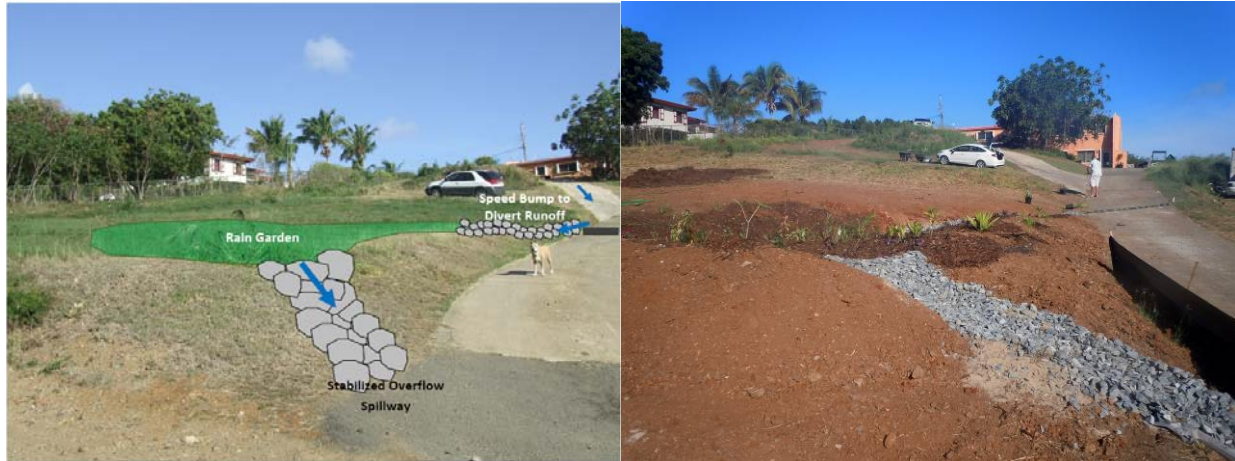
Figure 40. Initial rain garden concept (left) and finished rain garden (right), constructed as a part of a volunteer work day in October 2012.

Station 12 is a demonstration project that was constructed with volunteer help in late October 2012. The demonstration project involved the creation of a small residential rain garden in an existing grassed area adjacent to a driveway (see Figures 40, 41, and 42 below and the site plan in Attachment C) at 53 Hope and Carton. The purpose was to minimize surface runoff from the property onto the adjacent road and to serve as an example for other residents of the Hope and Carton Hill neighborhood and beyond. This is a great example of what homeowners should consider for their own driveway runoff.

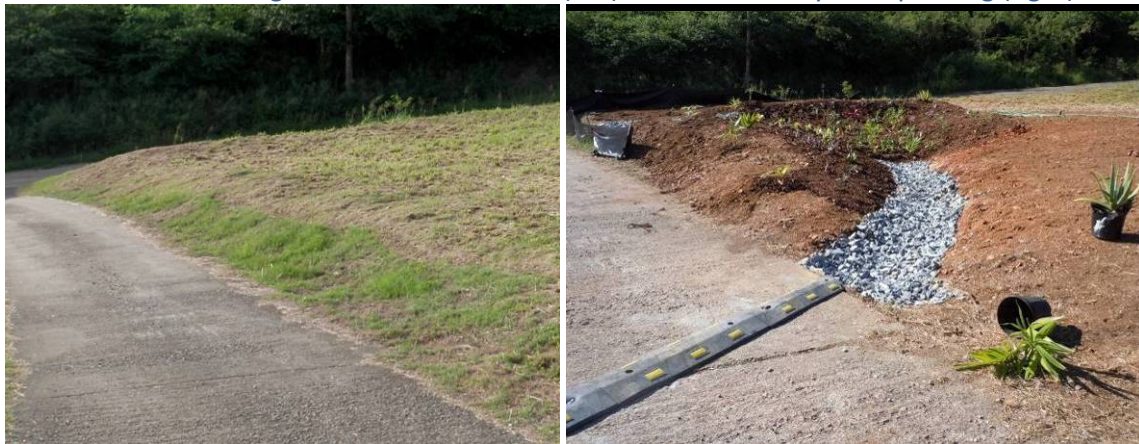
Figure 41. Before the rain garden was constructed (left) and immediately after planting (right).
