'A Day on the Tools' – An alternative way of learning about Cavity Wall Tie Failure

In this article, Sava student Christopher Moran discusses a recent practical day of mentoring when he shadowed a Property Care Association award winning company 'Bricktie Ltd' when they removed and replaced the cavity wall ties on a 3 bedroom semi detached house in Sheffield. He discusses his learning regarding cavity wall tie failure and alternative suggestions for mentoring during times when it has proven hard for many students to gain practical shadowing experience.

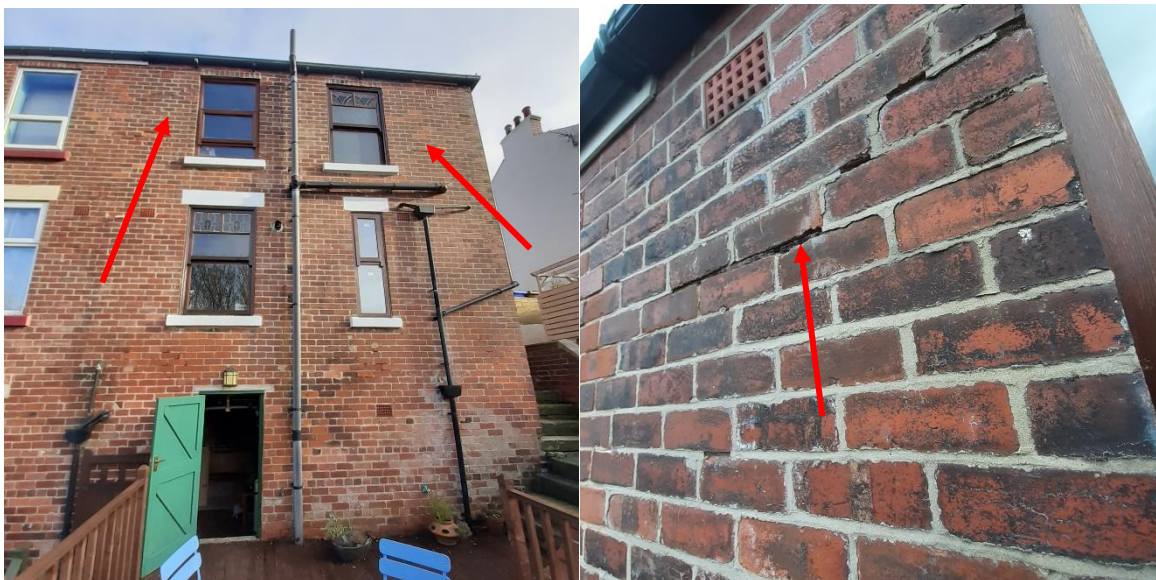
During a recent case study for my diploma in Surveying and Valuation I found a property that was suffering from suspected cavity wall tie failure.

It had many of the classic signs and warning signals of cavity wall tie failure; horizontal cracking high up on the exposed south westerly elevation, the property was built in the 1930's, it was made using black ash mortar and just visible within the cavity (which could be looked into through the cellar door entrance) was a wall tie with visible rusting.

I therefore recommended that the client instructed a specialist to have a cavity wall tie inspection conducted, to see if my suspicions were correct. After reflection, this experience also led me to wonder what happened after I had gone, how do the specialist companies conducted this survey? And how do they fix the issue of wall tie failure if it is found to be present?

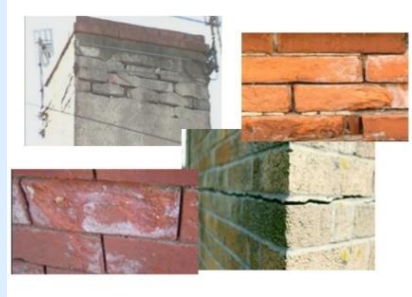
Cavity wall failure is identified by horizontal cracks that correspond to the mortar courses containing the ties. Often at 450mm intervals.

Sulphate attack in brick walls may occur in every joint. Often a white colouring is seen in the mortar as it deteriorates. It is also often accompanied by frost attack as a by-product of the large volume of water involved.

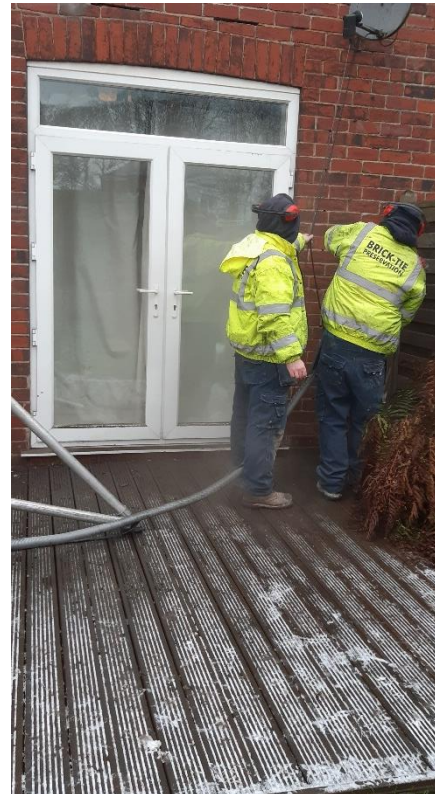
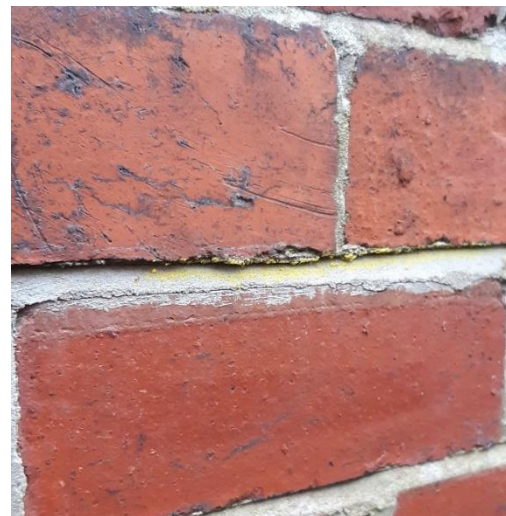
1 - A metal detector is used to locate all the ties within the cavity, marking their position with a **builder's crayon** (see the yellow line on the image on the right). Interestingly, some wall ties may be so corroded that the metal detector gives only the faintest of signals. The metal detectors have adjustable sensitivity, and the skill of technician comes into play to locate the ties.

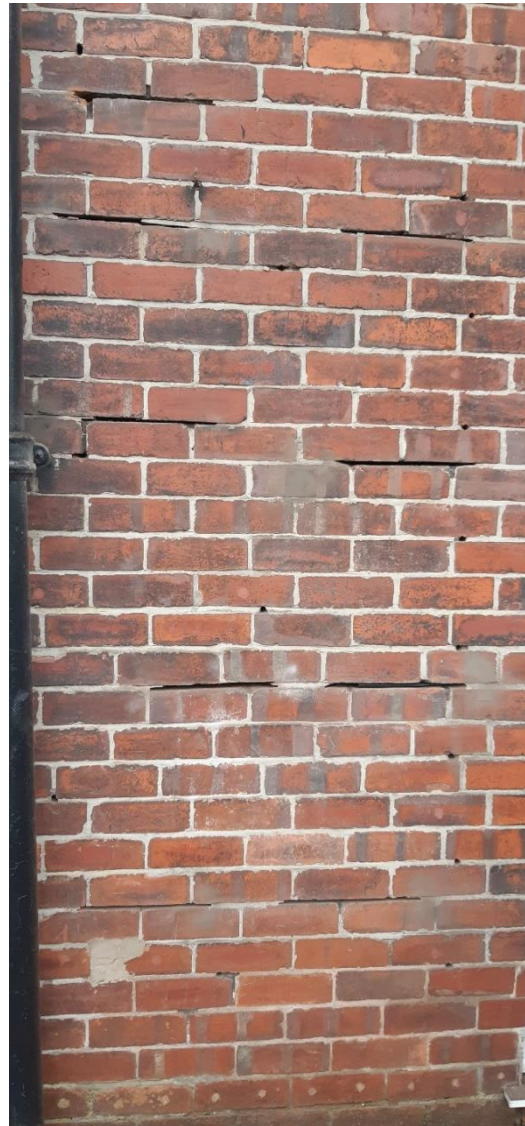
2 – Once all the old ties are marked, the technician uses a **heavy-duty angle grinder** to grind through the mortar and then into the head of the tie itself, in essence chopping the tie down to about two thirds of its original length. A **vacuum attachment** is of vital importance at this stage, as it removes the debris created by the grinding, rather than having it fall into the bottom of the cavity and potentially cause damp bridging issues in the future. This process leaves a wall with a very pronounced series of horizontal chases in the outer leaf wall, as can be seen on the right.

3 - The new remedial wall **tie holes are drilled** into the mortar where the new ties will be installed. (Seen on the right also). The technician drills the holes into both the outer and inner leaf at a **slight upward angle**, meaning in the future that any water that gets onto the new ties will be pulled by gravity towards the outer leaf. Brick-Tie used a ‘Helifix’ remedial tie with a helical twist along its full length. This helix acts as a repeating drip-feature, as well as providing an excellent key for the resin.

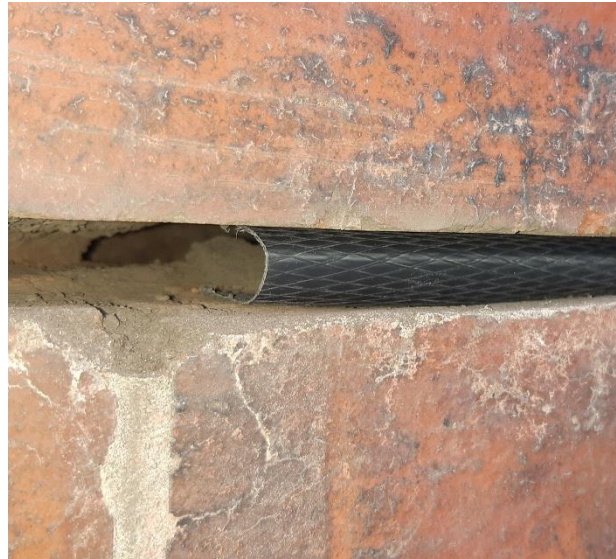
4. Isolation explained – The remaining old wall ties are **'isolated'** to prevent future issues. This is essential because there may be a small wafer of old tie left in the outer leaf, which will corrode and expand in the future. The chases (horizontal holes left by the angle grinder) need to be re-pointed without re-encapsulating the remaining tie section in mortar, where its continuing corrosion would otherwise cause new cracking. Although the new wall ties would hold the inner and outer walls together, the rusting old ties could still cause issues with expansion and cracking. As such they are **'isolated'**. There are many methods of doing this, but a common and efficient method is

cutting pieces of plastic DPC and creating an isolator hood that is pushed into the gap to encase the old tie and prevent new mortar from touching the tie. In effect the remaining section is left in a void – an expansion pocket, into which the slight growth of the thin section can expand, without being constrained. This is then over-pointed. The correct and diligent treatment of the old ties is the most frequently neglected part of wall tie corrosion projects. However, the basic methodology is proven to work and has been used for over 35 years.

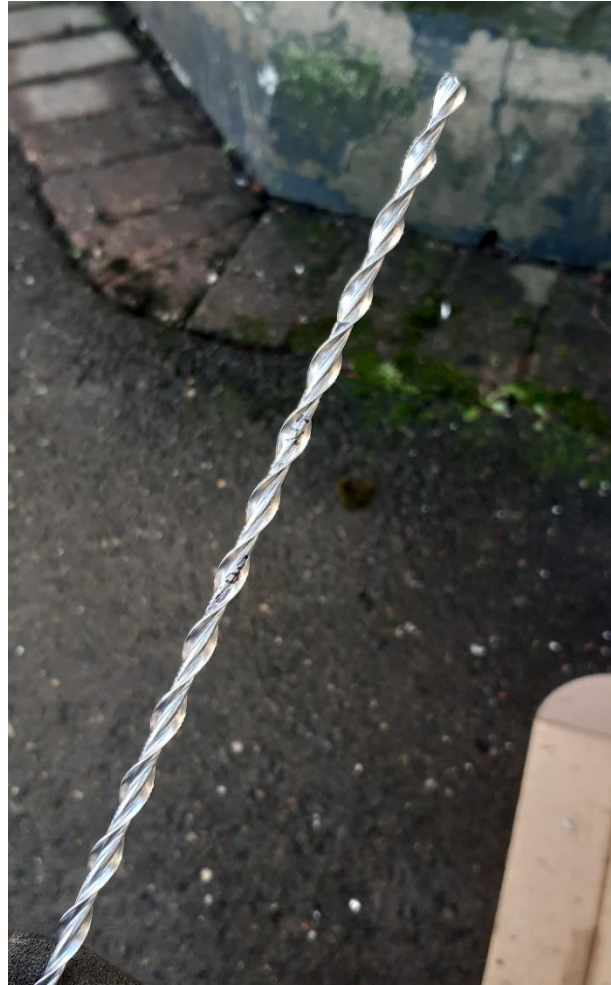
5. The resin-bonded tie system - Brick-Tie have their own styrene free, self-mixing resin, **which is injected** through the new drill holes first into the inner leaf. The **new wall ties are then inserted**, before resin is injected into the outer leaf and left to set. (The image on the right shows a Helifix remedial cavity wall tie used in this job).

A random selection of ties are only resined into the inner leaf and when all the resin is set, they are tension tested to ensure that they are of sufficient strength to hold the two walls together. The test results are recorded. The work can only be signed-off and guaranteed if the ties have passed all tests.

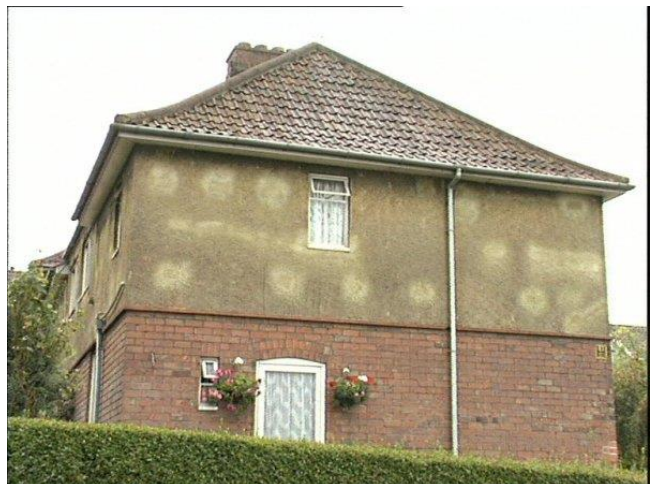
Stage 6 – The final part of the process is repointing all the holes and gaps left by the ground out mortar. A skilled technician brings a variety of mortar dyes and aggregates with them to colour match the mortar between bricks and the pattern of any render that may be on the property.

However, this is a challenging process, especially in render (see image on right from www.designingbuildings.co.uk - not the work of Bricktie) and as such repainting or repointing is common.

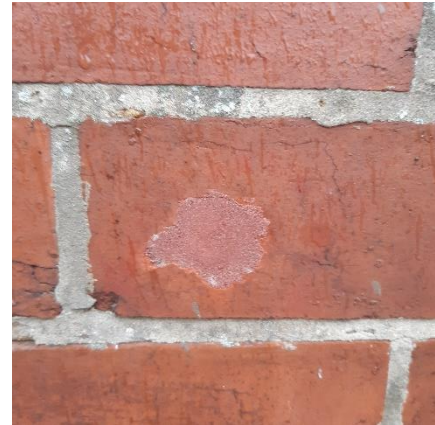
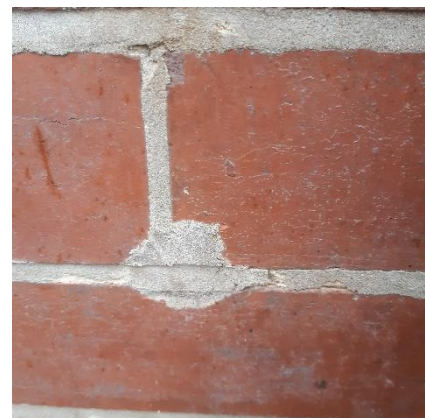
- I've often read that evidence of drill holes through brick indicate cavity wall tie replacement and drill holes through mortar indicate cavity wall insulation has been added. However, as I've described, I was advised by the technicians that cavity wall ties are now more commonly resin fixed in through the mortar and not mechanically fixed through the bricks.

As such when evidence of drill holes is found in external walls, although general principles can be followed, assumptions shouldn't be made too soon. Drill holes in mortar, at around 900mm x 450mm centres could be evidence of wall ties.

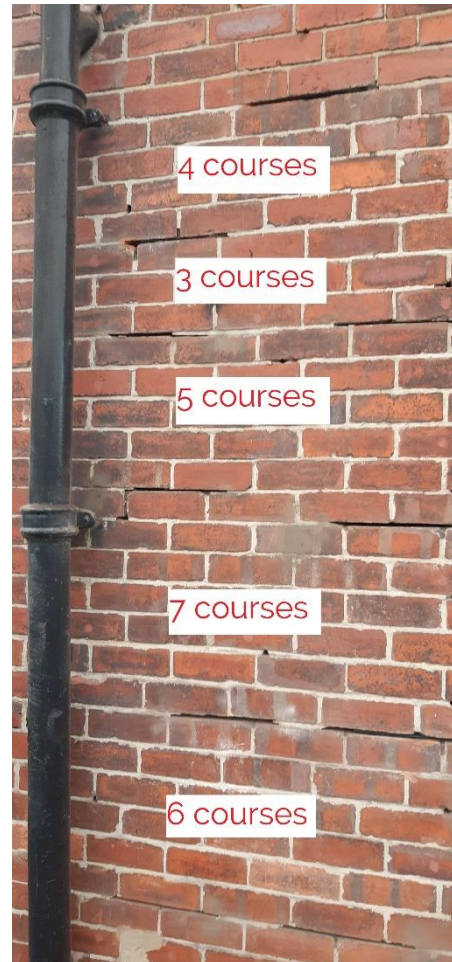
- It's really important to focus on the part of the text books that state wall ties are **OFTEN** at 450mm/6 brick course vertical intervals, **not ALWAYS**. As I found (image to the right) this really is not always the case, with one small section of wall having wall ties at intervals of **3,4,5,6 and 7 course intervals**! The original builder of the property may have miscounted, forgotten to add a tie, or maybe even dropped one down the cavity and not been bothered to climb down their ladder to get another!

As such, when inspecting a property, don't be tricked into thinking that if the horizontal cracking you are seeing doesn't correlate perfectly to 6 brick courses, it therefore can't be cavity wall tie failure.

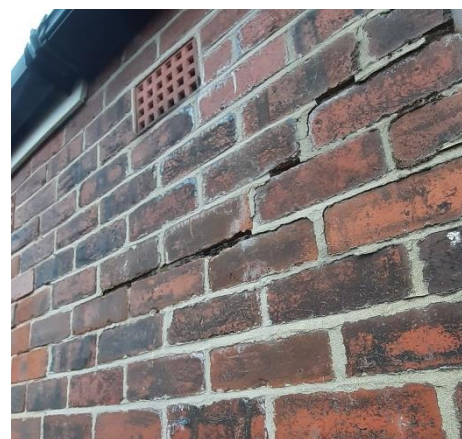
- Cracking is not always horizontal.** Although the wall tie may be the cause, the ensuing cracking pattern may follow lines of weakness. Stepped cracks will often propagate where the stresses associated with tie expansion resisted by returns at corners, placing the masonry in tension. This is especially prevalent near weakly loaded areas such as at eaves level, below low parapet walls and around and under openings.

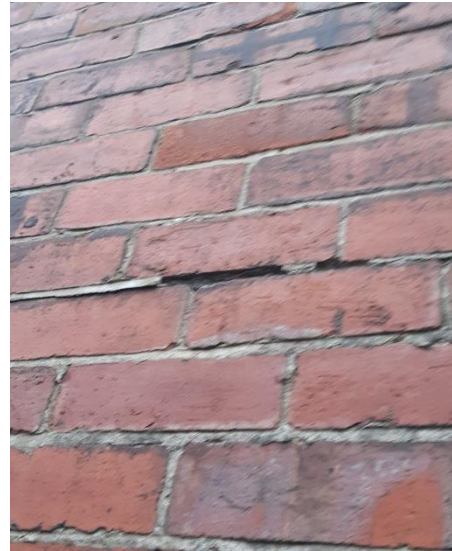
- **Wall tie failure can often be subtle** and easily missed. The property that I have been discussing throughout this article had only minor horizontal cracking and slight bowing to the side wall that could be easily missed. It really highlighted the importance of considering the **other evidence available**, such as the age of the property (and therefore it's likelihood of suffering from wall tie issues), the finding of black ash mortar, and any evidence obtained from neighbouring properties – that may be suffering from wall tie issues, or have had their wall ties replaced.
