**Precision 20/20
Full Reserve Study
for
The Overlook at River Place
Property Owners' Association
Austin, Texas
January 20, 2011**

**The Overlook at River Place Property Owners' Association
Austin, Texas**

EXECUTIVE SUMMARY

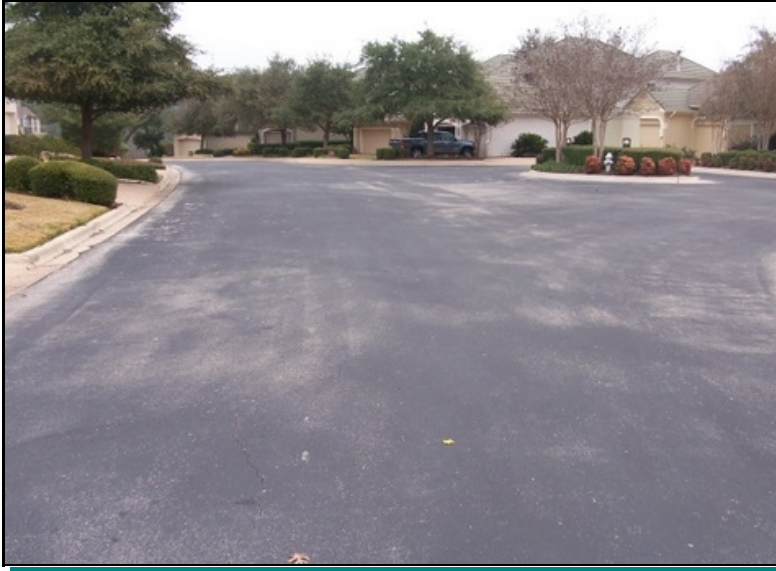
Asphalt Pavement, Crack Repair, Patch and Seal Coat - Asphalt pavement comprises 3,020 square yards of streets throughout the community. The pavement is in good overall condition at an age of 16 years. We note only isolated settlement and cracks. Parked vehicles leak motor oil and other fluids that can damage asphalt pavement. We recommend periodic *seal*

Asphalt pavement overview

We recommend that Overlook plan the next application of seal coat by 2015 and subsequent applications every four years thereafter except when repaving occurs. Line Item 4.020 of **Exhibit B Reserve Expenditures** notes our estimate of future costs and anticipated times of seal coat applications.

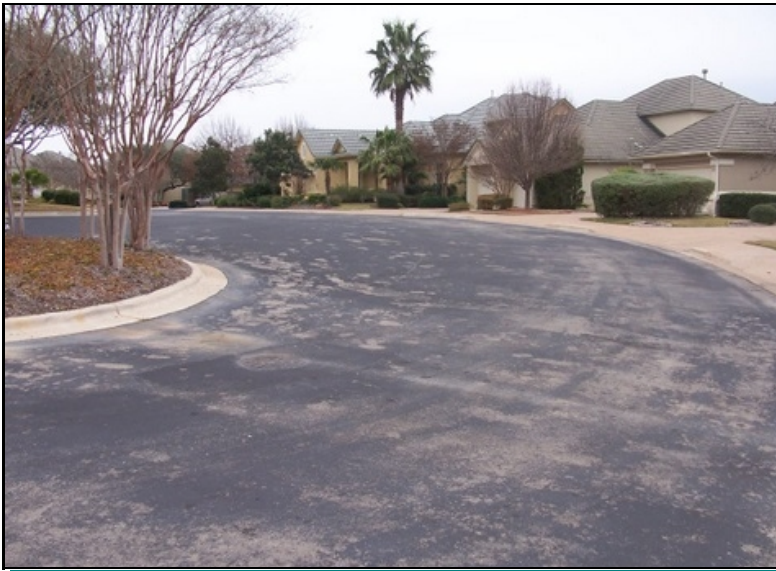
Worn seal coat at pavement

Overlook should repair any isolated areas of deteriorated pavement prior to seal coat applications. Proposals for seal coat applications should include both crack repair and area patching. These activities reduce water infiltration and the effects of inclement weather. The

contractor should only apply seal coat applications after remedial crack and surface repairs are completed. A seal coat does not bridge or close cracks, therefore, unrepaired cracks render the seal coat applications useless. Our future estimates of cost include an allowance for both crack repair and area patching.

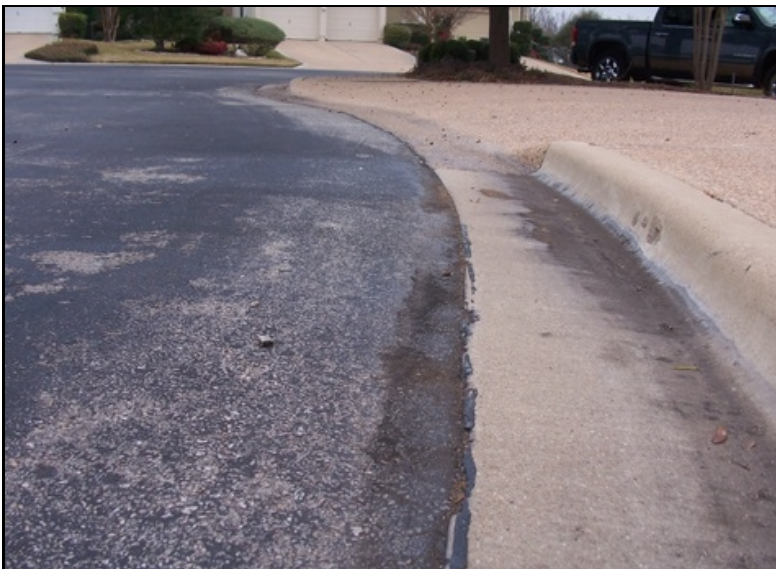
Isolated pavement settlement near gutter

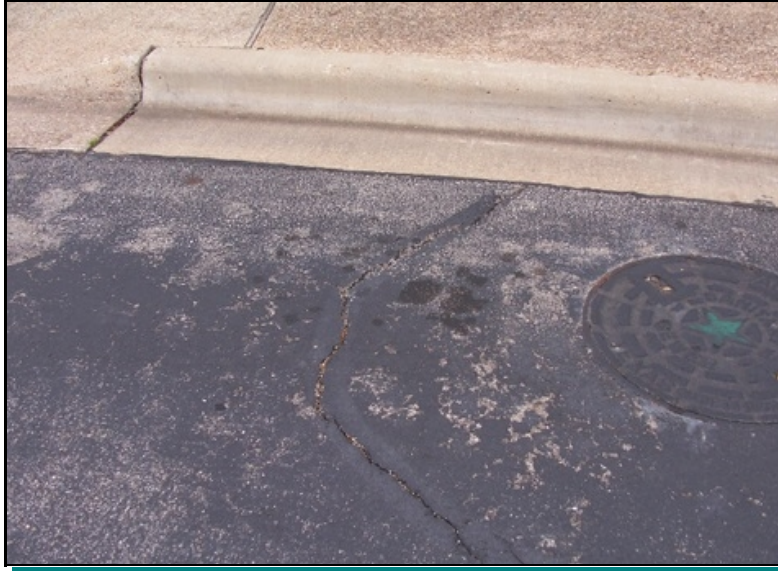
Isolated crack in pavement

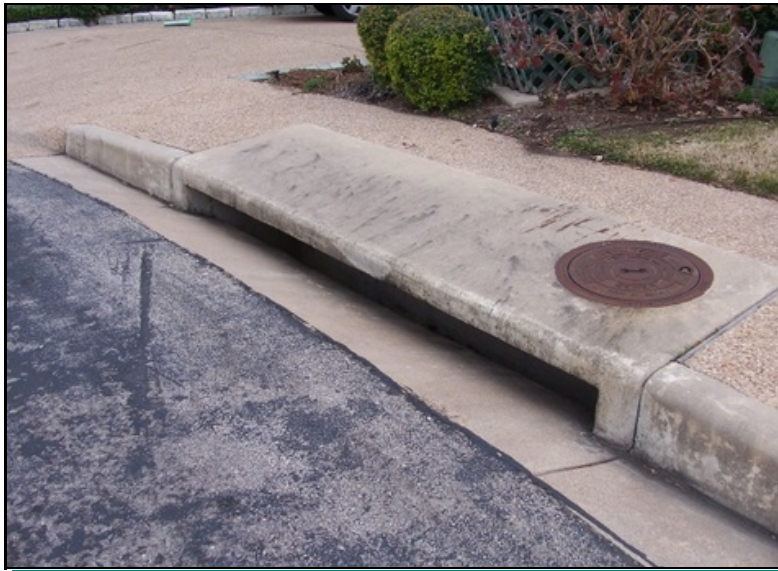
Catch Basins - Three catch basins collect storm water from the pavement and conduct it into the storm water system. The overall condition of the catch basins is good without settlement visually apparent. The useful life of catch basins is up to 60 years. However, achieving this useful life usually requires interim capital repairs or partial replacements every 15- to 20-years.

The Association should anticipate the occasional displacement or failure of a catch basin and the surrounding pavement from erosion. Erosion causes settlement around the collar of catch basins. Left unrepaired, the *entire catch basin* will shift and need replacement. Overlook should plan to repair or replace any displaced or failed catch basins concurrently with surrounding pavement or gutters. The exact times and amount of capital repairs or replacements are dependent upon variable natural forces. Based on the age and condition of the catch basins,

Typical catch basin

we recommend the Association anticipate the inspection, capital repair or partial replacement of the three catch basins in conjunction with each repaving event. We include this information on Line Item 4.100 of **Exhibit B Reserve Expenditures**.

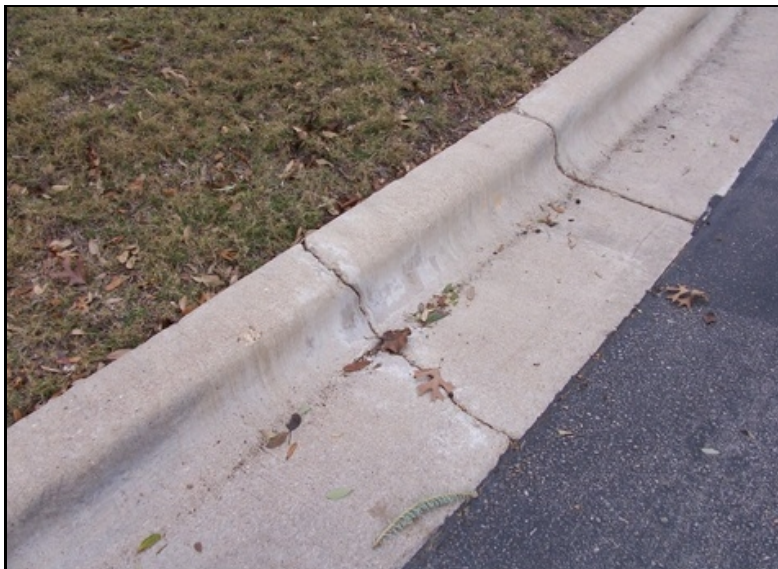
Concrete Curbs and Gutters - Concrete curbs and gutters line the pavement of Overlook. These curbs and gutters comprise 1,360 linear feet and are in good condition overall. We note isolated cracks at the curbs and gutters, as depicted on Page 2 of **Exhibit A Photographs**. We estimate that up to 310 linear feet of curbs and gutters, or twenty-three percent (22.8%) of the total, will require replacement in conjunction with each repaving event. We depict this information on Line Item 4.110 of **Exhibit B Reserve Expenditures**.

Crack in concrete curb

The Association should coordinate partial replacements of concrete curbs and gutters with asphalt pavement, due to the interrelated nature of these items. The times and costs of these replacements may vary. However, the estimated expenditures detailed in **Exhibit B Reserve Expenditures** are sufficient to budget appropriate reserves.

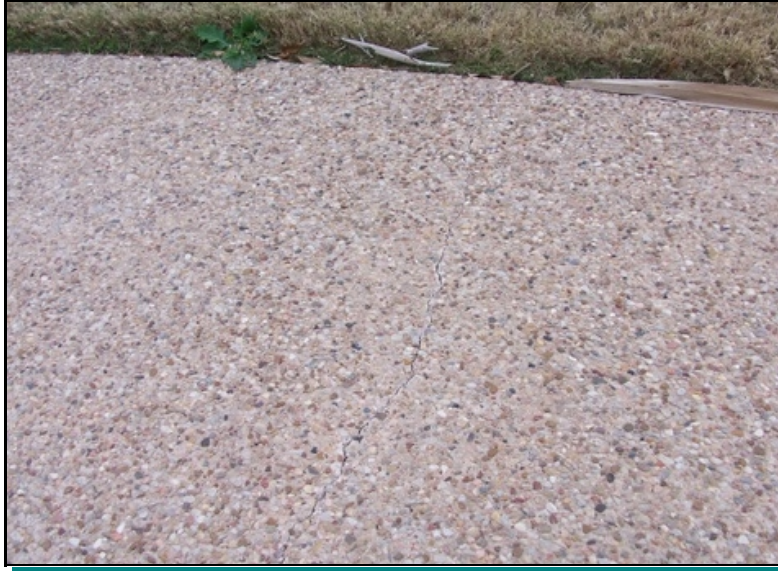
Concrete Sidewalks - Exposed aggregate concrete sidewalks comprise 2,300 square feet throughout the community. The sidewalks are in good overall condition. We

estimate that up to 1,050 square feet of concrete sidewalks, or forty-six percent (45.7%) of the total, will require replacement during the next 30 years. We recommend the Association budget for replacement of 210 square feet of concrete sidewalks every six years beginning by 2016. Line Item 4.140 of **Exhibit B Reserve Expenditures** notes our estimate of future costs and anticipated times of replacements. We recommend an annual inspection of the sidewalks to identify potential trip hazards. We suggest that the Association grind down or mark these hazards with orange safety paint prior to replacement and fund this ongoing activity through the operating budget.

Crack in concrete sidewalk

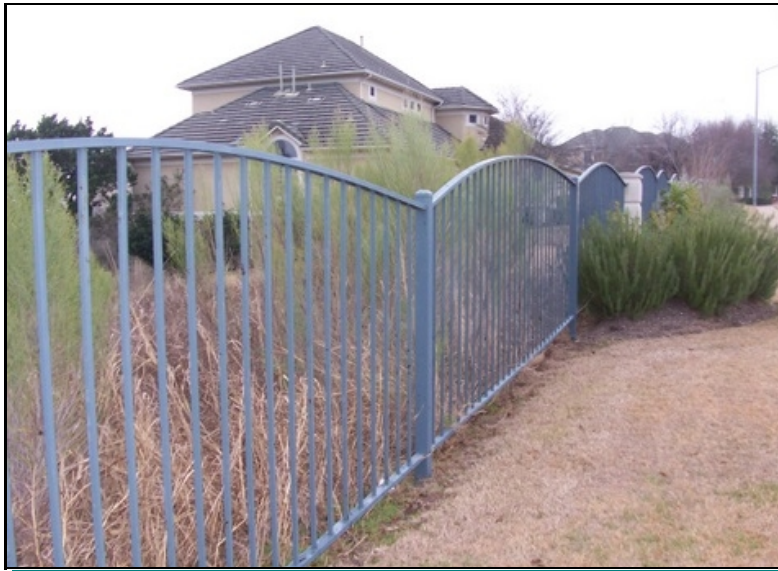
Fences, Metal - Approximately 1,005 linear feet of metal picket fences line the north perimeter of the property. Fences of this type have a long useful life but are not maintenance free. Periodic maintenance should include periodic applications of protective paint finish to the metal surfaces and partial replacement of deteriorated sections as needed. Metal components at grade and key structural connections are especially prone to failure if not thoroughly maintained. Secure and rust free fasteners and connections will prevent premature deterioration. The protective finishes are in poor overall condition at an age of two- to three-years. We note rust and paint finish deterioration. See Pages 3 and 4 of **Exhibit A Photographs** for examples of the condition of the fences. We recommend paint applications every six- to eight-years and we anticipate a useful life of up to 35 years for the fences.

Metal perimeter fence

Periodic applications of paint to the metal will help maximize their useful life. Preparation of the metal before application of the paint finish is important. The paint contractor should remove all soil, dirt, oil, grease and other foreign materials before application of the paint finish to maximize its useful life. The contractor should also remove paint blisters and rust prior to the paint finish application. We recommend the use of a power wire brush, scraper and/or sander as effective means of removal. The Association should require the application of a primer on bare metal. The primer for metal surfaces should include a rust inhibitor for added protection. We recommend the Association refinish the fences in 2012 and every six years thereafter except when replacement occurs. We anticipate replacement of the fences by 2030. We depict this information on Line Items 4.243 and 4.245 of **Exhibit B Reserve Expenditures**.

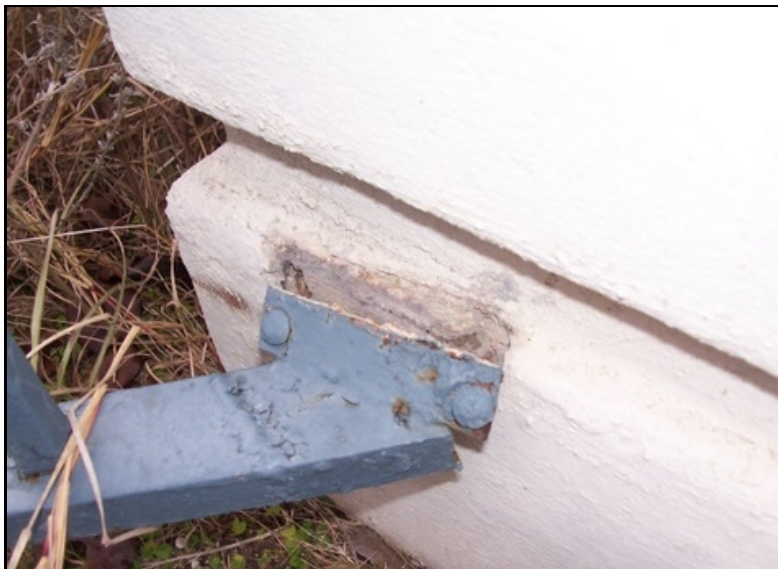
Loose connection at fence and
column

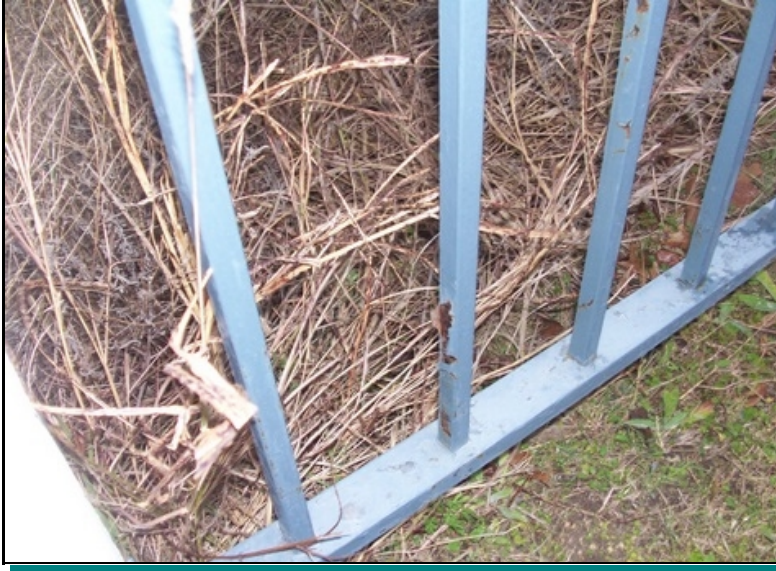
Rust and paint finish deterioration

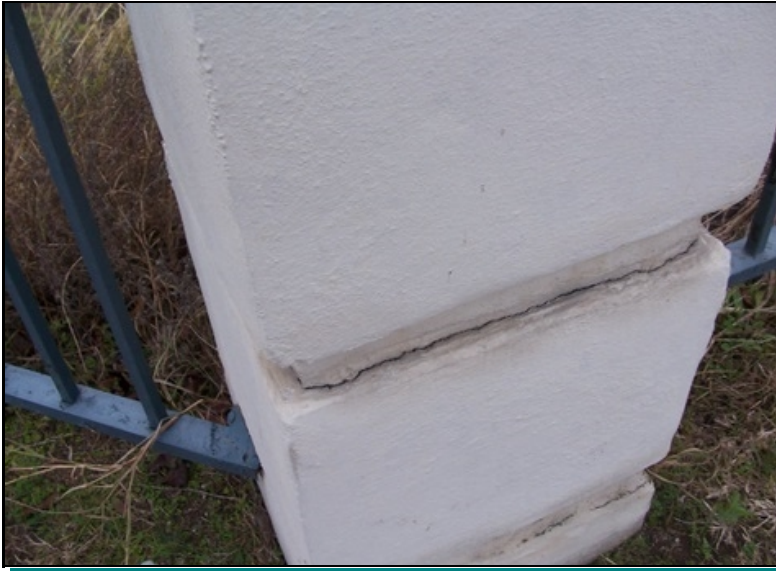
Crack at stucco finish

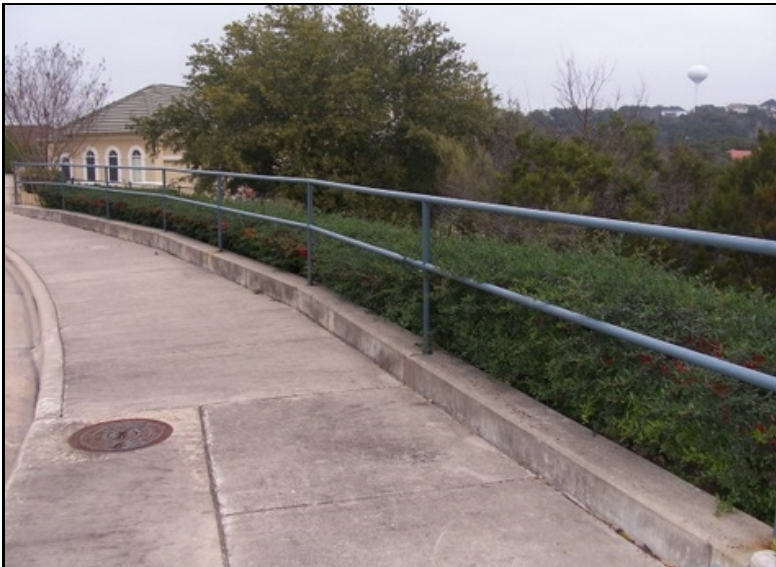
Metal railing on concrete retaining wall

*Maintain retaining wall through
operating budget*

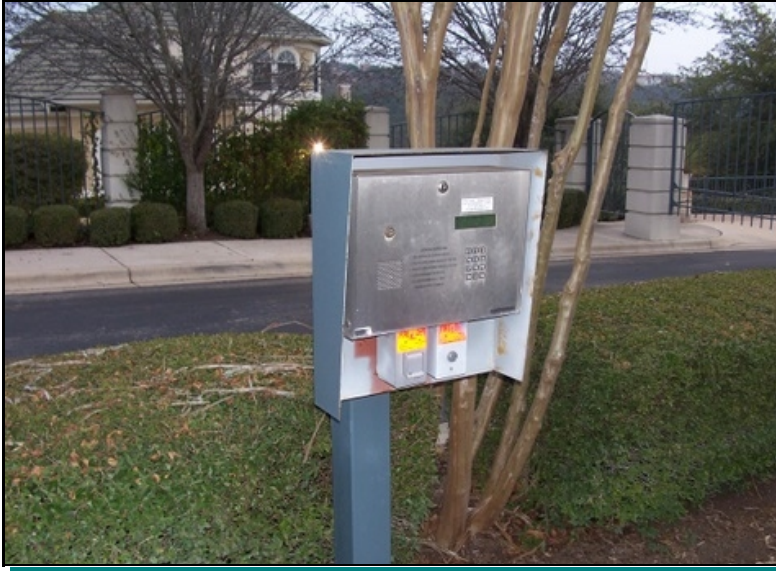
Intercom Panel - The Association utilizes an intercom panel for communication between the units and guests at Overlook. Management and the Board informs us that the panel is in good operational condition at an age of 16 years. Intercom panels of this type have useful lives of up to 20 years. We recommend the Association anticipate replacement of the intercom panel by

Intercom panel at entrance

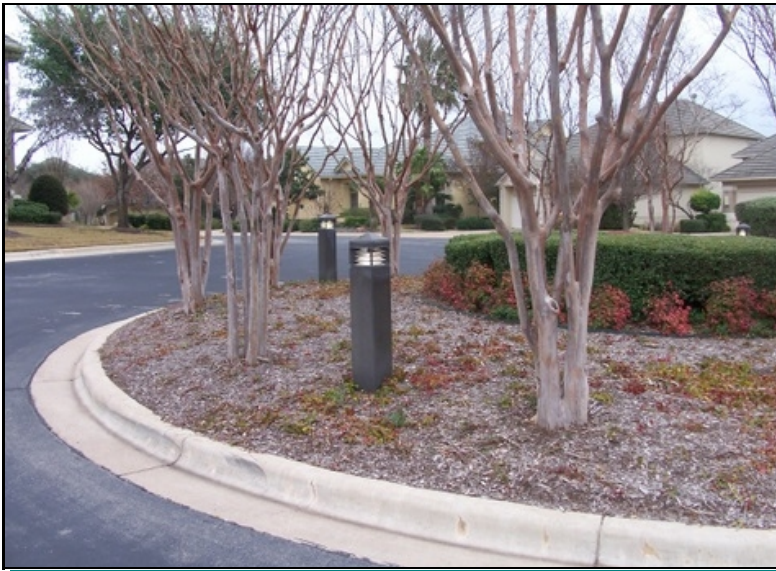
Lighted Bollards - The Association uses eight metal lighted bollards at the entrance to the property and at each landscaped island. The bollards are in good condition at ages of seven-to eight-years. These bollards have useful lives of up to 20 years. We recommend the Association budget for their replacement by 2023. We note this information on Line Item 4.560 of **Exhibit B Reserve Expenditures**.

Lighted bollards

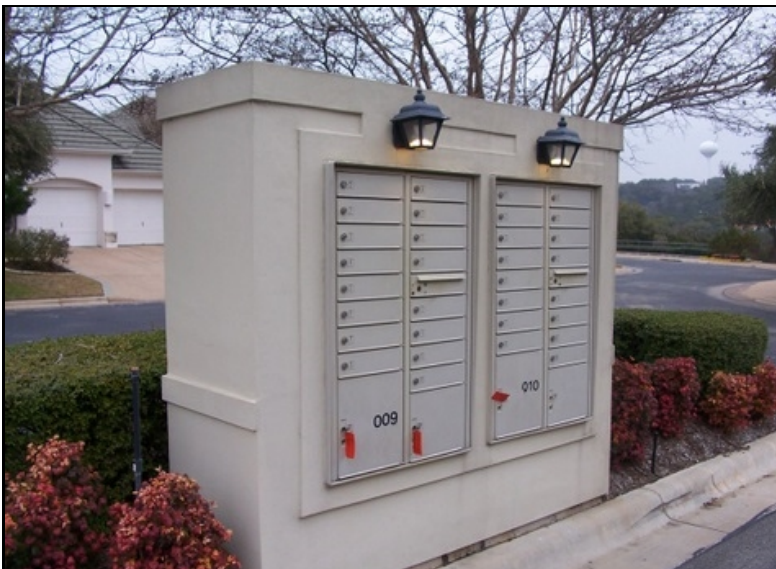
Mailbox Stations - A total of two metal mailbox stations located at a central landscaped island contain 21 individual mailboxes. The mailbox stations are in good overall condition at an age of 16 years and have a useful life of up to 25 years. Overlook should budget for replacement of the mailbox stations by 2020. We depict this information on Line Item 4.600 of **Exhibit B Reserve Expenditures**. The Association should verify the new mailboxes meet the specifications of the United States Postal Service.

Mailbox stations

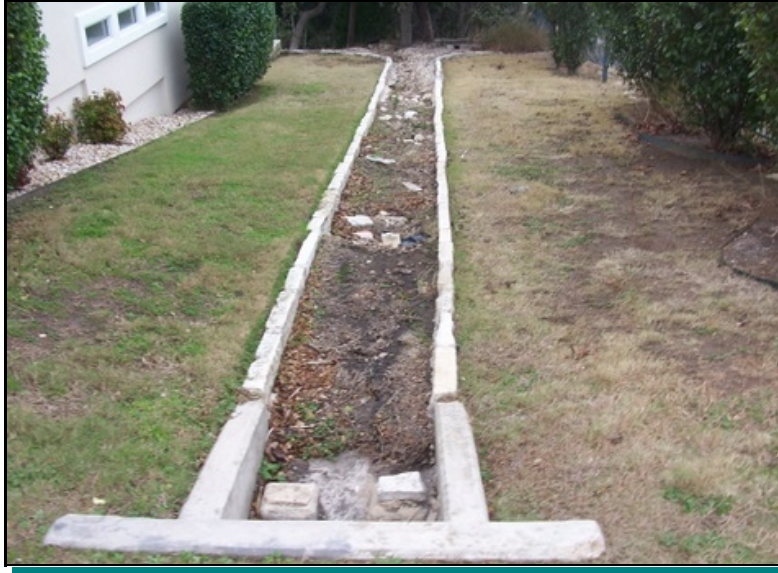
*Maintain storm water culvert
through operating budget*
