Clubhouse Roof Over Pool Area
Presentation
1-27-2026

CTR Roofing Report

Subject: Re: Rainbow Bend Clubhouse roof investigation

ROOF REPLACEMENT PROPOSAL

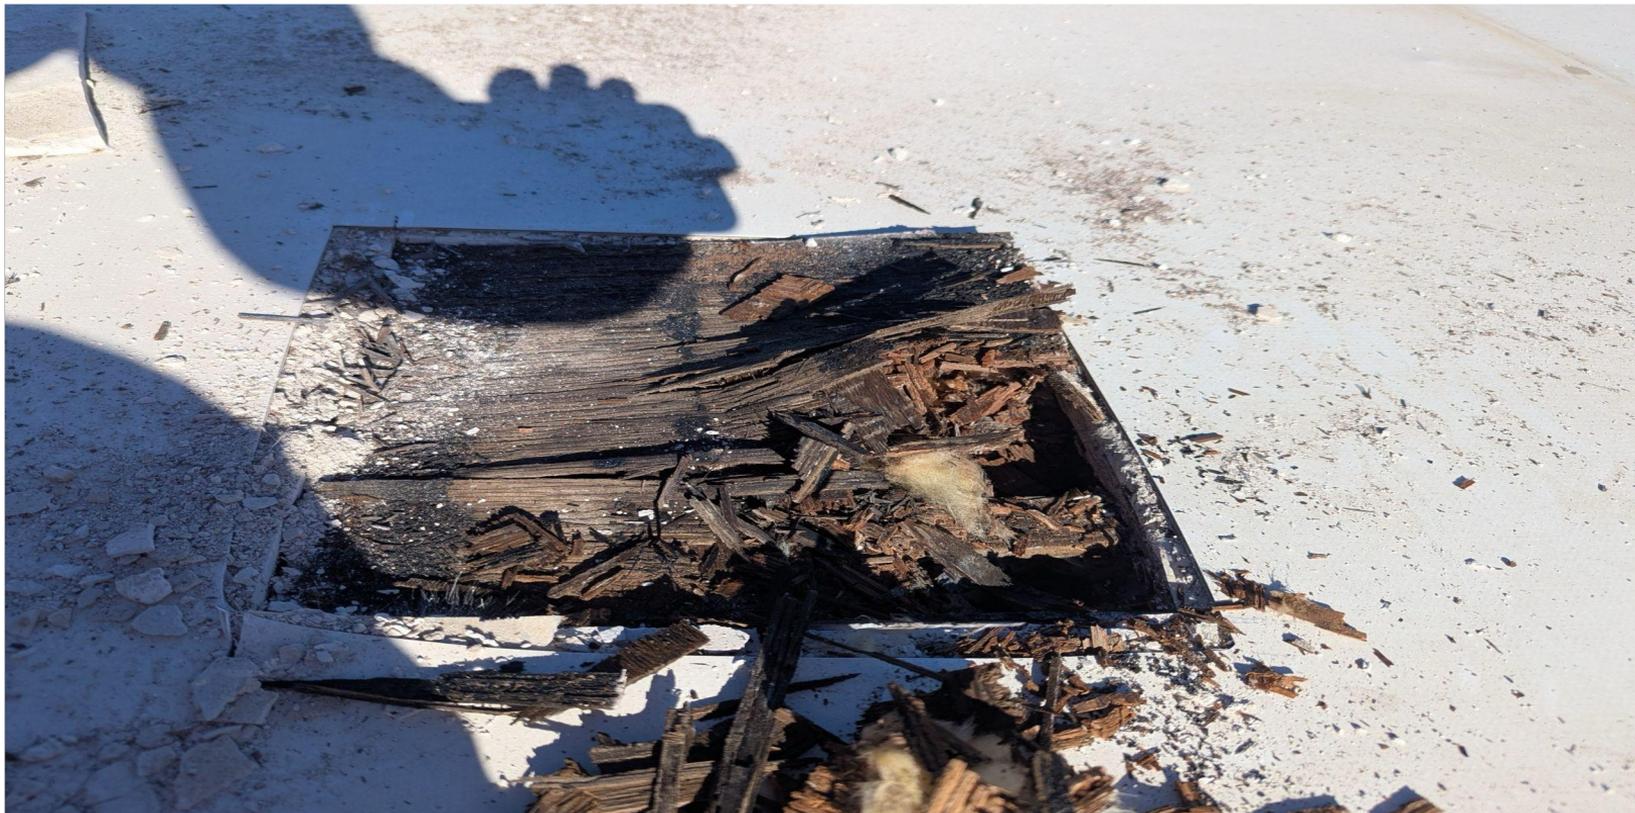
Roof Damage - #1

1. The decking is definitely rotted but the condensation is occurring on the underside of the membrane and is damaging the plywood from above.
2. Essentially, the warm air from inside is beading water on the backside of the roof membrane and absorbing in the plywood and rotting it.
3. The roof needs insulation at the very least and we recommend a vapor barrier to further protect the temperature difference.
4. Attached is a proposal to remove all the roofing. There is an option to add vapor barrier which we recommend and to replace the wood decking.
5. I have a combined price for the entire roofing system, vapor barrier, Insulation, and PVC that I really recommend to replace the wood decking.
6. I have a combined price for the entire roofing system, vapor barrier, Insulation, and PVC that I really recommen
7. Likely you will need to replace all the decking.
