Rainbow Bend Home Owners Association

Full Reserve Study

Start Date: 01/01/2019

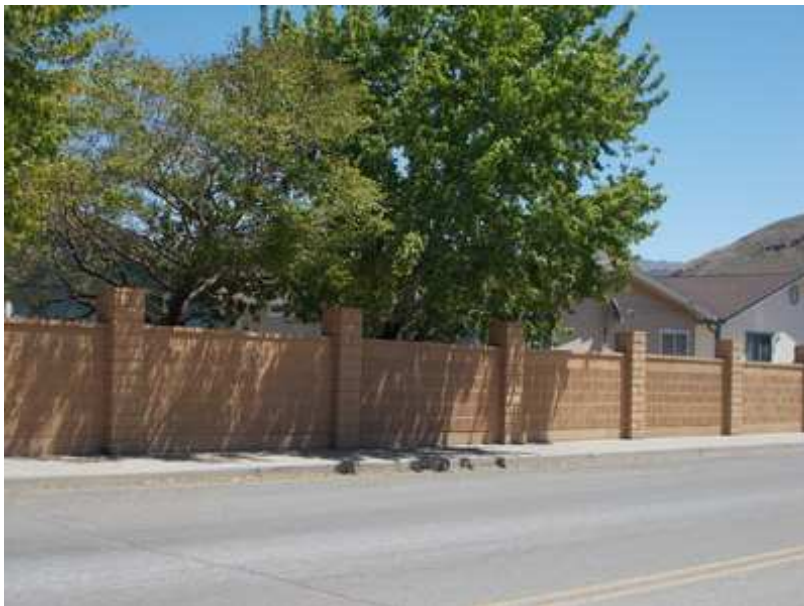
Perimeter Wall Repairs have been included in the Study as an allowance, to be done as needed.

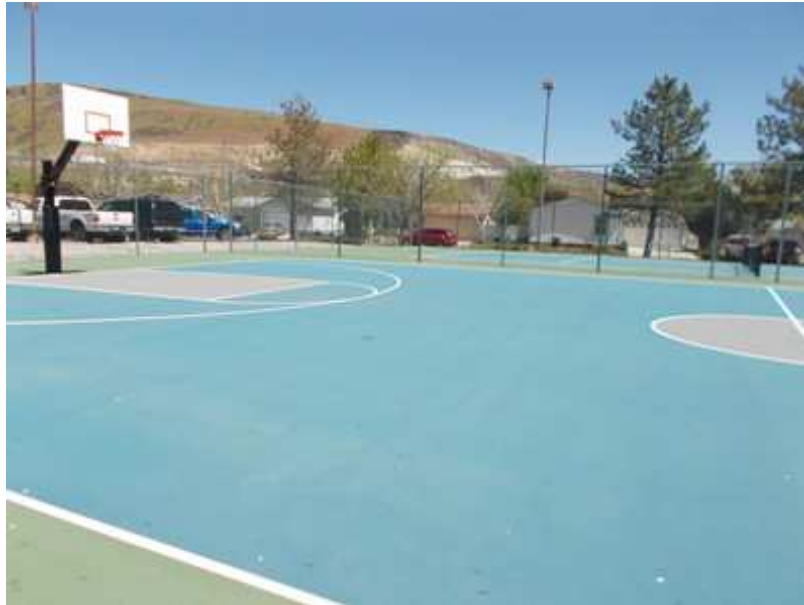
The Tennis Court Resurface, Sealing, Basketball Hoops and Chain Link Fencing have been included in the Common Area Category.

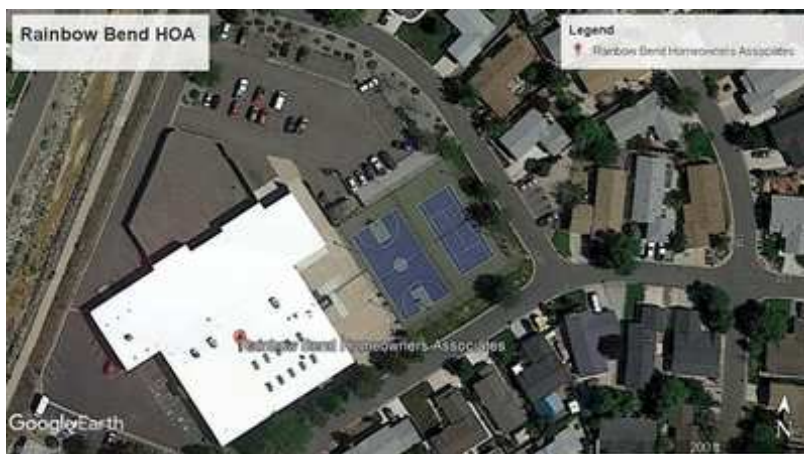
The Roofs of the Clubhouse and Lot A, the Acquired Building were replaced in 2017. The Roofs have an estimated useful life when new of 20 years. Regular Maintenance is required.

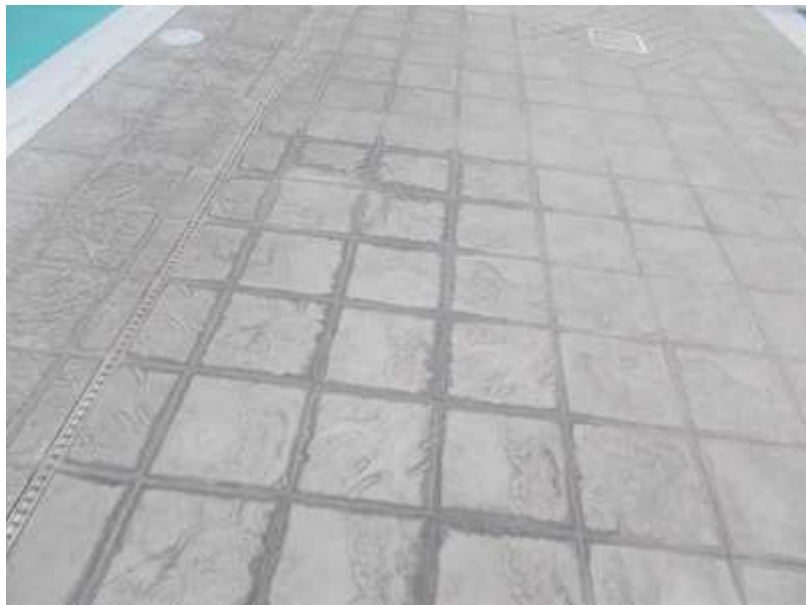
The Tile Re-Surface has been included in the Study to be done as needed. The Coating is peeling and damaged.

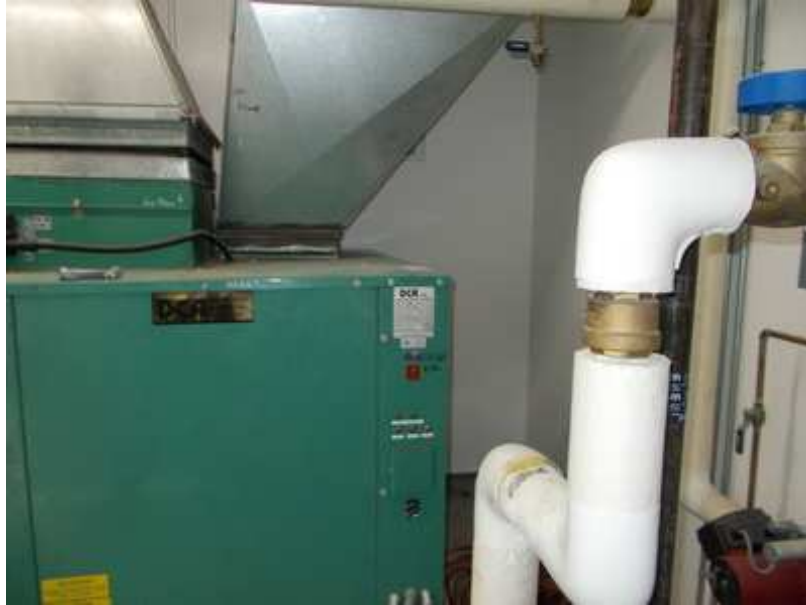
The Estimated Useful Life and Replacement Costs of the De-Humidifier/ Ventilation System and Pool Equipment was provided by Lee Joseph Pools, Reno, Nevada.

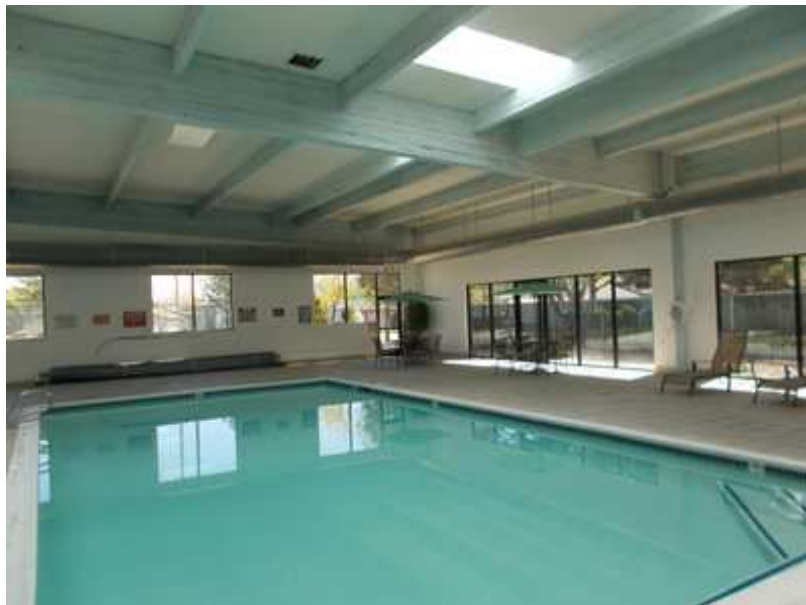
The Pool Area Components include Pool Concrete Deck, Pool Furniture, Pool and Spa Re-Surface, Heater, Pump, Pool Cover Interior Painting, Filter Replacement and Ventilation System. The Useful Life of each component is an estimation only.
