# Rainbow Bend Home Owners Association

## Annual Review Without Site Visit

Start Date: 01/01/2020

The Rainbow Bend Home Owners Association is located in Sparks, Nevada. The Association consists of 402 Assessment Paying Members. The Common Elements include the Clubhouse, Tennis Court/ Basketball Area, Park Areas, Road and Parking Area and Landscaping. The Association is well maintained and in overall very good condition.

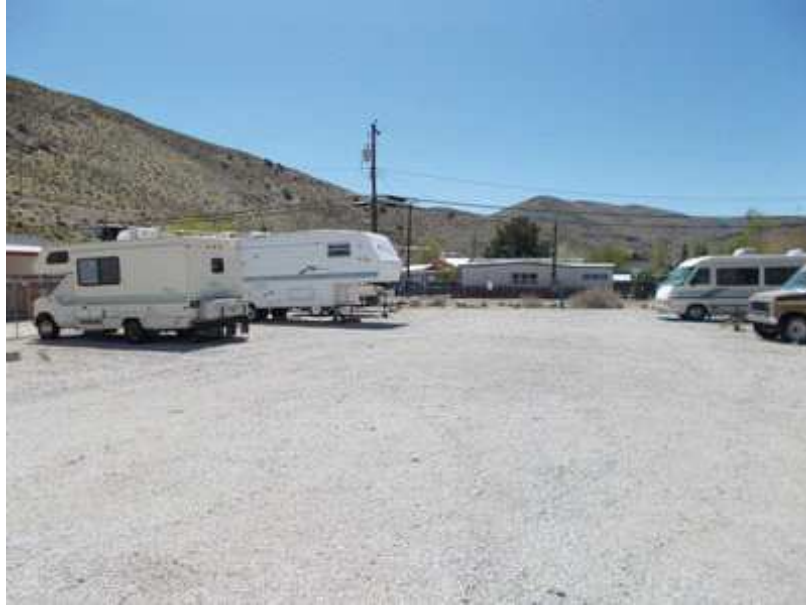
The RV Lot Maintenance has been included on a separate study.

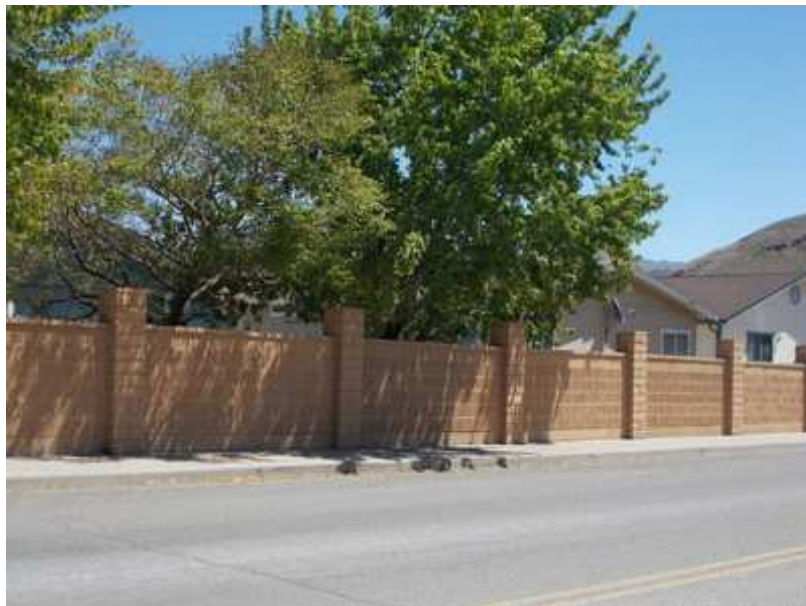
Perimeter Wall Repairs have been included in the Study as an allowance, to be done as needed.

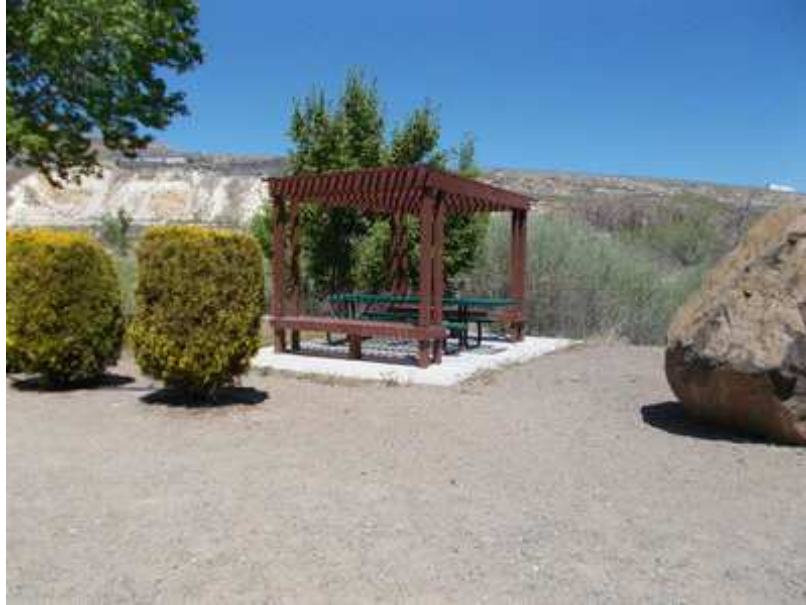
Park Area Components include the Gazebo, Picnic Tables, Benches and Trash Can Enclosures.

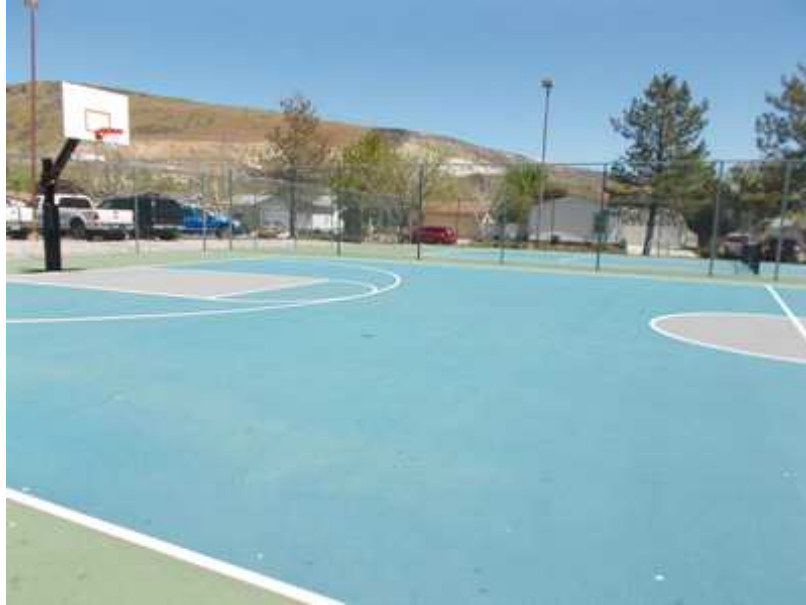
The Tennis Court Resurface, Sealing, Basketball Hoops and Chain Link Fencing have been included in the Common Area Category.

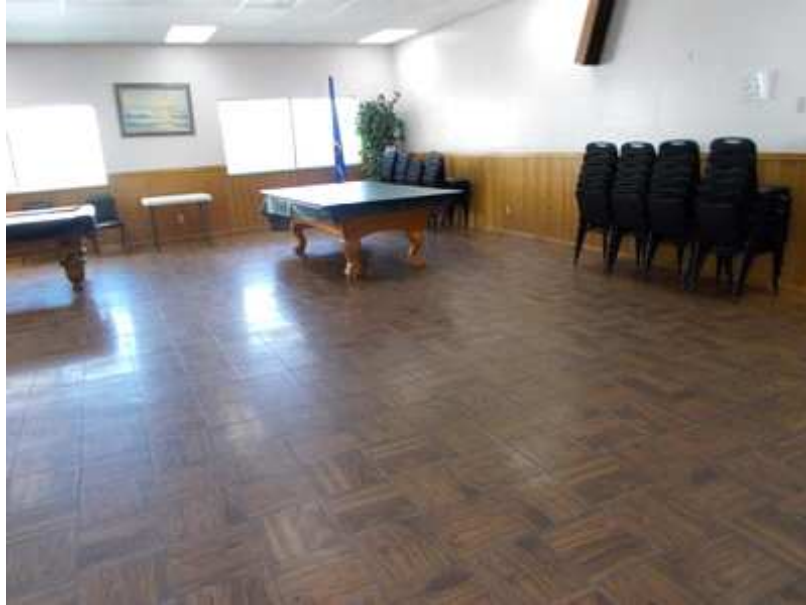
The Community Room Flooring, Pool Tables, Furniture, Painting and Lighting and Electrical have been included as components in the Study.

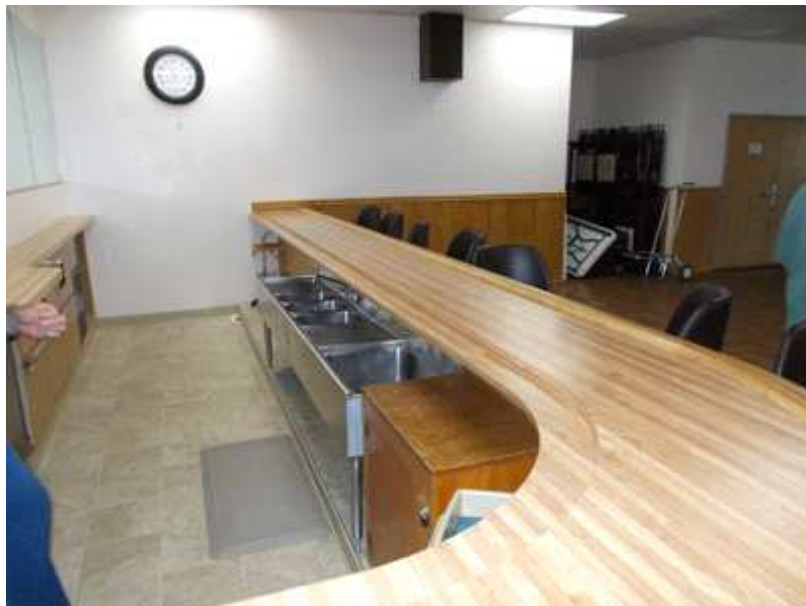
The Bar Area Components include the Appliances, Sinks, Bar Refurbishment, Flooring and Stools.

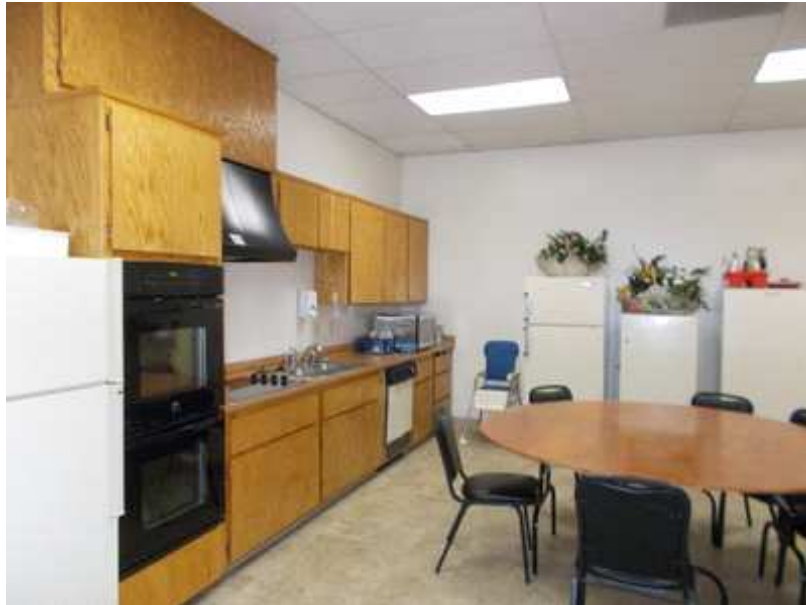
The Kitchen Remodel includes new Cabinets, Fixtures, Appliances and Renovation. The Appliances are scheduled to be replaced as needed through an allowance.

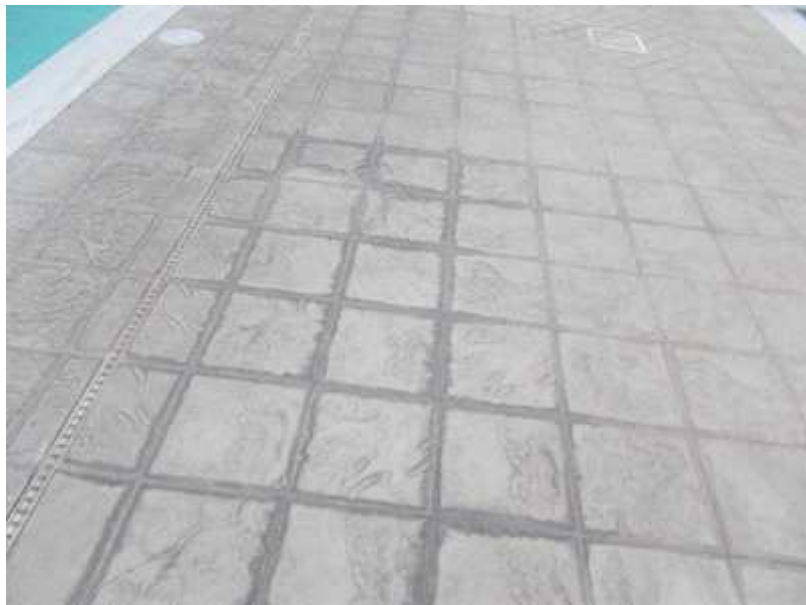
The Tile Re-Surface has been included in the Study to be done as needed. The Coating is peeling and damaged.

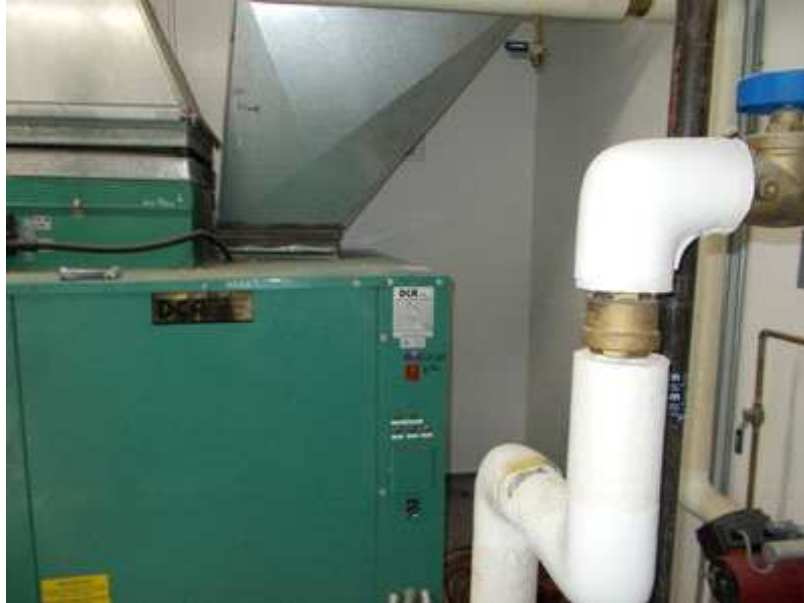
The Estimated Useful Life and Replacement Costs of the De-Humidifier/ Ventilation System and Pool Equipment was provided by Lee Joseph Pools, Reno, Nevada.

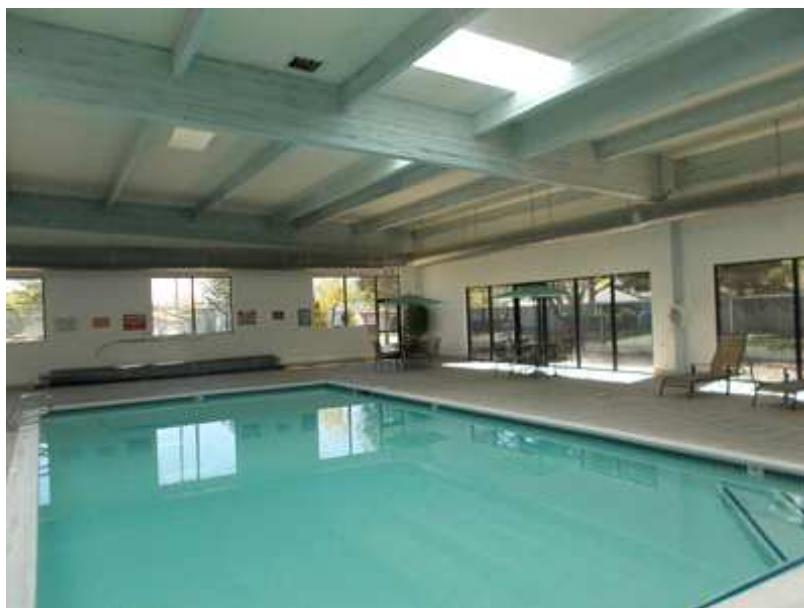
The Pool Area Components include Pool Concrete Deck, Pool Furniture, Pool and Spa Re-Surface, Heater, Pump, Pool Cover Interior Painting, Filter Replacement and Ventilation System. The Useful Life of each component is an estimation only.

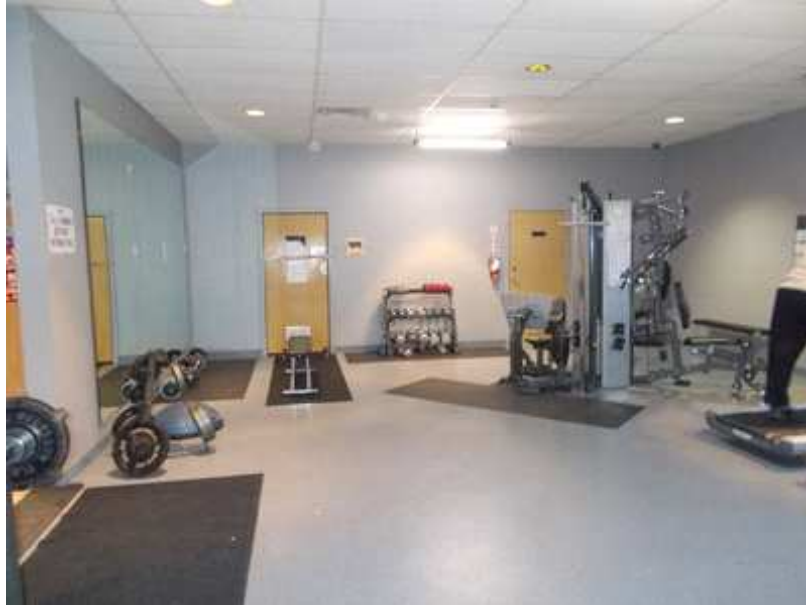
Complete Replacement of all Exercise Equipment has not been included in the Study. Instead, Exercise Equipment is replaced as needed through an allowance.

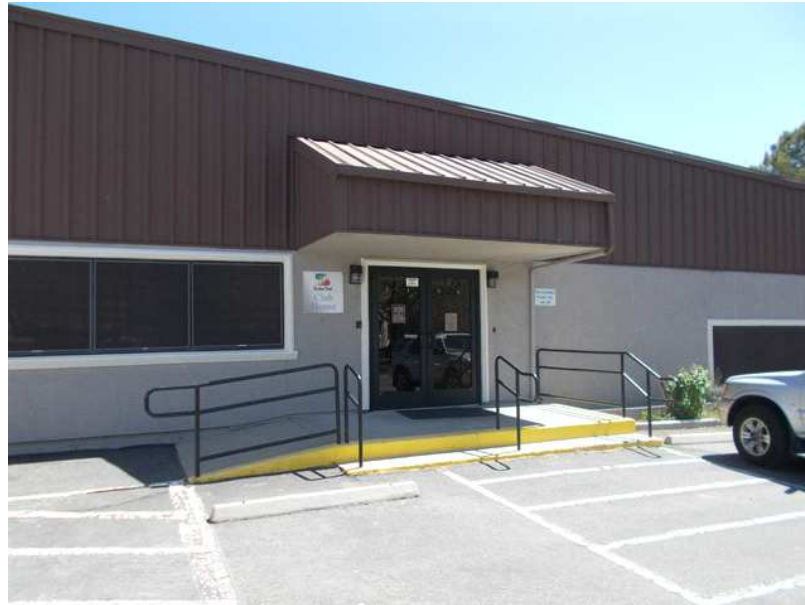
### Building Exterior

Component	Year Scheduled	Quantity	Cost Per Unit	Today's Cost	Estimated Remaining Useful Life (Years)	Estimated Life When New (Years)
1. Building Exterior - Front Doors and Lock System (Replaced 2018)	2038	1 unit	10,000.00	10,000.00	18	20
2. Building Exterior - Front Doors Repairs Allowance	2020	as needed	4,000.00	4,000.00	0	3
3. Building Exterior - Painting Exterior (Done 2017)	2028	all	12,000.00	12,000.00	8	12
4. Building Exterior - Roof Replacement (Done 2017)	2037	14935 sq ft	11.00	164,285.00	17	20

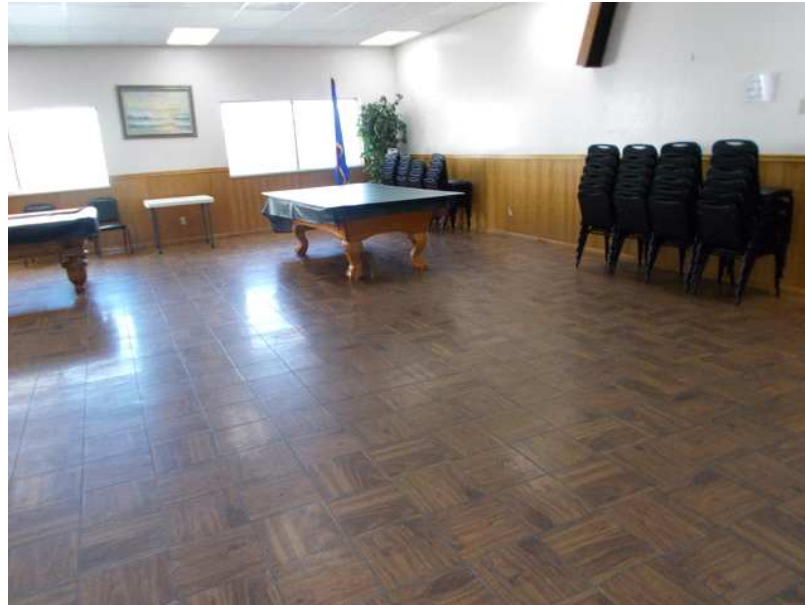
### Clubhouse

Component	Year Scheduled	Quantity	Cost Per Unit	Today's Cost	Estimated Remaining Useful Life (Years)	Estimated Life When New (Years)
1. Clubhouse - Art Work and Decorations	2024	as needed	2,500.00	2,500.00	4	10

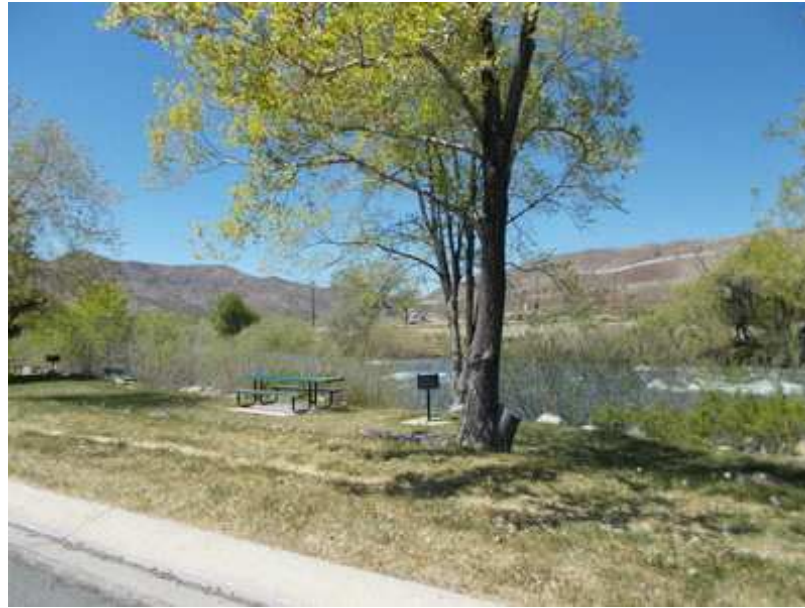
### Common Area

Component	Year Scheduled	Quantity	Cost Per Unit	Today's Cost	Estimated Remaining Useful Life (Years)	Estimated Life When New (Years)
1. Common Area - Concrete Repair or Replacement Allowance	2022	as needed	2,500.00	2,500.00	2	3

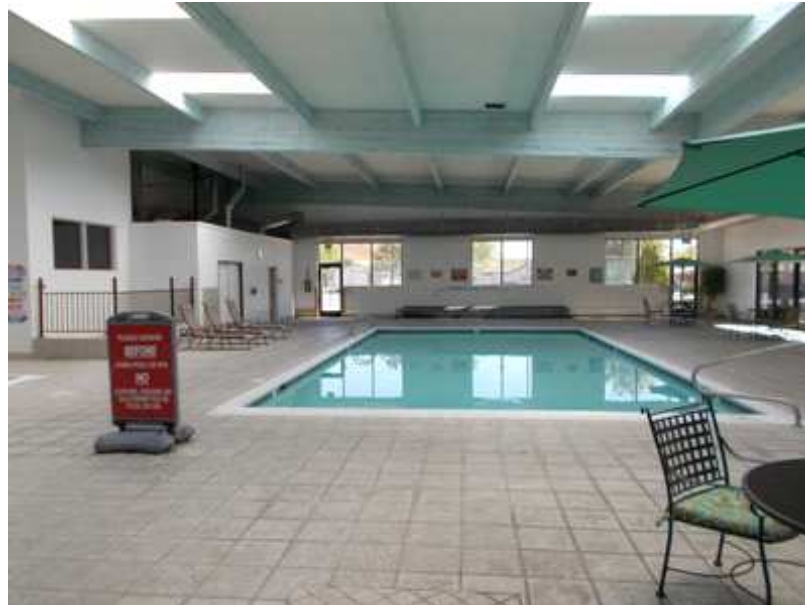
### Pool Area

Component	Year Scheduled	Quantity	Cost Per Unit	Today's Cost	Estimated Remaining Useful Life (Years)	Estimated Life When New (Years)
1. Pool Area - Furniture	2023	all	10,000.00	10,000.00	3	10

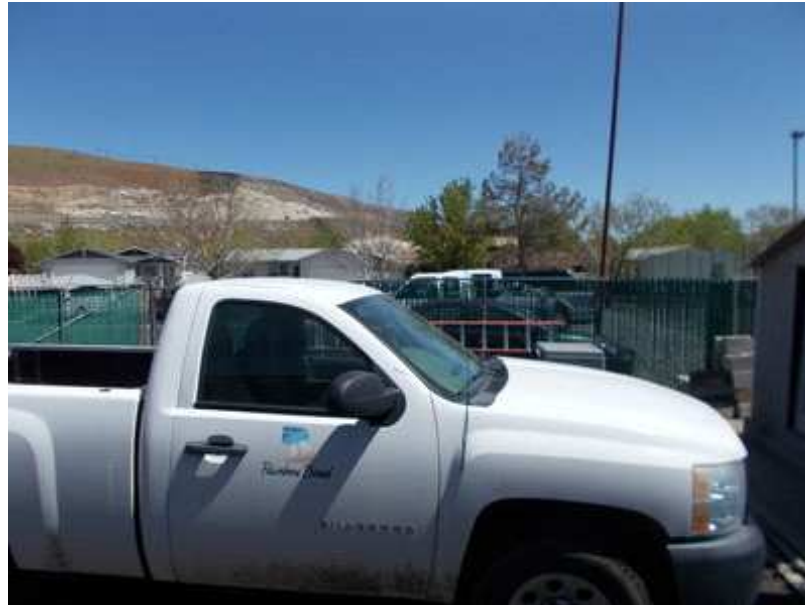
### Vehicles

<b>Component</b>	<b>Year Scheduled</b>	<b>Quantity</b>	<b>Cost Per Unit</b>	<b>Today's Cost</b>	<b>Estimated Remaining Useful Life (Years)</b>	<b>Estimated Life When New (Years)</b>
1.	Vehicles - Cars and Trucks -Honda Civic	2024	1 unit	22,000.00	22,000.00	4	10
2.	Vehicles - Cars and Trucks -Silverado	2022	1 unit	40,000.00	40,000.00	2	10
3.	Vehicles - Misc Allowance	2020	as needed	1,500.00	1,500.00	0	2
4.	Vehicles - Service and Inspection -Silverado 60 Mile Service	2024	as needed	2,500.00	2,500.00	4	5
5.	Vehicles - Utility Trailer	2024	1 unit	2,500.00	2,500.00	4	10
