Downtown Orinda San Pablo Creek Restoration: Phase I

Restoring ecological function to the creek while reducing the risk of flooding

Friends of Orinda Creeks 2022, V-2

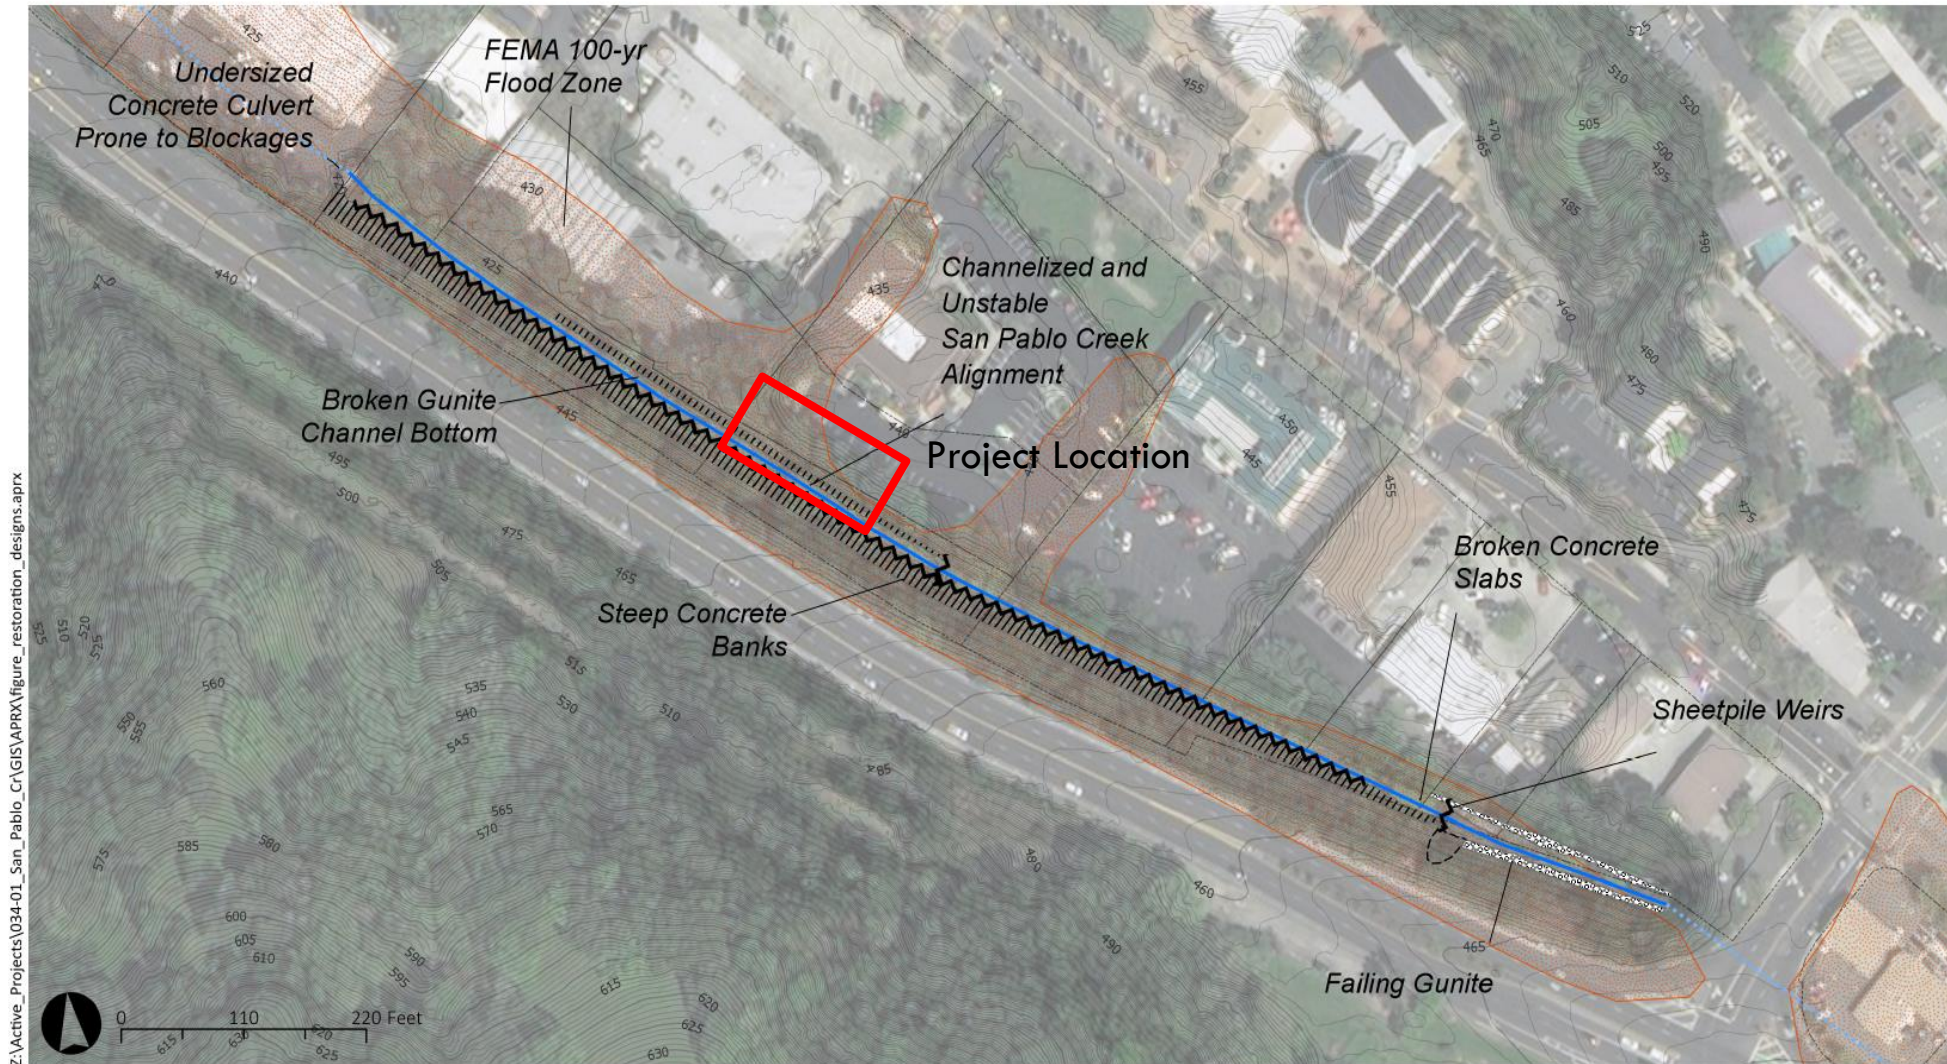
San Pablo Creek Restoration - Existing Conditions

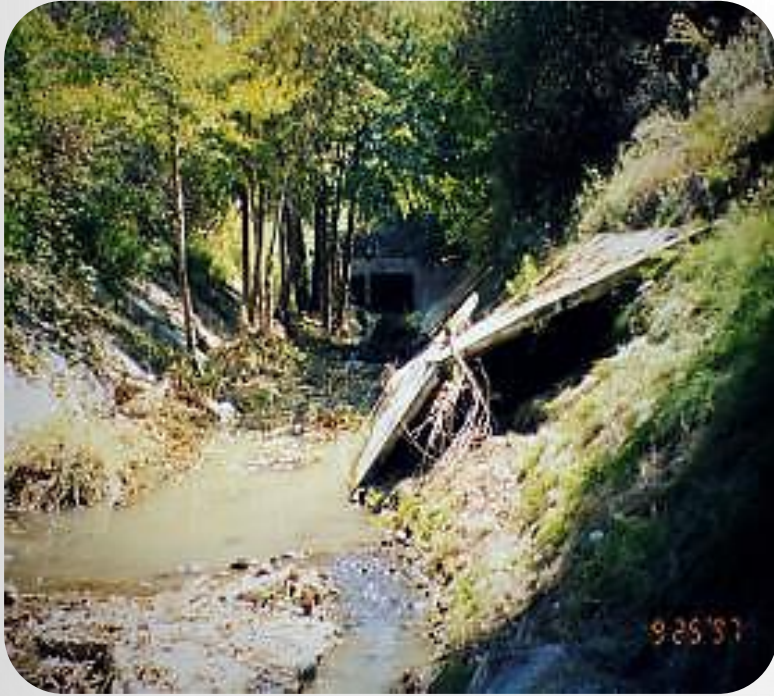
Existing Conditions: the Channel is Degraded

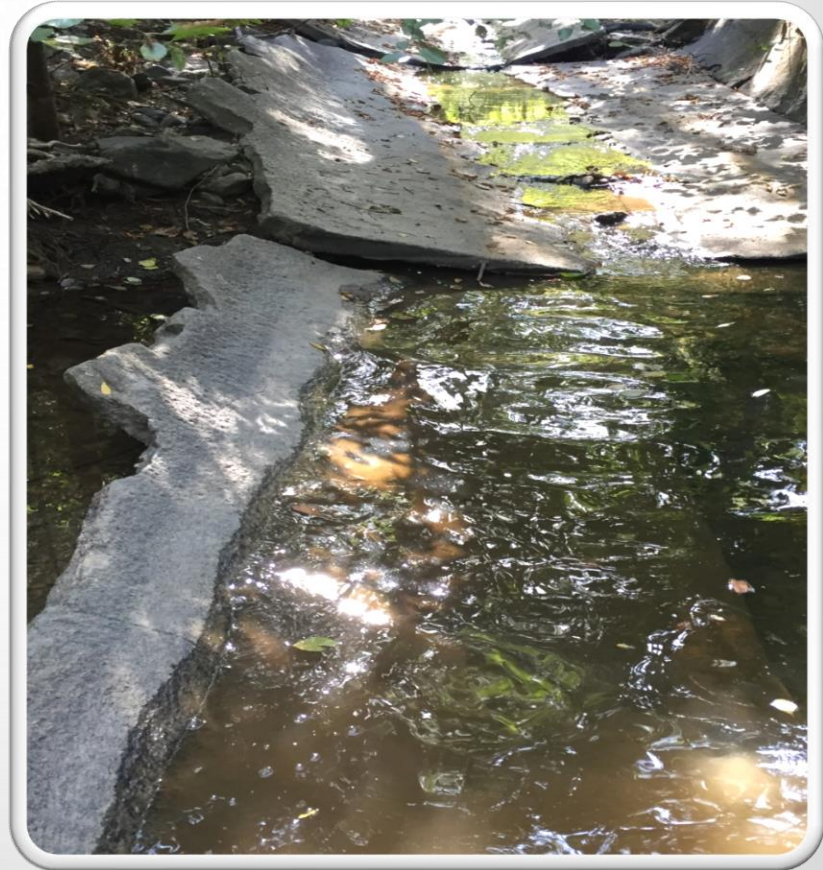
Damaged Side-Walls and Creek Bed

- The Creek was channelized in 1958 and realigned within a concrete and gunite trapezoidal channel. The Channel was severely damaged in a 1962 storm. Subsequent storm flows have undermined the walls and broken up the concrete into large slabs creating potential flow blockage⁶ at the downstream culvert.

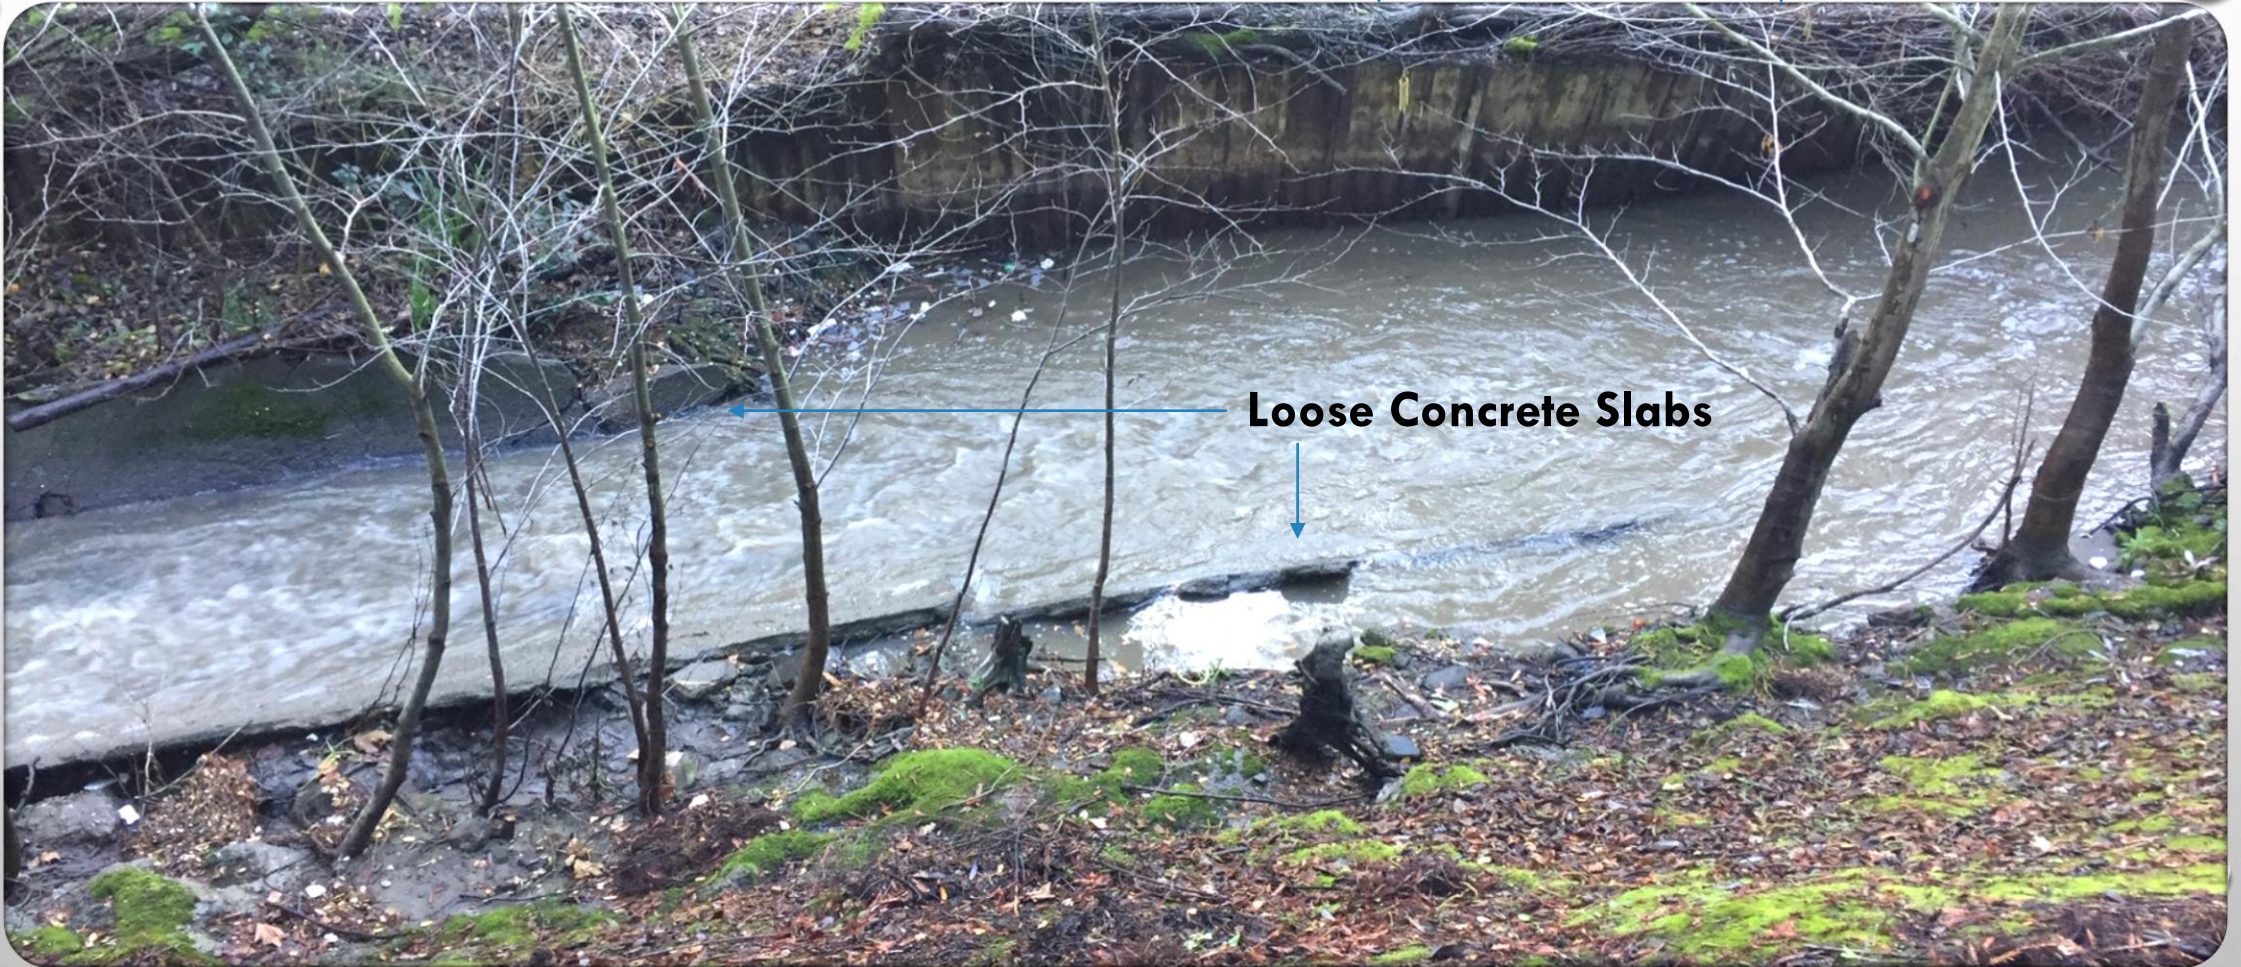
Camino Pablo Road

Sheet Pile Wall

Loose Concrete Slabs

Sheet Pile Wall Showing Water Undercutting the Base

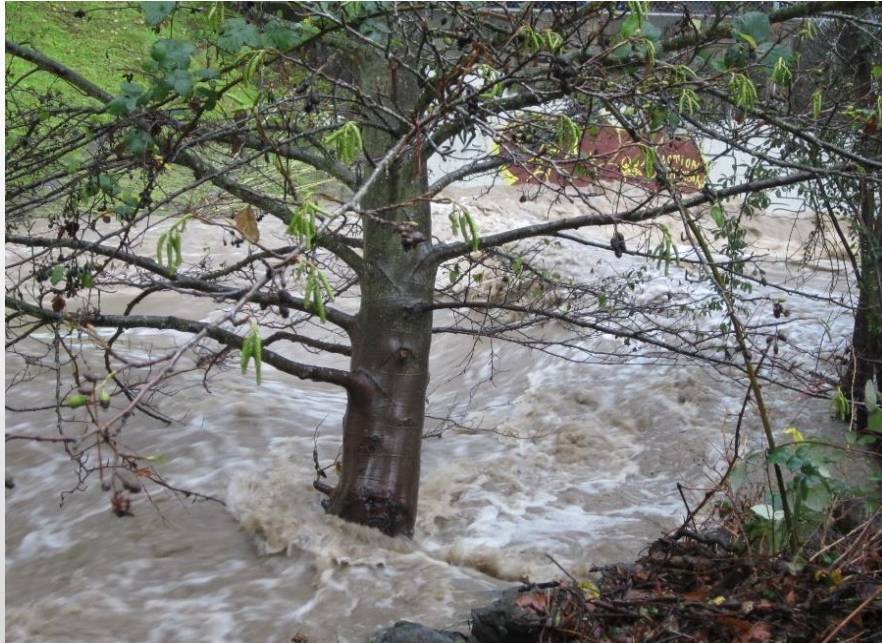
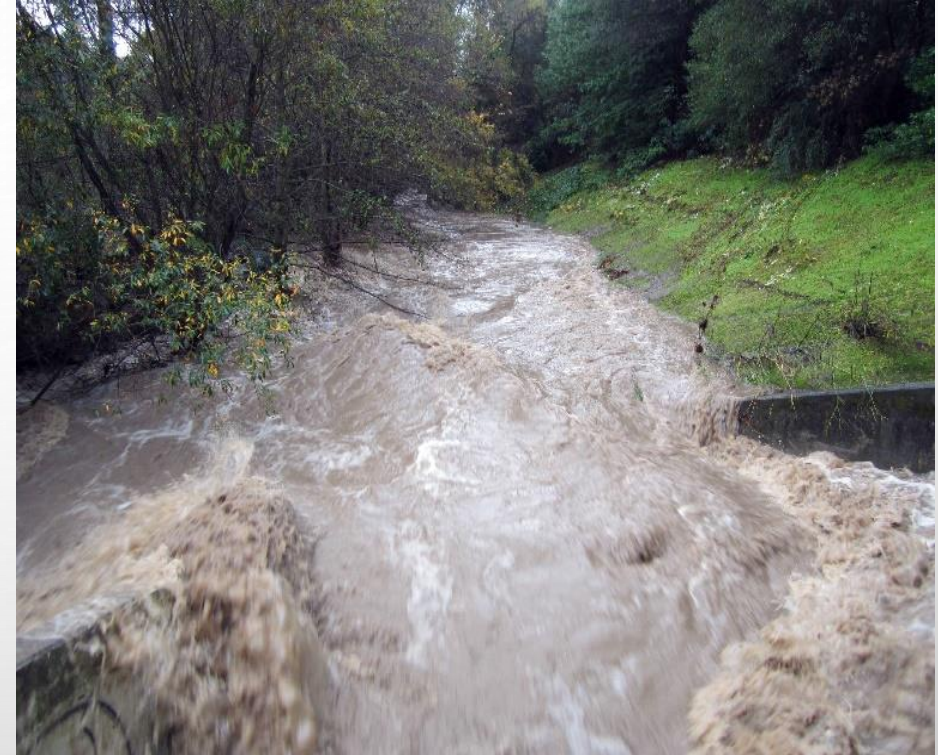
Severe Flooding is a Risk

Flooding has occurred in parking lots and businesses behind Safeway, Bank of America and the Post Office, usually as a result of a tree or large concrete slab blockage of the downstream culvert.

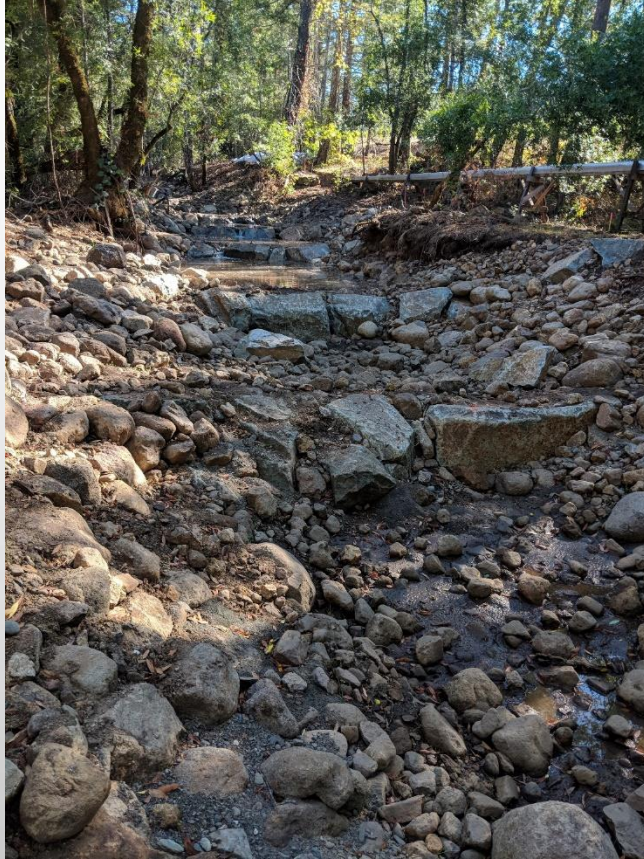
Natural Channel: Replace Concrete with Boulder Weirs forming Step Pools

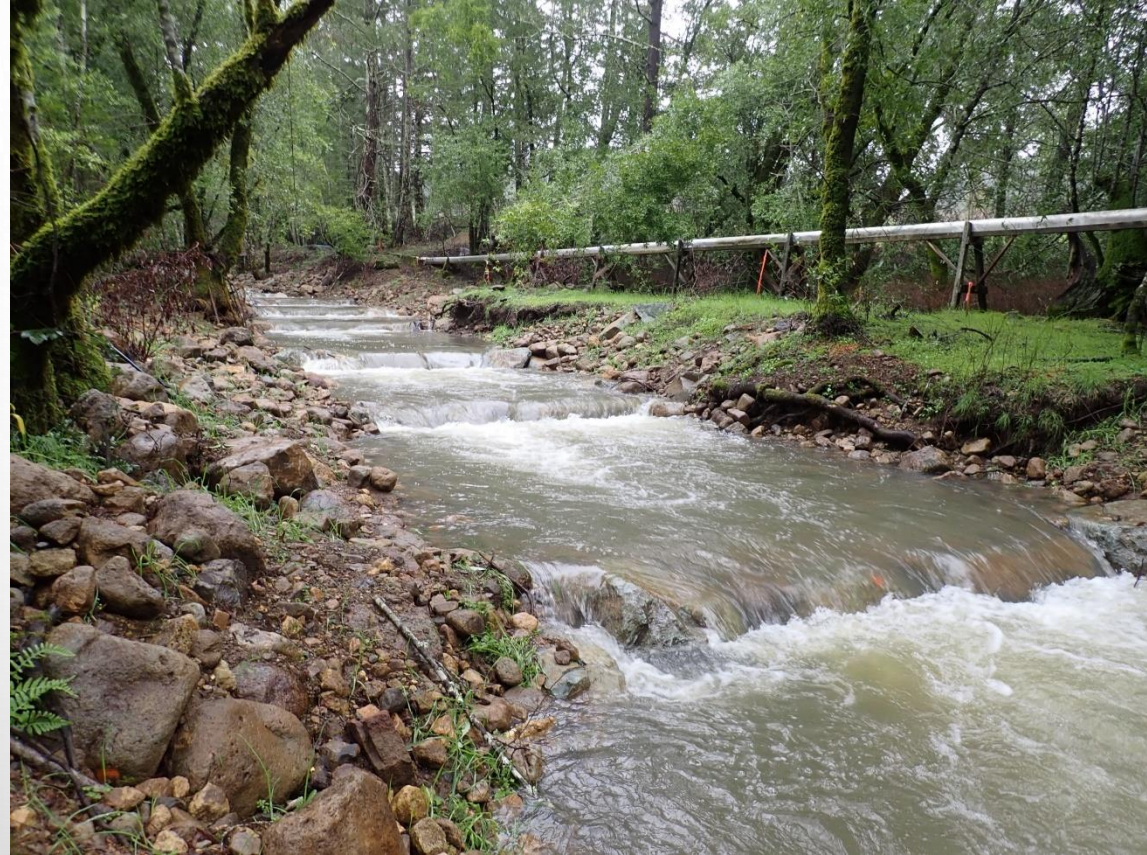
“Yellowjacket Creek step pool project during and post-construction, Sonoma Co”

Remove concrete channel lining and install 3 boulder “steps” separated by pools. The boulder steps will provide fish passage, improved aquatic habitat and channel esthetics.
