## **Bacteriological challenges to asbestos cement water distribution pipelines**

**NRCC-50035**

Wang, D.L.; Cullimore, D.R.

August 2010

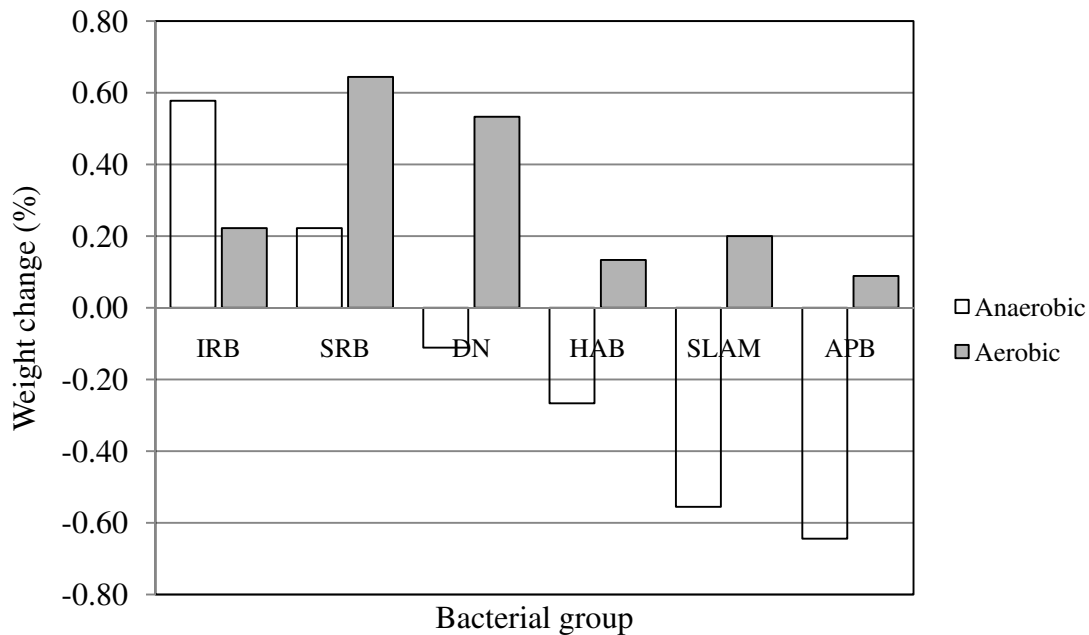
Change of wet weight for the paired AC segments submerged in different bacterial cultures is shown in Fig. 3. The changes were resulted from interactions between the bacterial cultures and the pipe segment during the 10 days of culture. The X-axis gives the six bacterial cultures applied in the order (from left to right) of IRB, SRB, DN, HAB, SLYM and APB. This order is selected to show the progression from weight gains (iron related and sulfate reducing in both aerobic and anaerobic conditions) to weight losses under anaerobic conditions particularly in the slime forming and acid producing. Weight gains have been associated with the buildup of iron oxides, and to a less extent, sulfides, under a reduced environment. Weight losses were experienced with four of the bacterial communities particularly under anaerobic conditions in a progressive manner from denitrification to heterotrophic, to slime forming and to acid producing bacterial cultures.

Fig. 3 Percentage of wet weight change of AC segments after 10 days immersion in previously prepared bacterial cultures.

When microorganisms challenge the concrete in AC pipe, it is clear that some of the bacterial groups can be very aggressive (Fig. 3). Under anaerobic conditions, the AC pipe segment immersed in APB and the SLYM bacteria cultures showed substantial losses in weight (range from 0.48% to 0.70%) during the 10 days period or a total loss of up to 1.5 g. A significant loss (0.25%) was also observed for the segment in HAB bacteria under anaerobic conditions. There was variance amongst the bacteriologically challenged AC segments and some conditions did not result in a significant loss in weight. Under aerobic environments, the concrete weights did not change much, or in some cases, gained in weight. For example, aerobic IRB immersion resulted in over a 0.2% weight gain that might have been the result of the deposition of a ferric form of iron and, for the SRB (0.65% gain), the depositions of the visible black sulfides on the concrete surface.
