Louisa Lodge East, Park Lane, Hawkhurst, Cranbrook, Kent TN18 5HA

Archaeological Watching Brief Report

Site Code: 33210

Planning Application Number: TW/21/04082/FULL

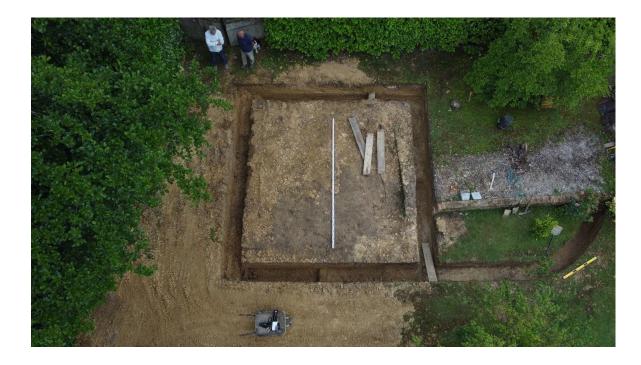
Plate 2 Aerial photograph of the development site following excavation of foundation trenches (4m scale)

4.2.1 The excavation of the topsoil and foundation trenches was carried out using a 1.5T 360° mechanical excavator. All spoil was removed using a 1T dumper truck and stockpiled, temporarily, within the site. Plate 2 provides an aerial view of the foundation trenches, taken using a mobile drone.

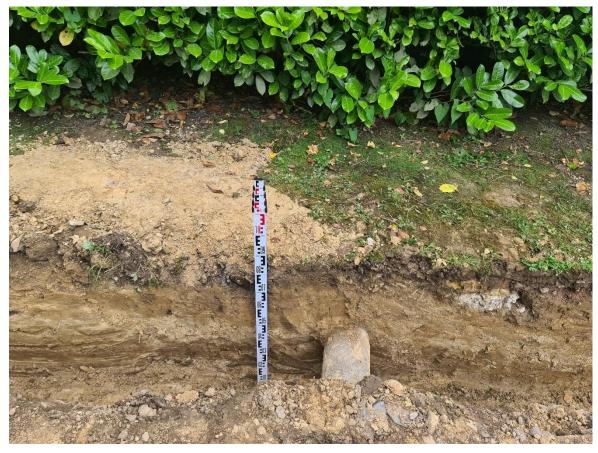
Plate 3 Representative Section RS1, viewed from the north

5.1.2 The stratigraphic sequence within this plot consisted of topsoil (101) overlaying natural buff yellow sandy silt (102). Four representative sections were recorded, as detailed on Figure 2. Sections were located across the foundation footprint in order to provide an overall stratigraphic sequence for the plot. Representative Section 1 (RS1) was located on the southern extent of the proposed development (Plate 3) and recorded topsoil (101) overlaying the natural geology (103) (Table 3).

Context Number	Description	Interpretation	Depths (m)
(101)	Dark grey brown silty clay	Topsoil	0.00-0.21
(103)	Mid orange silty sand	Natural geology	0.21-0.82+

Table 3 Stratigraphic Sequence representative Section RS1 (0.00m = 95.6m aOD)

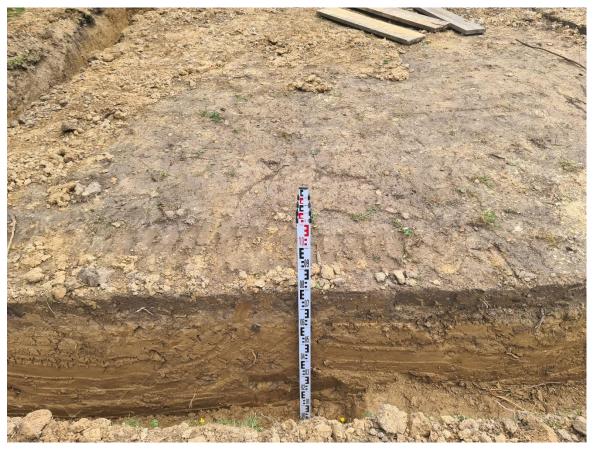
Plate 4 Representative Section RS2, viewed from the north

5.1.3 Representative Section 2 (RS2) was located on the northern extent of the proposed development (Plate 4) and recorded topsoil (101) overlaying the natural geology (102) (Table 4), while Representative Section 3 (RS3) recorded the same deposits (Plate 5) at slightly varying depths (Table 5).

Context	Description	Interpretation	Depths (m)
Number			
(101)	Dark grey brown silty clay	Topsoil	0.00-0.11
(102)	Mid orange silty sand	Natural geology	0.11-0.78+

Table 4 Stratigraphic Sequence representative Section RS2 (0.00 = 94.9m aOD)

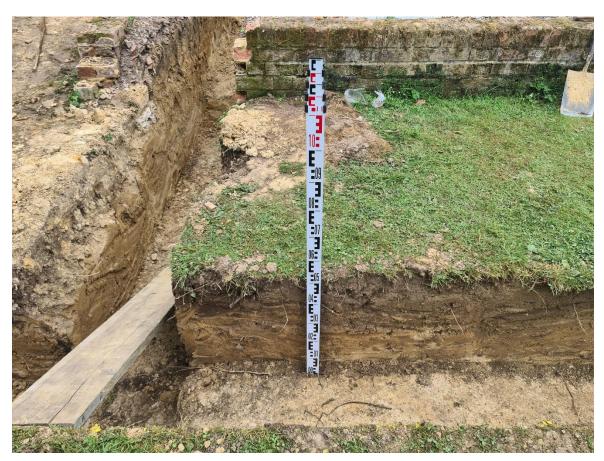
Plate 5 Representative Section RS3, viewed from the north

Context	Description	Interpretation	Depths (m)
Number			
(101)	Dark grey brown silty clay	Topsoil	0.00-0.19
(102)	Mid orange silty sand	Natural geology	0.19-0.52+

Table 5 Stratigraphic Sequence representative Section RS3 (0.00 = 94.9m aOD)

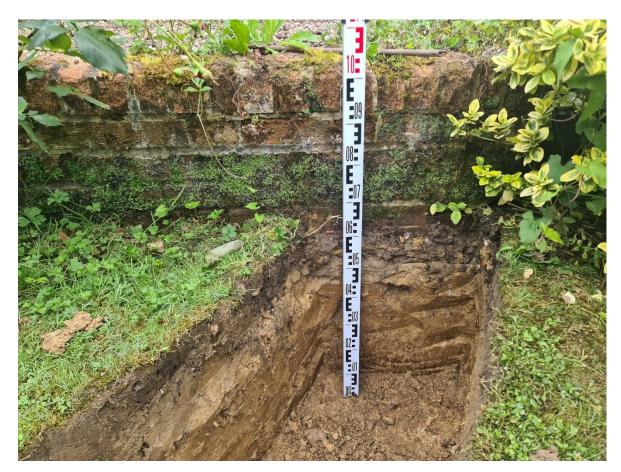
Plate 6 Representative Section RS4, viewed from the north

5.1.4 Representative Section 4 (RS4) was located on the western extent of the proposed development within a spur off the foundation towards the main house (Plate 6) where an existing brick terrace wall (103) overlay former topsoil (101) and natural geology (102) (Table 6).

Context	Description	Interpretation	Depths (m)
Number			
(103)	Brick wall, five courses deep	Terrace wall	0.00-0.41
(104)	Dark grey brown silty clay with occasional rounded	Former topsoil	0.41-0.52
	stone		
(102)	Mid orange silty sand	Natural geology	0.52-1.01+

Table 6 Stratigraphic Sequence representative Section RS4 (0.00 = 96.5m aOD)

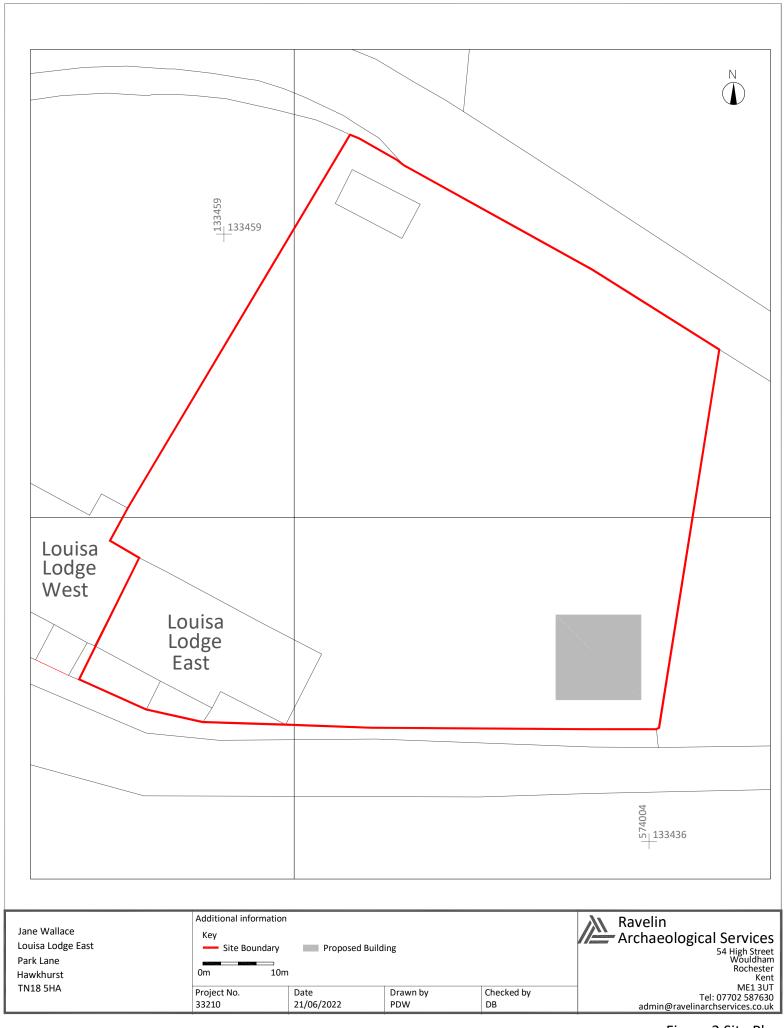
Figure 2 Site Plan

5.1.1 Archaeological monitoring was carried out following the excavation of foundation trenches associated with the proposed development. The foundation layout was rectangular in plan measuring approximately 6m by 6m and formed by trenches measuring 0.5m in width excavated to a depth of approximately 0.6m (Figure 2). A spur towards the east was also excavated for
