Norse Mill at Loch Borrallie, Durness, NW Scotland

Björn S Hardarson and Ishbel S Macdonald

4. The Loch Borrallie Norse Mill

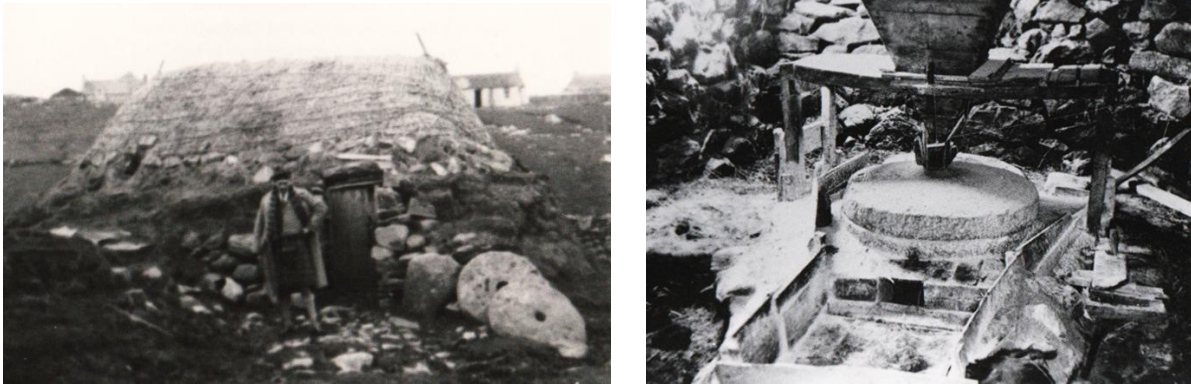
Figure 1. The Norse mills did not always have to be sophisticated (left photo) as long as they served their purpose (right photo). These photos are of working horizontal mills on the Isle Lewis from 1930 and 1935 respectively (Macleod, 2009).

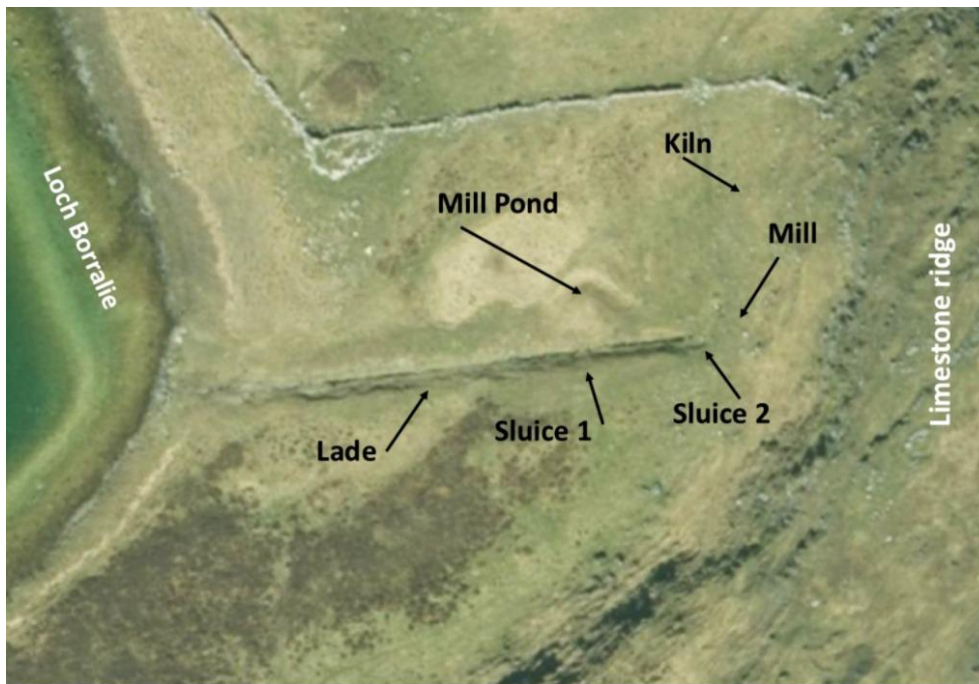
Figure 3. Location map of the Norse mill at Loch Borrallie (GoogleEarth).

It was always necessary to dry grain before it could be milled and one way of doing this was in a kiln. The kiln was solidly built with large stone slabs and clay, and its purpose was to dry the grain by having smoke filter through it (Macleod, 2009). We have not found definite evidence of a kiln, but there is vague evidence of stone walls to the NW of the mill house (Figure 3), forming a credible candidate for such a structure.

Figure 11. The sluices in the lade leading into the Borrallie mill. Refer to figure 3 for relative location.

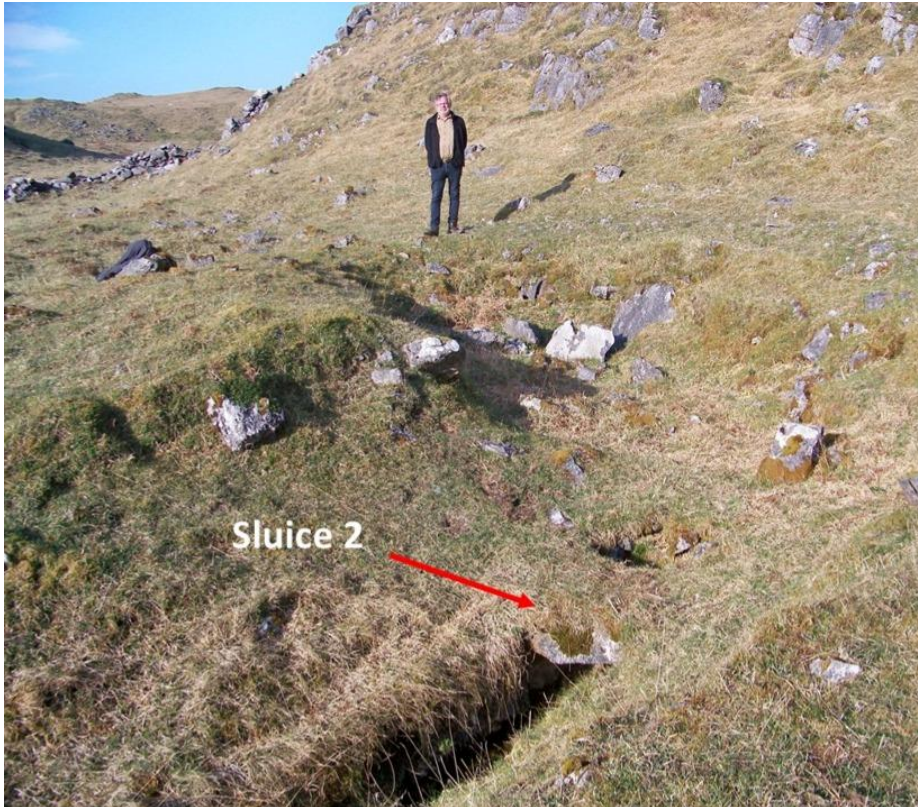
The remains of the upper house (Figure 7) are about 8 m long, 5 m wide and 2 m high from floor level to present ground level. It is mostly collapsed and almost all the wall rocks have been robbed. However, the base of the walled structure can be recognised. 'Sluice 2' on Figure 7 is located where water would have entered the under house of the mill. There is no clear evidence of where the vertical shaft and millstones would have been located as the floor of the upper house is completely obscured by rock debris and vegetation.

Figure 7. The Borralie upper house is located in front of the person.

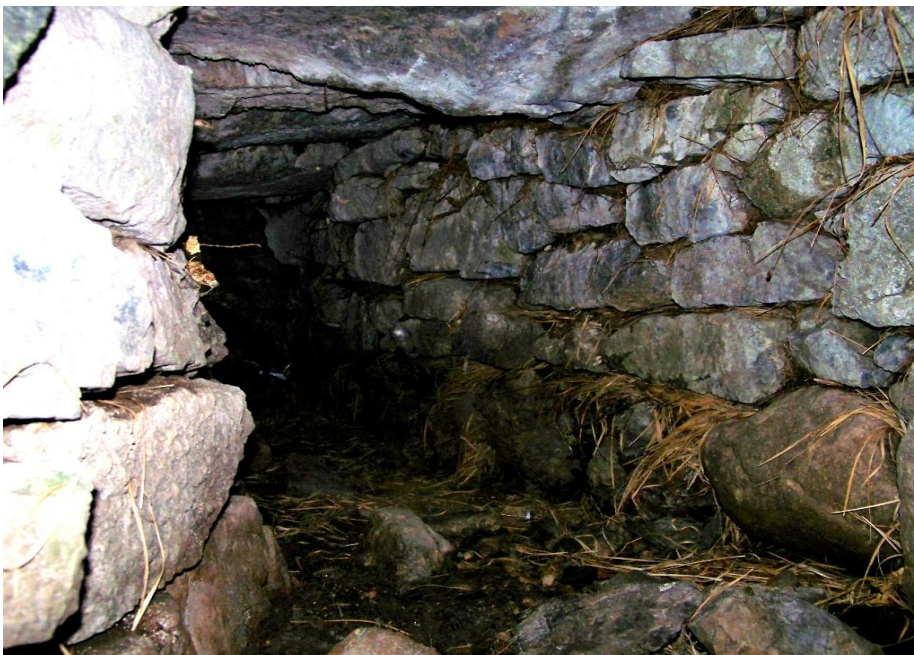
The under house (Figure 8) can be approached from sluice 2 (Figure 7) and from the NE corner of the mill (below feet of person in figure 7). It is very well preserved. The dimensions are about 1,2 m high and 90 cm wide. The walls are perfectly constructed from Durness limestone and quartzite erratics.

Figure 8. The under house seen from sluice 2 (see Figure 7).

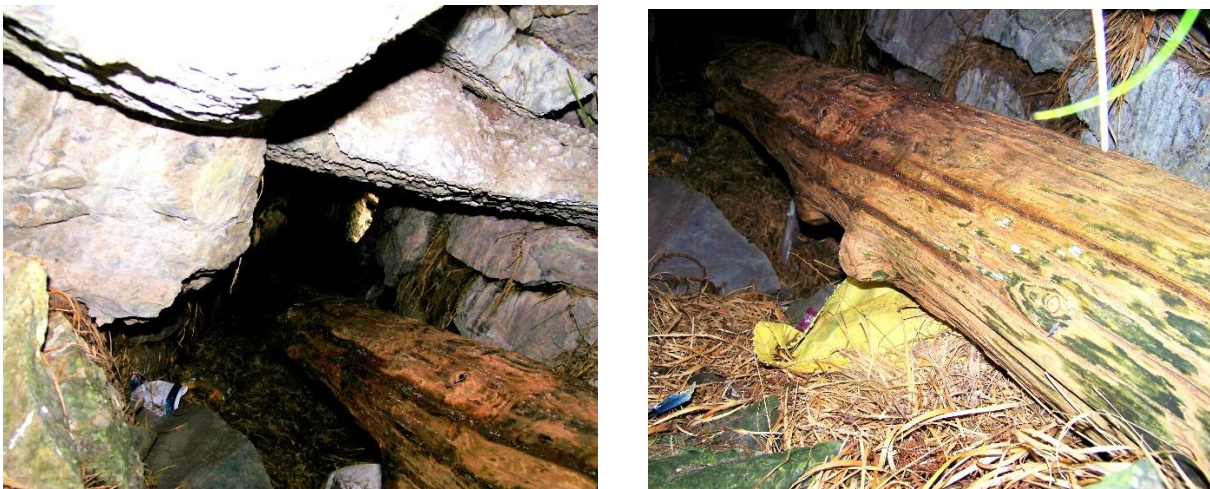
A substantial horizontal wooden pole is sitting on the floor of the under house about 25-30 cm in diameter (Figure 9). The length is unclear due to limited access. However, it is clear, that the dimensions of the pole are such that the mill structure would have had to be partly dismantled to put it into position. It is therefore likely it was an integral part of the structure, probably forming a saddle for the vertical shaft leading up to the upper house. The pole is in a relatively good condition, which may imply that the mill was in use until Early Modern Periods. No excavation, test units/trenching, geophysical survey or detailed mapping has been executed. No artifacts have been found at the mill site and due to limited access to the under house, we have not found the vertical shaft, or paddles, or any other smaller objects relating to the mechanism of the mill and the millstone is missing.

Figure 9. The under house showing the horizontal tree trunk.

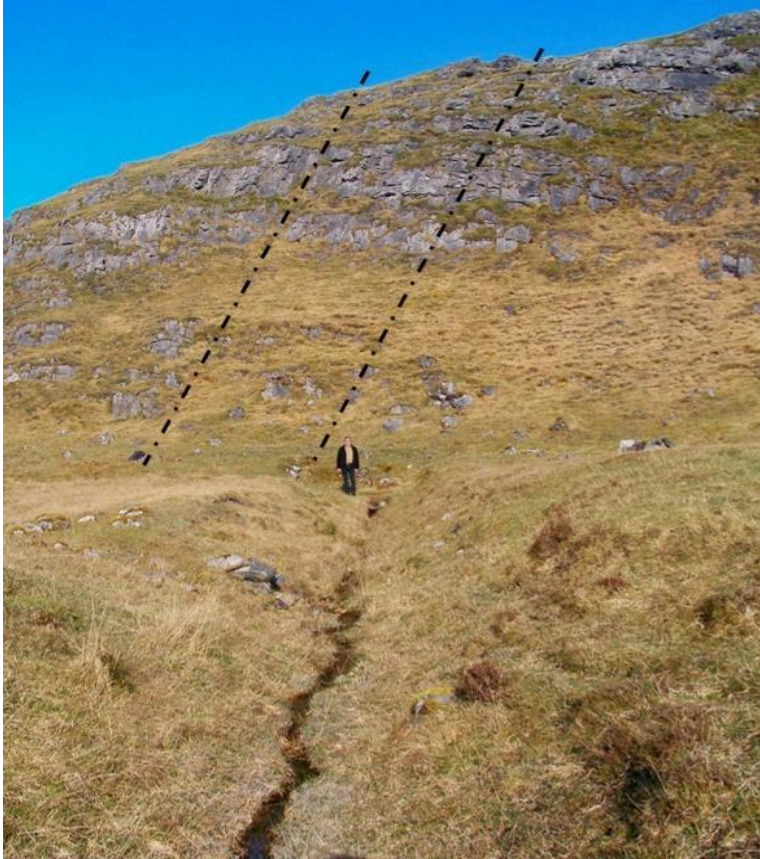
The lade is about 80 m long running from Loch Borralie to sluice 2, about 2 m deep, 3,5 m wide at the top but less than 1 m at the base (Figure 10). It is overgrown, partly collapsed but dammed at the entrance to the loch. However, it is clearly walled and appears to have a pristine V-shaped structure, which is obscured by crumbling from the top edge.

Figure 10. The lade leading towards the mill from Loch Borralie. The faults in the limestone ridge into which the stream disappears are shown as broken black lines. The upper house is located at the far end, to the left of the person.
