TRUTH HOME INSPECTIONS REPORT

1234 Main St. Boynton Beach FL 33426

02/09/2022 9:00AM

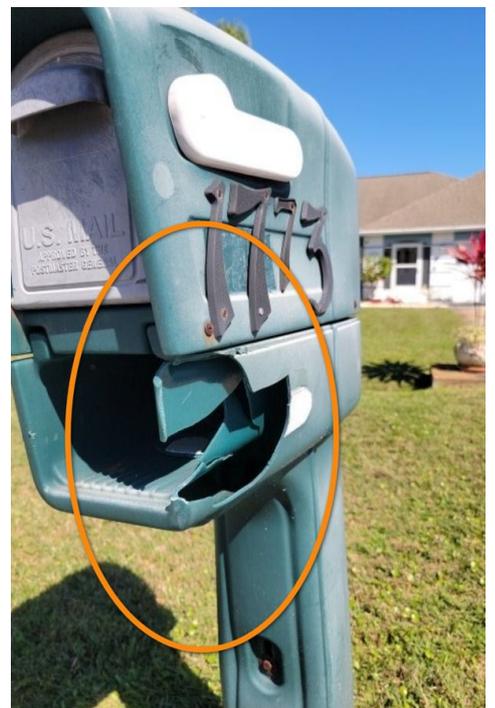
DAMAGED MAILBOX

Improve

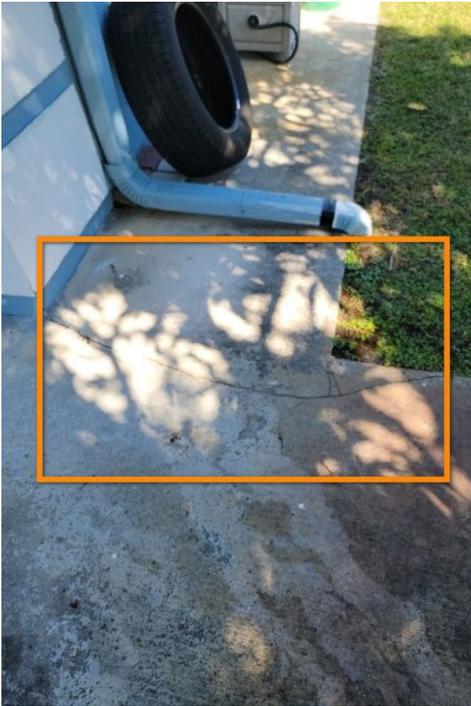
3.3.1 Walkways, Patios & Driveways

DRIVEWAY CRACKING - MINOR

Minor cosmetic cracks observed, which may indicate movement in the soil. Recommend monitor and/or have concrete contractor patch/seal.

Contact a qualified professional.

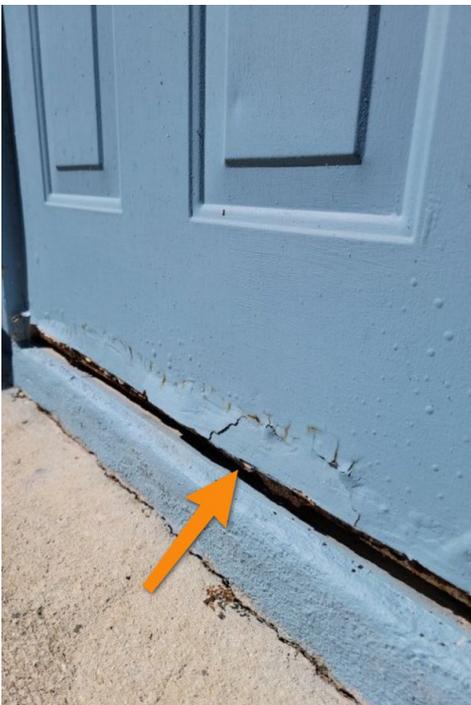
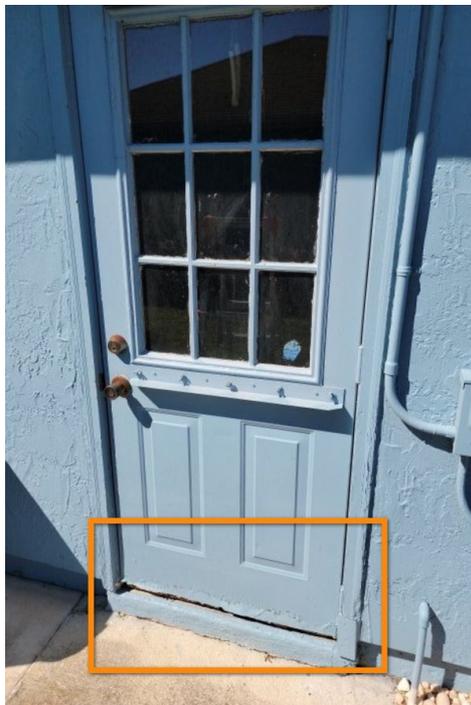
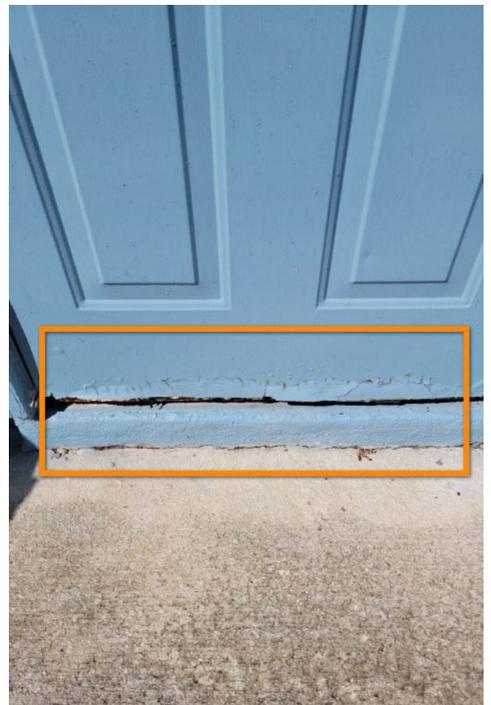
3.4.1 Exterior Doors

DOOR DAMAGE

There was wood damage to the left/right side of the doors.

Contact a qualified professional.

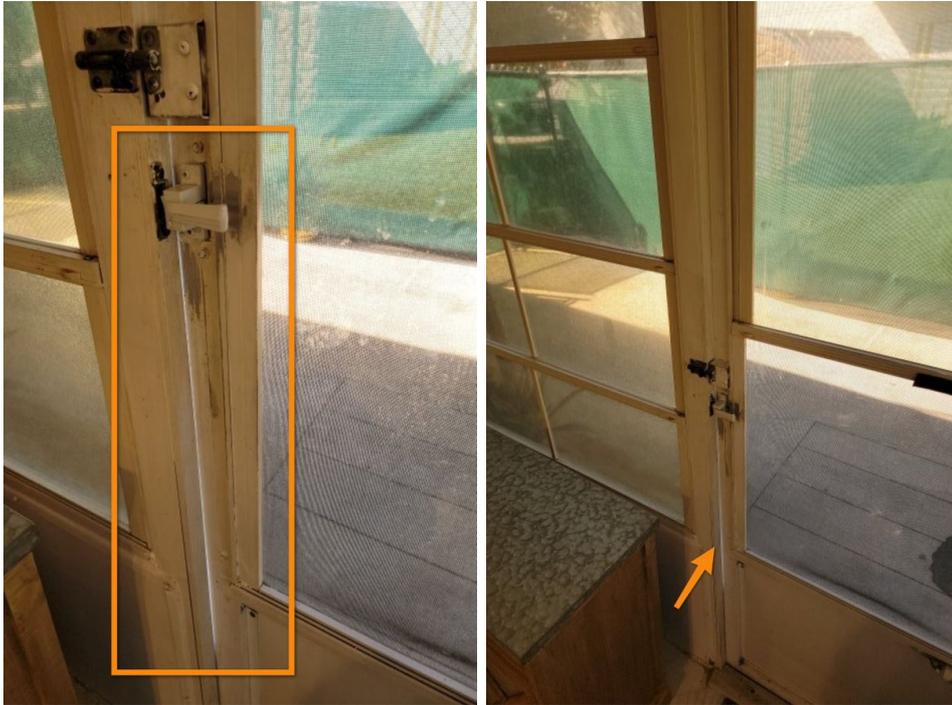
3.4.2 Exterior Doors

DOOR WEATHERSTRIP

At the time of the inspection, weather-stripping at interior doors was generally damaged or deteriorated. The Inspector recommends replacement/installation of effective weather-stripping components as necessary by a qualified contractor.

Contact a qualified professional.

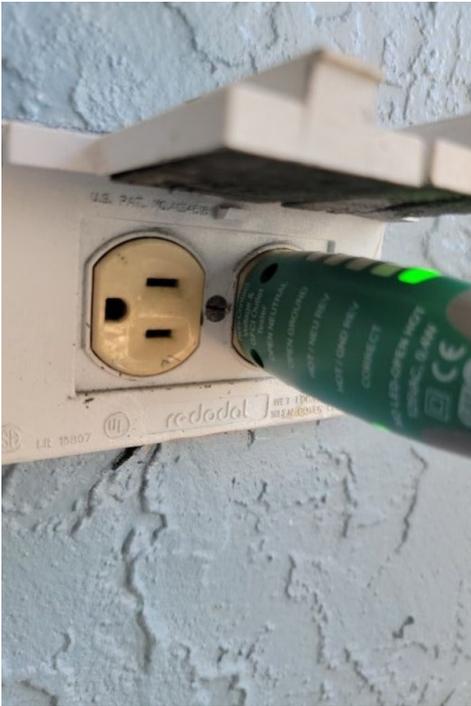
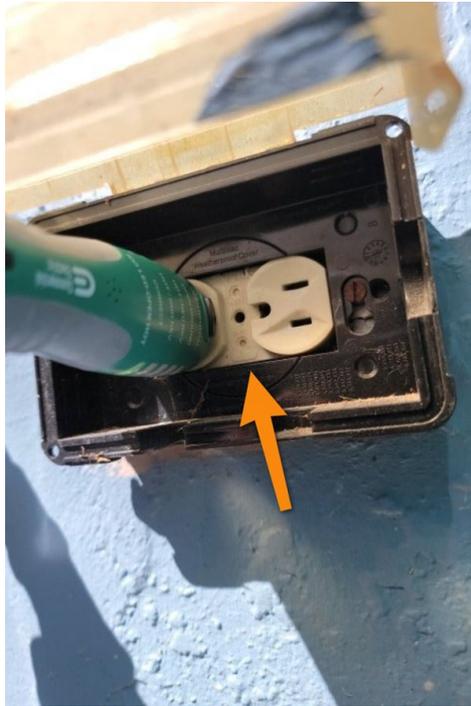
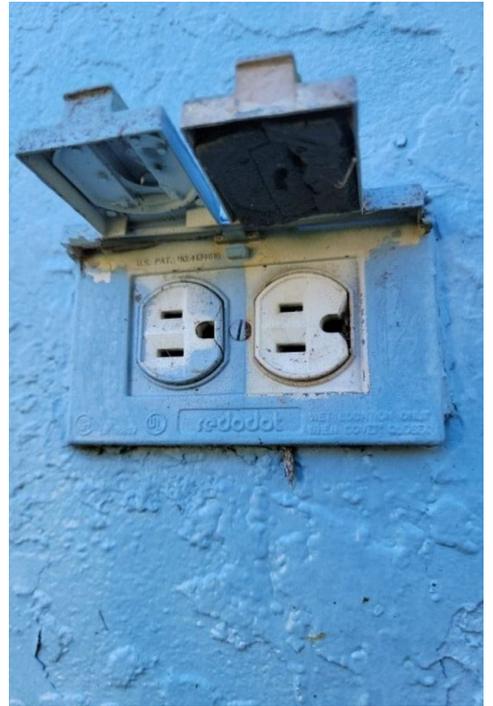
3.7.1 Lighting Fixtures, Switches & Receptacles

NO GFCI PROTECTION INSTALLED

No GFCI protection present in all locations. Recommend licensed electrician upgrade by installing ground fault receptacles in all locations.

Contact a qualified professional.

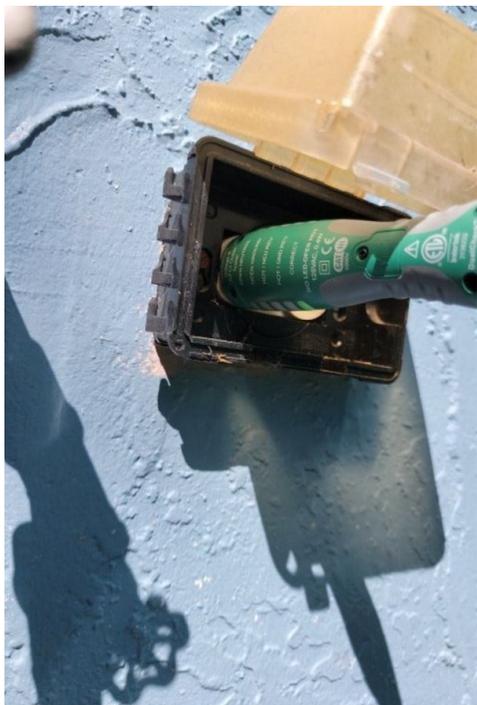
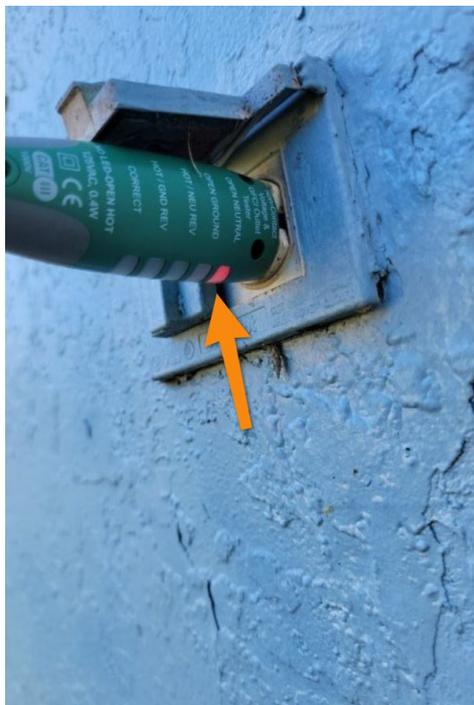
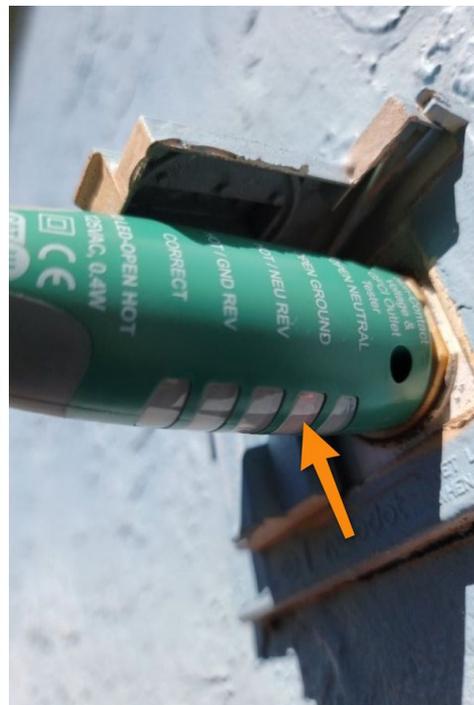
3.7.2 Lighting Fixtures, Switches & Receptacles

OUTLET NOT WORKING

Contact a qualified electrical contractor.

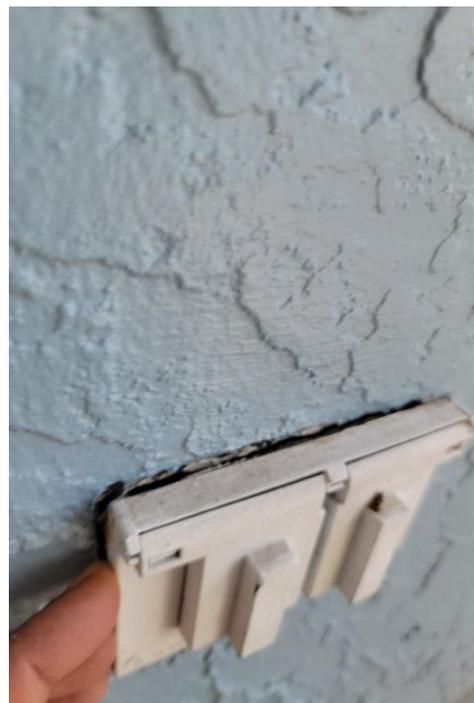
3.7.3 Lighting Fixtures, Switches & Receptacles

OUTLET LOOSE

Contact a qualified electrical contractor.

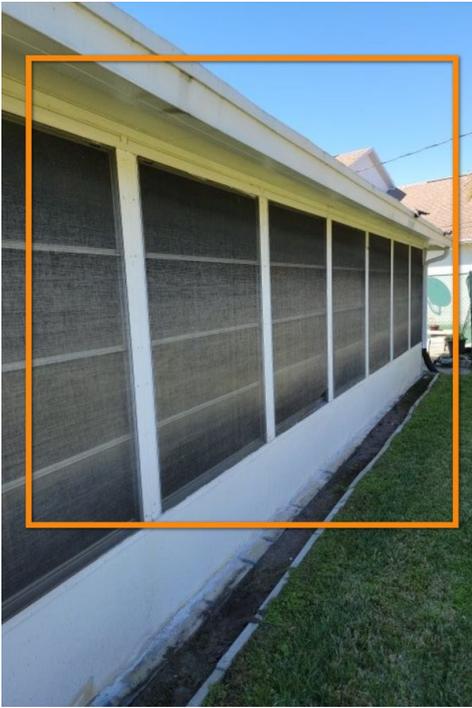
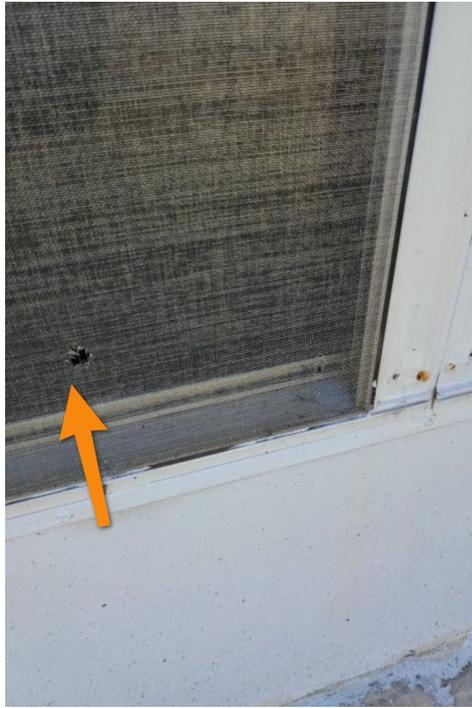
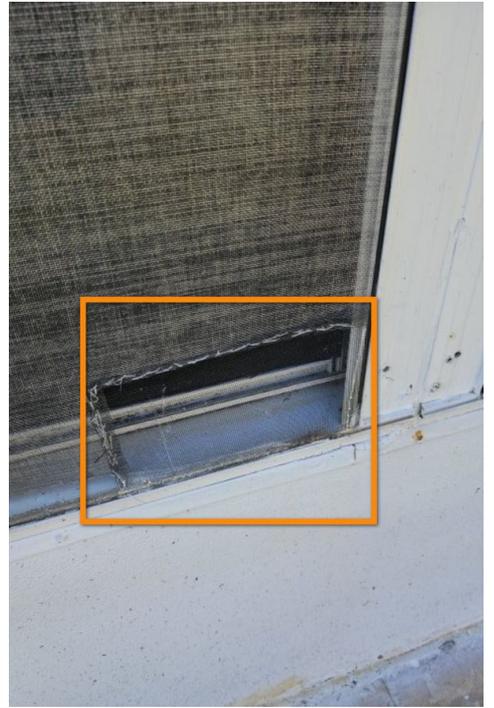
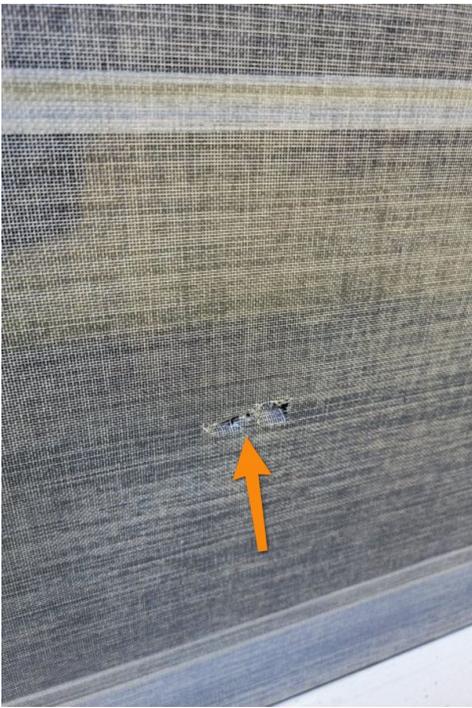
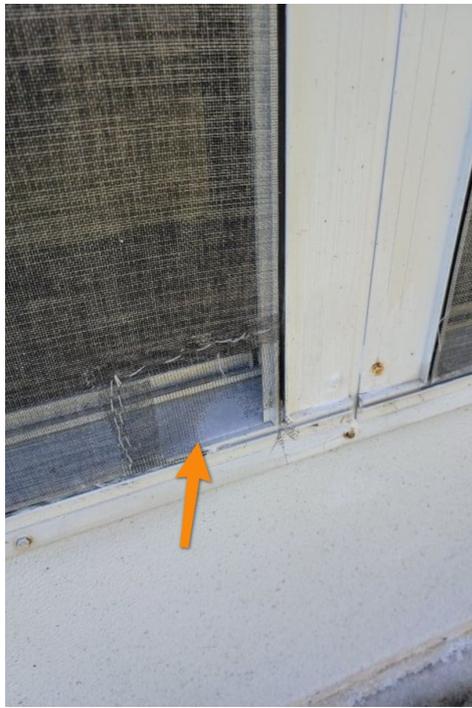
3.10.1 Decks, Balconies, Porches & Steps

DAMAGED SCREEN

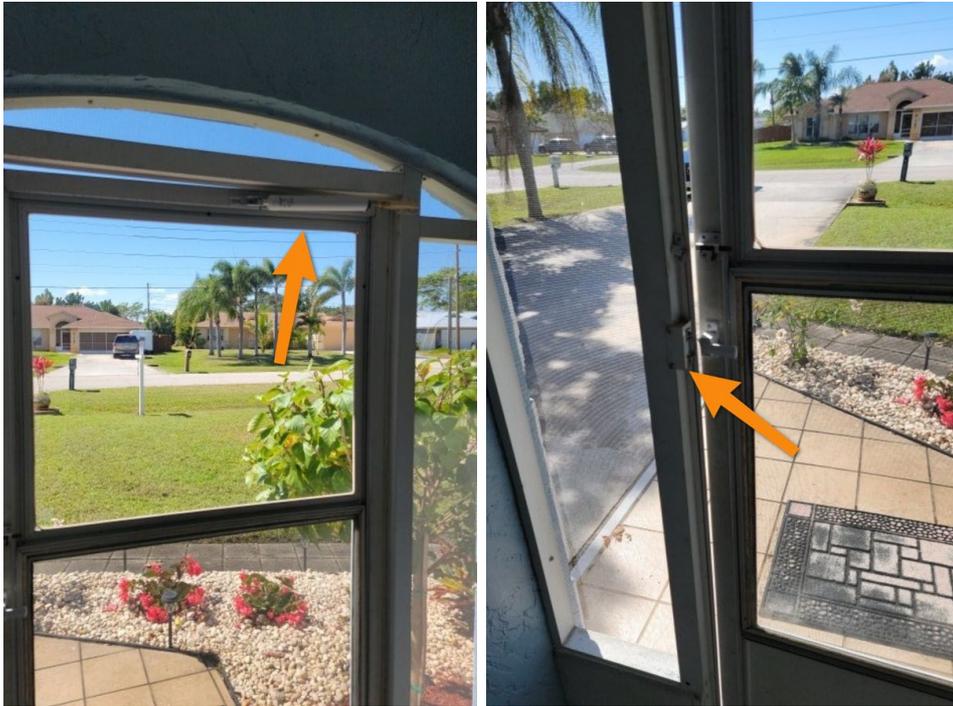
3.10.2 Decks, Balconies, Porches & Steps

FRONT PORCH DOOR NEEDS ADJUSTMENTS

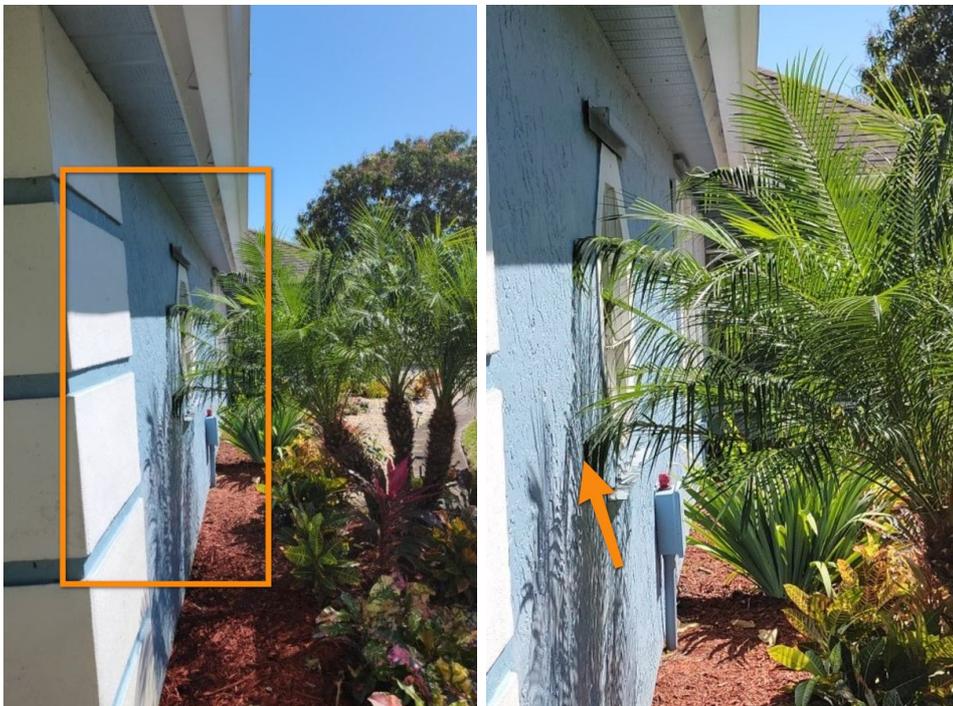
3.11.1 Vegetation, Grading, Drainage & Retaining Walls

The vegetation is touching the homes exterior wall, this can cause moisture issues in the future. Recommend trimming

Contact a qualified lawn care professional.

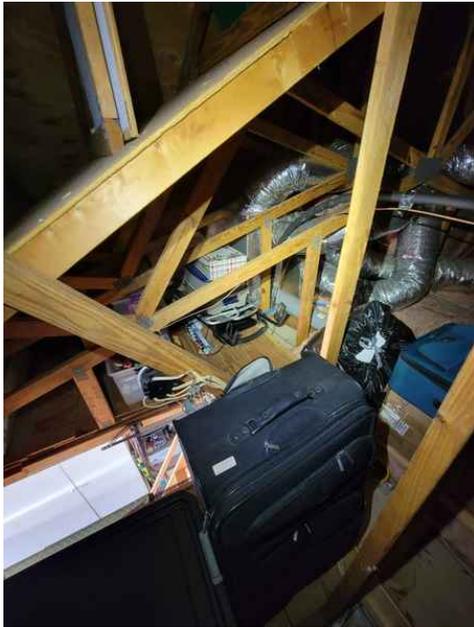
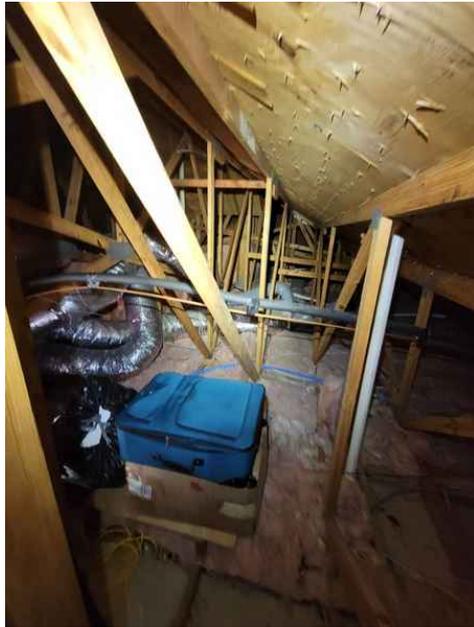
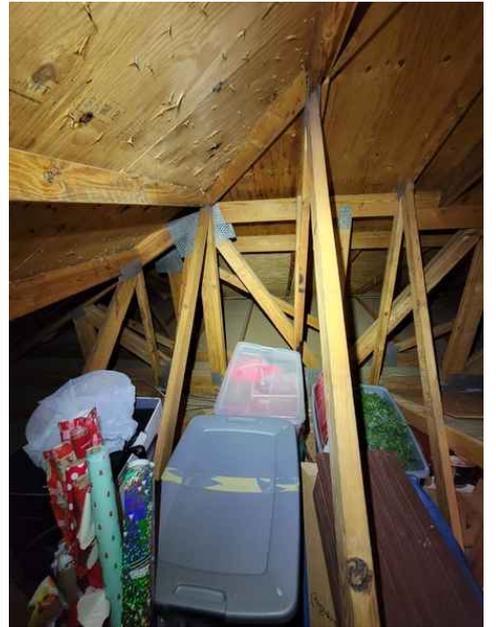
COULD NOT SEE EVERYTHING IN ATTIC

I could not see and inspect everything in the attic space. The access is restricted and my inspection is limited.

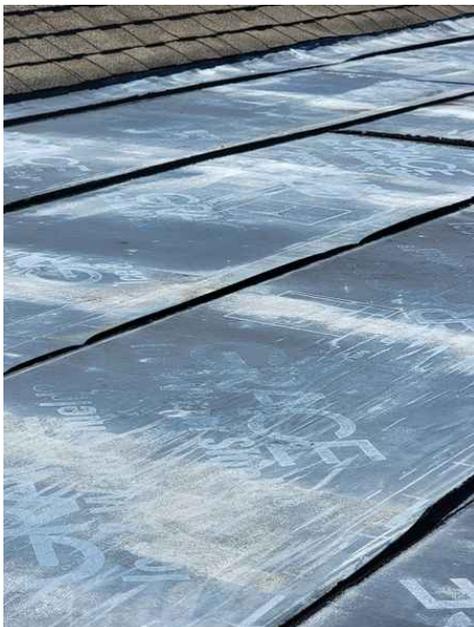
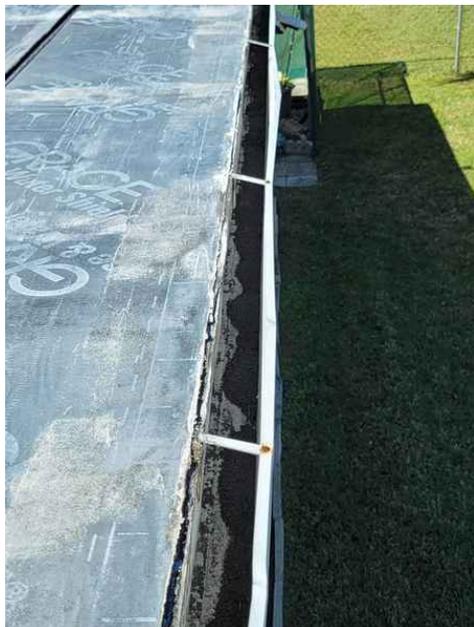
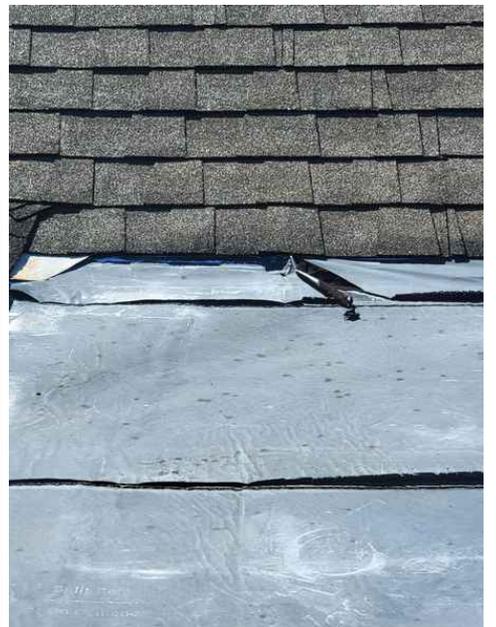
4.2.1 Roof Covering

MISSING ROOF-COVERING MATERIAL

I observed missing roof-covering material. Prone to leaking. Correction and further evaluation by a roofing professional is recommended.

Contact a qualified roofing professional.

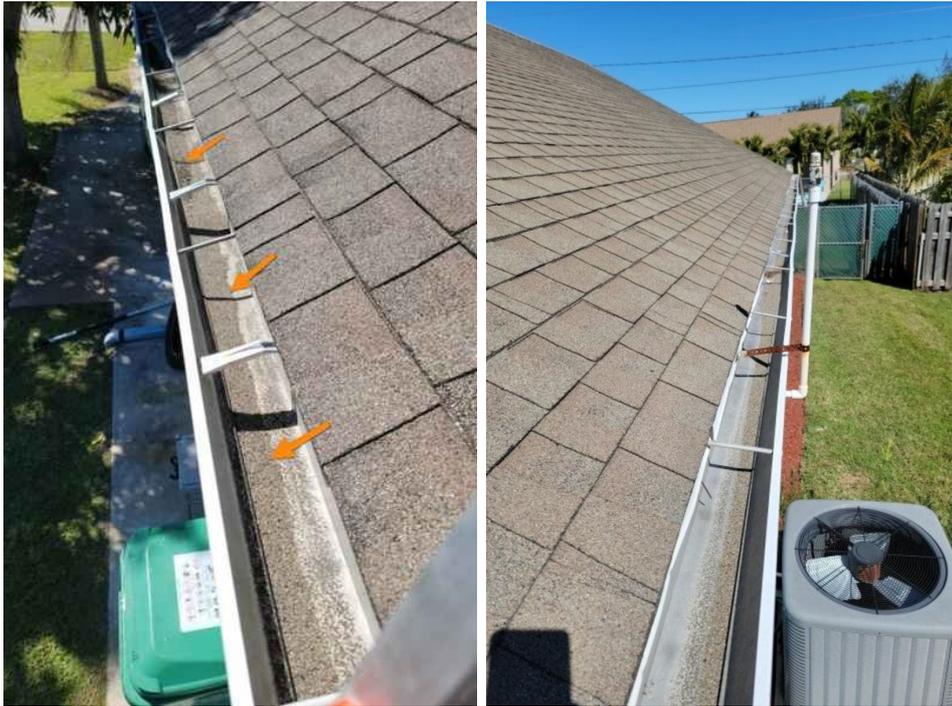
4.2.2 Roof Covering

SHINGLE ROOF RUNOFF

Granule loss which is uniform across the roof is usually a result of normal weathering. Over time, the bond between the granules and asphalt deteriorates, and granules will be loosened and carried away by runoff. Prolonged exposure to hail can also loosen granules.

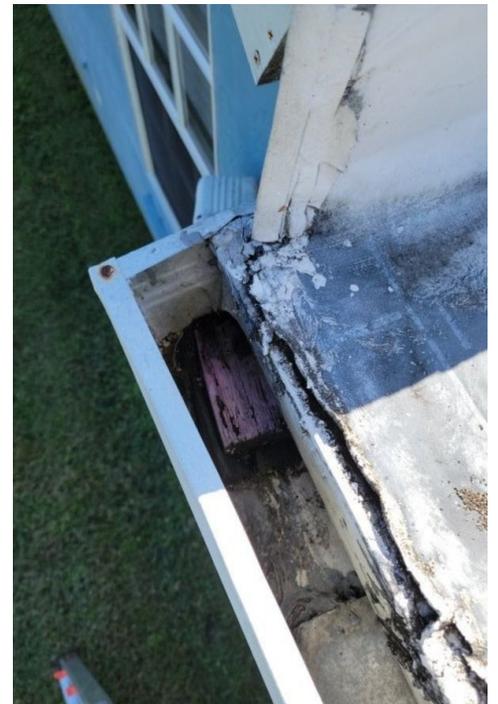
4.5.1 Gutters & Downspouts

I observed debris in the gutter. Cleaning and maintenance is recommended.

Contact a qualified gutter contractor

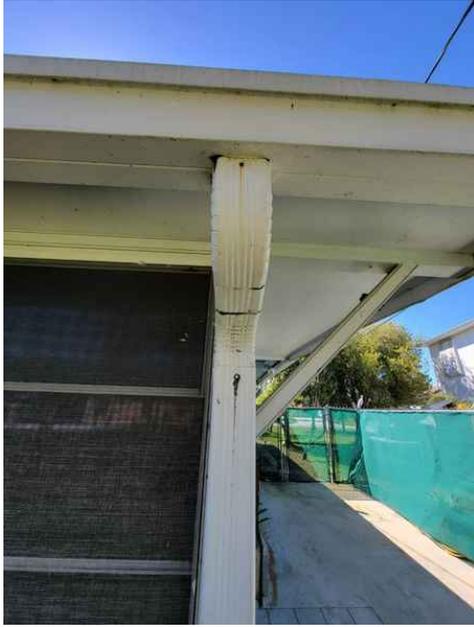
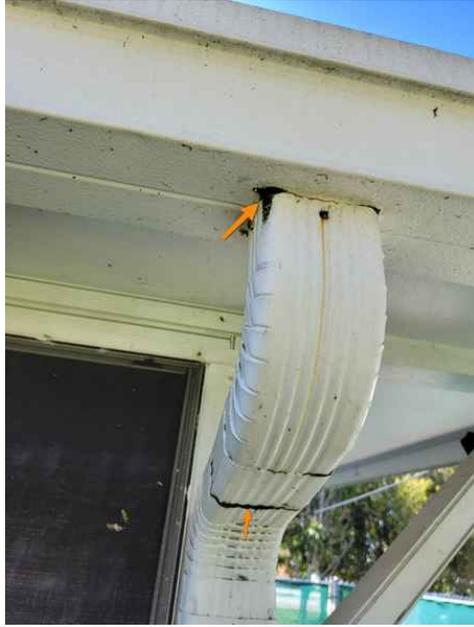
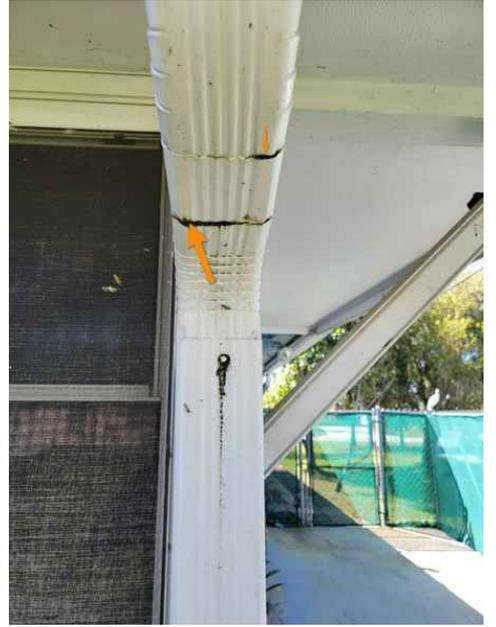
4.5.2 Gutters & Downspouts

GUTTER LEAKAGE

I observed a water leak from a gutter, which could result in water not being properly collected and drained away. This is a defect that should be corrected by a professional contractor.

Contact a qualified gutter contractor

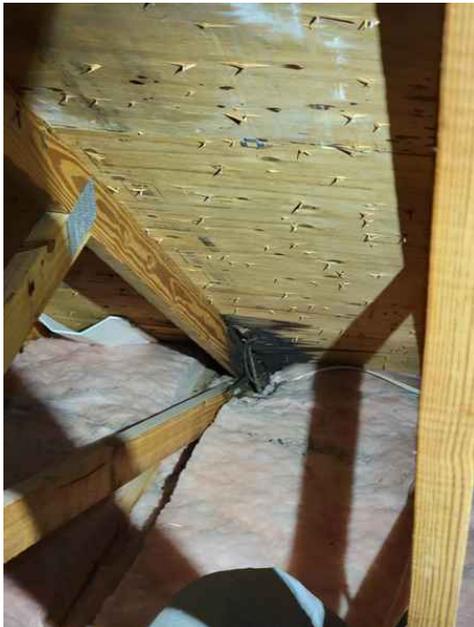
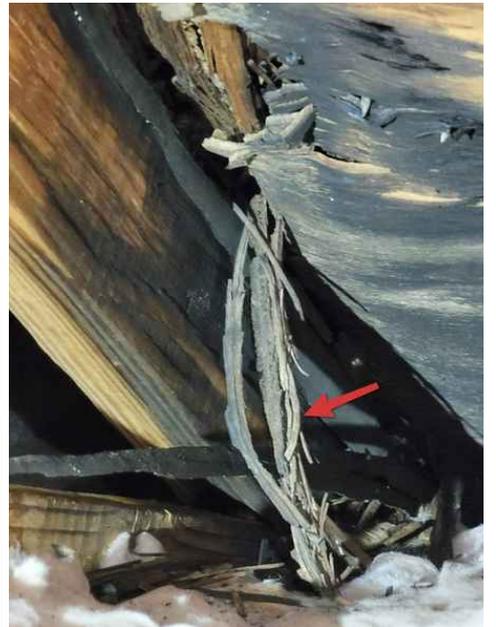
4.6.1 Structural Components & Observations in Attic

BURNT SHEATHING AND TRUSSES

Major Concern/Safety Hazard

Signs of a short electrical fire was observed at the time of the inspection. This dangerous and should be looked by an Electrical contractor to investigate and resolve. Recommend also having roof repaired.

Contact a qualified professional.

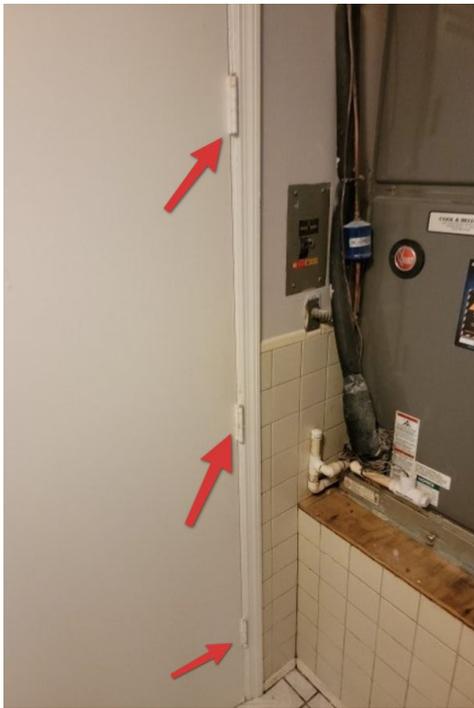
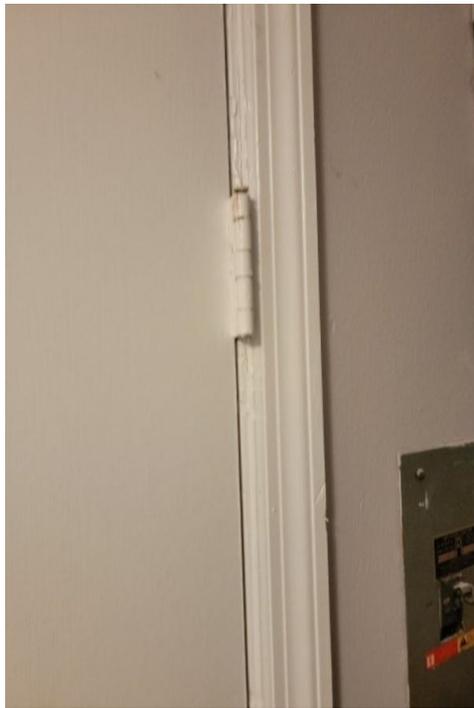
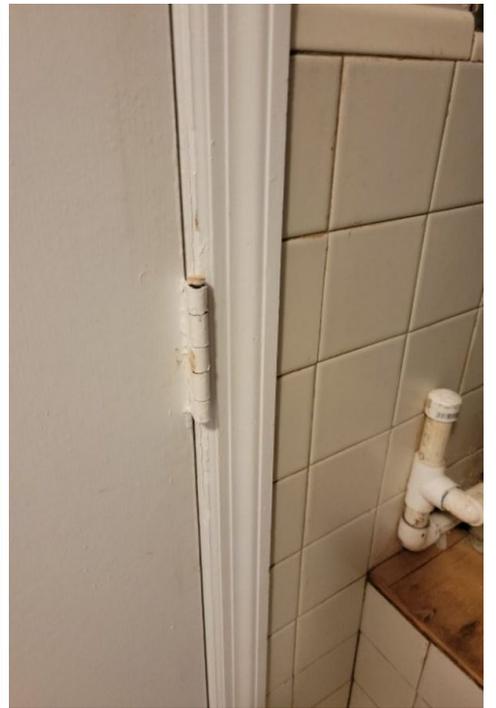
5.9.1 Occupant Door (From garage to inside of home)

OCCUPANT DOOR (GARAGE TO INSIDE OF HOME)

Major Concern/Safety Hazard

Self-closing hinges are designed to close the door automatically once a person turn loose of the door. They are inexpensive to install. The purpose of the door self closing is to keep fumes, gasses and other hazards from quickly entering the home and harming occupants.

Contact a qualified professional.

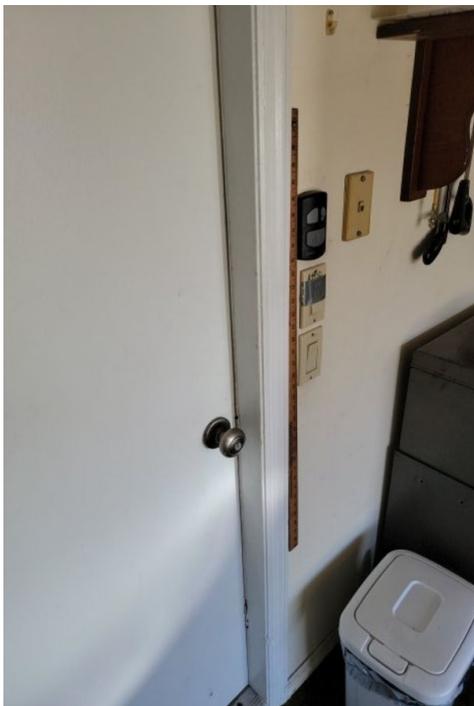
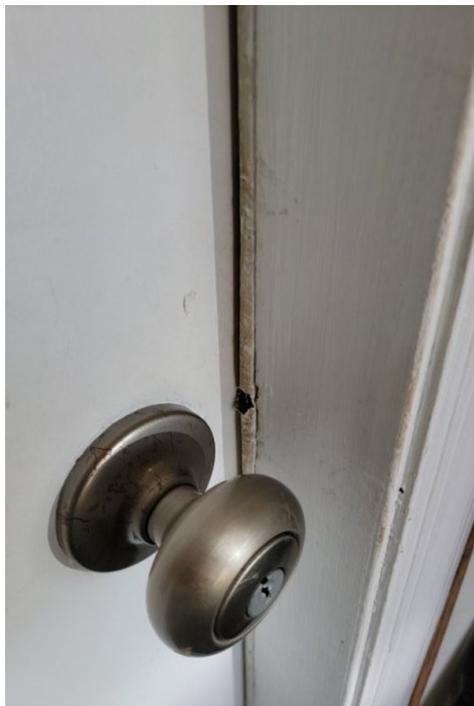
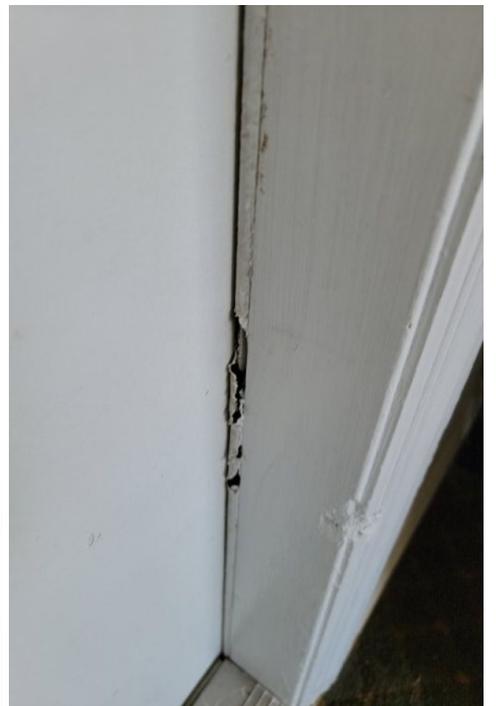
5.9.2 Occupant Door (From garage to inside of home)

WEATHER STRIPPING DAMAGED

Contact a qualified handyman.

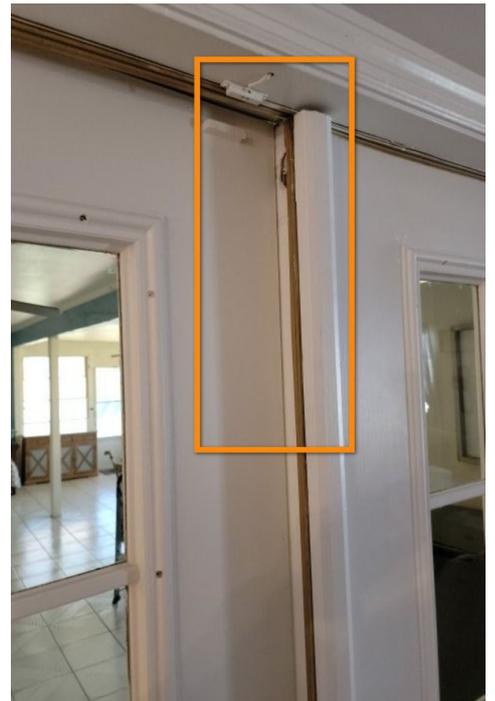
9.3.2 Interior Doors

Door Rubs with Dryer in the Laundry Room. Recommend Handyman evaluate repairs.

Contact a qualified professional.

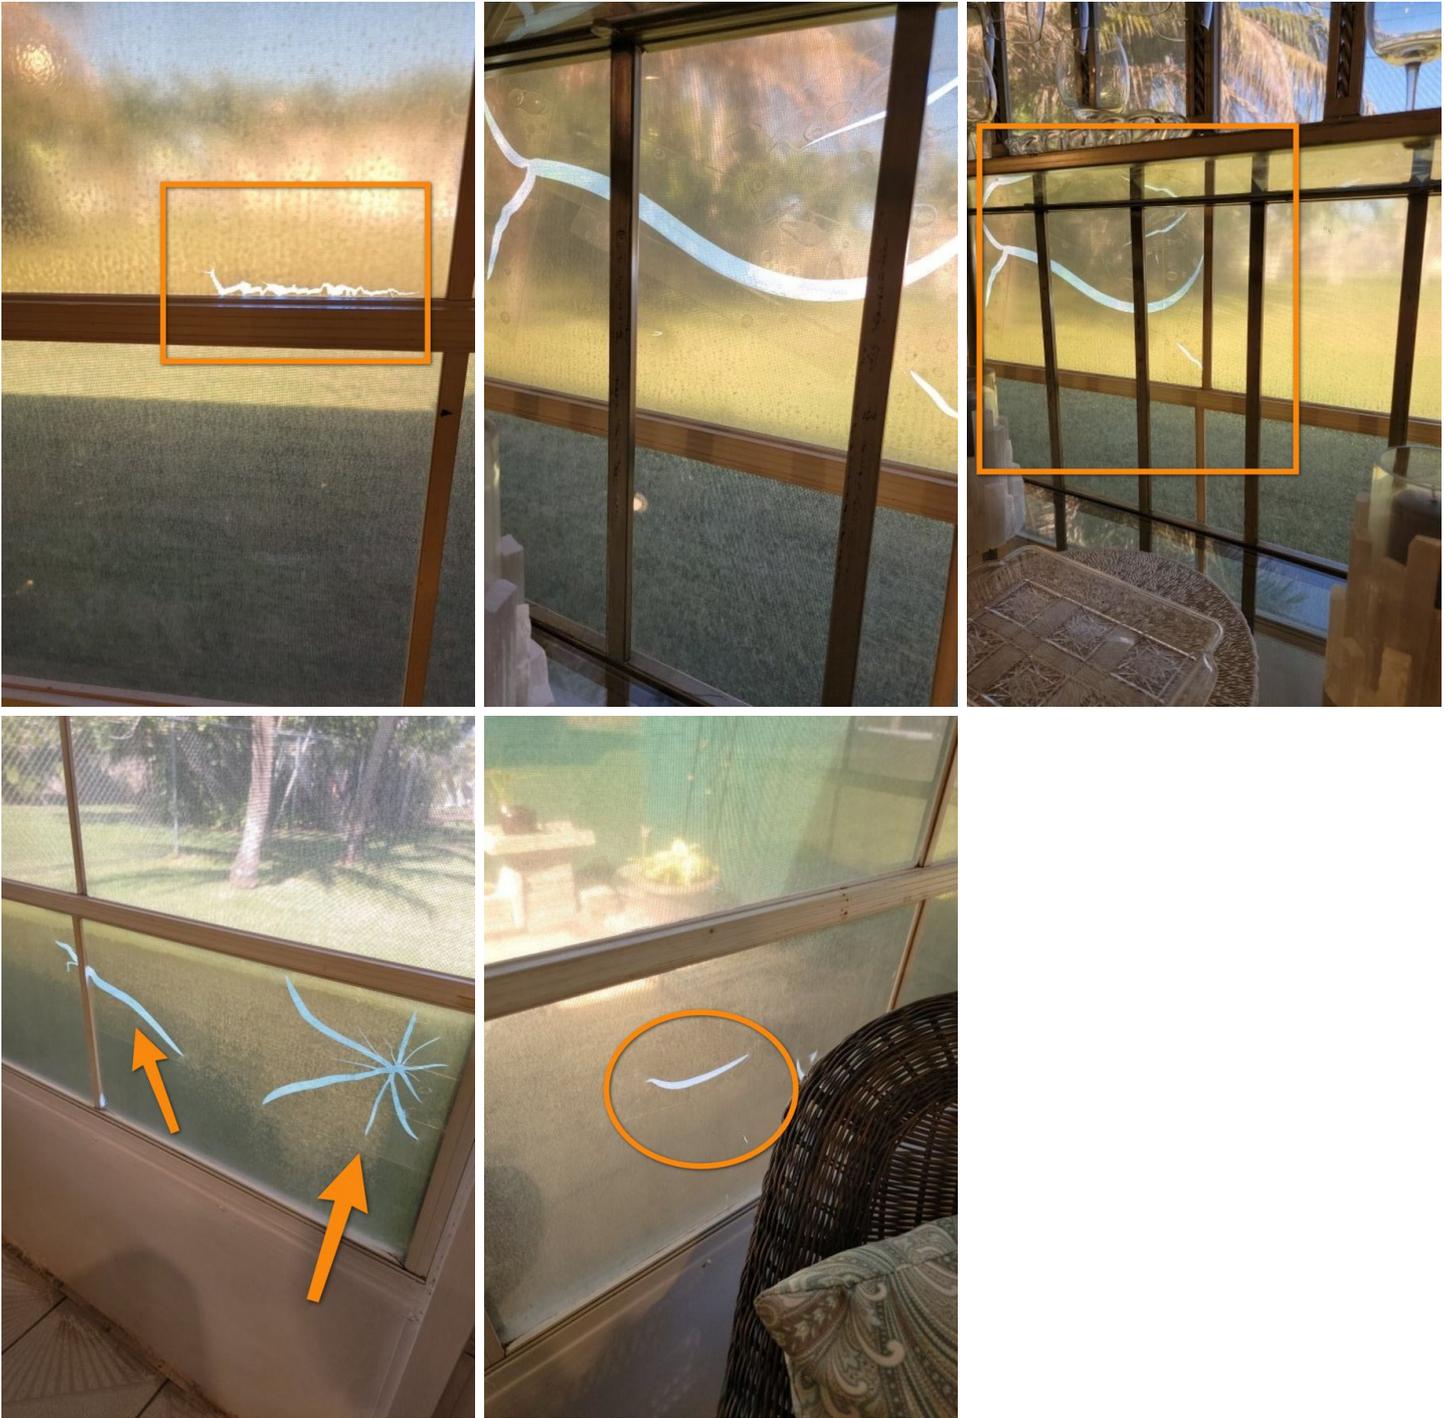
9.7.1 Windows

DAMAGED

One or more windows appears to have general damage, but are operational. Recommend a window professional clean, lubricate & adjust as necessary.

Contact a qualified window repair/installation contractor.

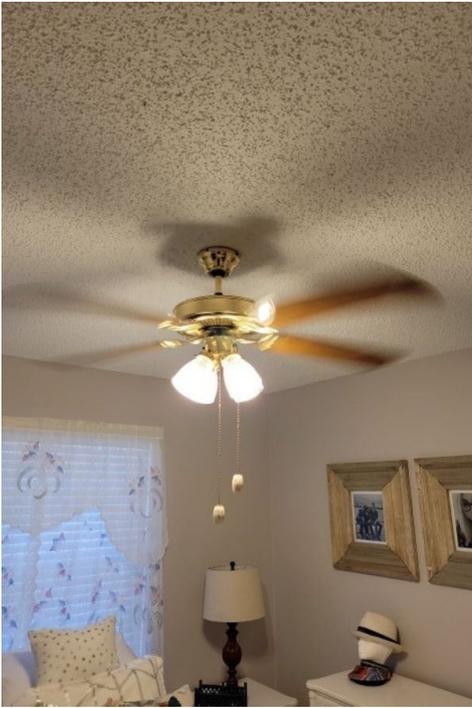
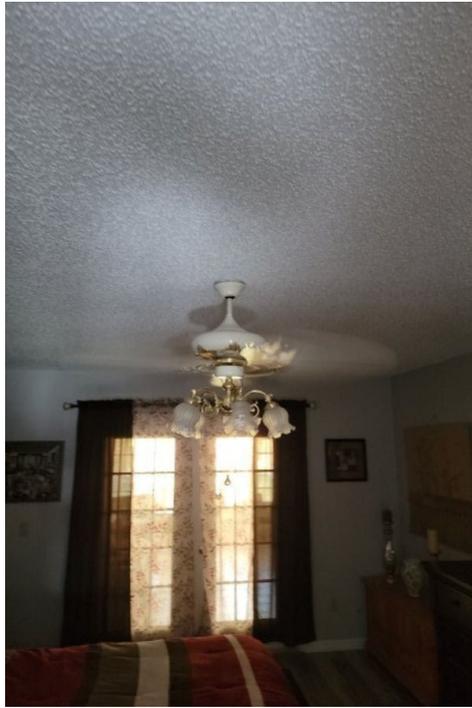
9.9.1 Lighting Fixtures, Switches & Receptacles

CEILING FAN NOT BALANCED

Contact a qualified professional.

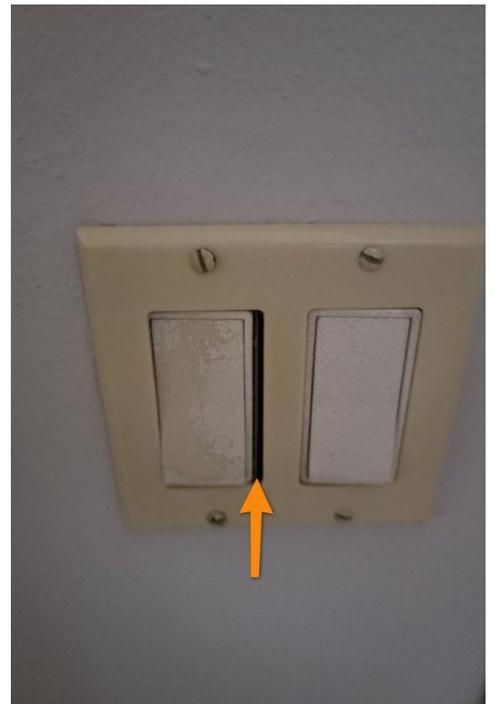
9.9.2 Lighting Fixtures, Switches & Receptacles

OUTLET BOX LOOSE

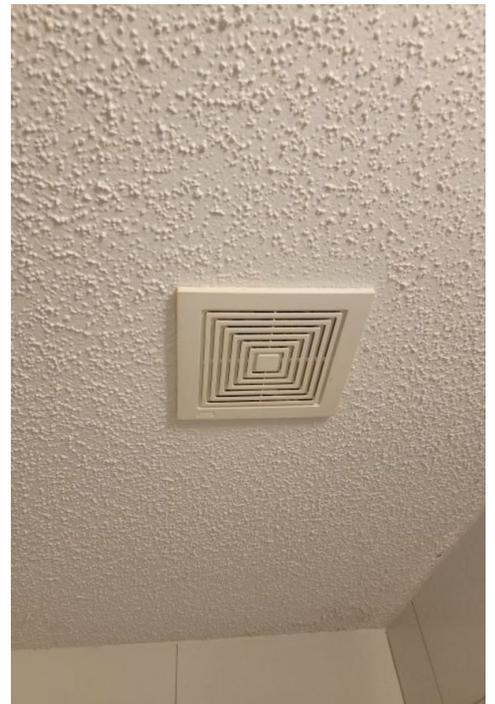
10.11.1 Exhaust Systems

FAN NOT WORKING

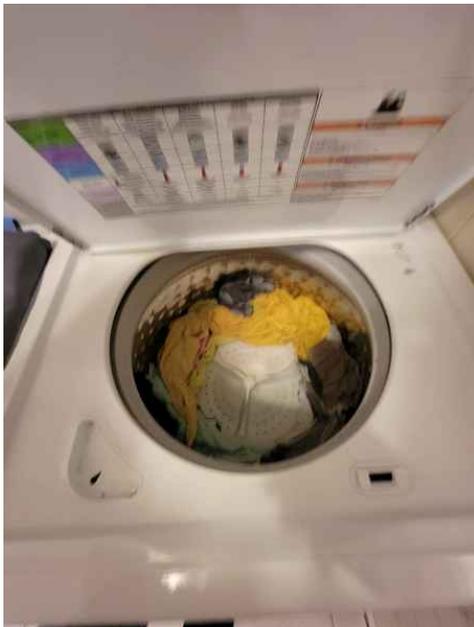
DID NOT INSPECT

I did not inspect the clothes washer, sellers personal belongings were in the washer at the time of the inspection.

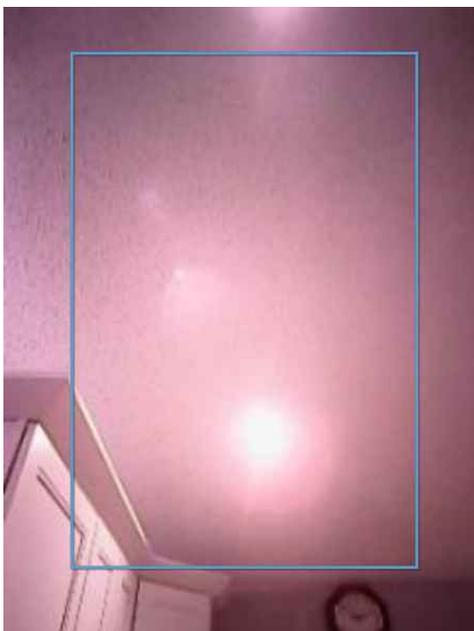
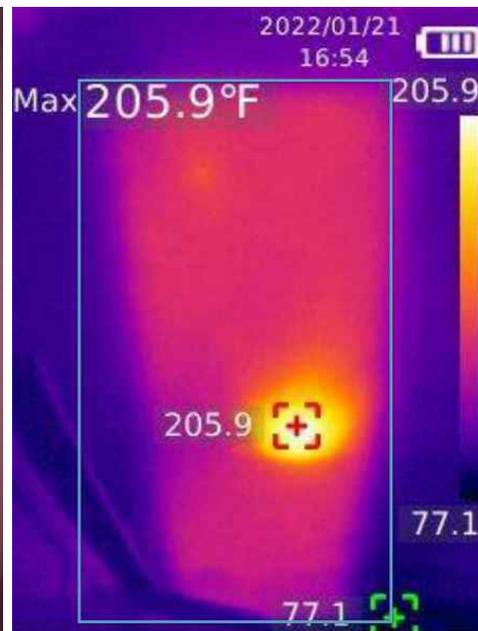
missing insulation

MISSING INSULATION

Missing insulation allows either heat or cold to infiltrate, which shows as hot or cold spots on your walls or ceiling when viewed by a thermal camera.

Contact a qualified professional.

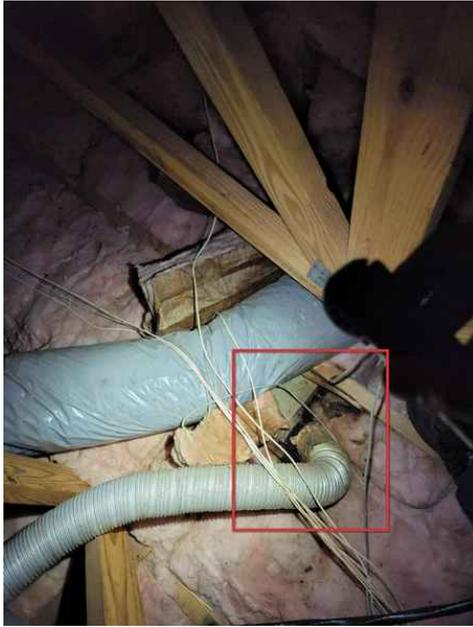
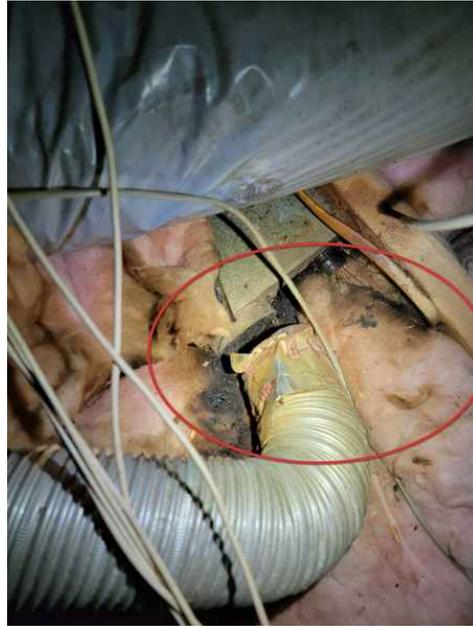
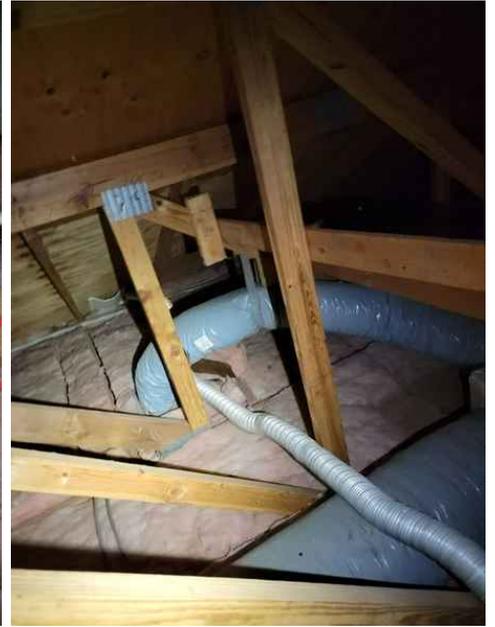
11.13.1 Clothes Dryer

Major Concern/Safety Hazard

I observed indications that the clothes dryer is not exhausting outside. Exhaust damaged in the attic, there are signs of charring from the heat of the dryer. This is dangerous and can cause a fire.

Contact a qualified appliance repair professional.
