TRUTH HOME INSPECTIONS REPORT

1234 Main St. Boynton Beach FL 33426

Buyer Name 01/17/2022 9:00AM

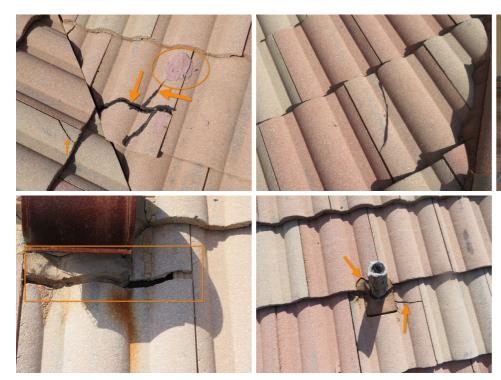
3.3.2 Coverings

TILES CRACKED/BROKEN

Roof had cracked/broken tiles. Recommend a qualified roof contractor repair or replace to prevent moisture intrusion.

Contact a qualified roofing professional.

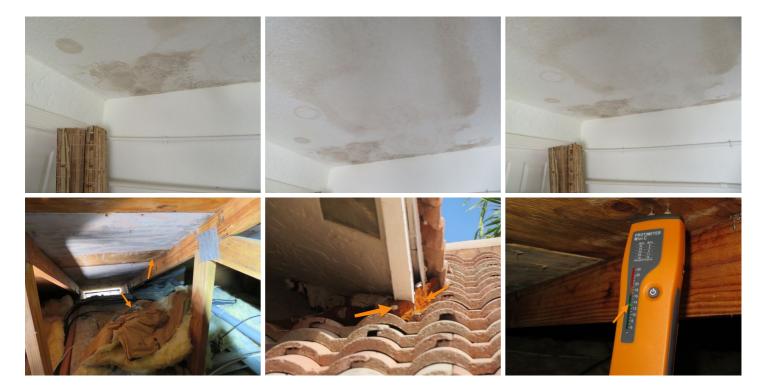
4.5.1 Ceiling

STAIN

Staining on ceiling indicate previous water leak. Recommend replacing damage piece of dry wall. Roof and attic photos shows repair work.

Contact a qualified professional.

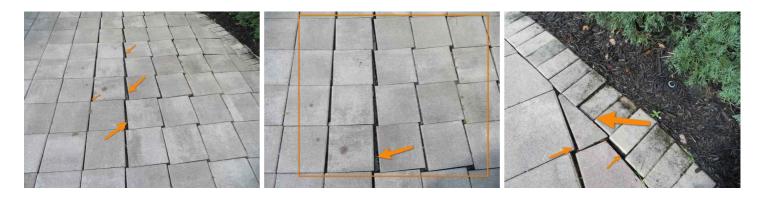
5.8.3 Walkways, Patios & Driveways

DRIVEWAY LOOSE PAVERS

Pavers are loose and moving apart, as well as there are gaps in between pavers that need more fillers. Recommend a paving company repair pavers.

Contact a qualified driveway contractor.

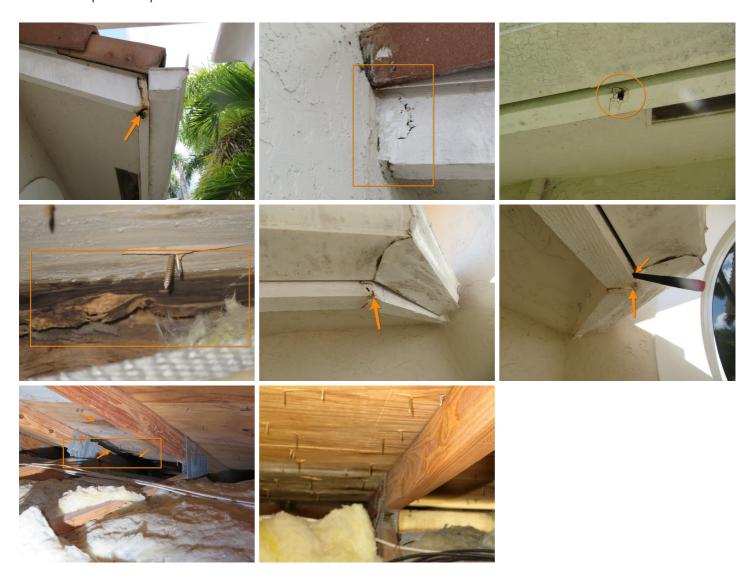
5.9.1 Eaves, Soffits & Fascia

FASCIA - ROTTED

One or more sections of the fascia are rotted. Recommend qualified roofer evaluate & repair. Recommendation

Contact a qualified professional.

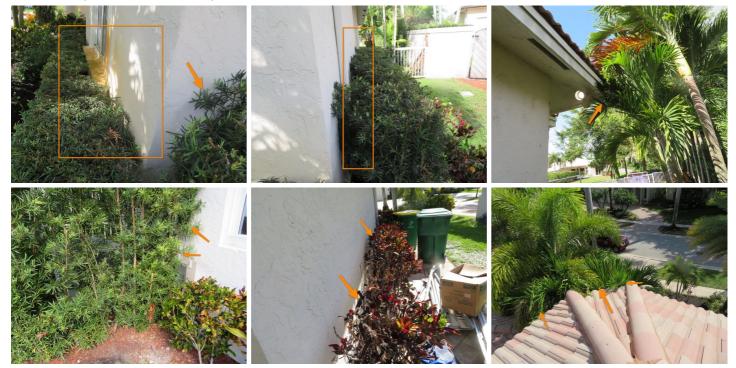
5.11.1 Vegetation, Grading, Drainage & Retaining Walls

VEGETATION NEAR HOME

The vegetation is touching the homes exterior wall, this can cause moisture issues in the future. Recommend trimming

Contact a qualified lawn care professional.

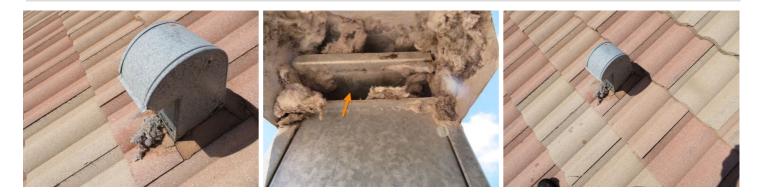
Exterior flap that prevents critters and insects from entering the home thru the dryer vent pipe is missing or damaged.

Contact a qualified handyman.

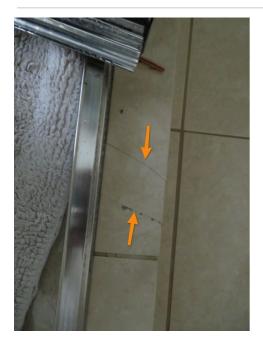
CRACKED TILES

Shower has one or more cracked tiles. Recommend a bathroom contractor or handyman repair or replace.

Contact a qualified handyman.
