## PROPERTY INSPECTION REPORT

Prepared For: Susan & Samual Smith  
(Name of Client)

Concerning: 3323 Babbling Brook Bend Ln., Spring, TX 77380  
(Address or Other Identification of Inspected Property)

By: Matthew Brading, Lic #TREC # 22654 07/17/2018  
(Name and License Number of Inspector) (Date)

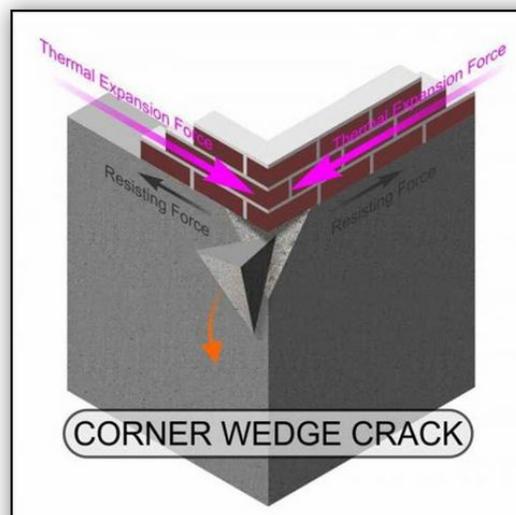
- One or more of the foundation perimeter beam corners were observed to be sheared off (corner pop). This is a common condition to observe and is do to thermal expansion and contraction of the different building materials. This condition does not adversely affect the foundation performance. However, in some cases, some cosmetic improvements may be necessary.

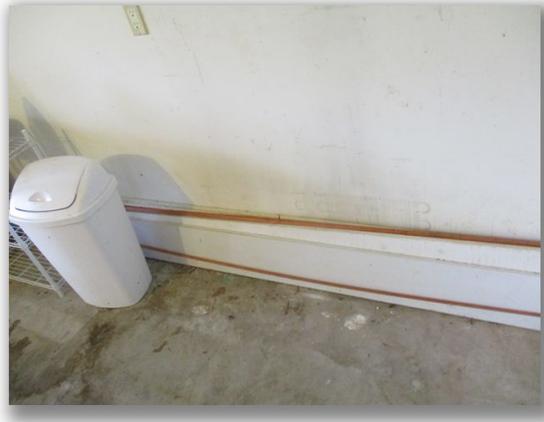
- Observed evidence of repairs to foundation. This is believed to be only cosmetic and not due to any structural issue

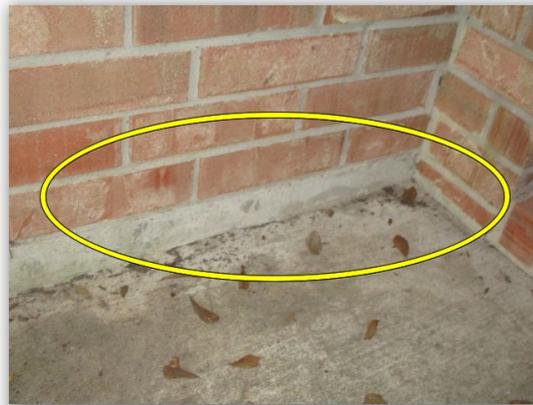
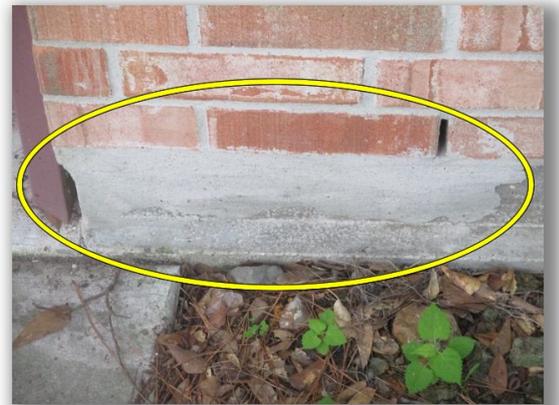
- Observed small crack near front entryway. This is not believed to be due to any structural failure. All cracks should be monitored over time.

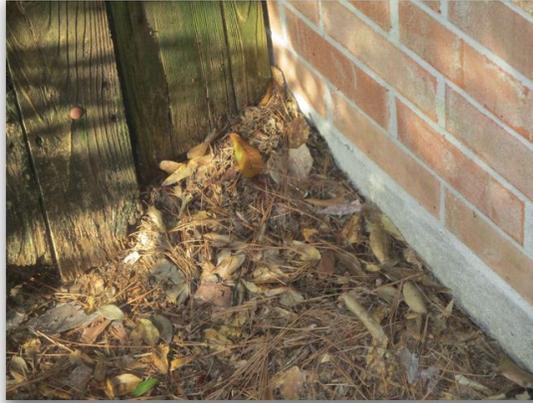
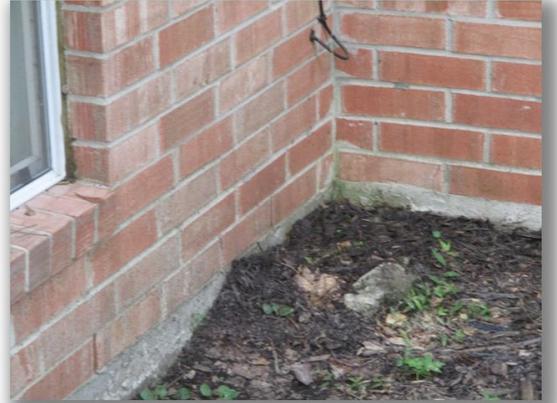
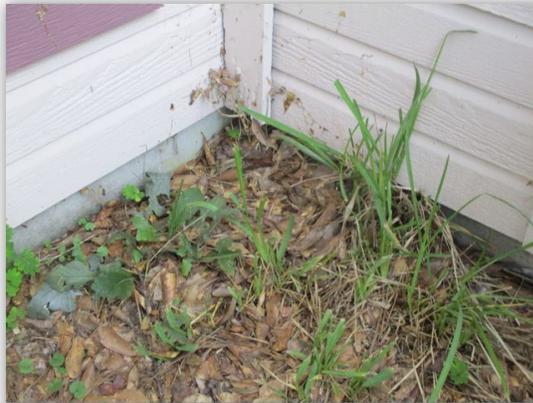
- The soil line was observed to be marginally high on the several areas around the structure. Under current building standards there should be at least 4-inches of foundation visible below masonry veneer and 6-inches of foundation visible below wood type veneer.

- The gutters require cleaning.

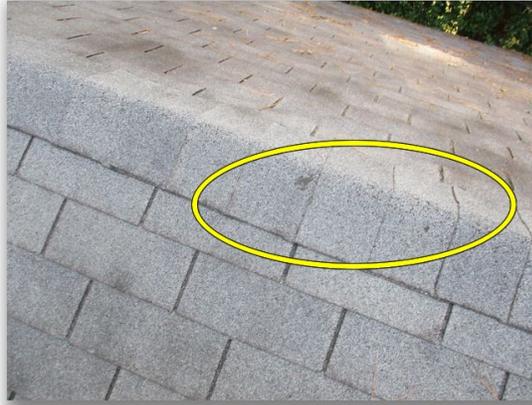
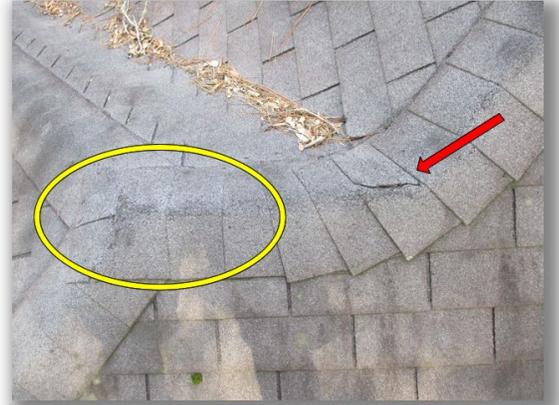
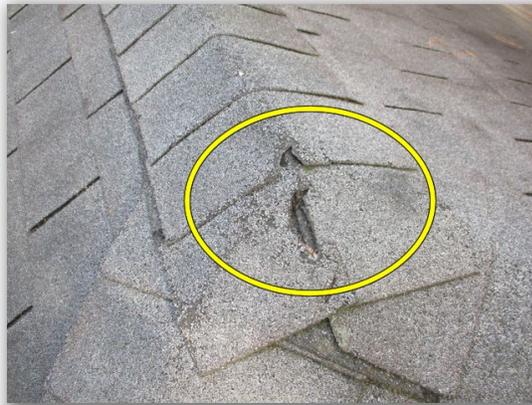
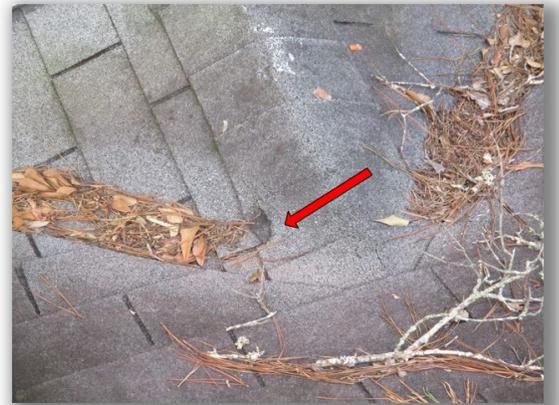
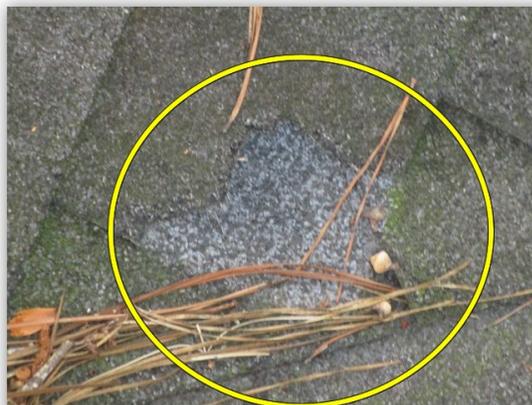
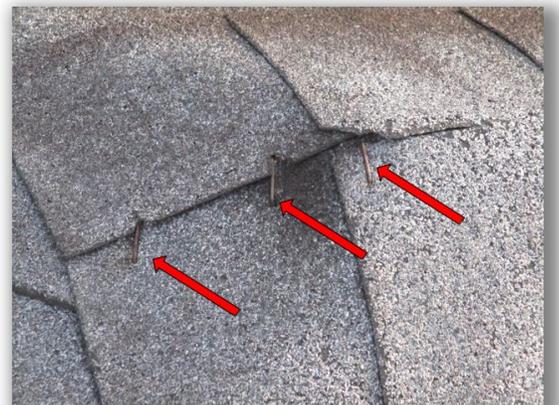
- Damaged shingles were observed on several areas of the roof structure.
- The composition roofing material has experienced considerable granular loss in various locations throughout the roof.

- **Note:** Roof fasteners (nails and/or staples) were observed to be exposed and should be properly sealed at the ridge caps. This can be an area for future water penetration

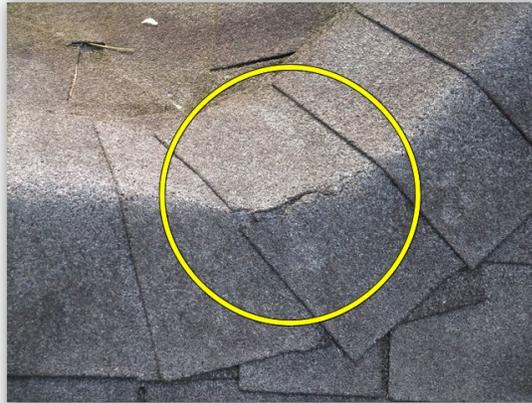
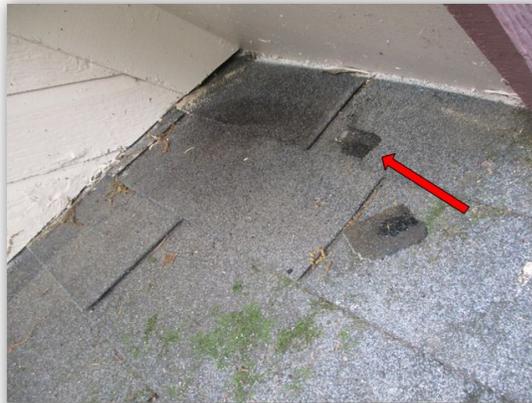
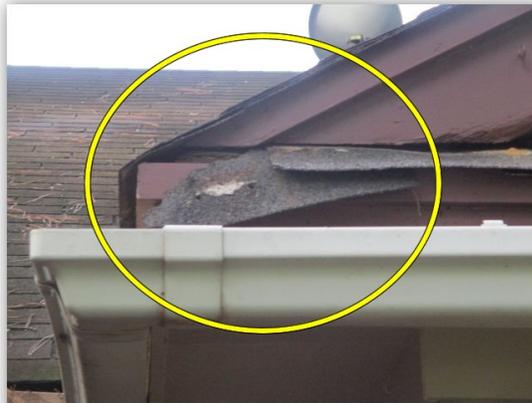
- **Note:** Prior repairs to the roofing material and/or flashing were observed in one or more locations.

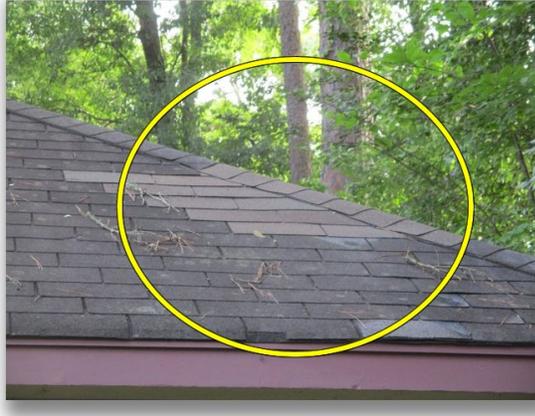
**Flashing Details**

- Some of the metal flashing details were observed to be rusted and should be corrected as necessary.
- The lead jack flashing at the plumbing vent stack needs to be checked, reset or repaired as necessary. The lead jack flashing detail was observed to be improperly installed at one or more of the roof level plumbing vent pipes. The lead flashing should run full length of the vent pipe and turn down into the top of the vent pipe to help prevent water intrusion at this point.

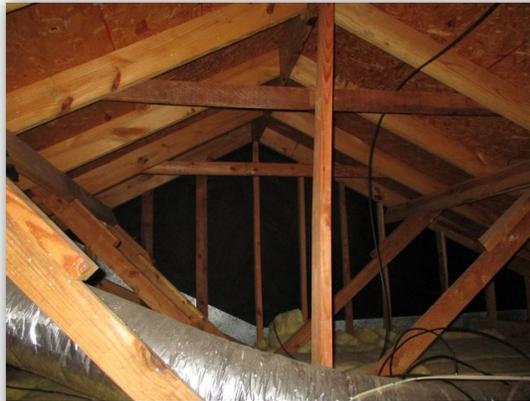
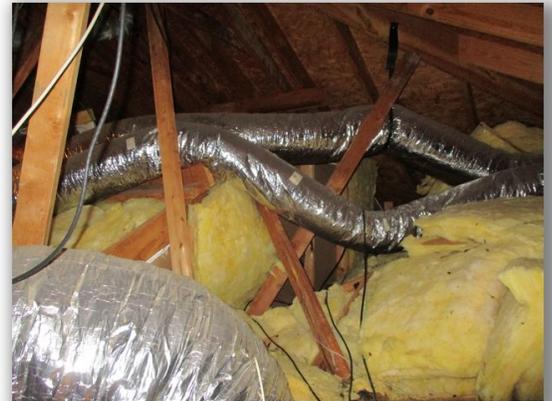
General photos of roof and attic structure

- One or more of the roof structure rafters were observed to be pulling away from the top ridge board. This is relatively common with normal amounts of settlement. Recommend bracing rafters to ridgeboard.

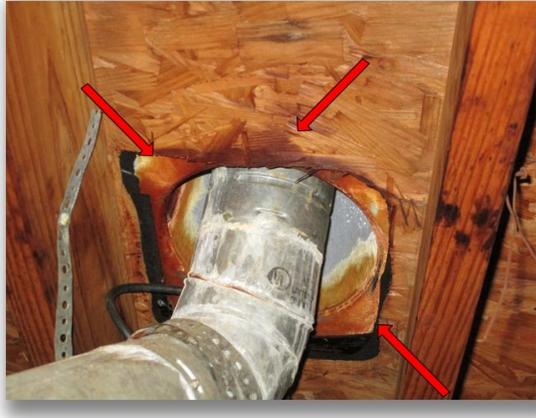
- Evidence of previous water penetration near furnace exhaust flue. No water damage was observed at time of inspection

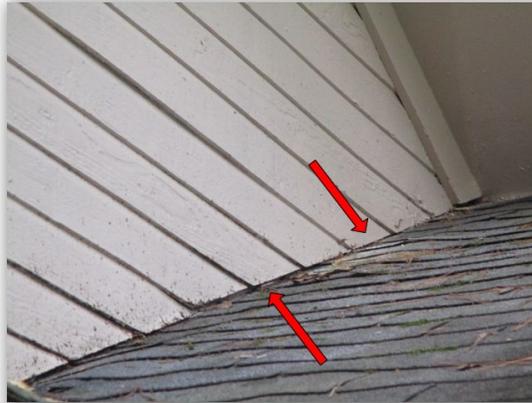
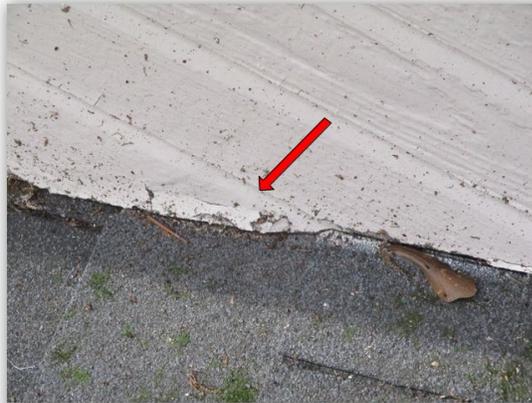
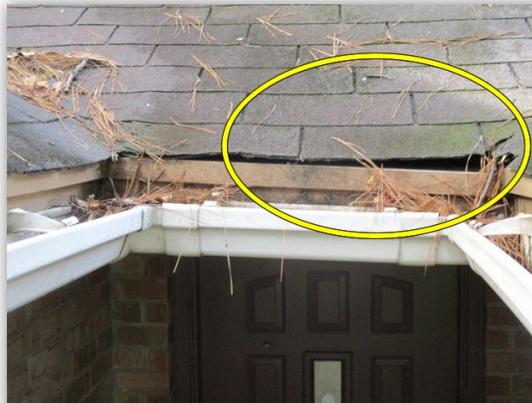
- Soffit under above area showing signs of water damage/deterioration

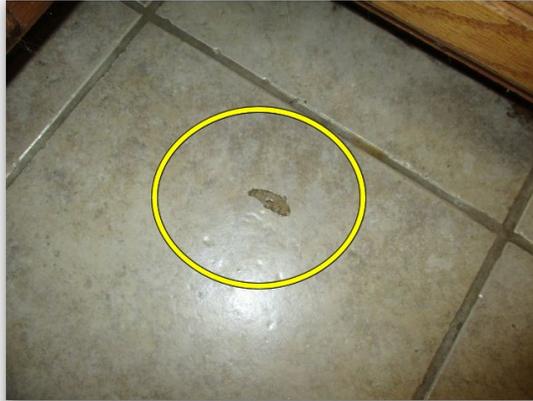
- The floor covering was observed to be water damaged in the dining room. Moisture meter indicates that moisture is present on the dark area of floor but not beyond
- **Note:** There is loose dirt just outside the dining room window. Recommend discussing with homeowner to find out if there is a relation between loose dirt and moisture in flooring.

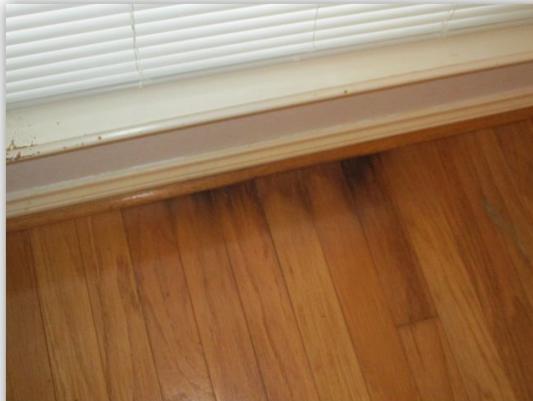
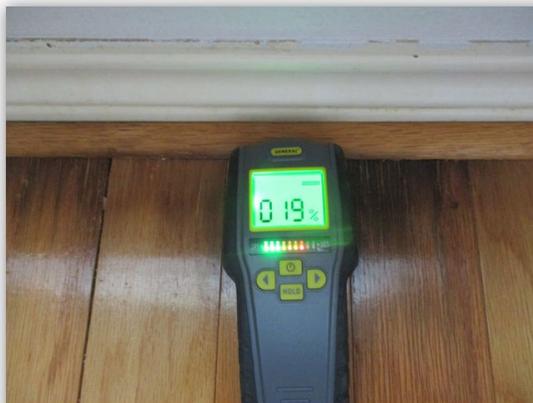
- Observed poor installation of wood flooring in front bedroom closet

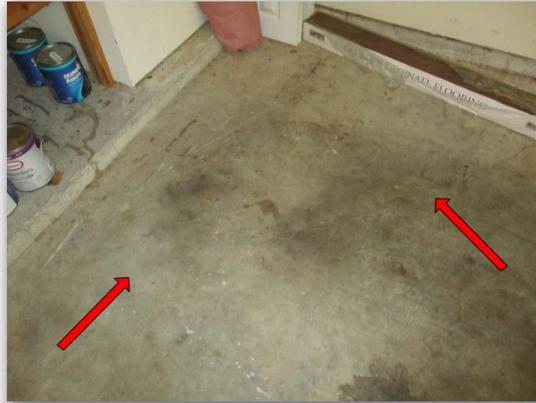
- **Note:** Some cracking of the garage concrete floor finish was observed.

This crack stems from the hairline crack near the entryway in the foundation. There are no other signs of any structural failure.

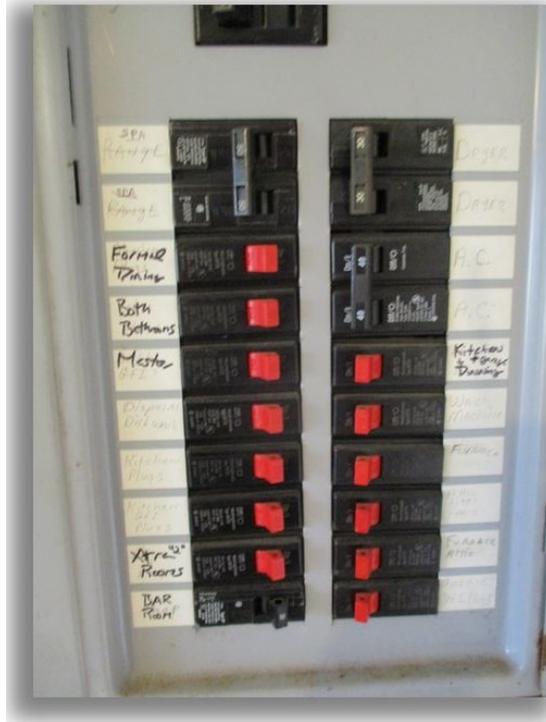
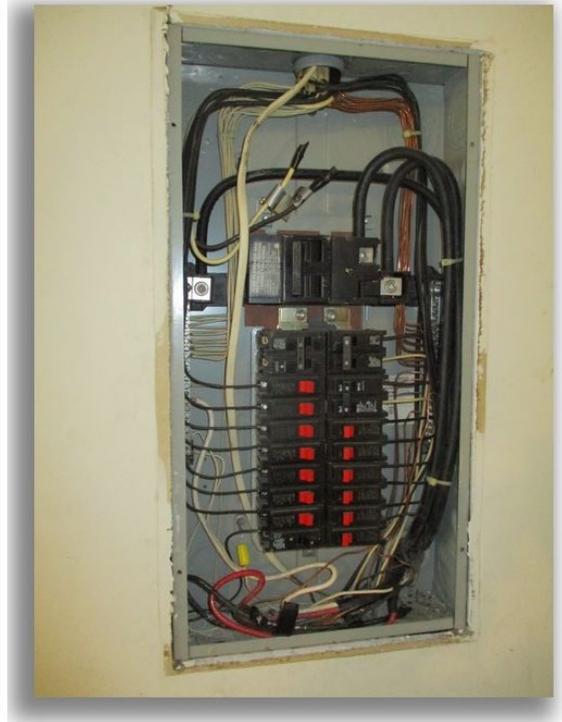
- Observed several neutral wires "double tapped" (more than one wire per lug). This is not allowed under current building codes.

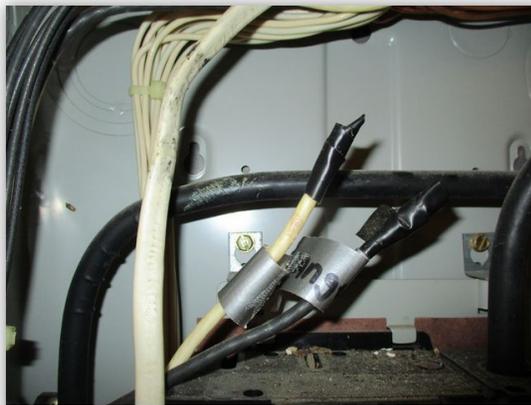
- Breaker labeled "Spa" was observed to be in the off position
- There were loose wires found inside panel. These are believed to have previously gone to the spa system but are now disconnected and no hot

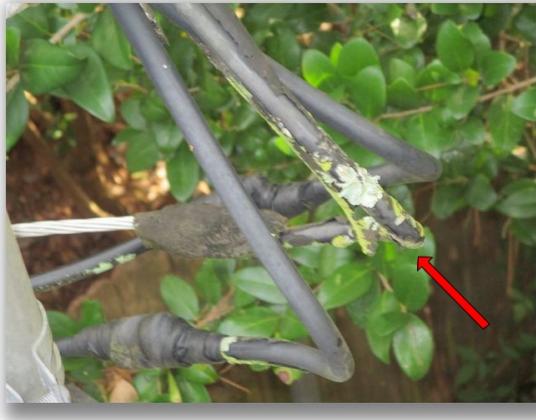
- Damaged wire sheathing was observed at the electrical service entrance.

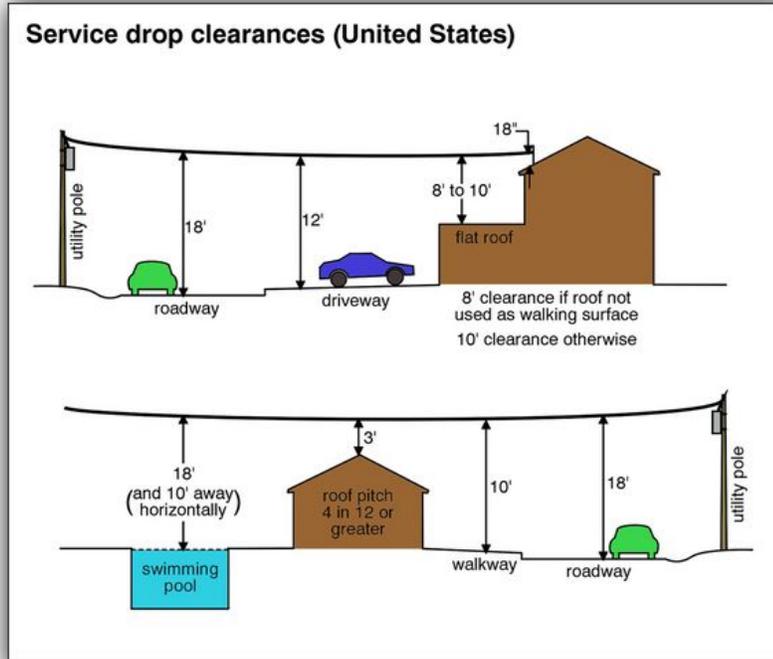
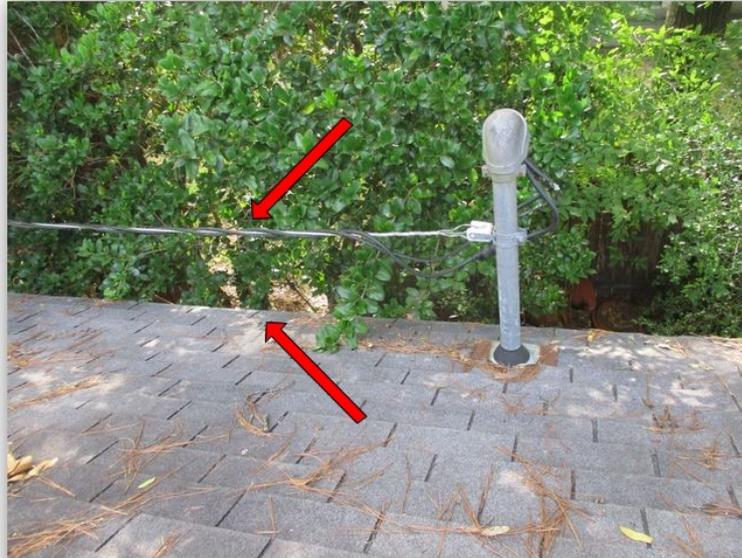
- The electrical service wires hang to low over the roof structure. The electrical service wires from the service pole to the structure should clear all roof structure components by a minimum of 3-feet.

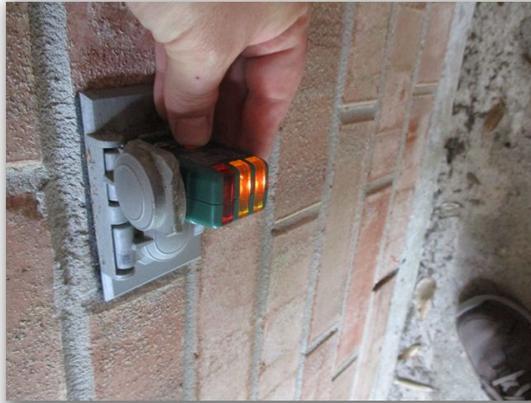
- The garage receptacles do not appear to be connected to a ground fault circuit interrupter (GFCI) device. Under current electrical standards, all of the garage receptacles should have GFCI protection.
- The exterior receptacles do not appear to be connected to a ground fault circuit interrupter (GFCI) device. Under current electrical standards, all of the exterior receptacles should have GFCI protection.

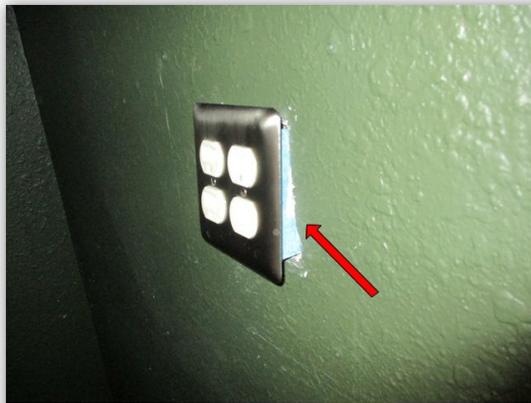
- Observed outlet in front bedroom closet coming loose from wall

Conduit observed in yard from believed to be from previous spa equipment. Wires do not appear hot when tested.

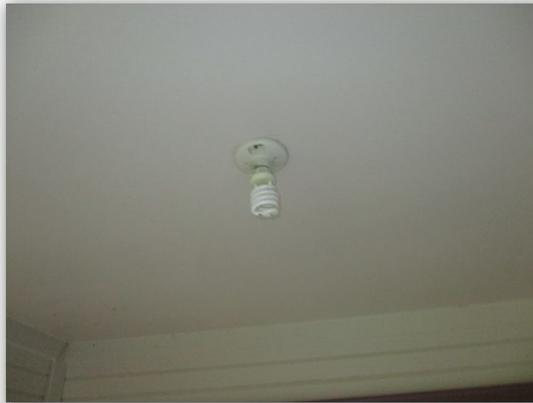
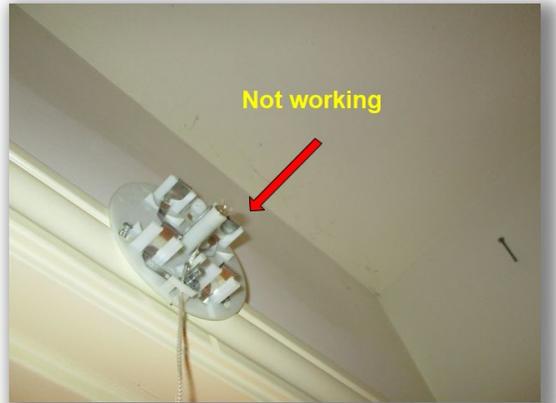
**Fixtures**

- One or more of the closet light fixtures appear to be installed without globes and/or covers. Safety precautions should be taken around these light fixtures.
- The ceiling fan appears to be inoperative in the entryway closet.

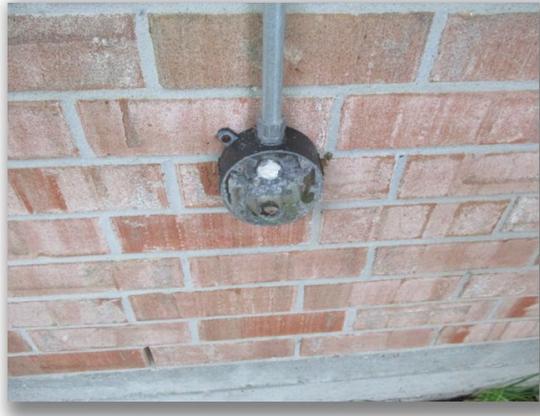
- Observed old junction box on side of house. Appears not to be in use

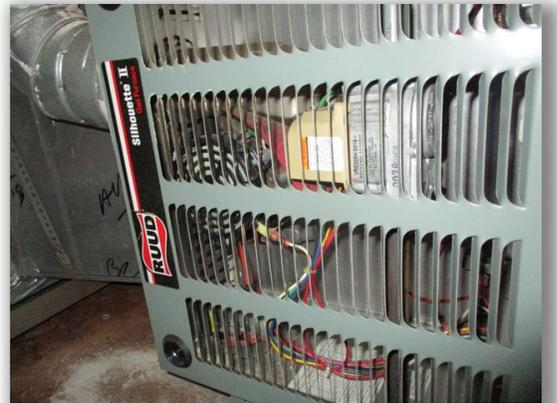
- The attic equipment service platform is inadequate or missing. There should be at least a 30 X 30 inch floored service space in front of the service side of the equipment.
- There is no decked service passage to the attic mounted equipment. Under current mechanical installation standards, all appliances (i.e. HVAC Equipment and/or Water Heaters) mounted in an attic space should be accessible with a passageway of continuous solid flooring not less than 24-inches wide. A level service space at least 30-inches deep and 30-inches wide should be present along the side of the appliance where access is required.

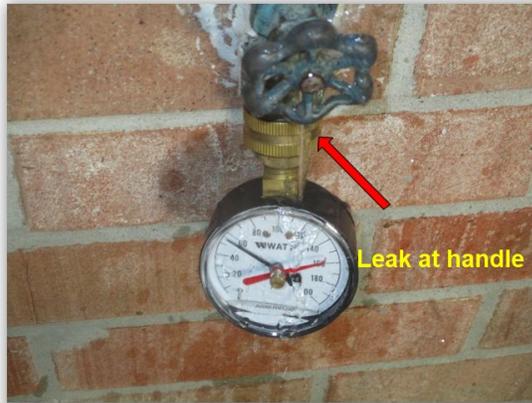
##### Exterior Faucets/Fixtures

- One or more of the exterior water hose bibbs (faucet) do not have a back-flow or anti-siphon device (Vacuum Breakers) in place. **Note:** This is not uncommon to observe with a home of this age.
- The exterior water hose bibb (faucet) is leaking at the handle when operated on the north side of the structure.

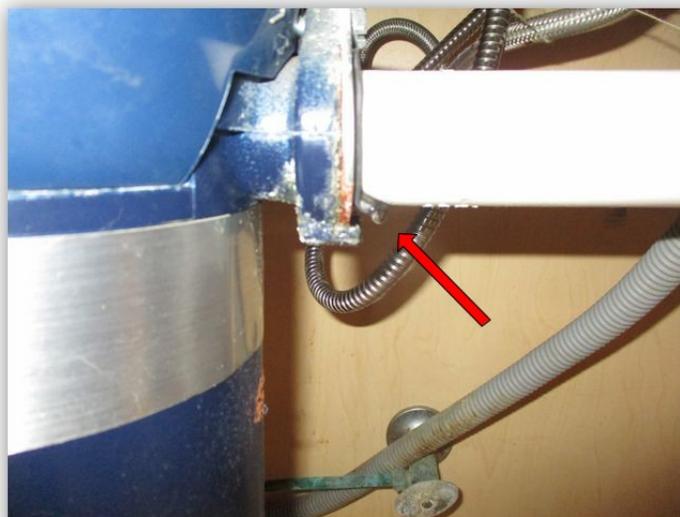
- The drain leaks water into the cabinet when drained

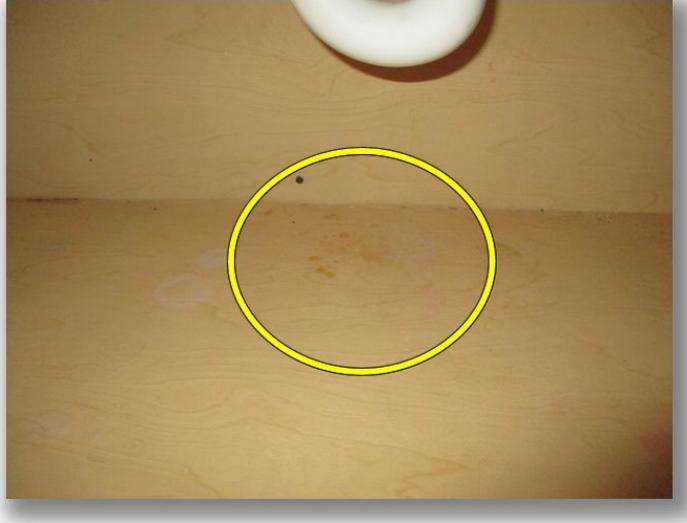
- The drain leaks water into the cabinet when drained

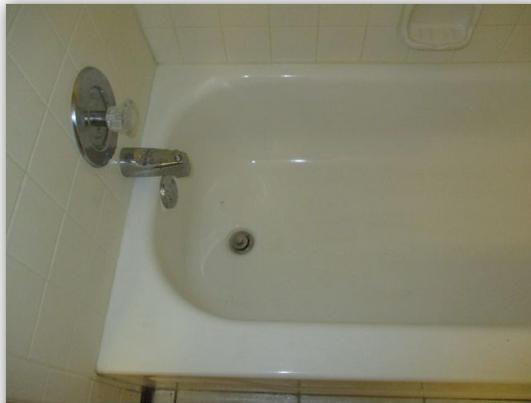
*Bathtub*

- Drain stop missing in master bathtub
- The master bathtub was observed to drain slowly, suggesting that an obstruction may exist.
- Drain stop not holding water guest bathtub
- Guest bath faucet does not fully switch to shower (shower and faucet run at the same time)
- The faucets hot/cold water orientation is reversed guest bathtub

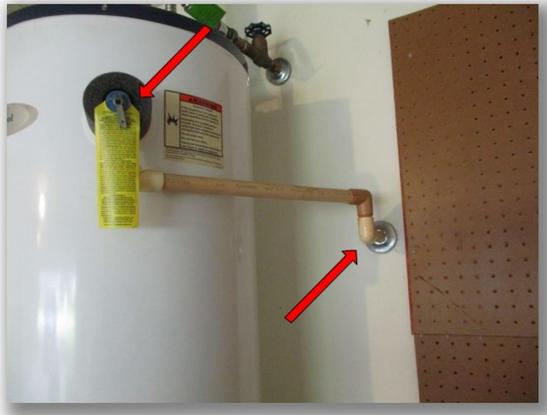
- Unable to determine the termination of TPR Valve (Temperature Pressure Relief)

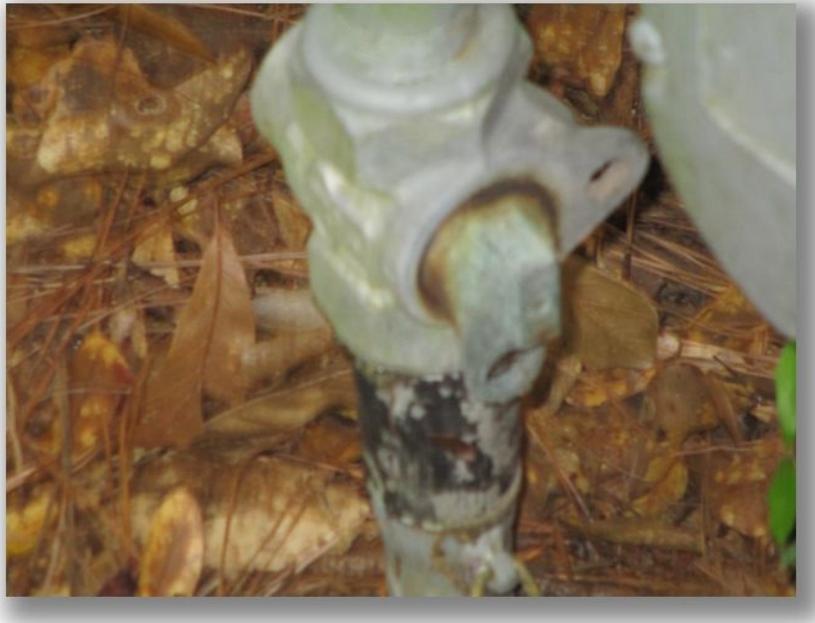
- There was a gas leak detected at the outside service meter near the shut off valve. This was detected with a combustible gas meter. Recommend having gas company replace valve

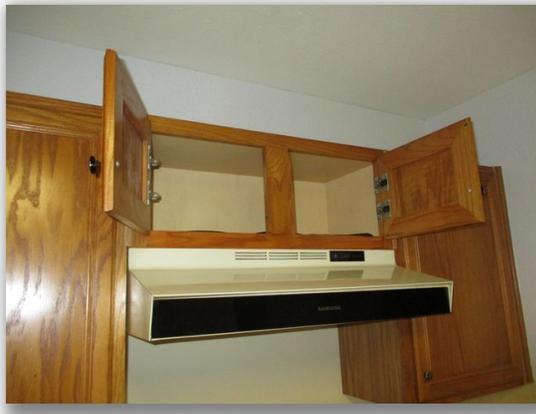
- **Note:** The vent hood does not terminate outside
