**Mark Marrows**  
**7854 Green Trail Dr**  
**Tomball, TX 77375**

April 2, 2021

## PROPERTY INSPECTION REPORT

By: Matthew Brading, Lic #TREC # 22654 04/02/2021  
(Name and License Number of Inspector) (Date)

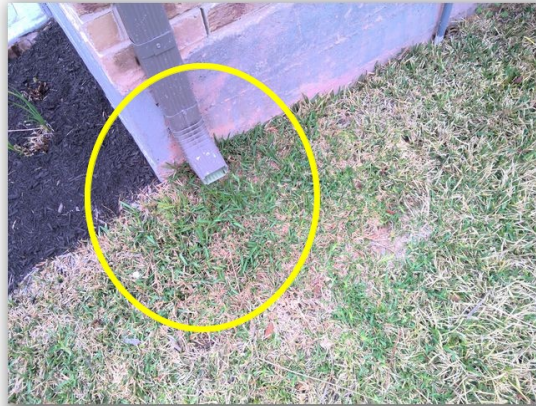
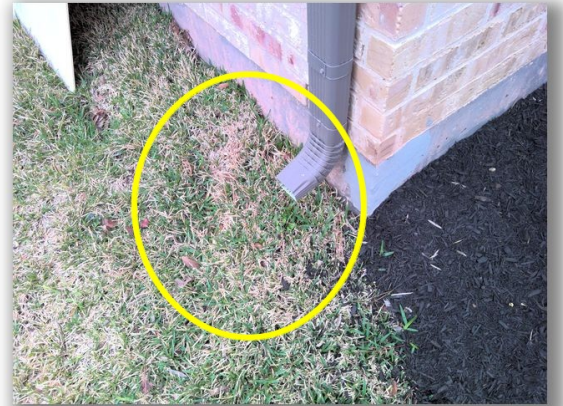
**Gutter & Downspout System**

- **Note:** The gutter downspouts should discharge water at least thirty-six inches (36") away from the foundation perimeter beam. Storm water should be encouraged to flow away from the structure at the points of discharge.

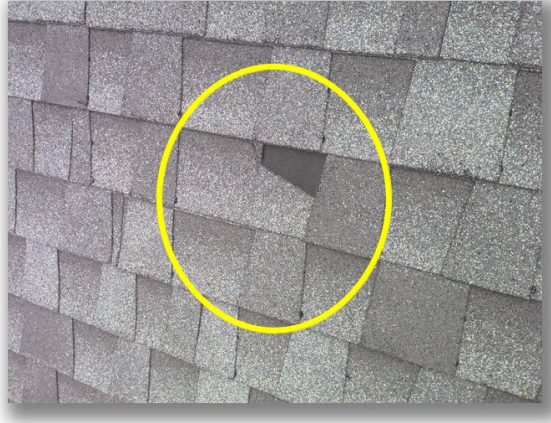
- Damaged shingles were observed on the left side of the roof structure.

**Note:** When D (**D=Deficient**) is marked. It is recommended that all of the roofing material and its components be fully evaluated by a Qualified Roofing Specialist, prior to the expiration of any time limitations such as option or warranty periods.

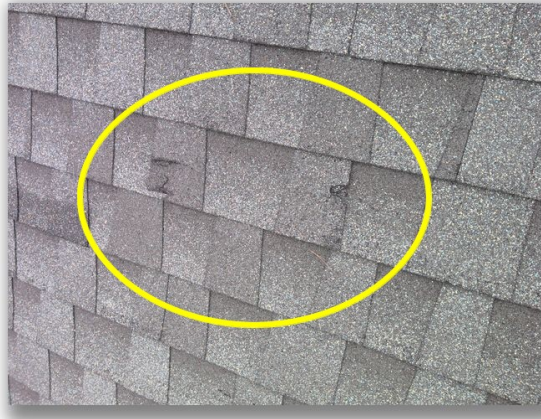
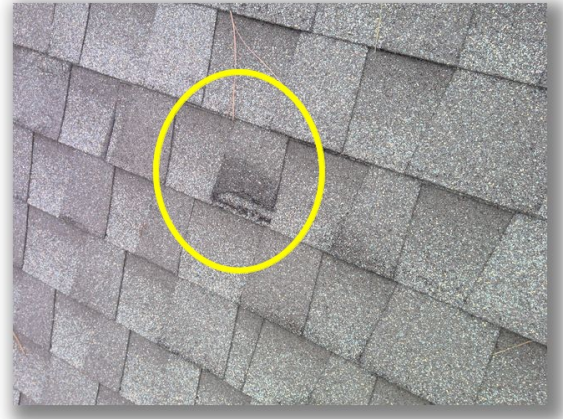
- Damaged shingles were observed on the back side of the roof structure.

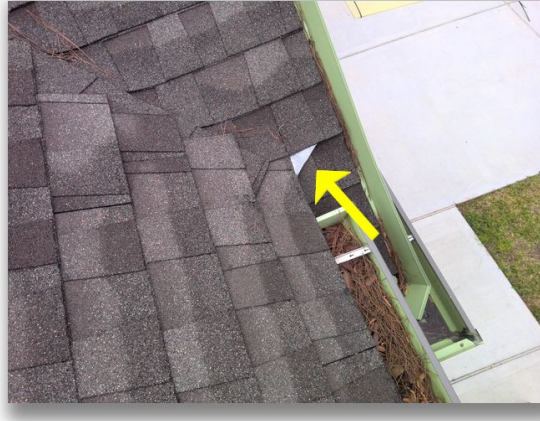
- Recommend painting all metal flashing & flues to help prevent rust/deterioration.

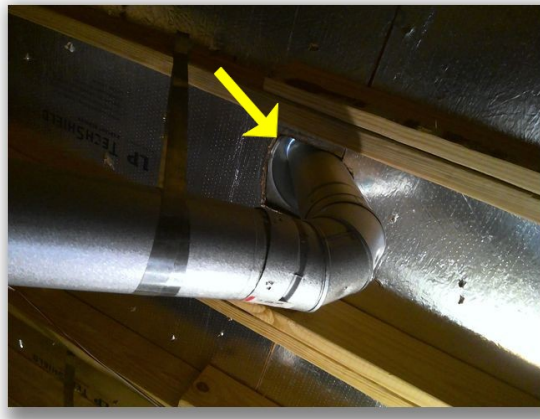
- The storm collar(s) at the roof level gas equipment vent pipe(s) need to be properly sealed to help prevent water intrusion into the structure.

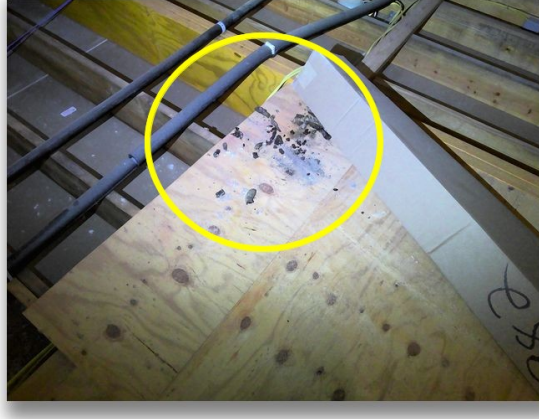
**Roof Structure**

- **Note:** Visible evidence of rodent activity was observed in the attic area. It is recommended to have a Certified Pest Control Operator further evaluate this condition and make corrections as necessary.

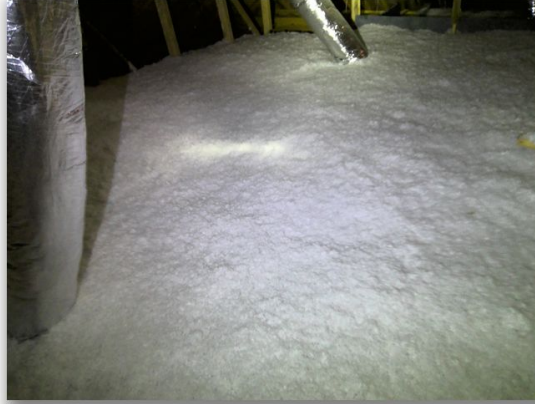
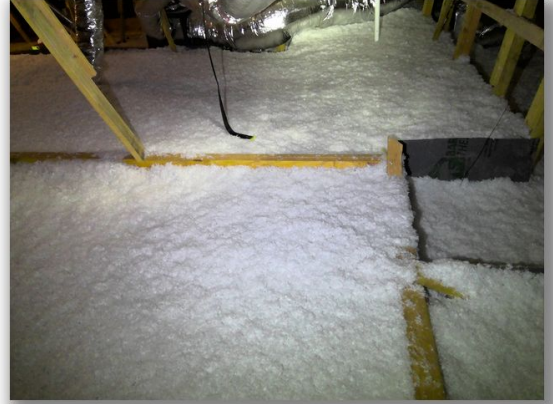
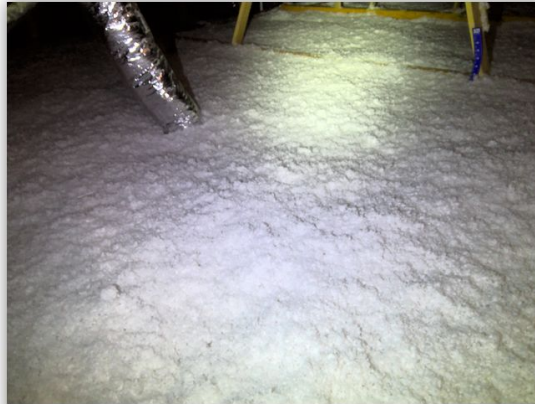
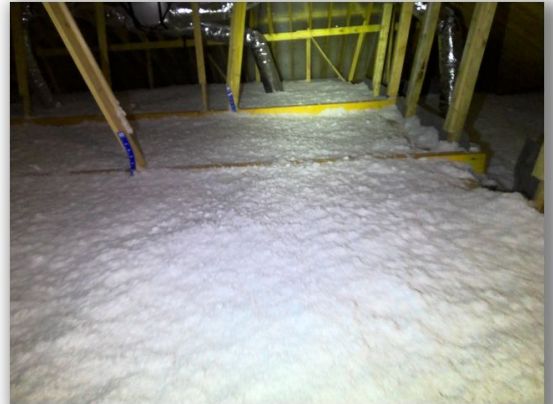
**Attic Insulation**

All components were found to be performing and in satisfactory condition on the day of the inspection.

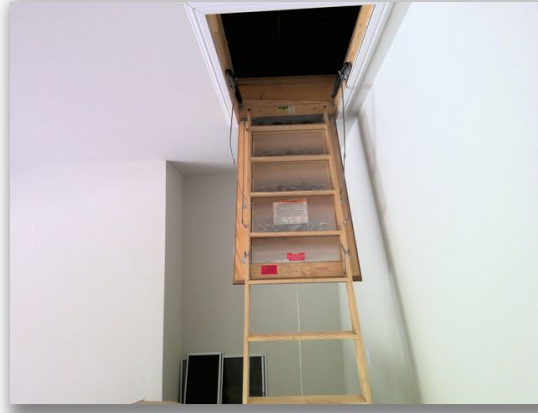
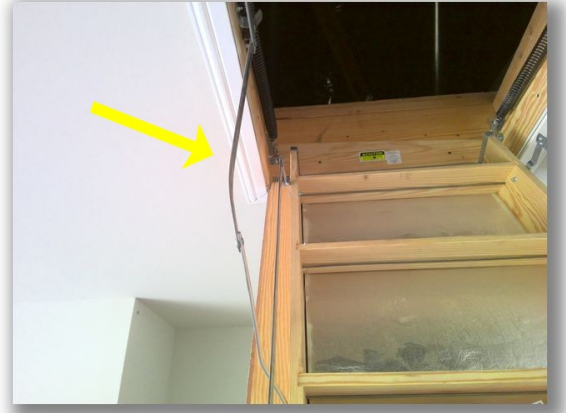
### Attic Ladder

- The attic ladder was observed to be damaged and the ladder will not close properly.

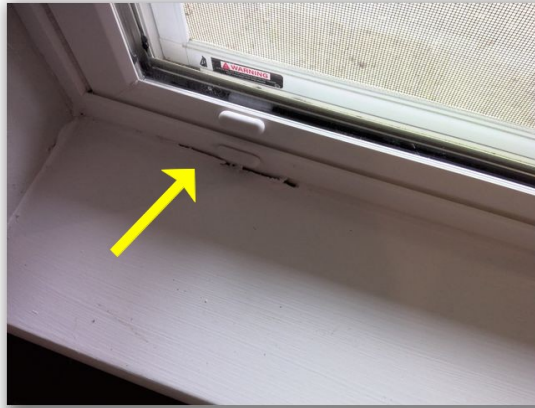
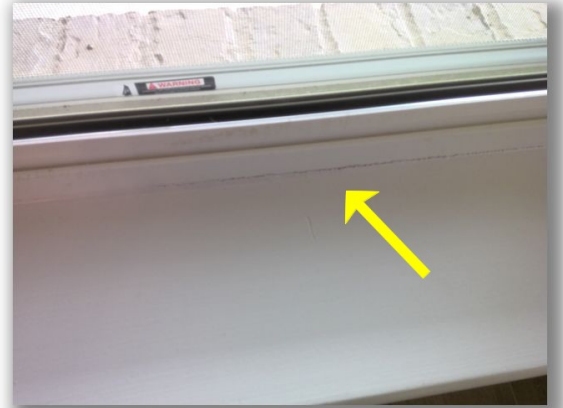
- Caulking improvements are recommended at one or more of the interior windows.

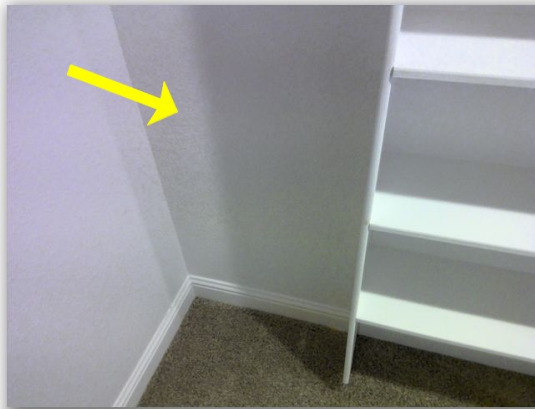
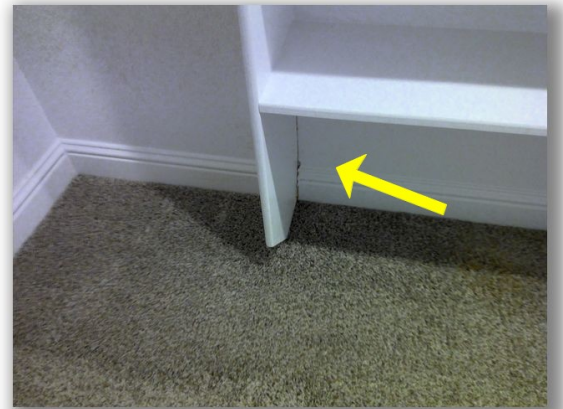
- Incomplete wall repairs were observed in the master bedroom closet area.

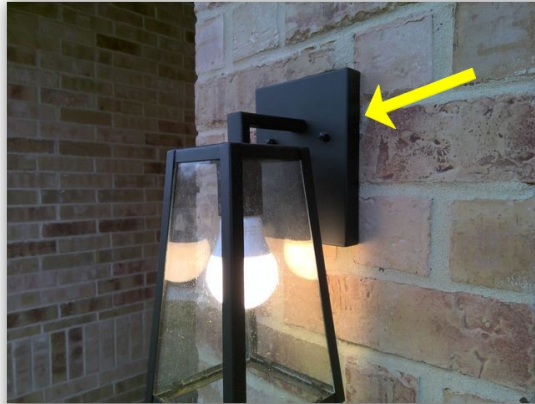
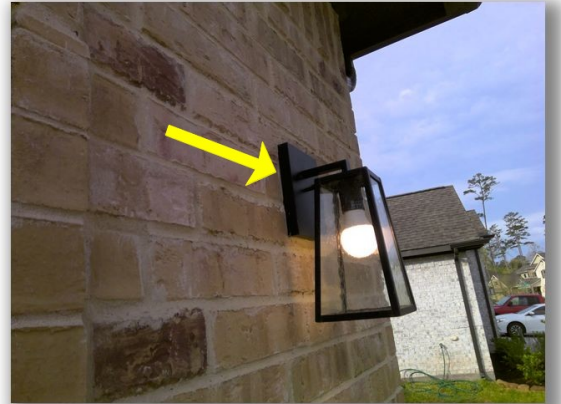
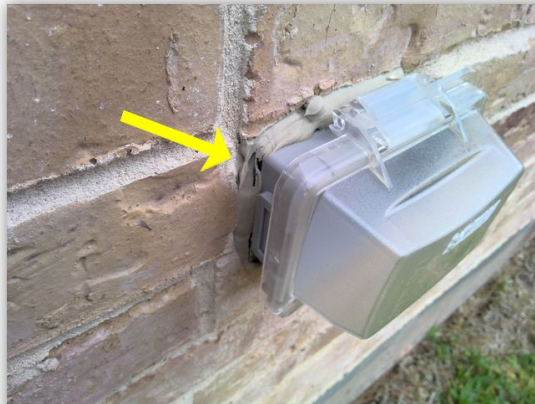
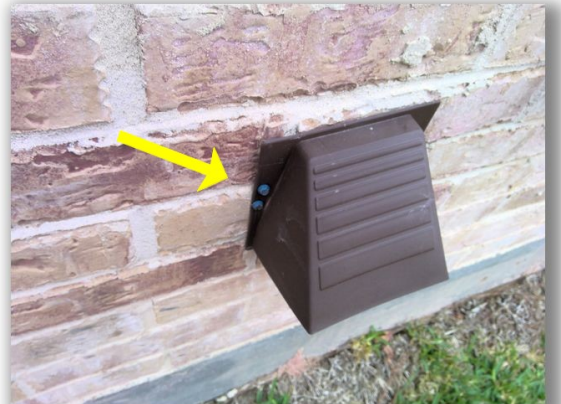
### Exterior Walls & Surfaces

- The area between the exterior cladding / veneer and all of the wall penetrations / openings need to be properly sealed. Areas such as utility connections, downspouts, hose bibbs, lighting fixtures, receptacles etc. It is recommended to use an elastomeric caulking / sealant.

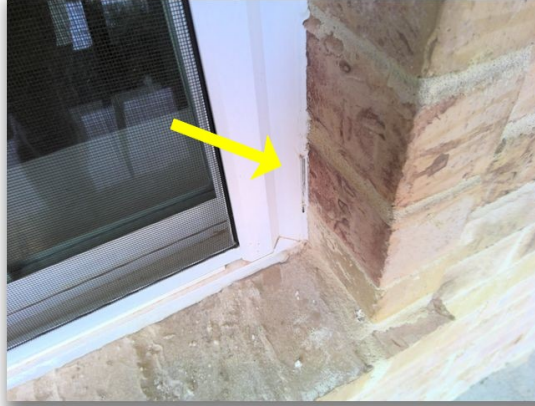
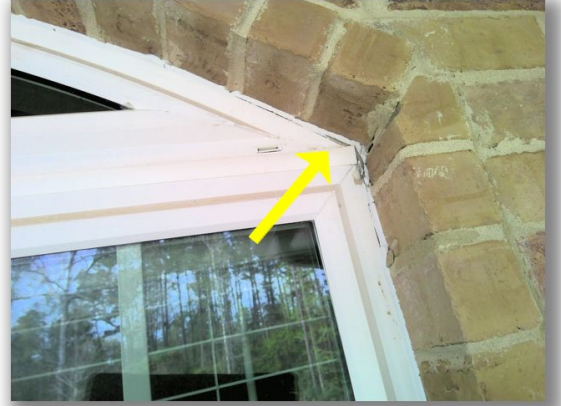
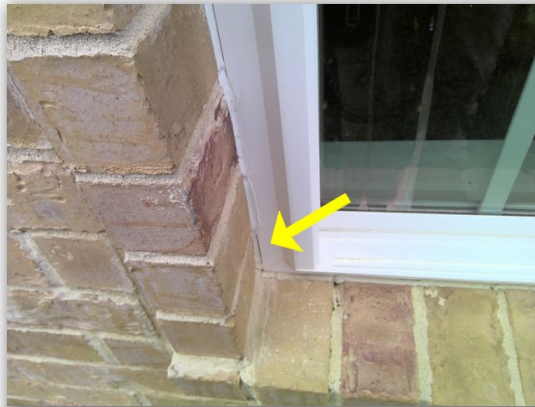
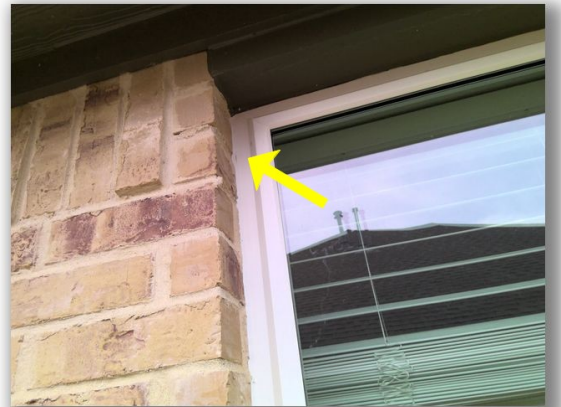
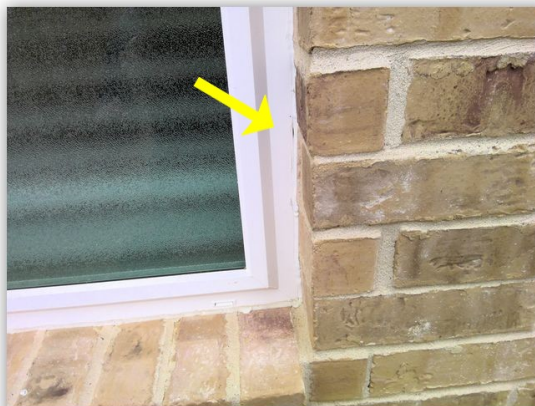
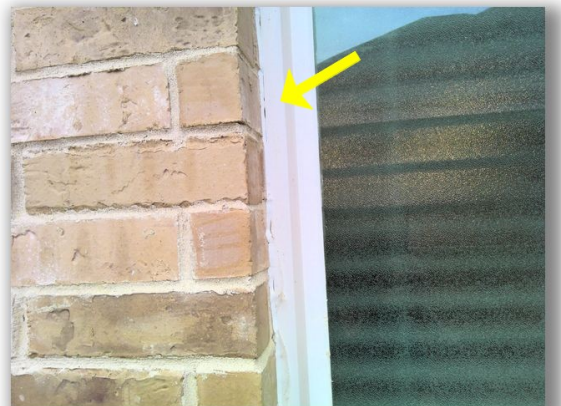
- Caulking improvements are recommended for the area between the exterior veneer and the window frames. It is recommended to use an elastomeric caulking.

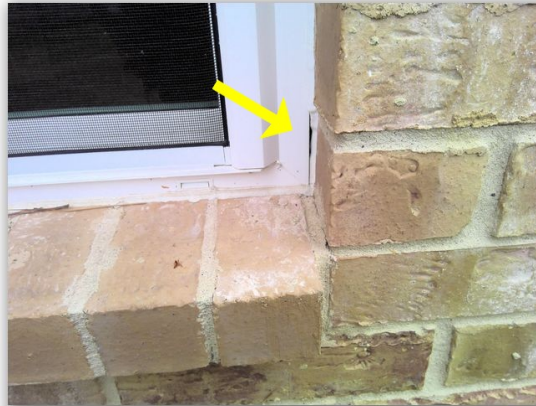
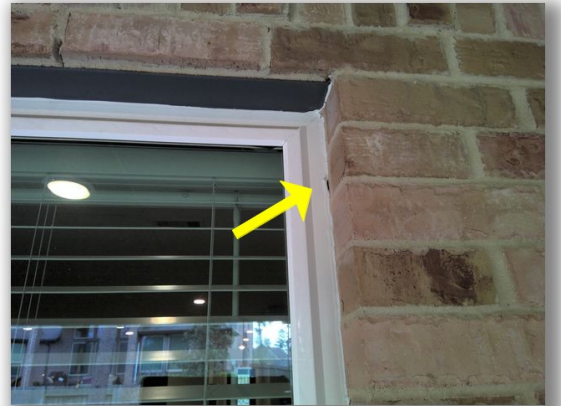
- The wall expansion joint(s) need to be properly sealed on the front of structure/outside front door of the structure. It is recommended to use an elastomeric caulking.

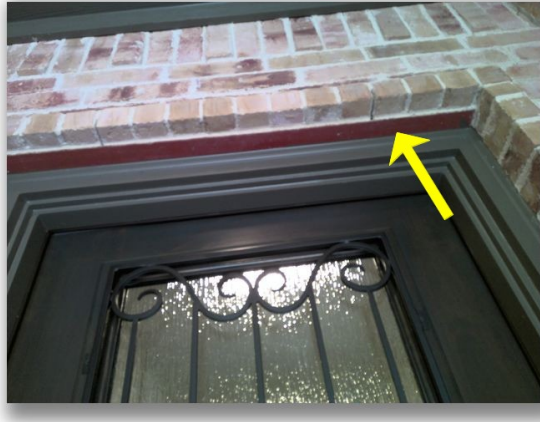
- The steel lintels over the exterior doors and windows need to be painted.

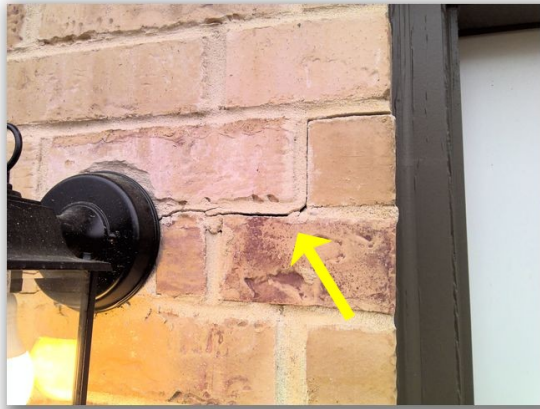
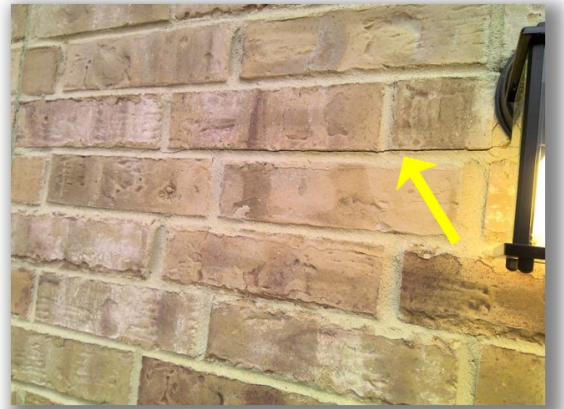
- **Note:** Minor mortar and/or brick cracks were observed in the exterior veneer on the right side of the structure.

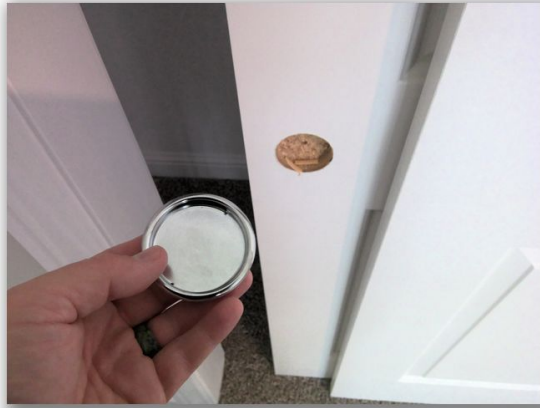
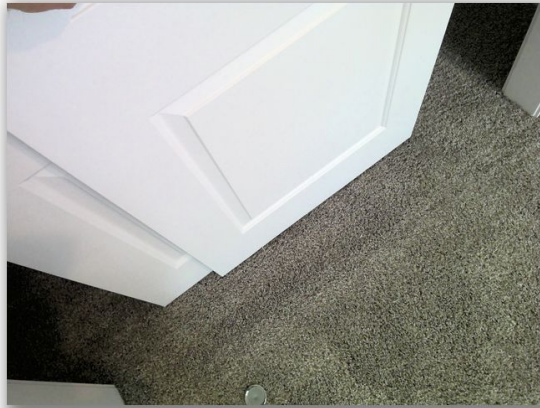
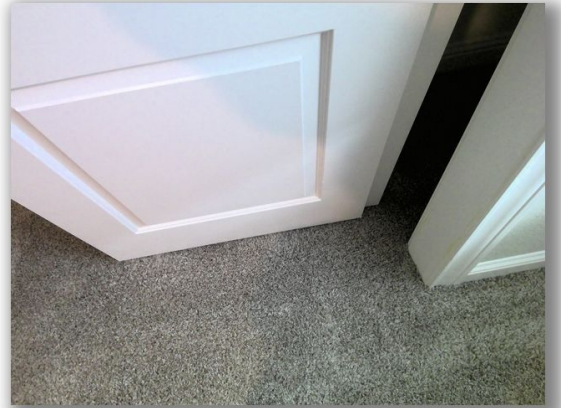
**Interior Doors**

- The door hardware is missing to the front corner bedroom closet.
- The door hardware is missing to the side middle bedroom closet front corner bedroom closet.
- \*\*\*No bottom bracket/brace\*\*\*

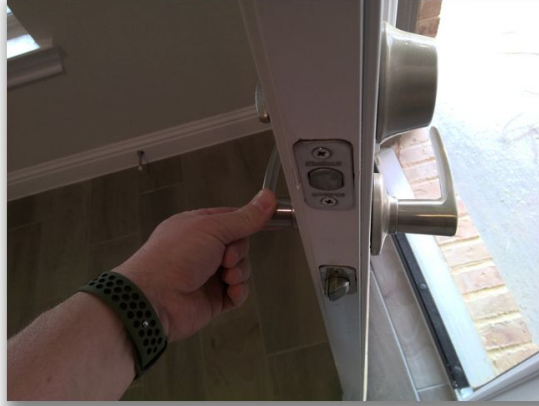
### Exterior Doors

- The door hardware is loose to the backyard entry door.

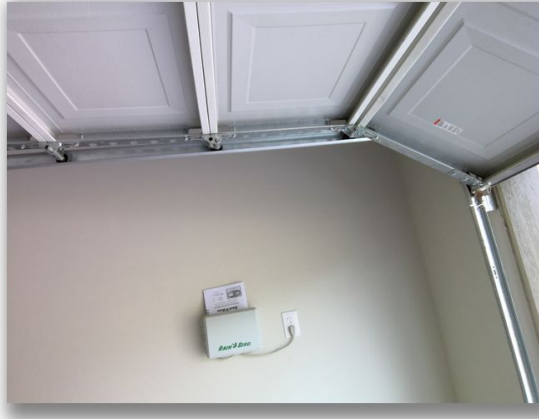
### Overhead Garage Door

- The garage door shakes excessively when starting to close. Further evaluation is recommended.

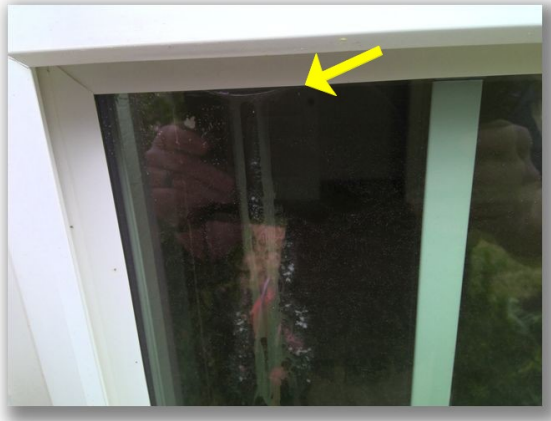
**Windows**

- Cracked and/or broken window glass was observed in the front corner bedroom.

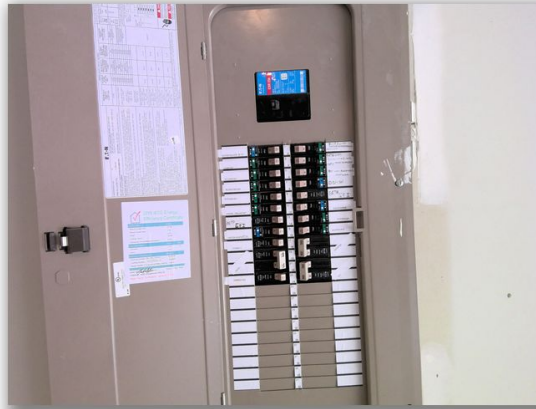
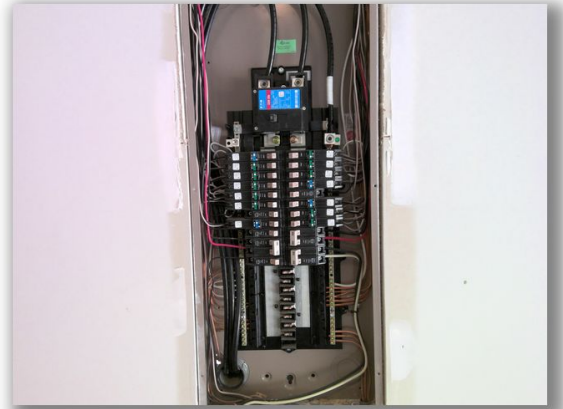
*Cabinet Manufacturer: EATON*

*Branch Circuit Wire Type: Copper*

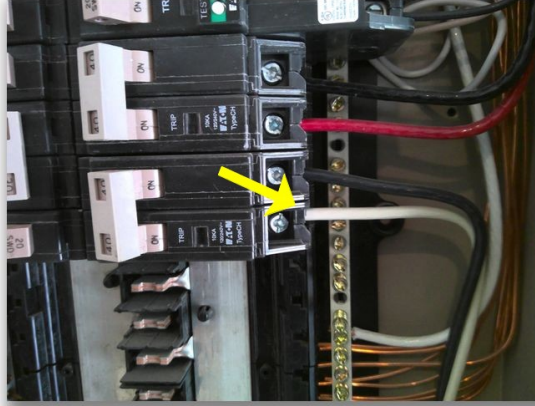
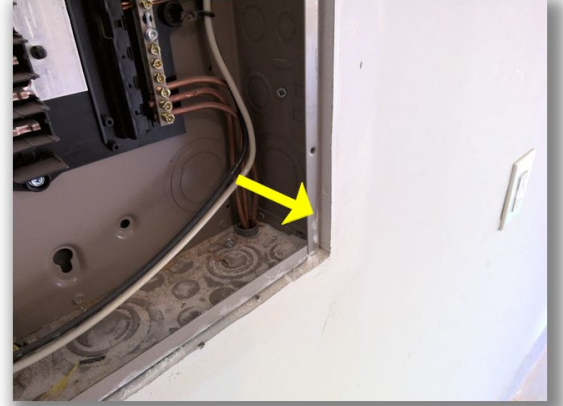
- White hot wires should be labeled with black tape.
- The panel box is not mounted to be flush with the drywall.

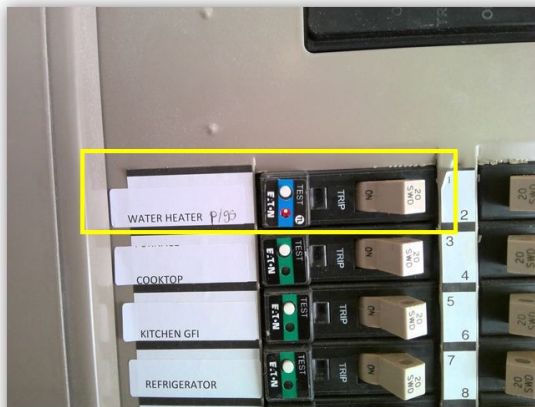
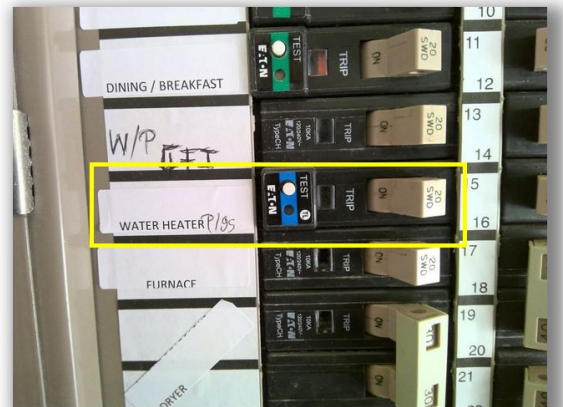
- The breakers (overcurrent devices) in the electrical panel are not properly labeled.

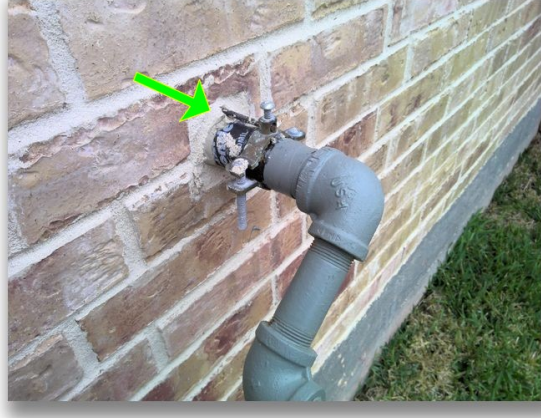
**Grounding / Bonding**

- Gas pipe bonding was observed at the gas meter entrance area.

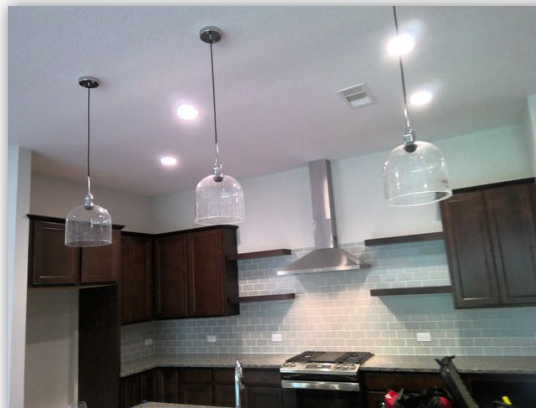
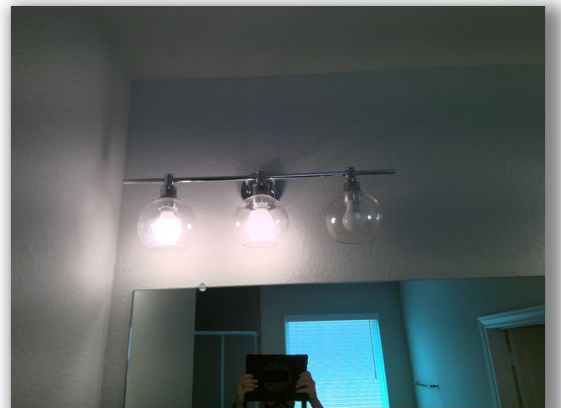
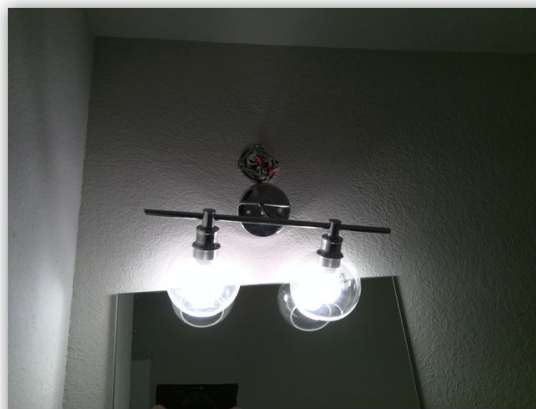
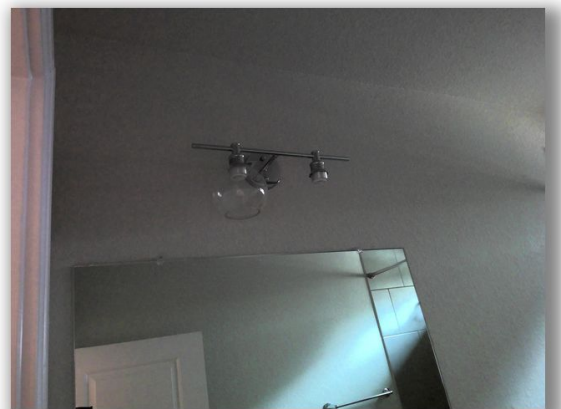
**Fixtures**

- One or more of the light fixtures appear to be inoperative in various locations throughout the house. This may be due to a bad bulb or some other unknown condition. This condition should be further evaluated and corrected as necessary.
- One or more of the light fixtures are loose at the ceiling mount in the half bathroom.

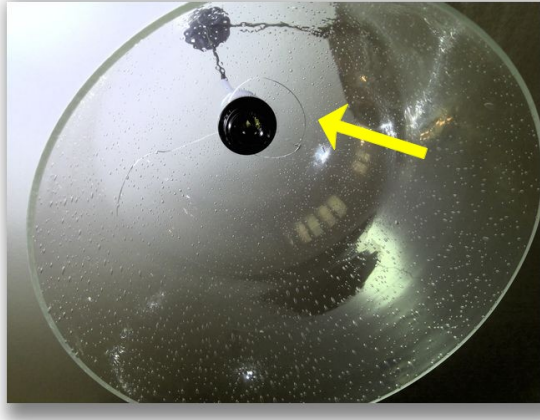
- One or more of the light fixtures were observed to be damaged in the kitchen.

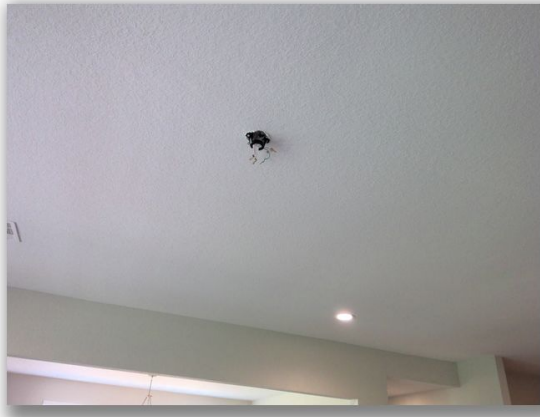
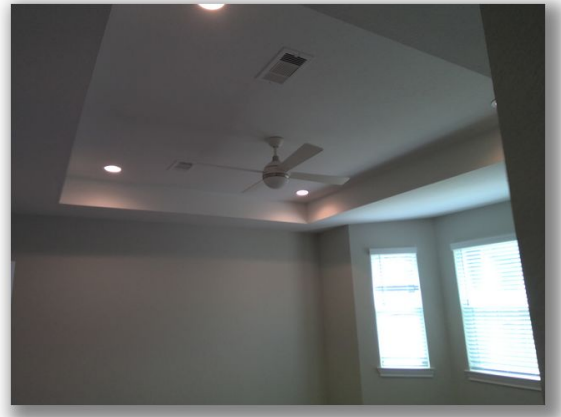
- The ceiling fan appears to be inoperative in the master bedroom.
- The ceiling fan appears to be missing in the living room.

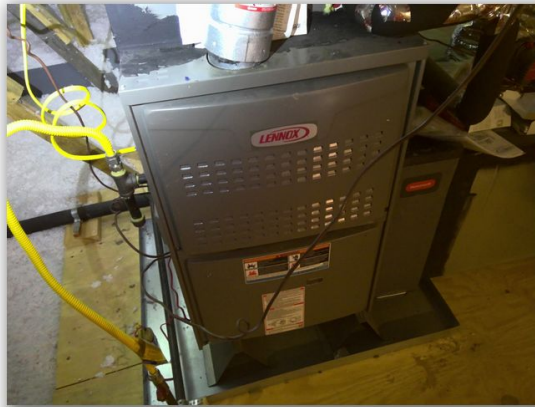
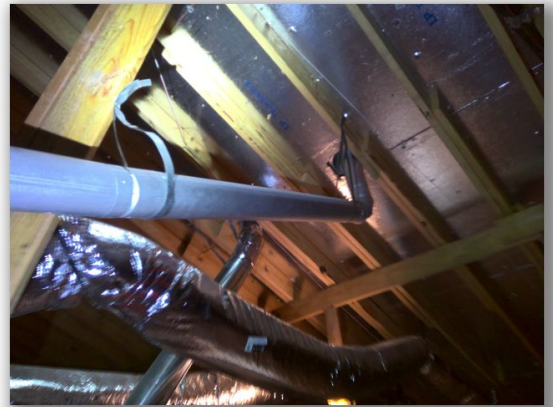
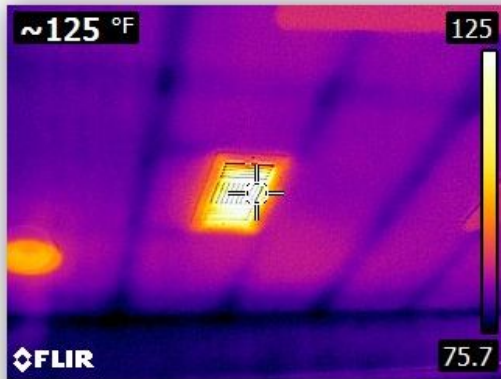
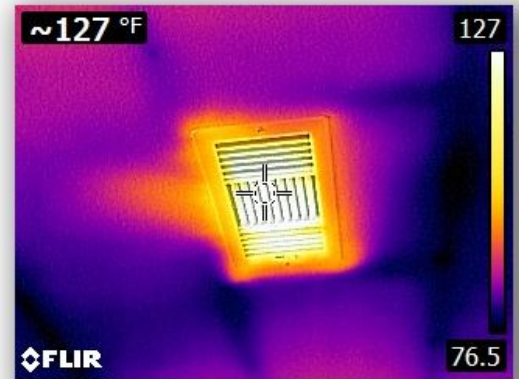
Brand Name: Lennox

This component appears to be performing adequately at the time of this inspection.

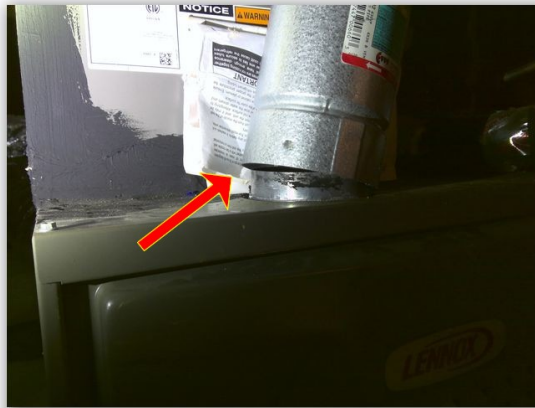
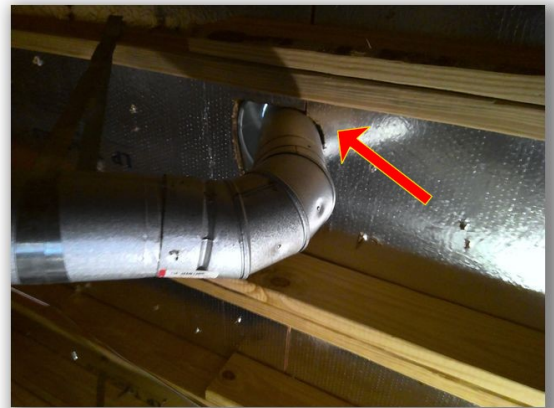
- The heating unit vent pipe is separated in the attic. This configuration will emit Carbon Monoxide into the attic area, which is a known safety hazard.
- The heating unit flue (vent pipe) has inadequate clearance from combustibles. Double walled vent pipes should have at least 1-inch of clearance and single walled vent pipes should have at least 6-inches of clearance from combustible material.

The HVAC system needs to be checked and serviced by a Qualified / Licensed HVAC Technician. The observations made to support the rendering of this opinion are listed but may not be limited to the following:

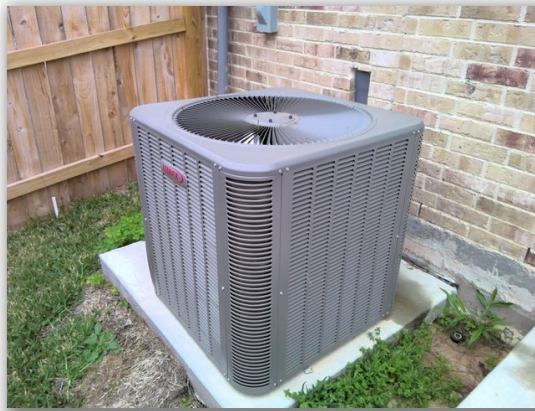
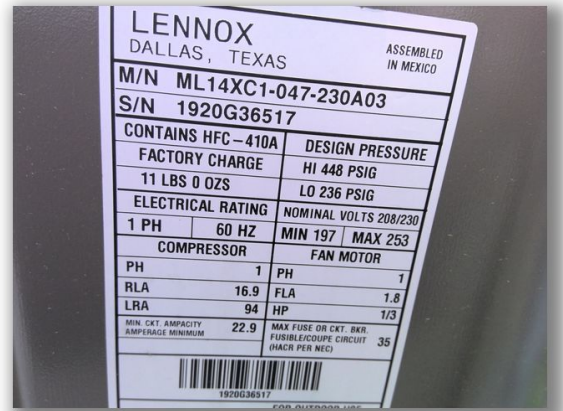
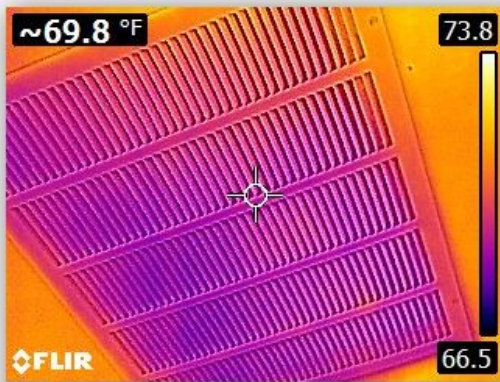
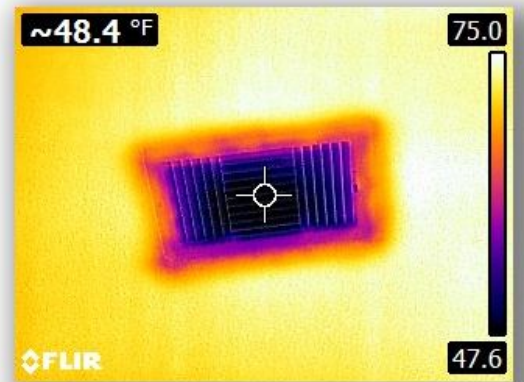
Brand Name: Lennox

This component appears to be performing adequately at the time of this inspection.

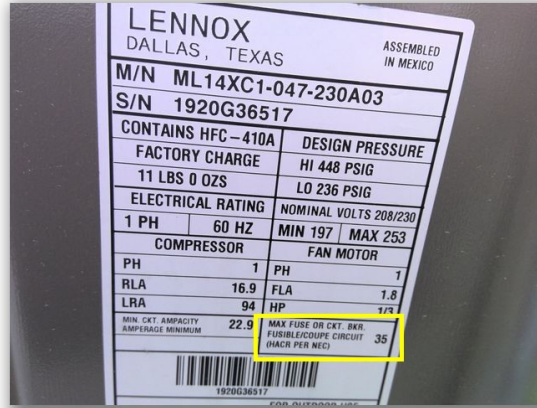
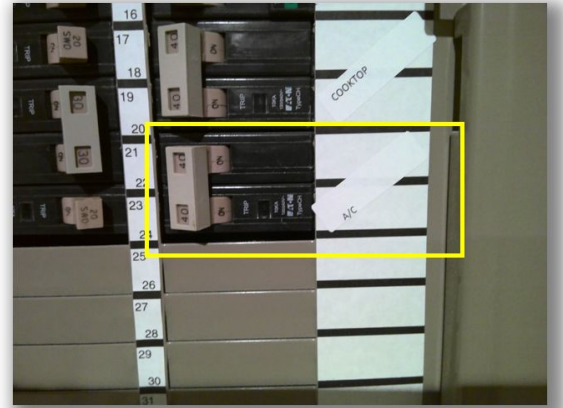
- The manufacturers listing plate on the outside condenser/coil list that the maximum over current device (breaker) to be used should not exceed 35-amp. There is a 40-amp breaker in place at this time. This breaker in place does not meet the manufacturers listing plate requirements.

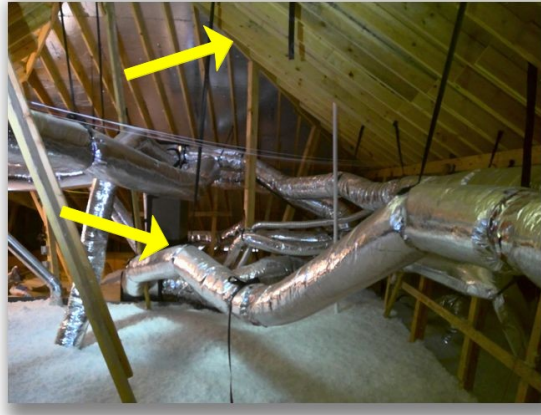
- The duct work in the attic area appears to have excessive sags between the supports. This condition can cause pressure loss and affect the airflow through the duct system.

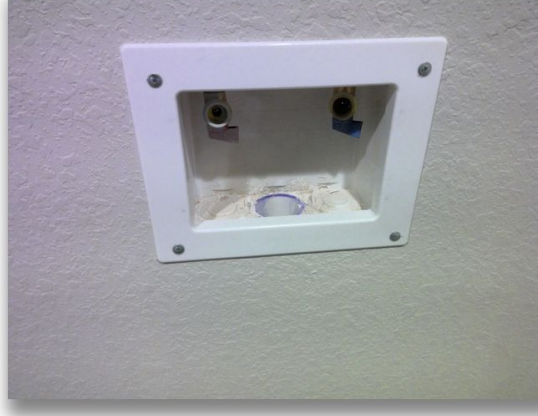
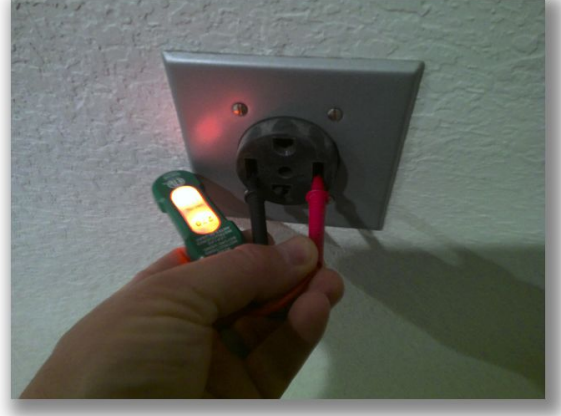
**Laundry Connections**

All components were found to be performing and in satisfactory condition on the day of the inspection.

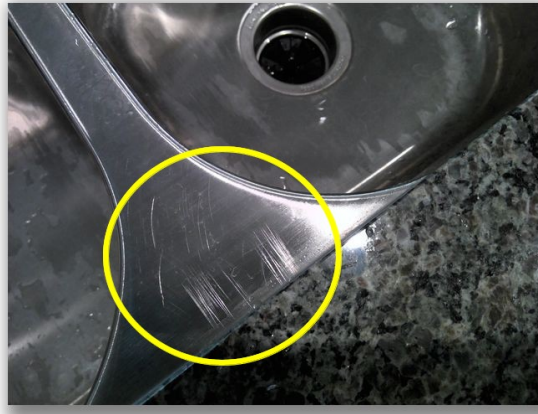
**Kitchen Sink**

- The sink has some surface damage.

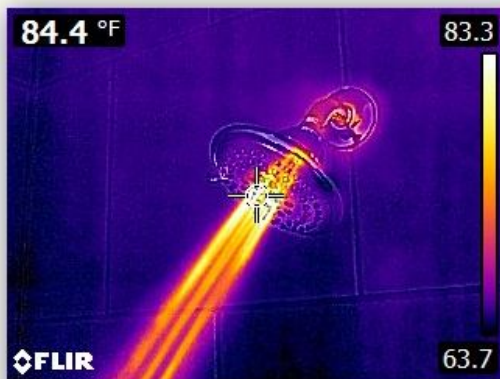
*Shower*

- The shower was not achieving the same temperature as the other fixtures throughout the house. Further evaluation is recommended.

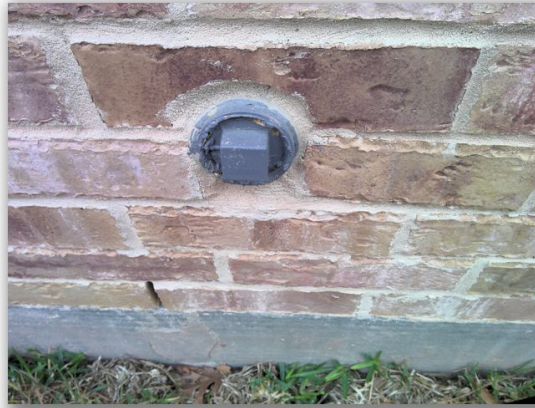
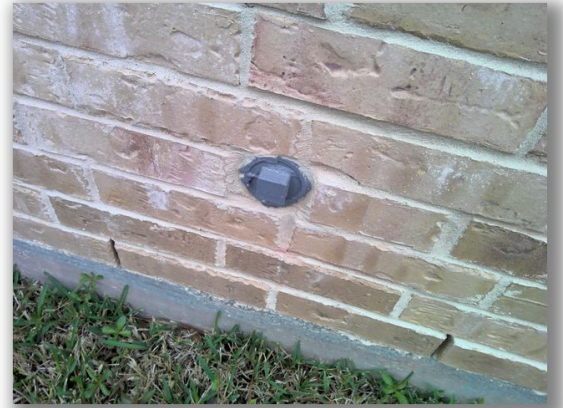
**General Photo(s) of Plumbing Cleanout(s)**

**Note:** The inspector was unable to locate the main plumbing cleanout at the time of inspection.

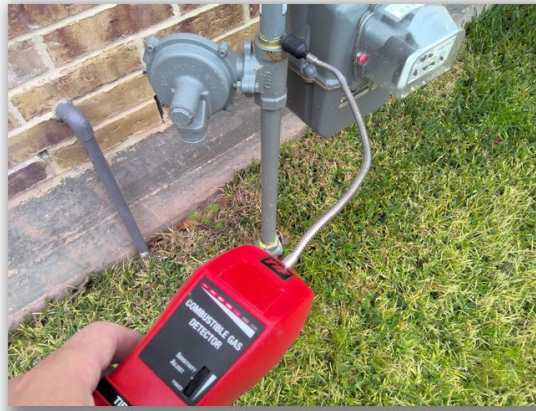
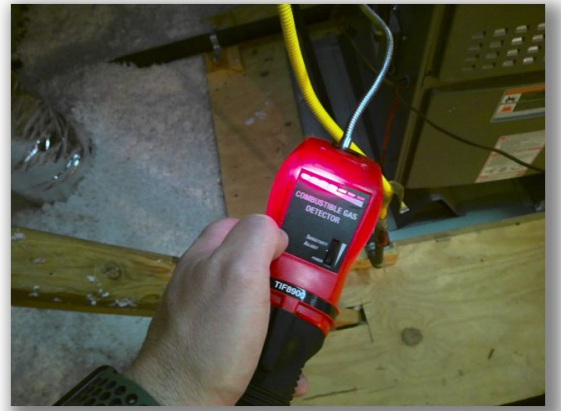
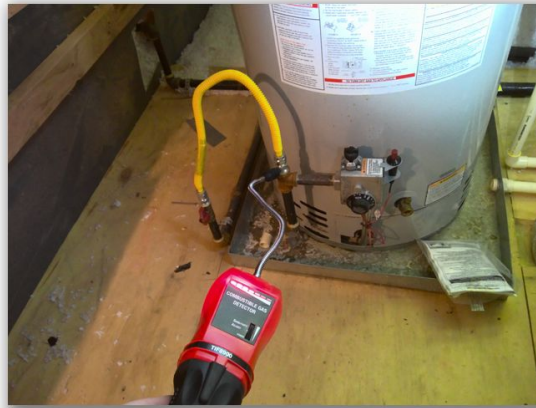
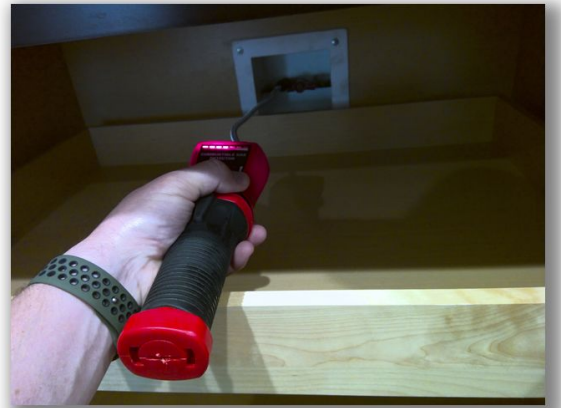
**General Photo(s) of Inspector Checking Gas Lines**

This component appears to be performing adequately at the time of this inspection.

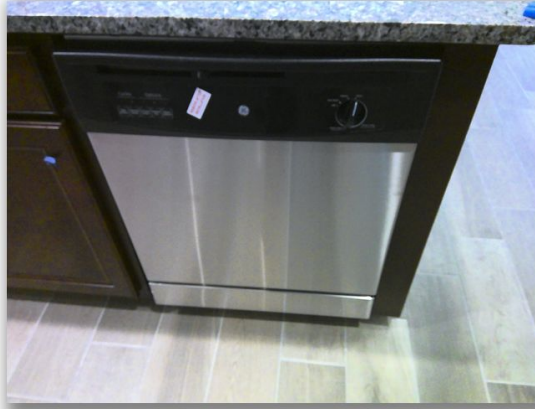
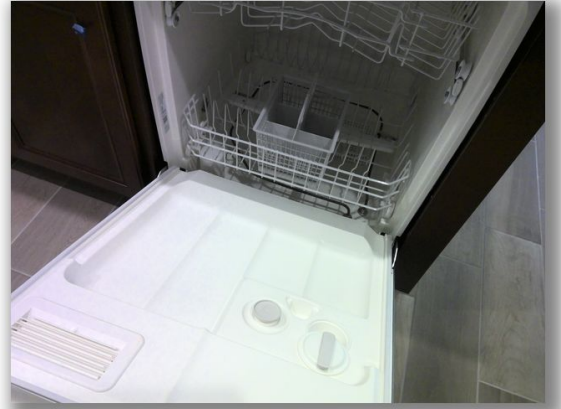
- The dishwasher was inoperative at the time of this inspection.

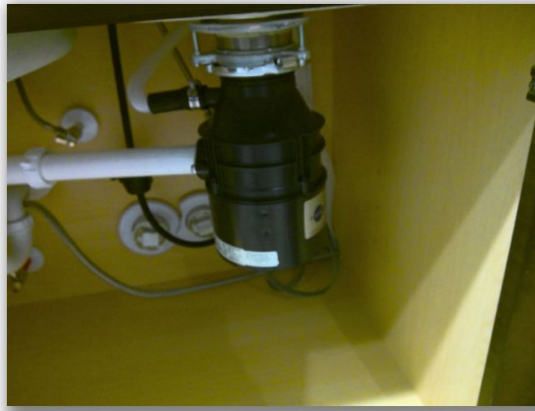
### B. Food Waste Disposers

- The food waster disposer was unusually noisy at the time of the inspection.

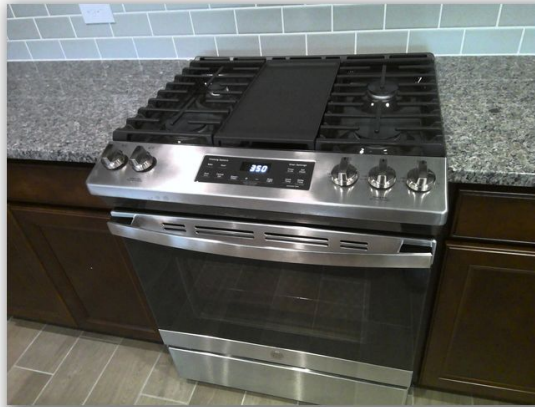
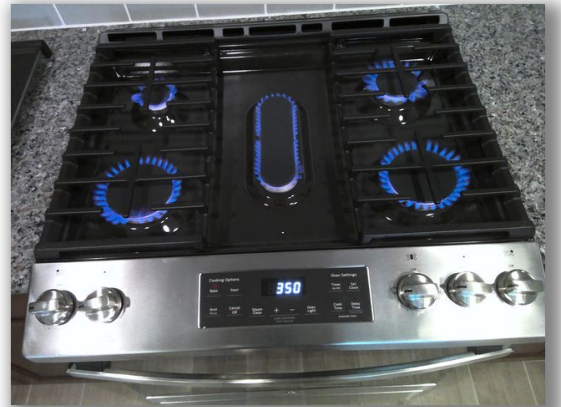
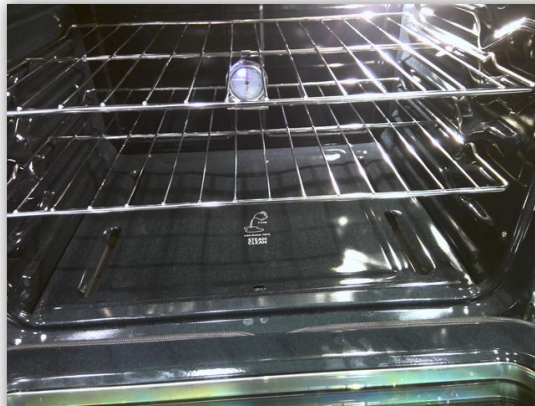
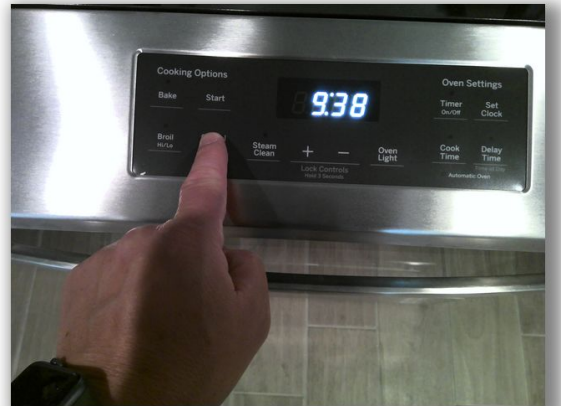
**Range Brand Name:** General Electric – GE

This component appears to be performing adequately at the time of this inspection.

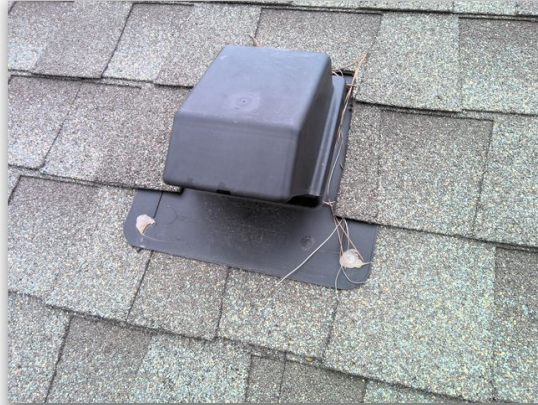
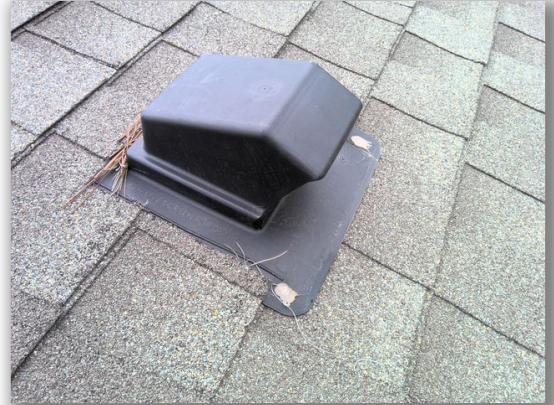
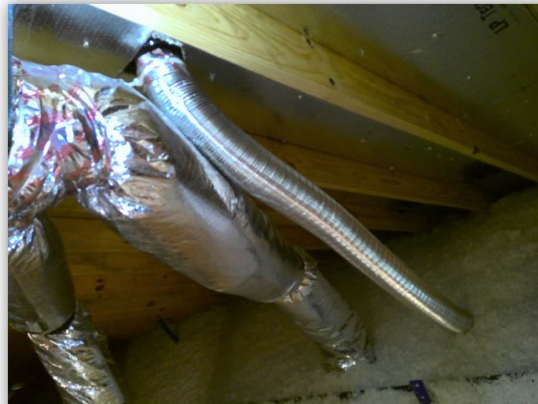
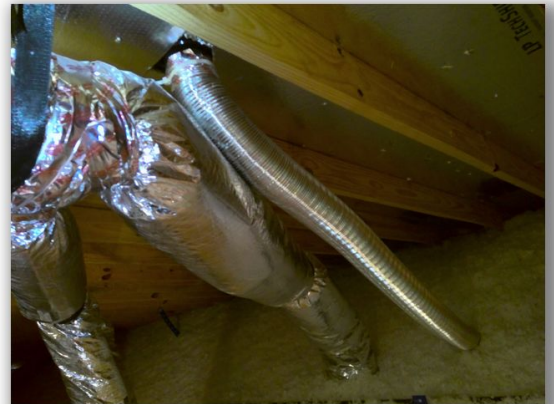
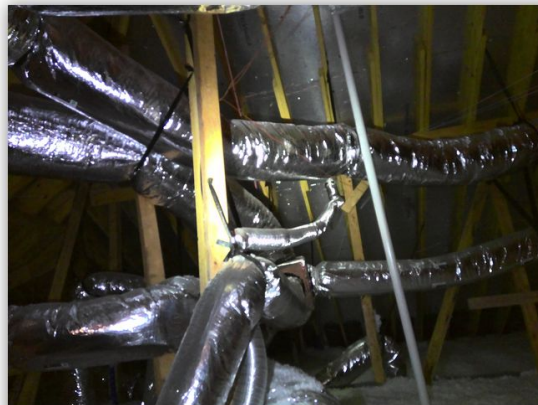
- **General Photo(s) of Mechanical Exhaust Vents**

- The ducting to one of the mechanical exhaust fans was observed to be separated in the attic area over the master bathroom.

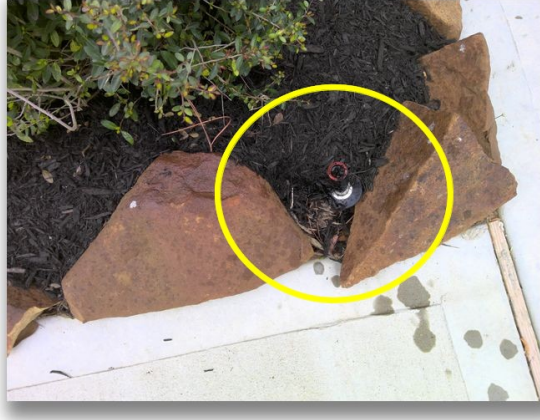
- One or more of the sprinkler heads do not disperse water in stations(s); 1.

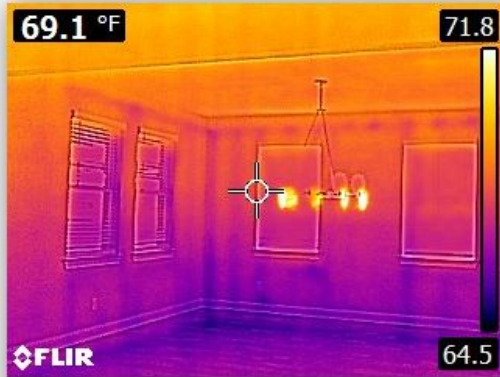
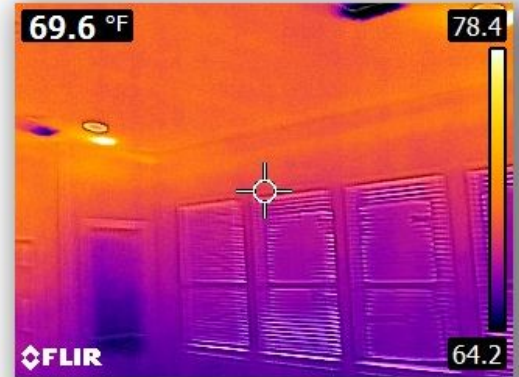
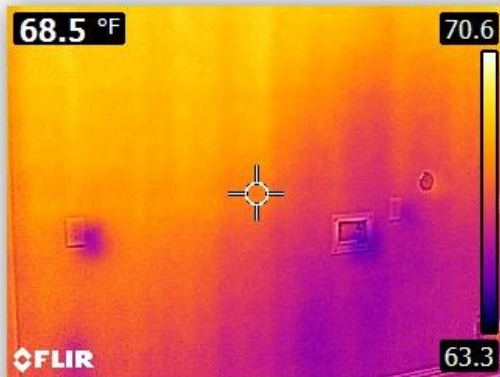
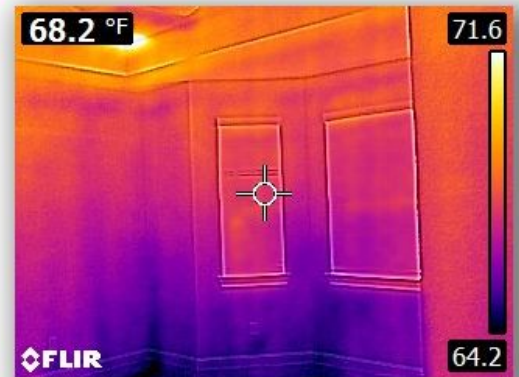
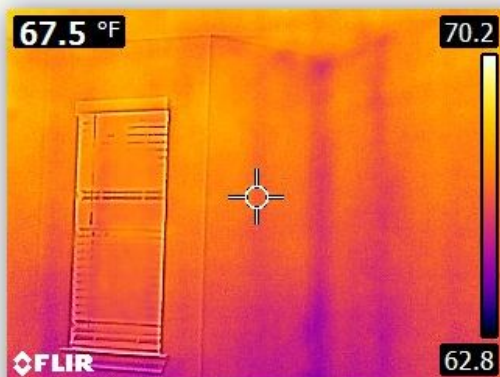
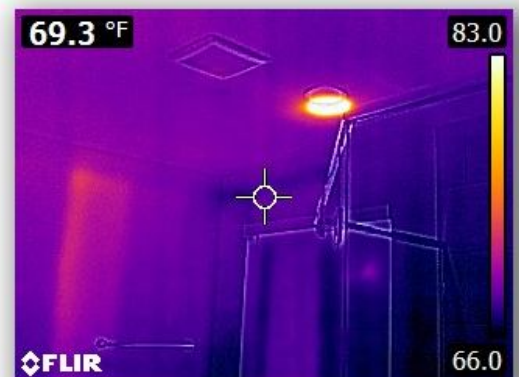
**Thermal Imaging / Infrared**

All components were found to be performing and in satisfactory condition on the day of the inspection.
